# Dragages-Nishimatsu Joint Venture

**Contract No. DC/2007/10**  
**Design and Construction of**  
**Hong Kong West Drainage Tunnel**

Monthly EM&A Report

November 2011

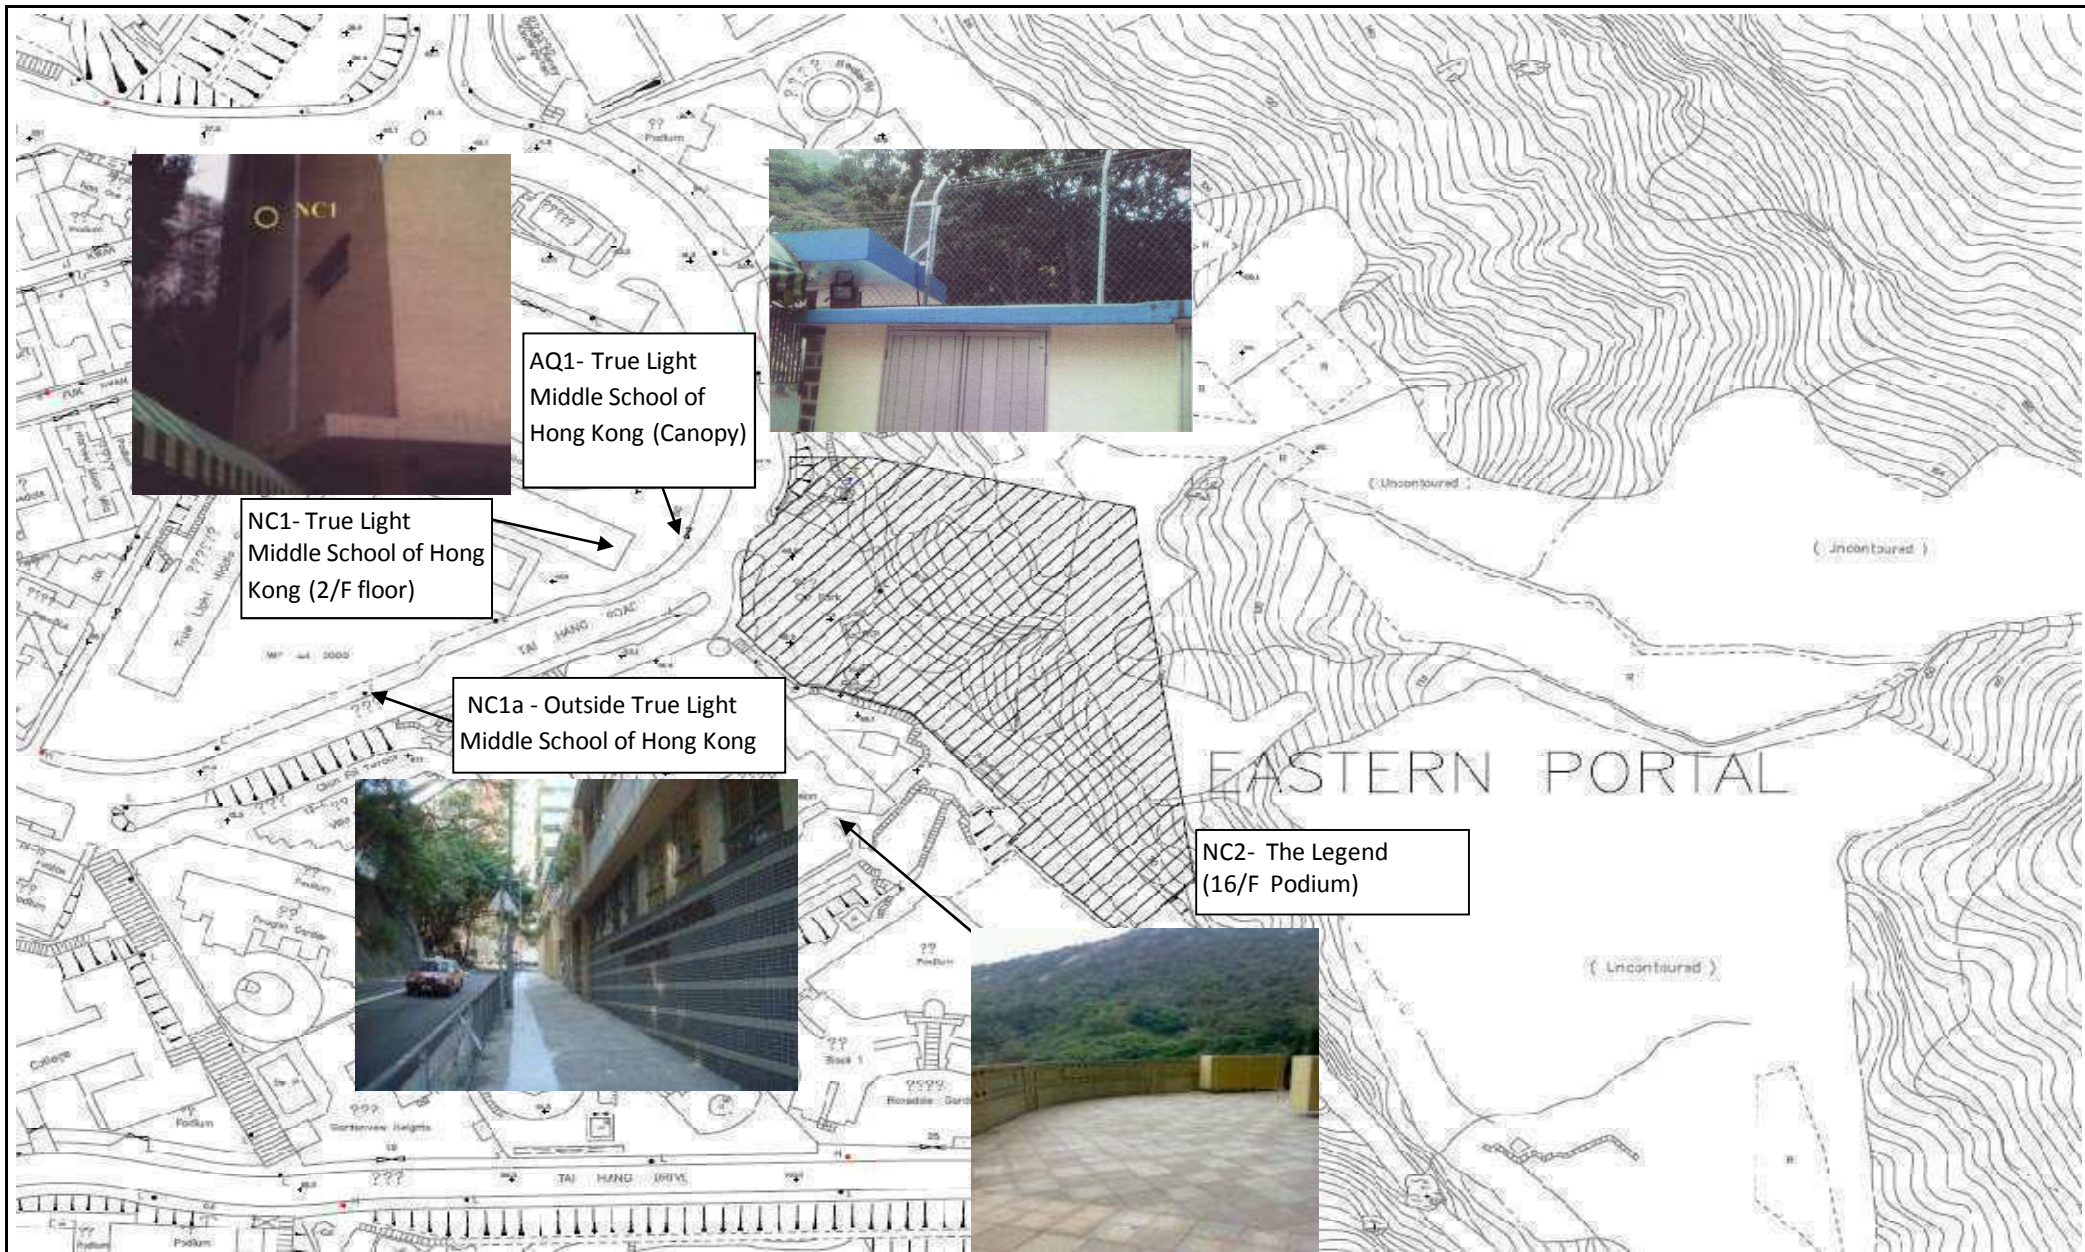
Project  
 No. MA 8001  
 Figure  
 3.1a

Title  
 Contract No. DC/2007/10  
 Design and Construction of Hong Kong West Drainage Tunnel  
 (Eastern Portal)  
 Locations of Air Quality and Noise Monitoring Station

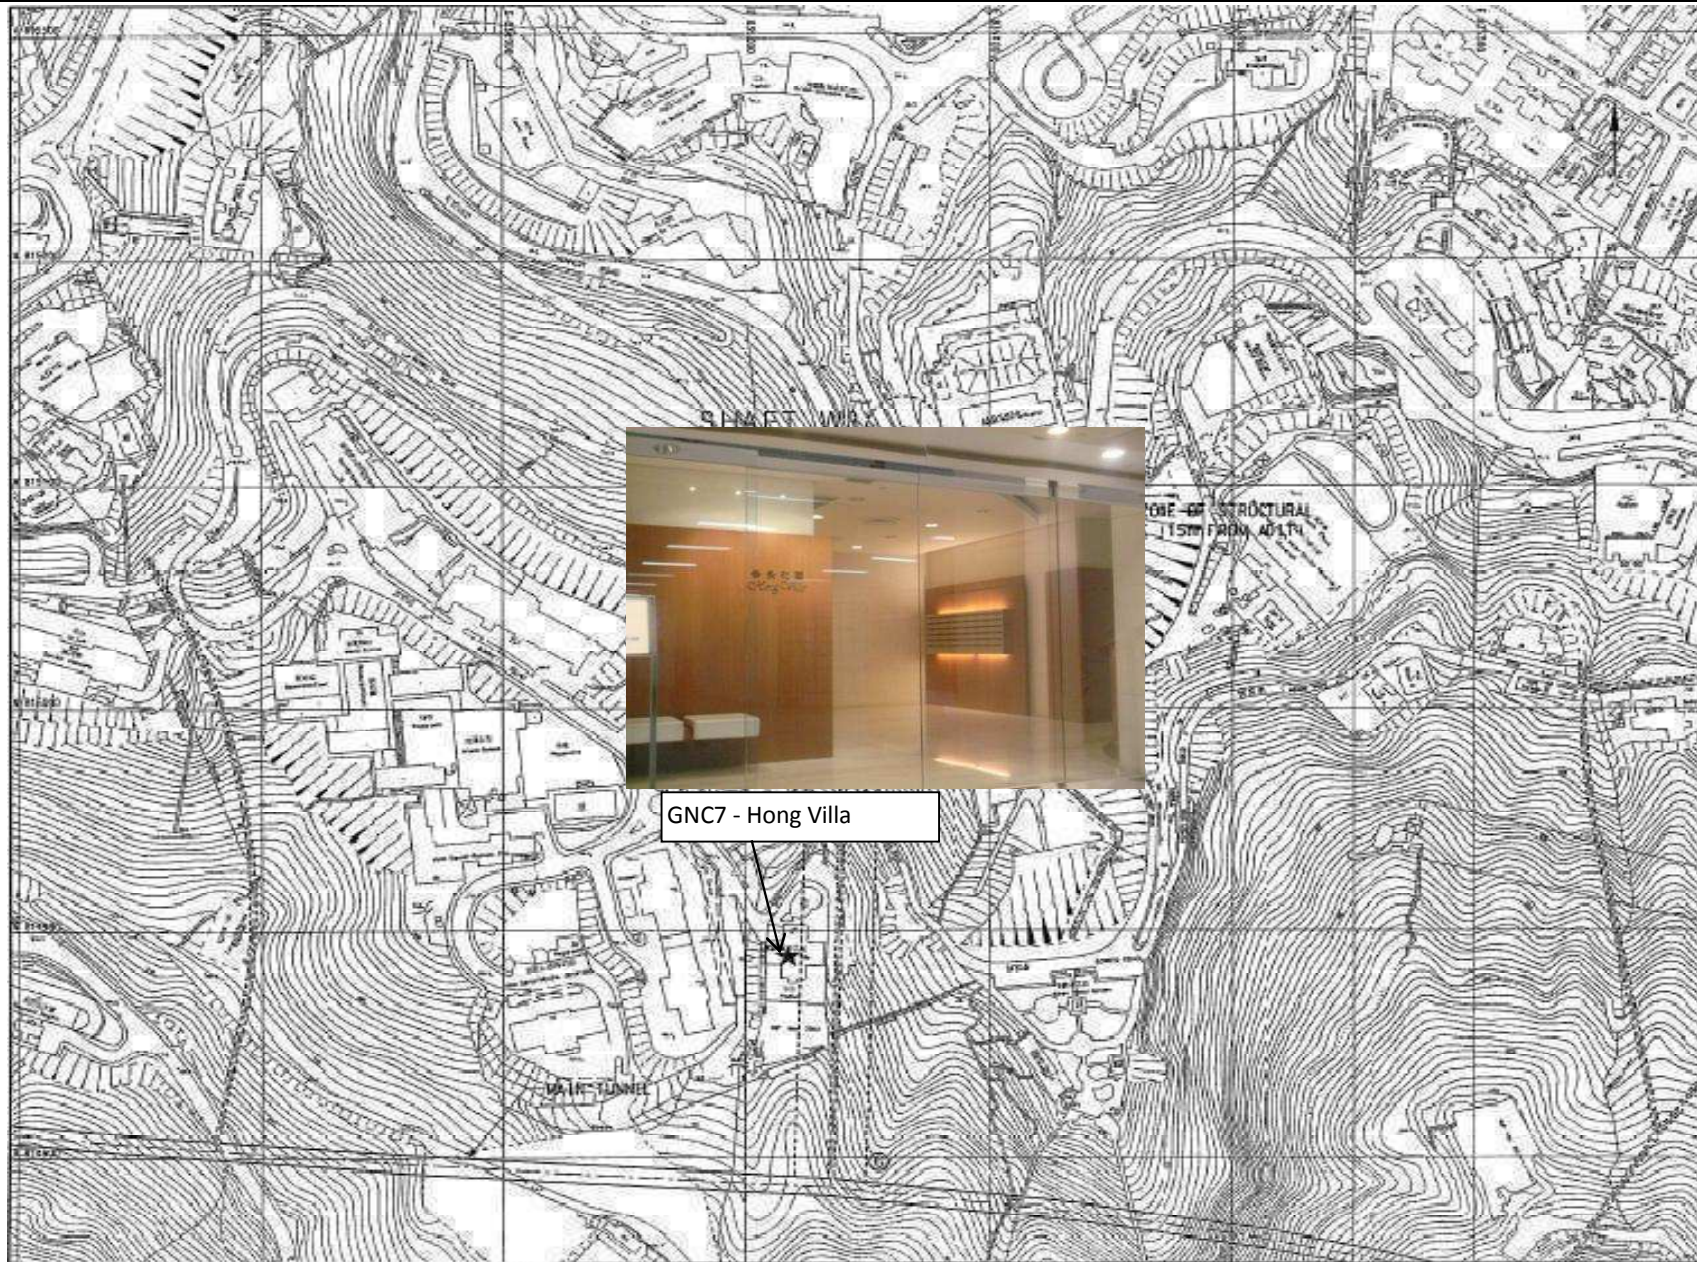
GNC7 - Hong Villa

- 3.38 In accordance with the recommendations of the EIA study, ground borne noise monitoring is required to carry out during the TBM operation. Eight designated monitoring stations (GNC1 to GNC8) are designated for construction groundborne noise monitoring to check for compliance.

Title	Contract No. DC/2007/10		Scale	Project		CINOTECH
	Design and Construction of Hong Kong West Drainage Tunnel		N.T.S	No.	MA 8001	
	Locations of Groundborne Noise Monitoring Station		Date	Figure		
	GNC7 (Hong Villa)		Nov-10	3.1o

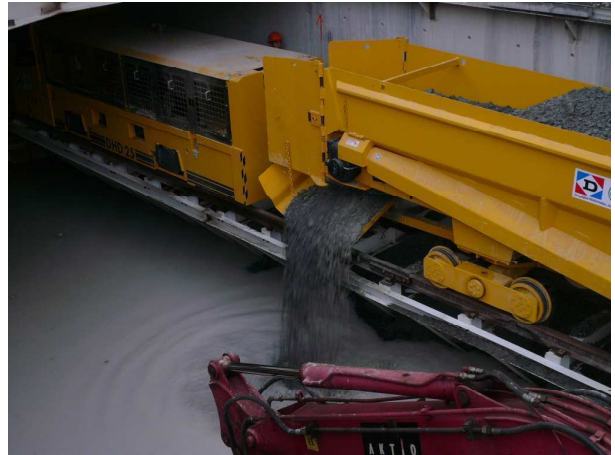
**Photo 5: Shuttle car discharging excavated materials at the Adit Spoil Basin**

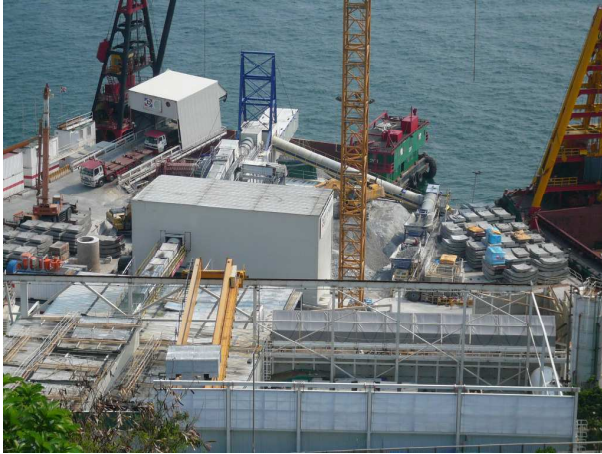
**Photo 8:** Covered Conveyors

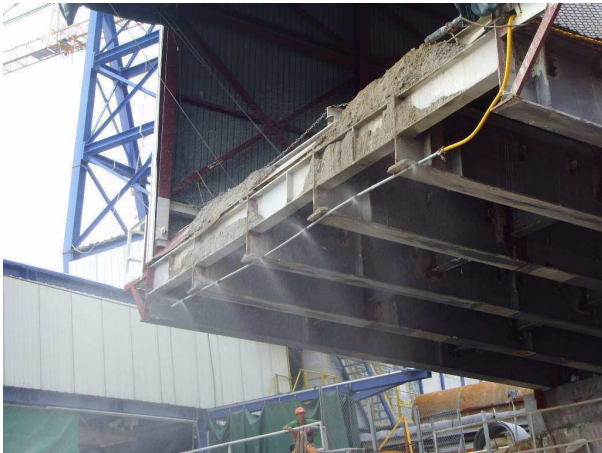
**Photo 9:** Sprinkler system installed at the ramp jetty

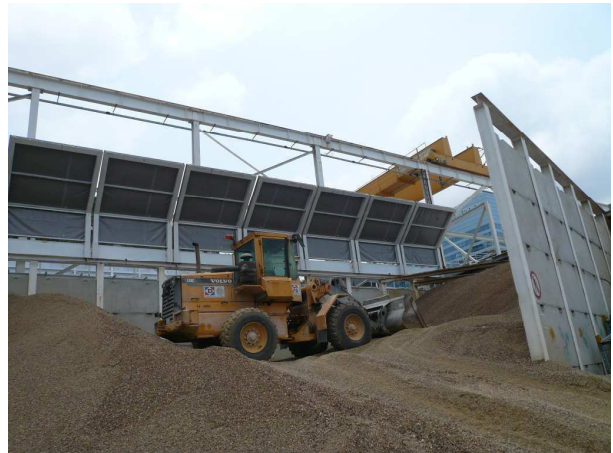
In addition to the noise enclosure erected at the Western Portal, a row of noise barrier was built in the Western Portal adjacent the pea gravel storage yard (*Photo 12*). The barrier does not only screen the mobile plant at the pea gravel storage yard from the views of the Aegean Terrace residents, but it shields part of the noise generated from the operation of such plant. There is another row of barriers erected at the side abutting the Cyberport Road (*Photo 13*).

**Photo 12:** Noise barrier at the pea gravel storage yard at the side facing Aegean Terrace

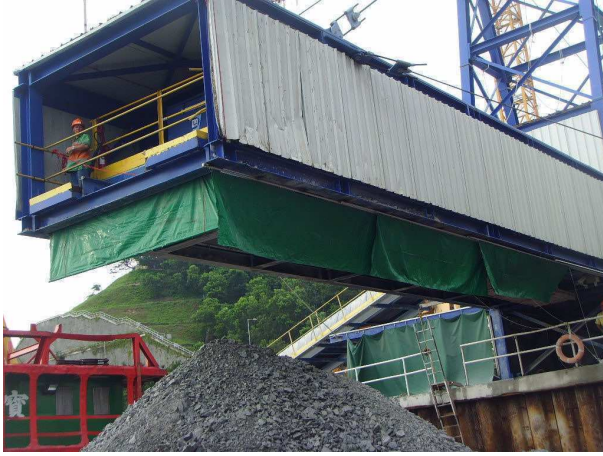
**Photo 10: Dust curtains at the discharge point**

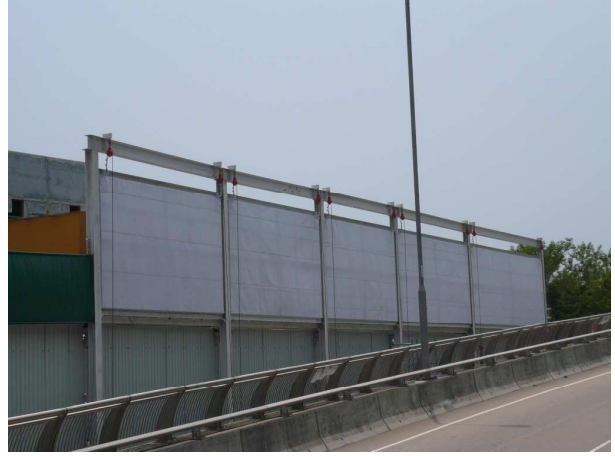
**Photo 13: Noise barrier along Cyberport Road**
