Contract No. DC/2007/10
Design and Construction of
Hong Kong West Drainage Tunnel

Monthly EM&A Report

December 2011
(version 3.0)

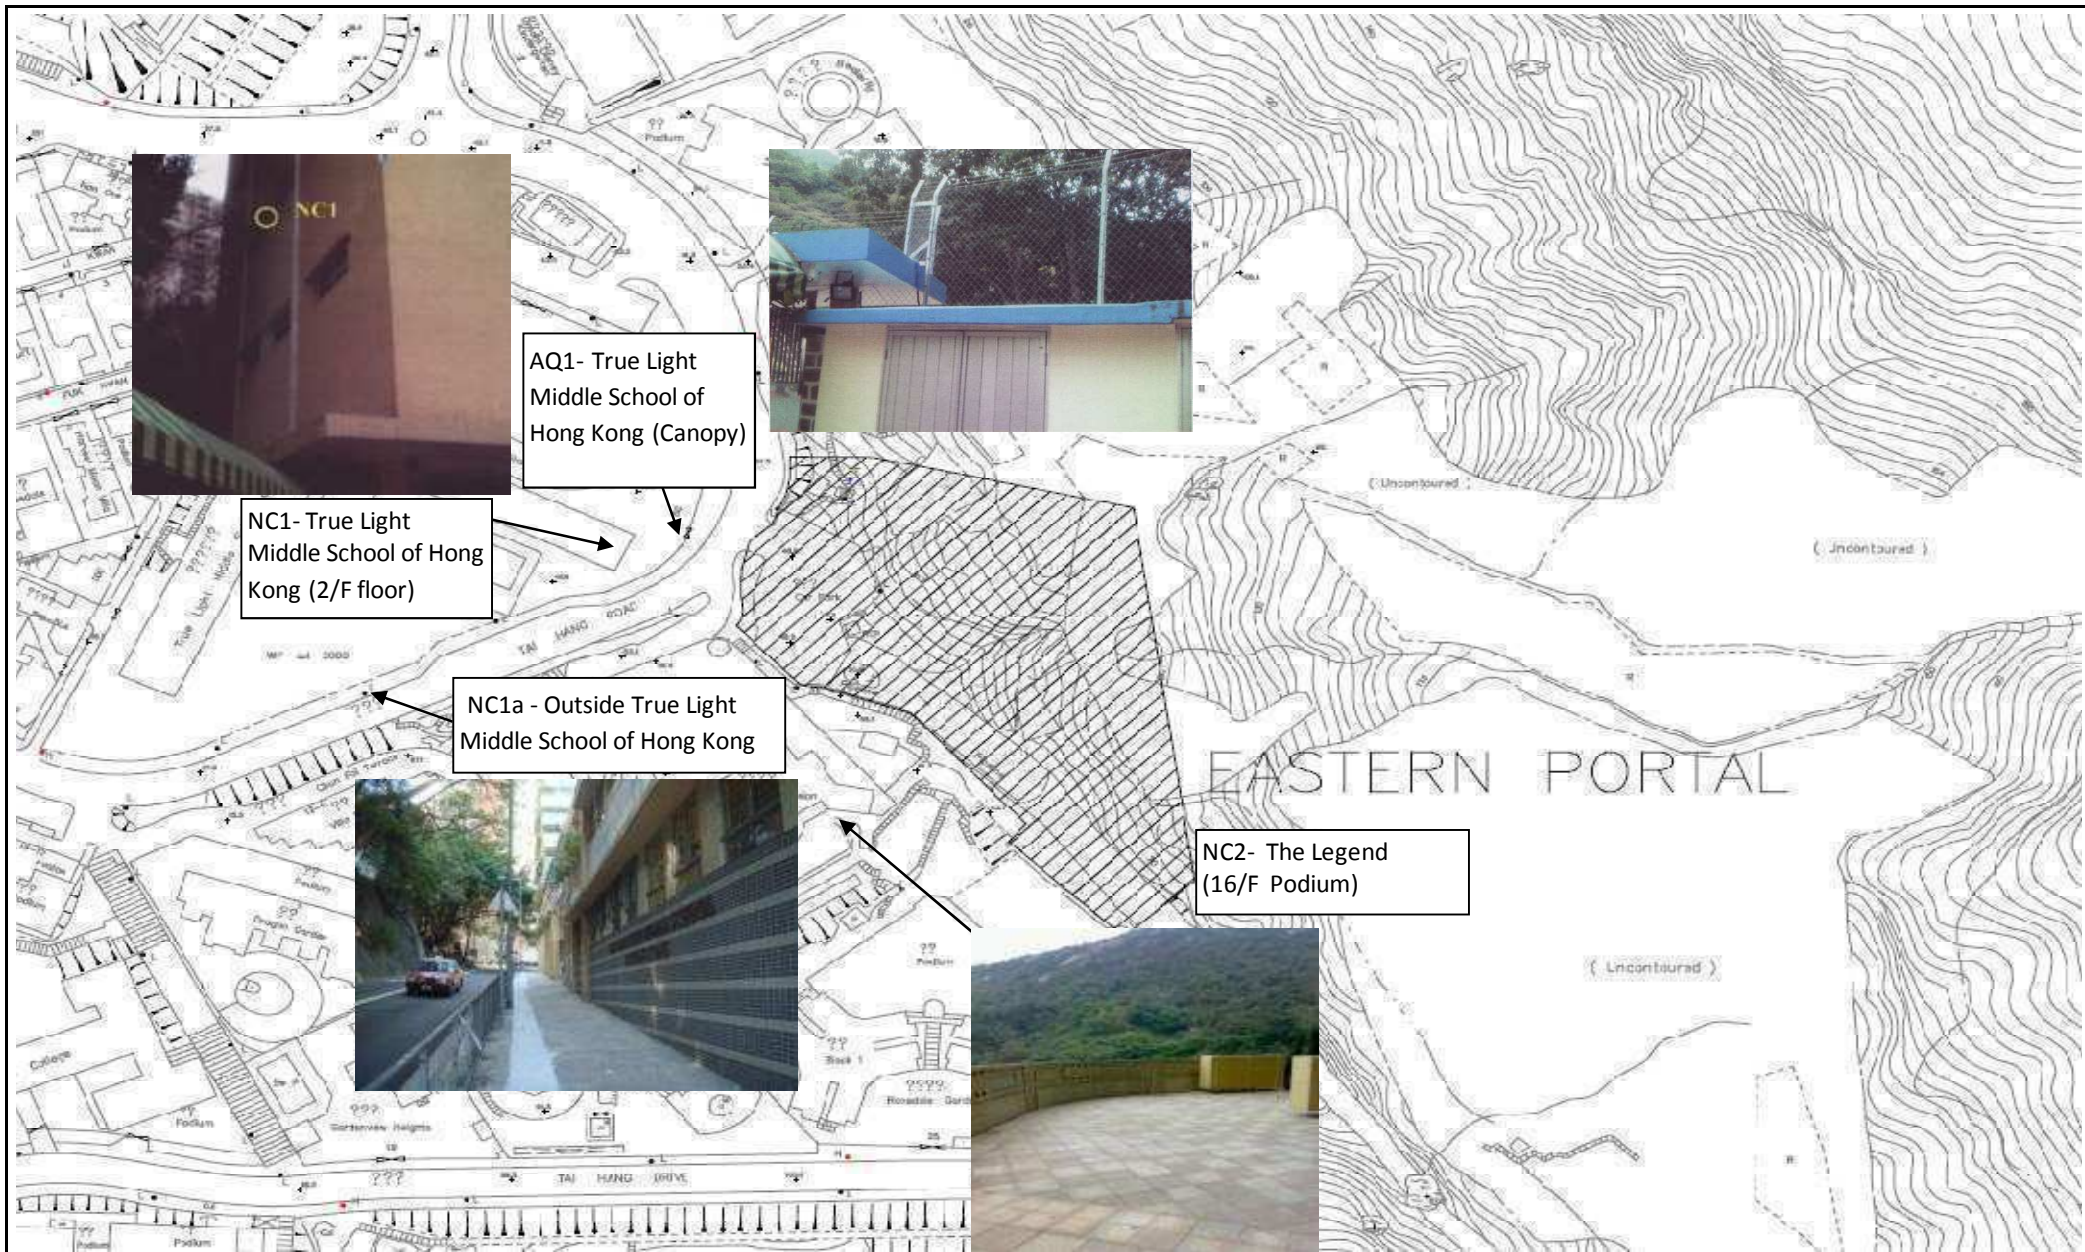
Title
 Contract No. DC/2007/10
 Design and Construction of Hong Kong West Drainage Tunnel
 (Eastern Portal)
 Locations of Air Quality and Noise Monitoring Station

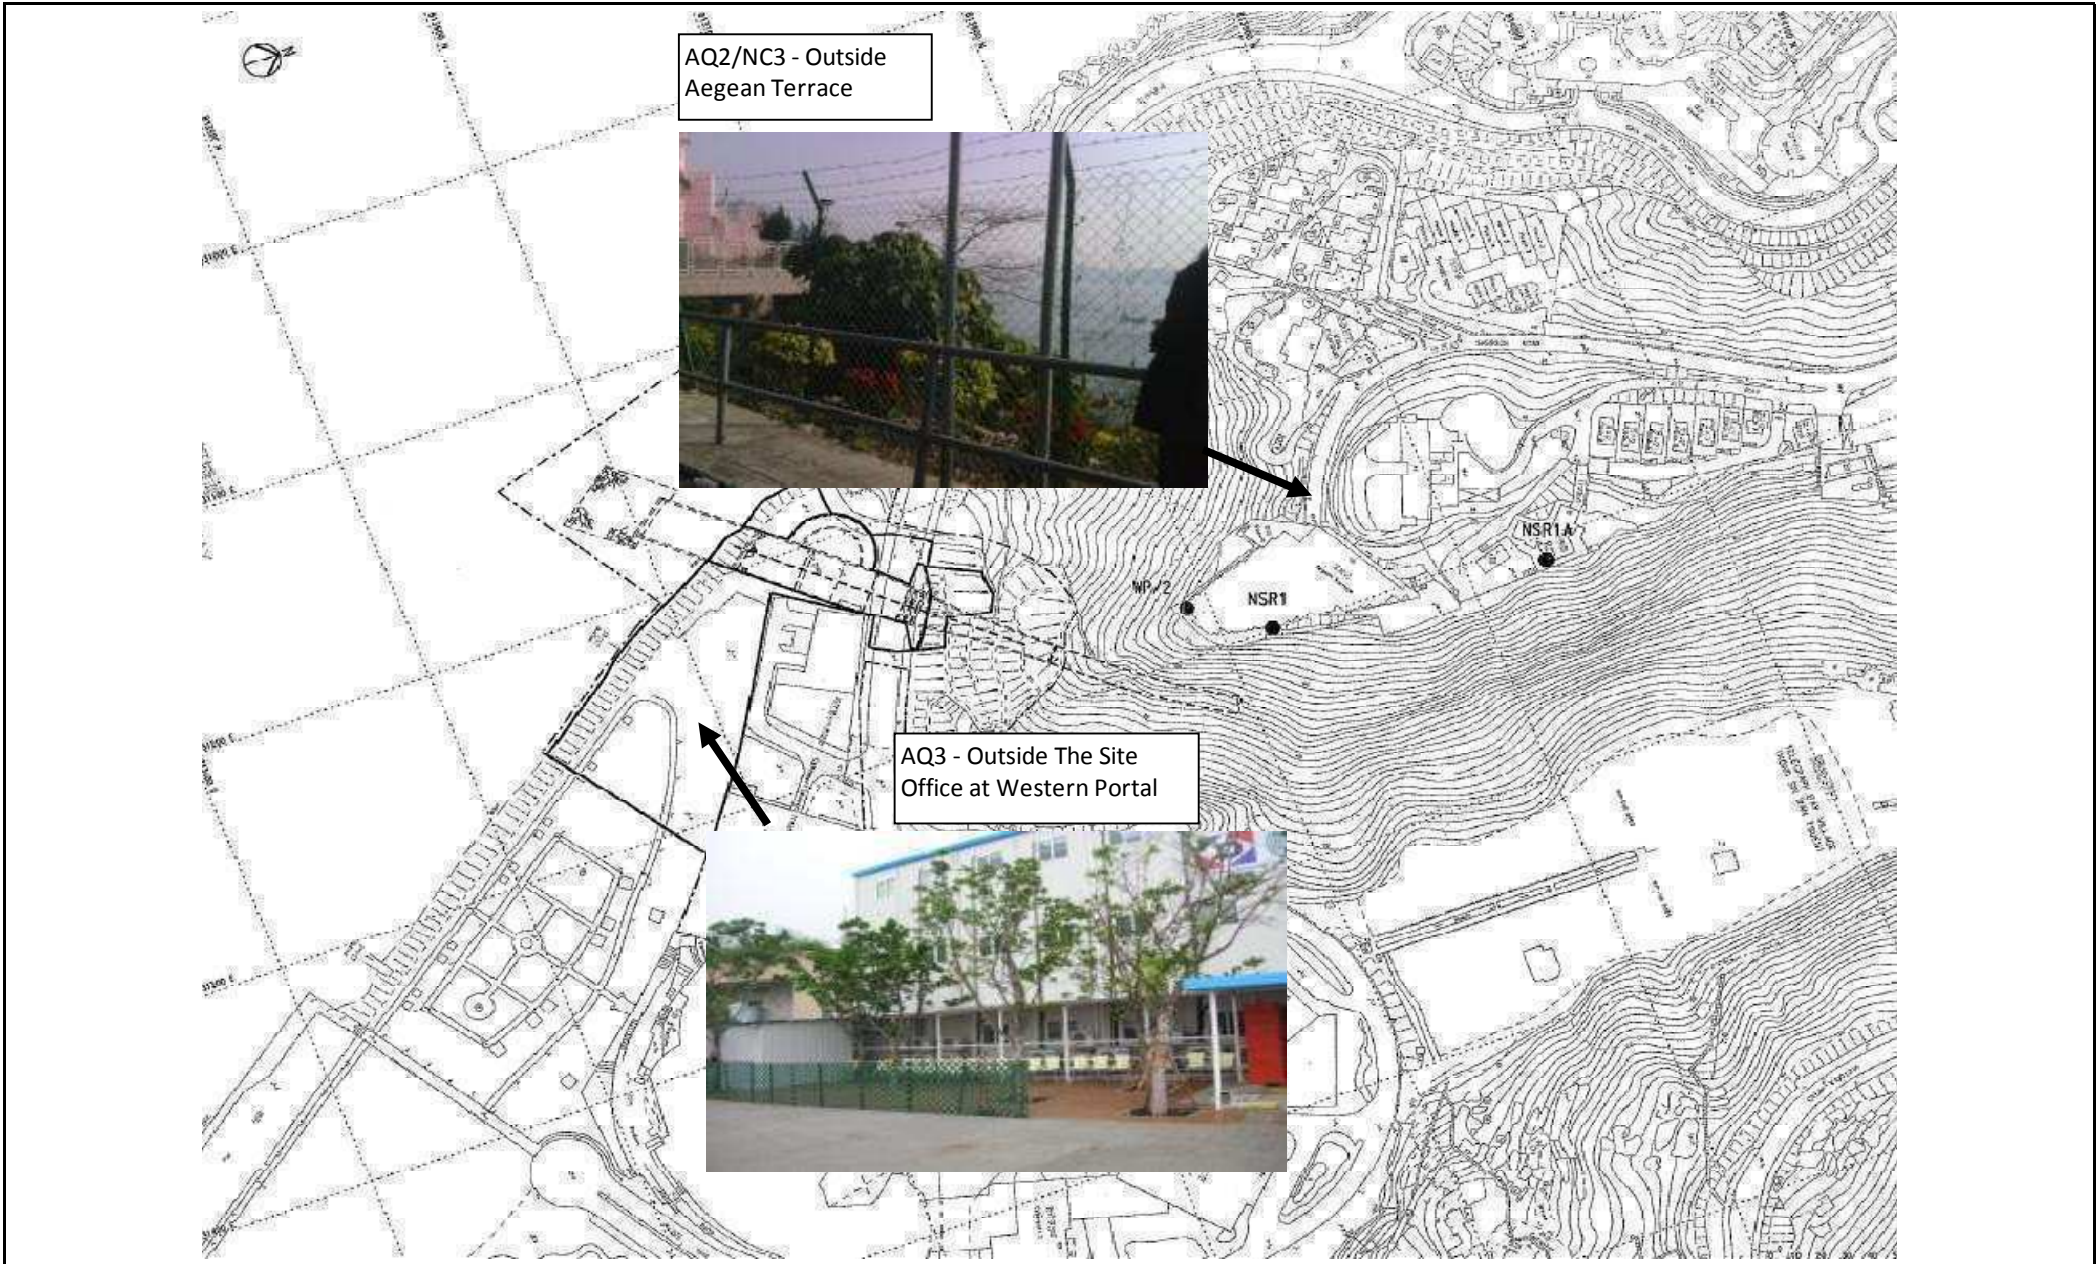
Title	Contract No. DC/2007/10		Scale	Project		CINOTECH
	Design and Construction of Hong Kong West Drainage Tunnel (Western Portal)		N.T.S	No.	MA 8001	
	Locations of Air Quality and Noise Monitoring Station		Date	Sep-09	Figure	3.1b

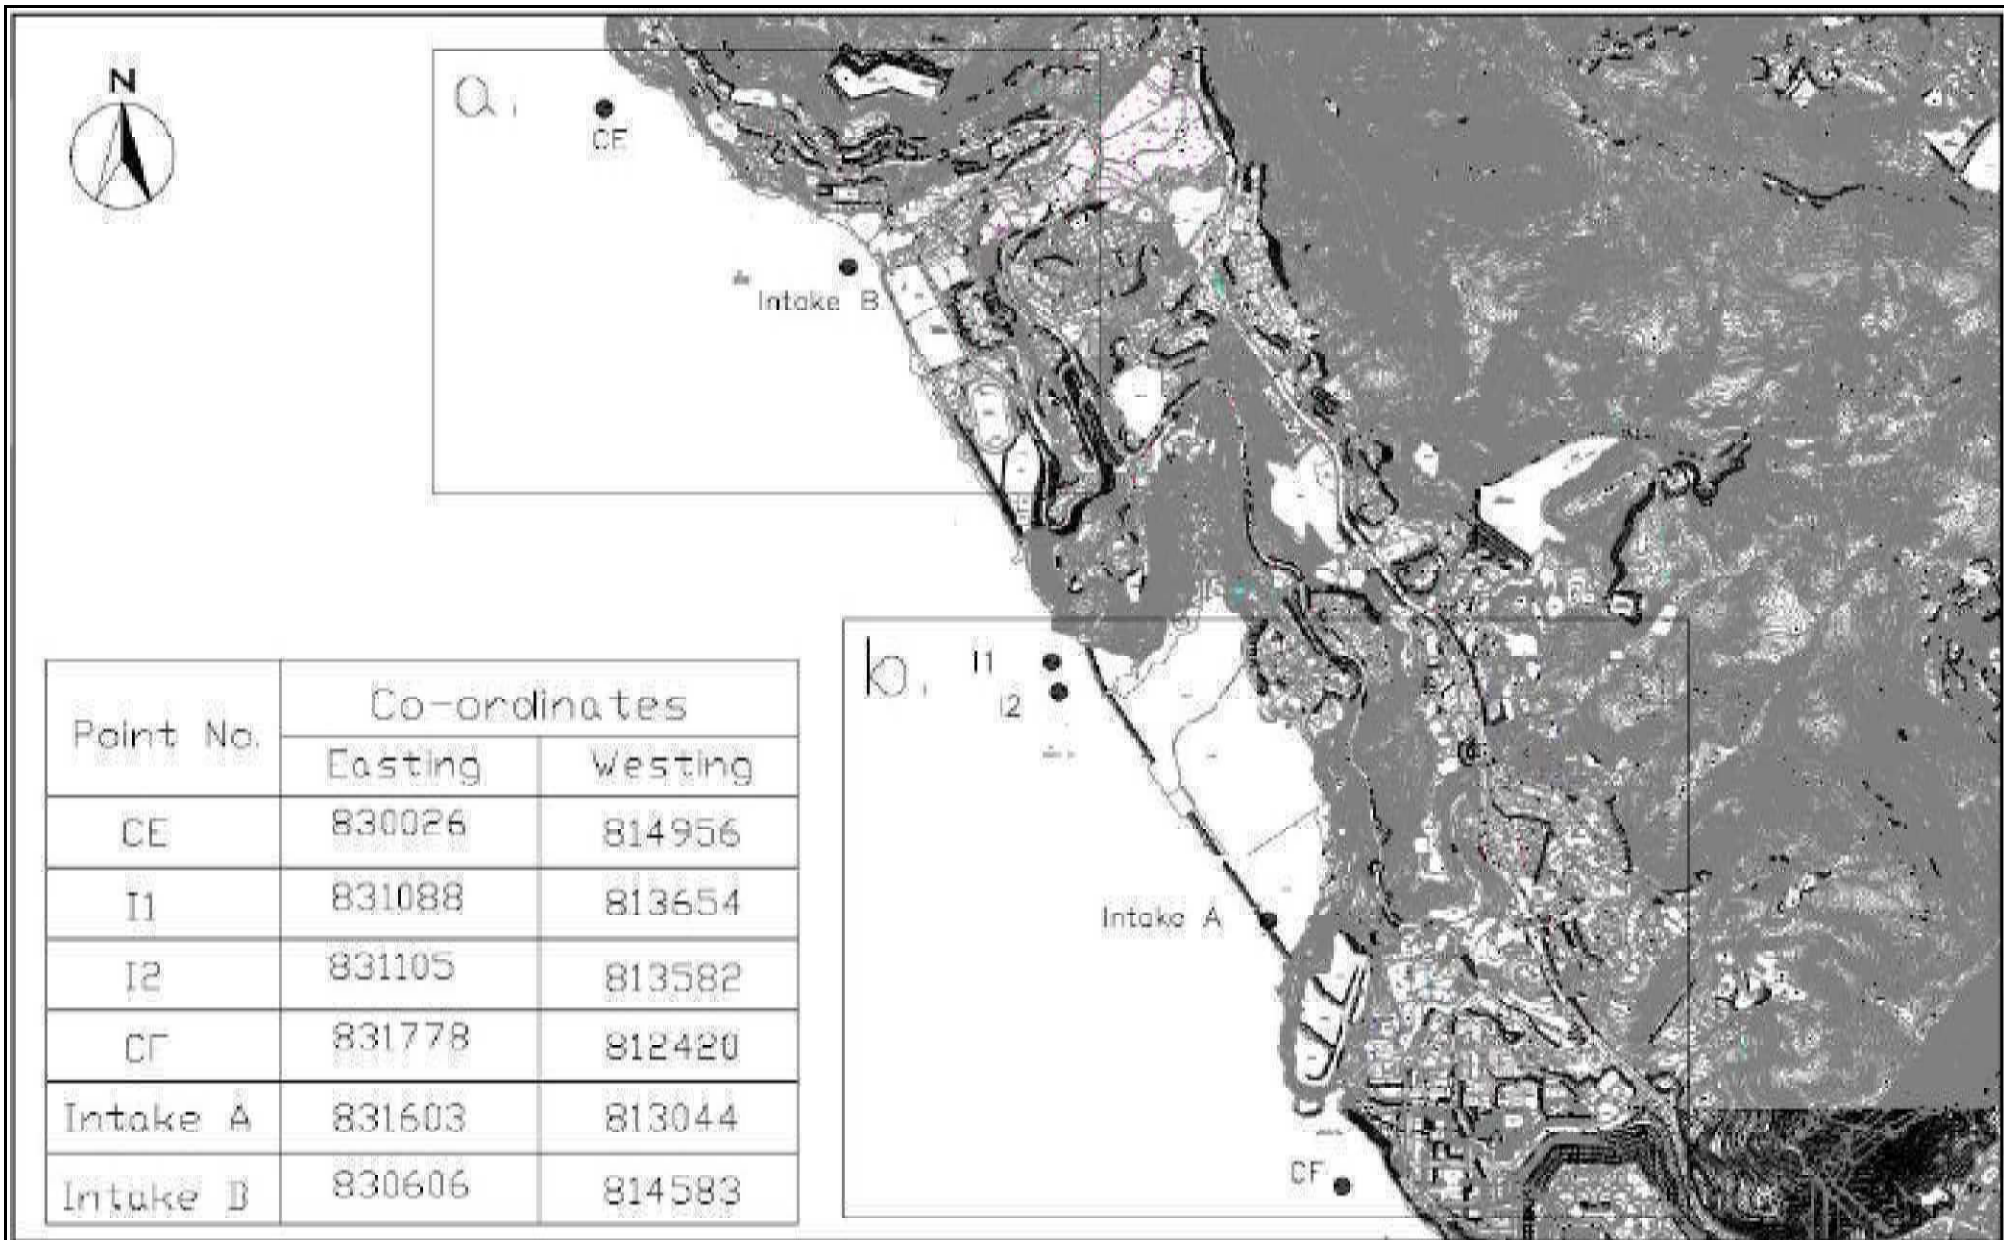
Title	Contract No. DC/2007/10		Scale	Project	CINOTECH
	Design and Construction of Hong Kong West Drainage Tunnel		N.T.S	No. MA8001	
	Locations of Water Quality Monitoring Stations		Date	Figure	
			Jun-08	4.1

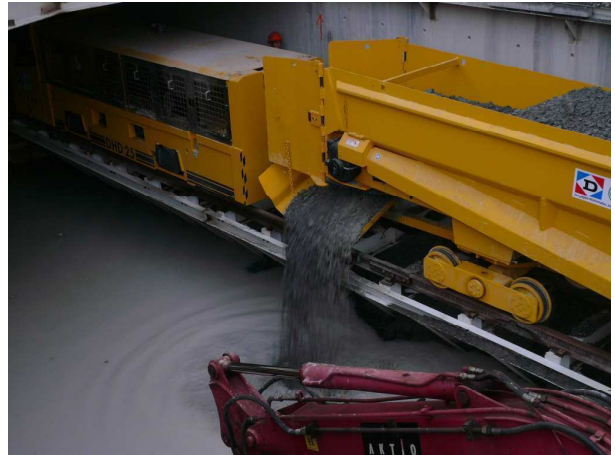
Photo 5: Shuttle car discharging excavated materials at the Adit Spoil Basin

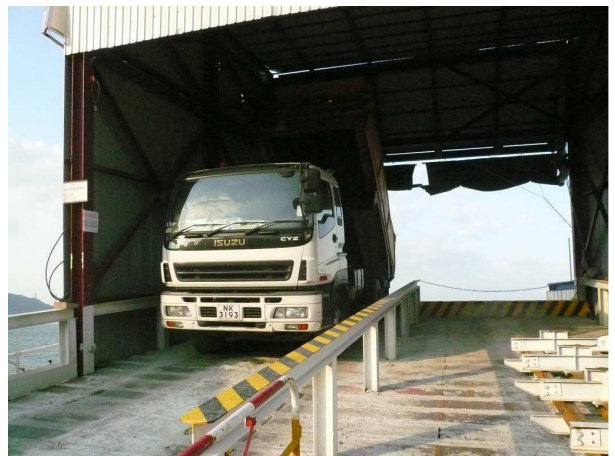
Photo 7: Dump truck discharging excavated materials onto the barge at the ramp jetty

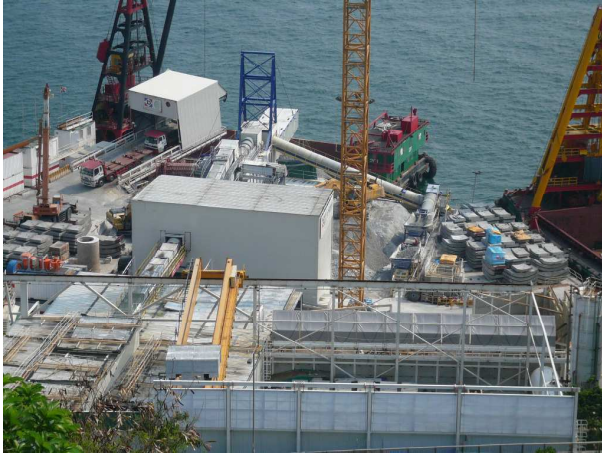
Photo 8: Covered Conveyors

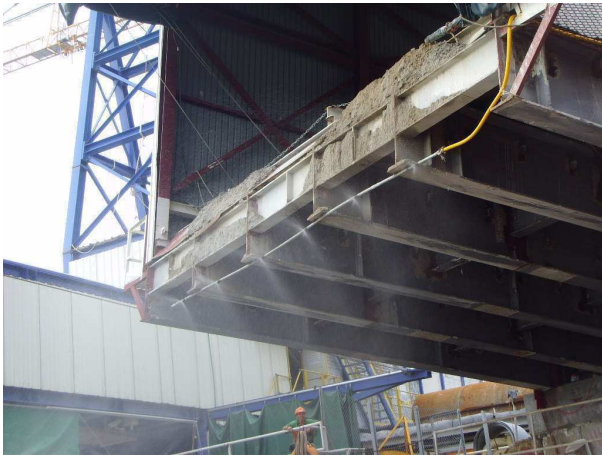
Photo 9: Sprinkler system installed at the ramp jetty

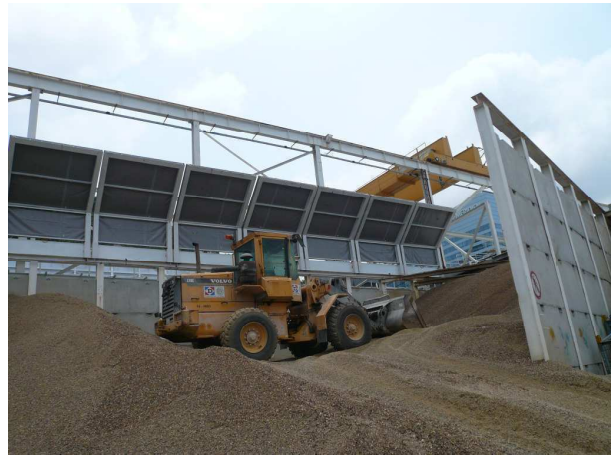
In addition to the noise enclosure erected at the Western Portal, a row of noise barrier was built in the Western Portal adjacent the pea gravel storage yard (*Photo 12*). The barrier does not only screen the mobile plant at the pea gravel storage yard from the views of the Aegean Terrace residents, but it shields part of the noise generated from the operation of such plant. There is another row of barriers erected at the side abutting the Cyberport Road (*Photo 13*).

Photo 12: Noise barrier at the pea gravel storage yard at the side facing Aegean Terrace

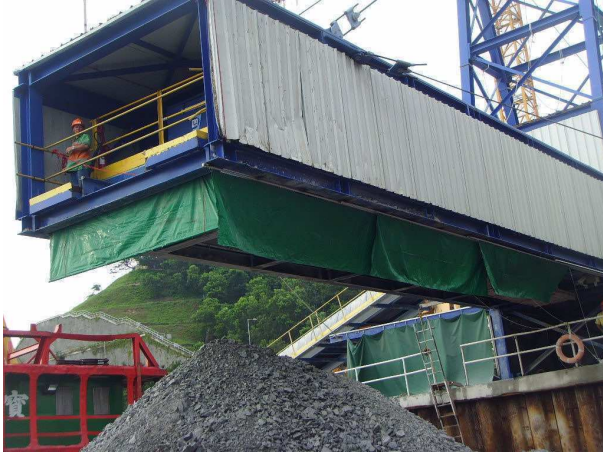
Photo 10: Dust curtains at the discharge point

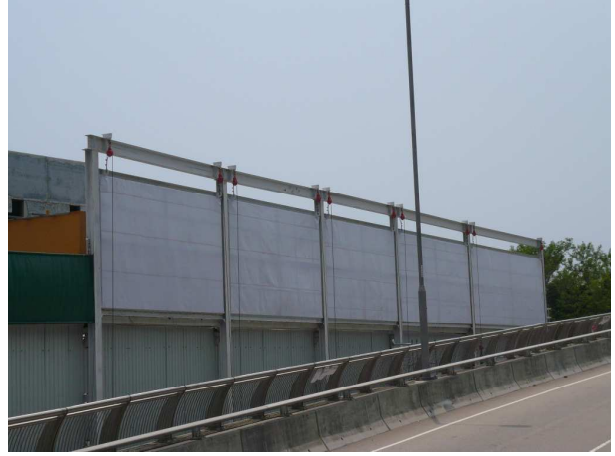
Photo 13: Noise barrier along Cyberport Road

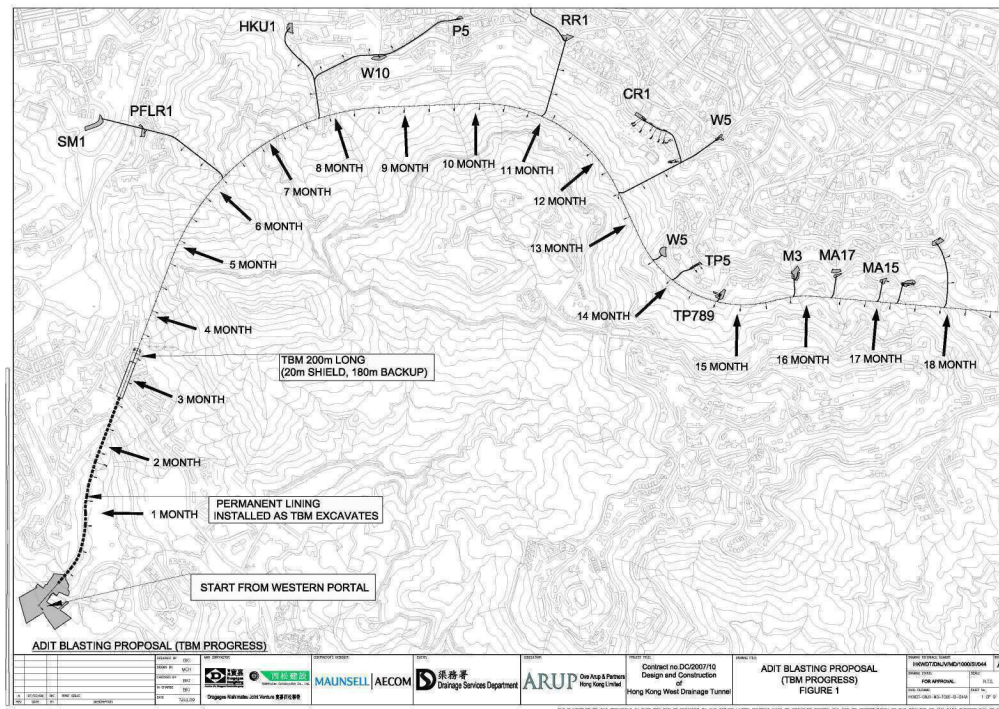
Figure 1 illustrates the alignment of the West Tunnel and West Adits and the progress of TBM excavation in the West Tunnel.

Figure 1: West Tunnel/Adit Alignment and TBM Progress
