# Dragages-Nishimatsu Joint Venture

**Contract No. DC/2007/10**  
**Design and Construction of**  
**Hong Kong West Drainage Tunnel**

Monthly EM&A Report

March 2012  
(version 2.0)

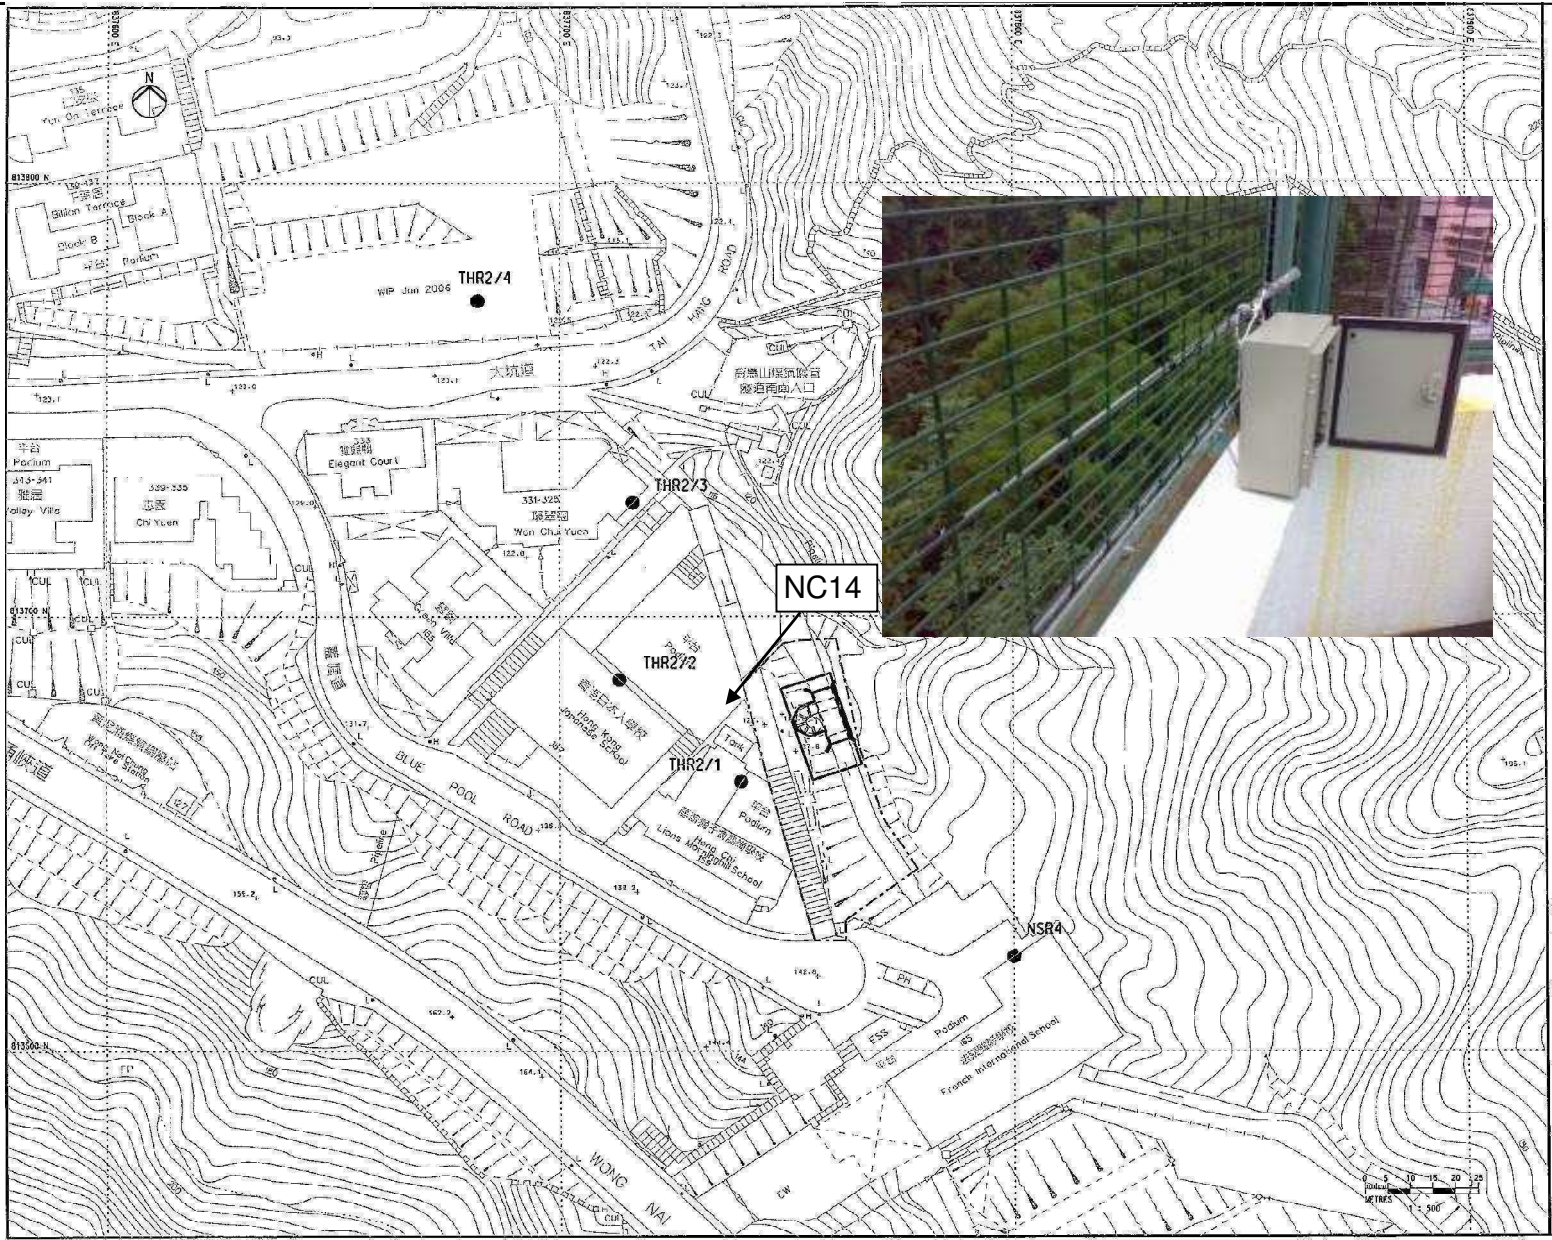
Project  
 No. MA 8001  
 Figure  
 3.1h

Title  
 Contract No. DC/2007/10  
 Design and Construction of Hong Kong West Drainage Tunnel  
 (Intakes E5A)  
 Locations of Noise Monitoring Stations

- 3.2 Noise monitoring was conducted at 19 designated monitoring stations as listed in Table 3.1. **Figure 3.1a-n** shows the locations of these stations.
- 3.3 The location of Hong Kong Academy, the noise monitoring station (NC15) at nearby the construction site (Intake W0), has been removed. The existing location has become a temporarily vacancy for future purpose. Therefore, the proposed location (NC15a) is shifted to the 12 Tung Shan Terrace from the original location.

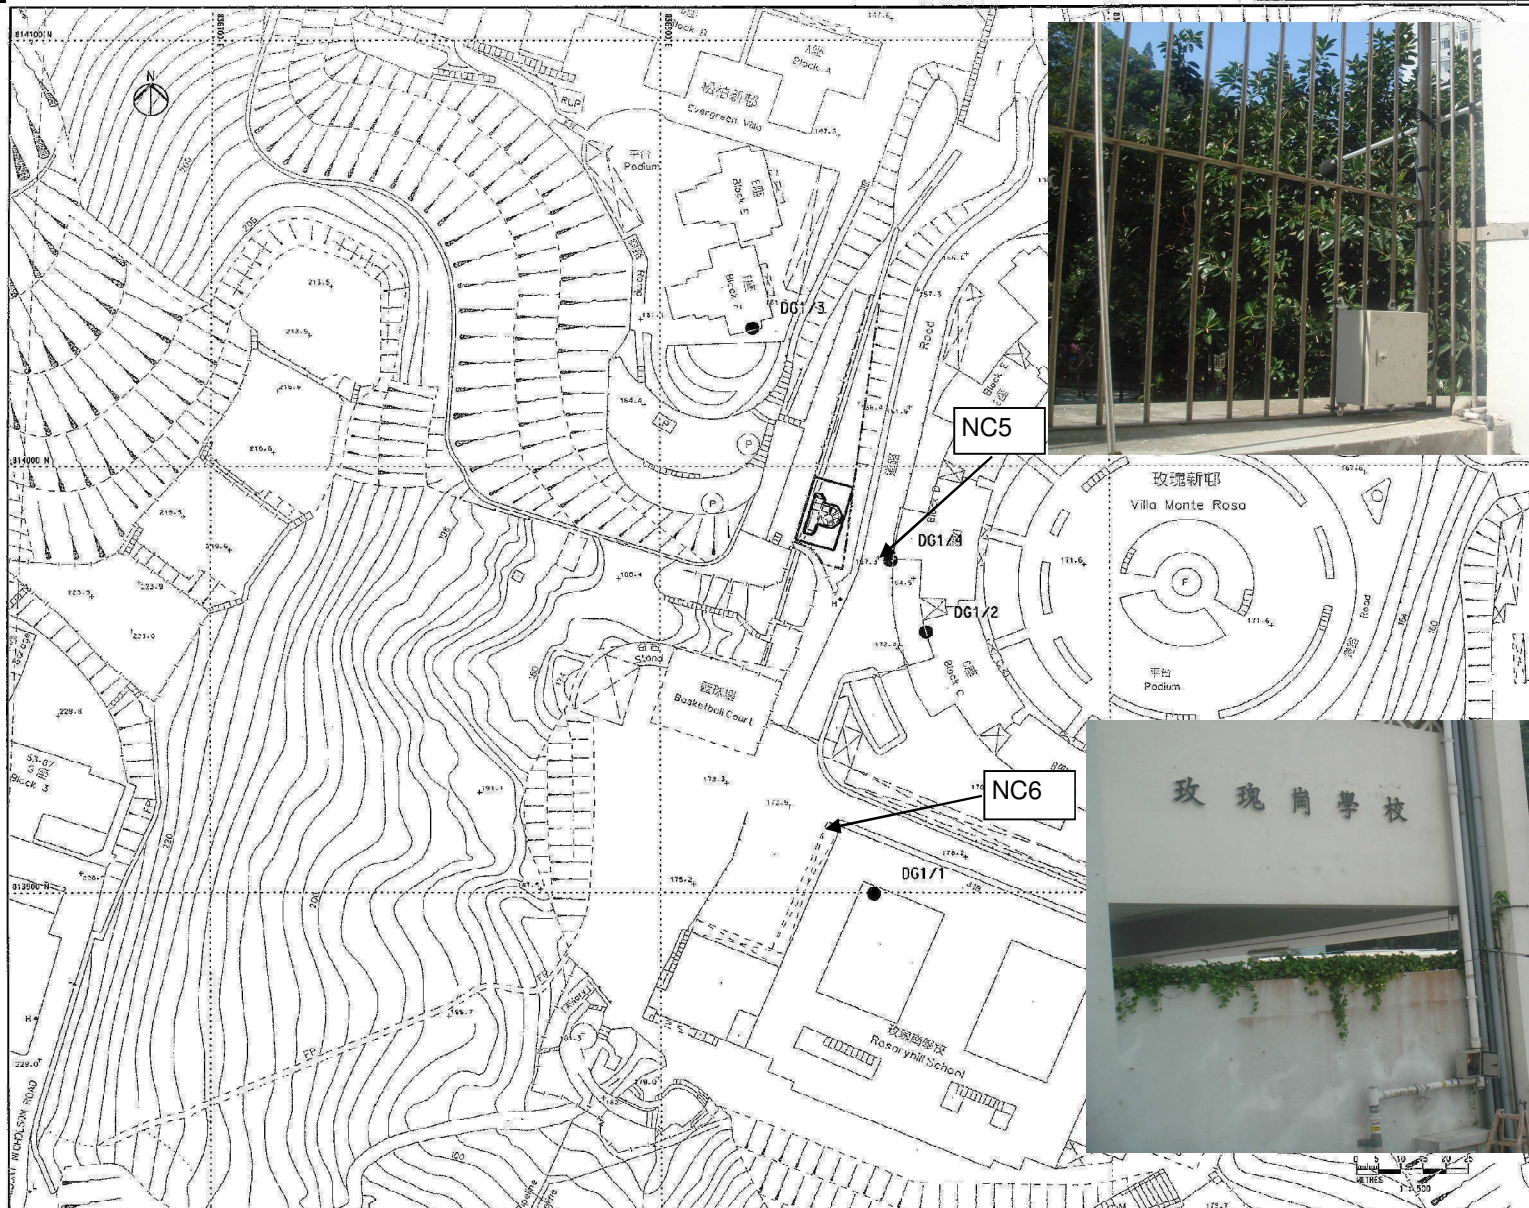
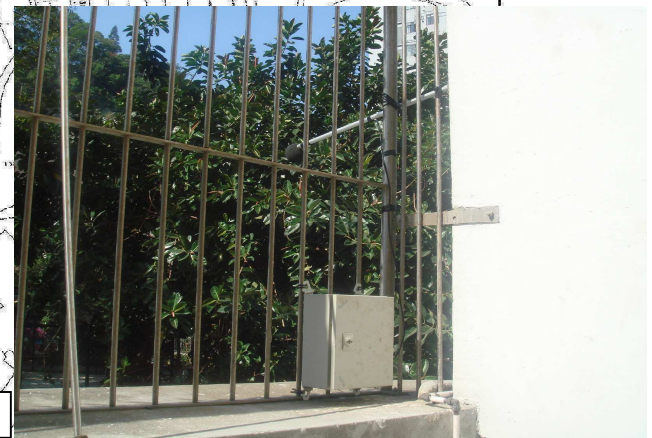
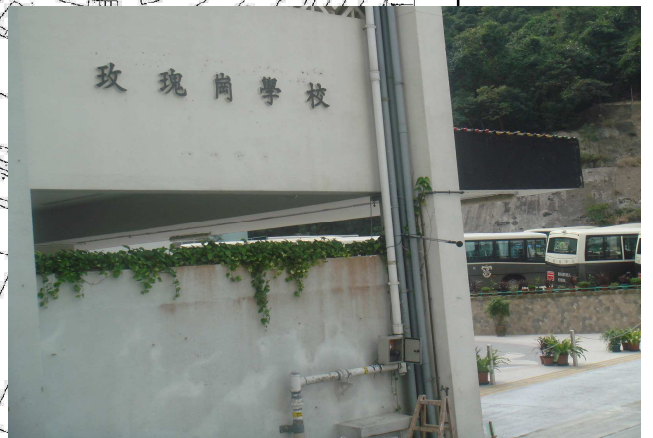
3.1k

Contract No. DC/2007/10  
 Design and Construction of Hong Kong West Drainage Tunnel  
 (Intake W8)  
 Locations of Noise Monitoring Stations

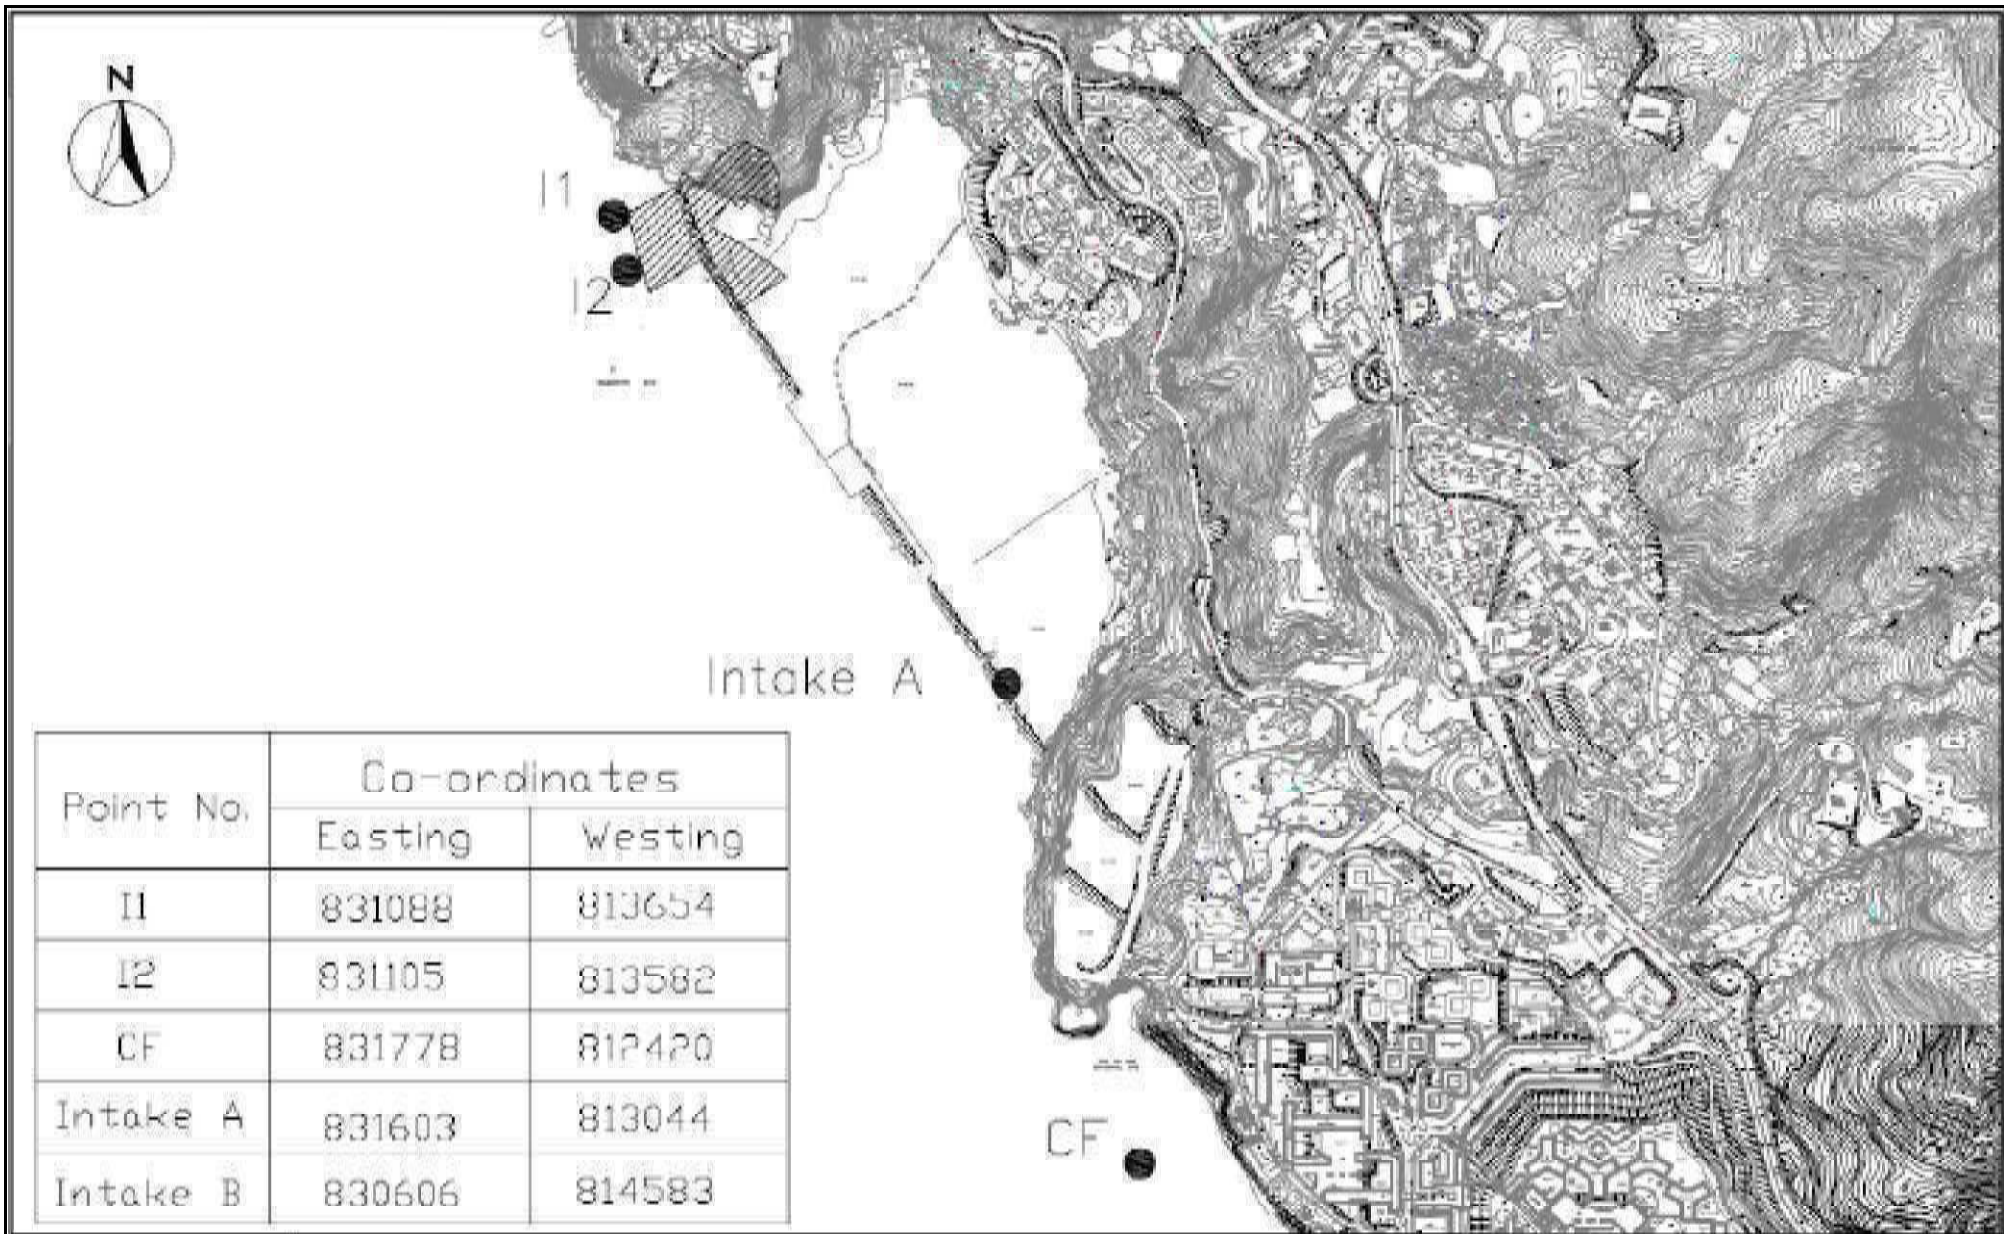
Scale	N.T.S	Project No.	MA8001
Date	Jun-08	Figure	4.1a

Title Contract No. DC/2007/10  
 Design and Construction of Hong Kong West Drainage Tunnel  
 Locations of Water Quality Monitoring Stations

- 4.3 Locations of designated Water Quality Monitoring Stations are shown in **Figure 4.1a-b** and described in Table 4.1. Samples shall be taken at all designated Monitoring and Control Stations.

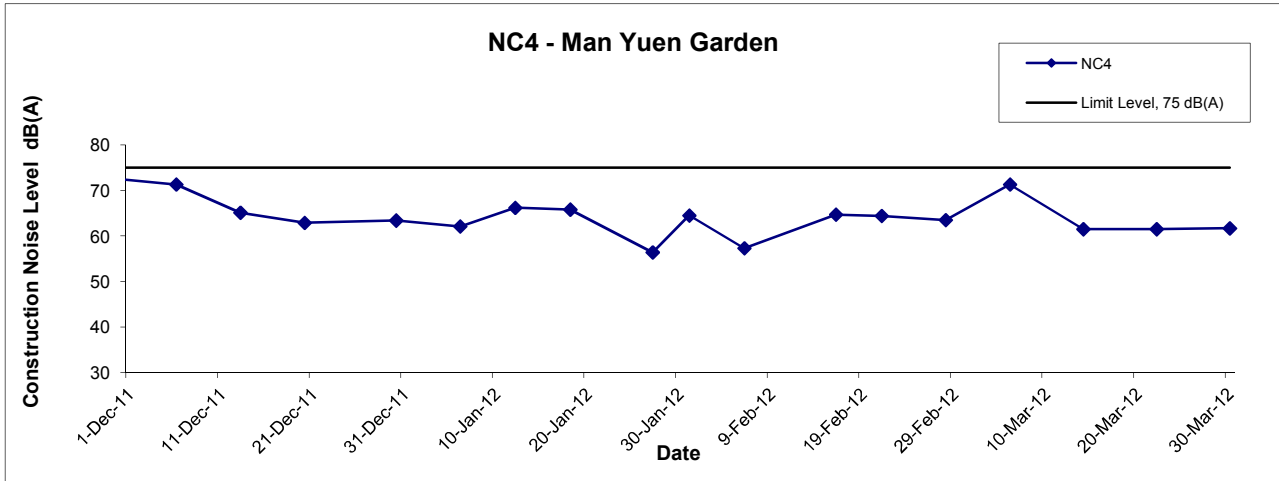
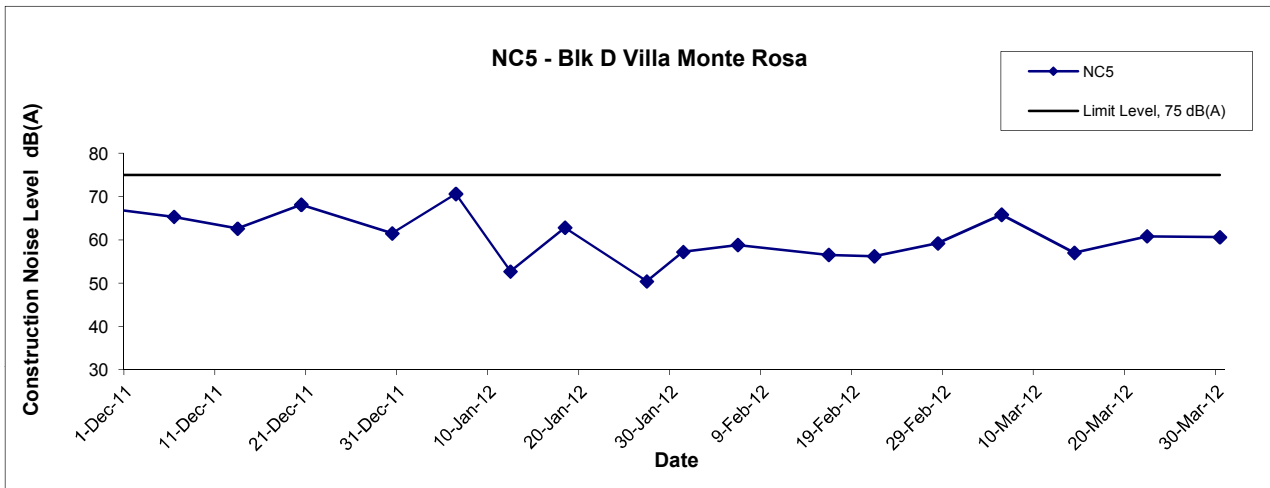
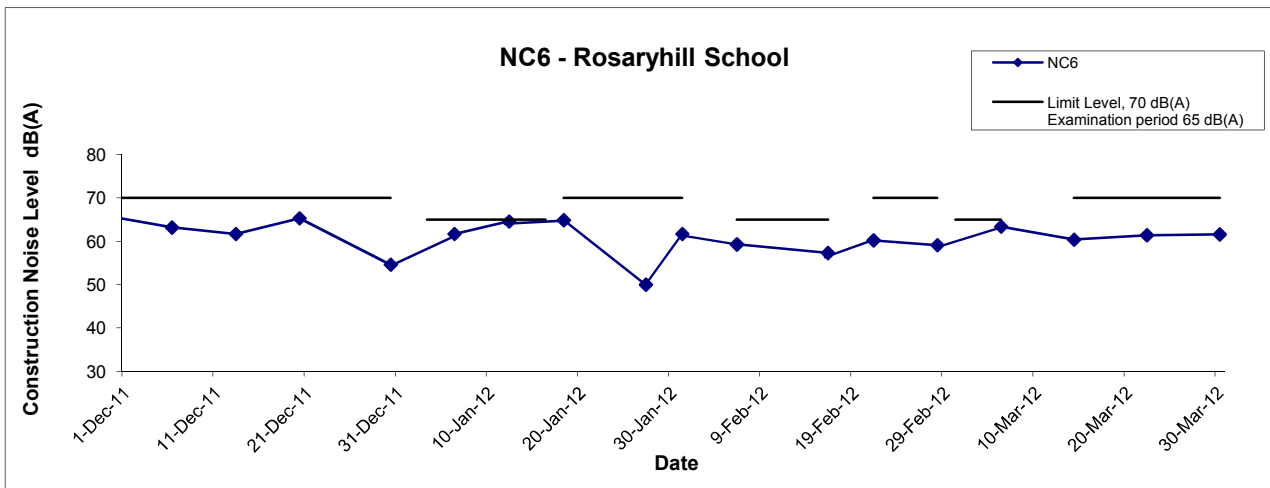
## Noise Levels

Title Contract No. DC/2007/10 Design and Construction of Hong Kong West Drainage Tunnel Graphical Presentation of Construction Noise Monitoring Results	Scale N.T.S	Project No. MA8001	CINOTECH
	Date Mar 12	Appendix G

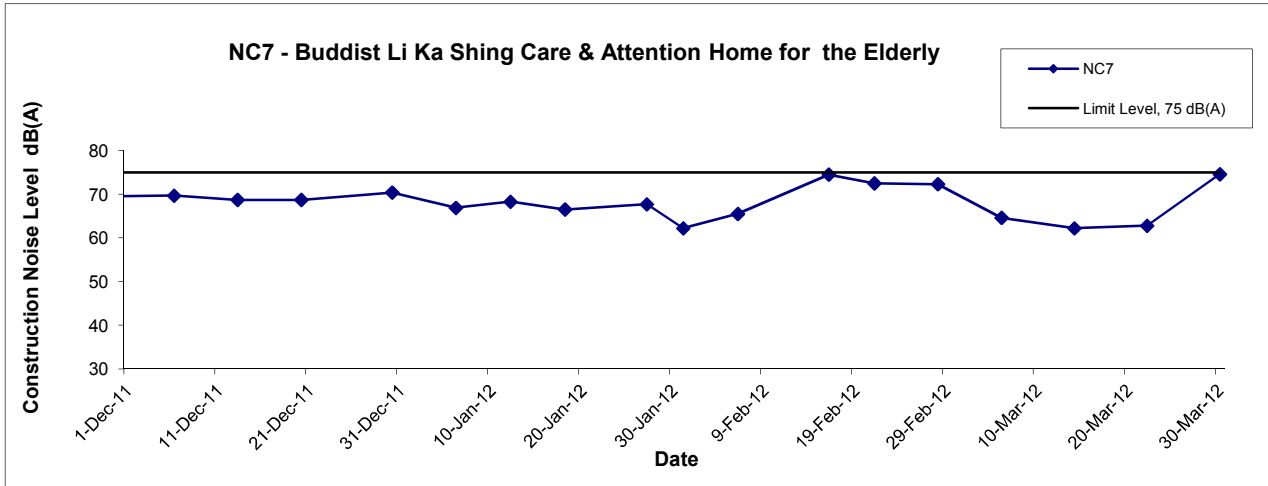
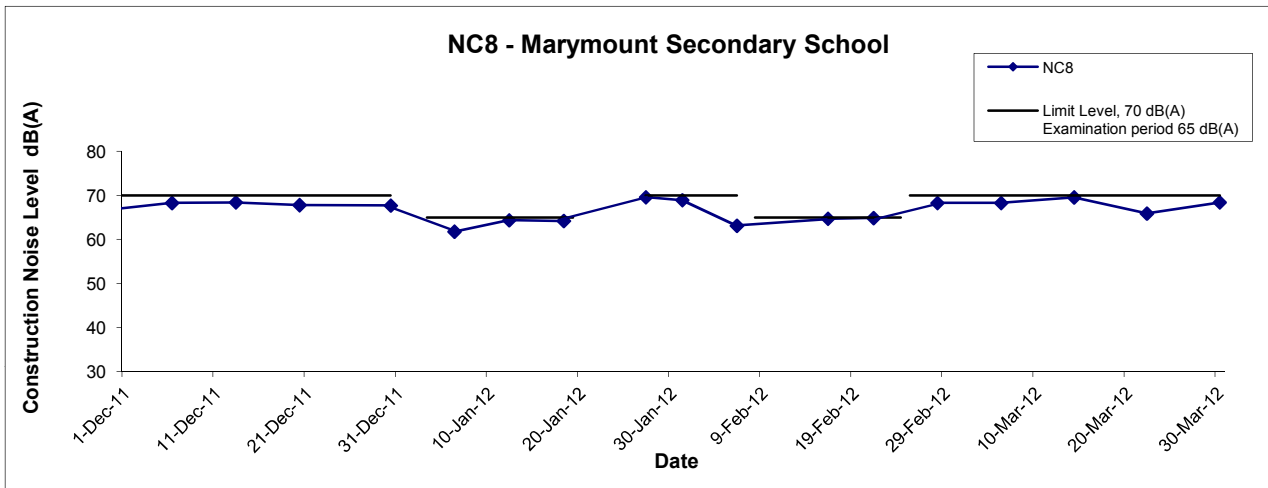
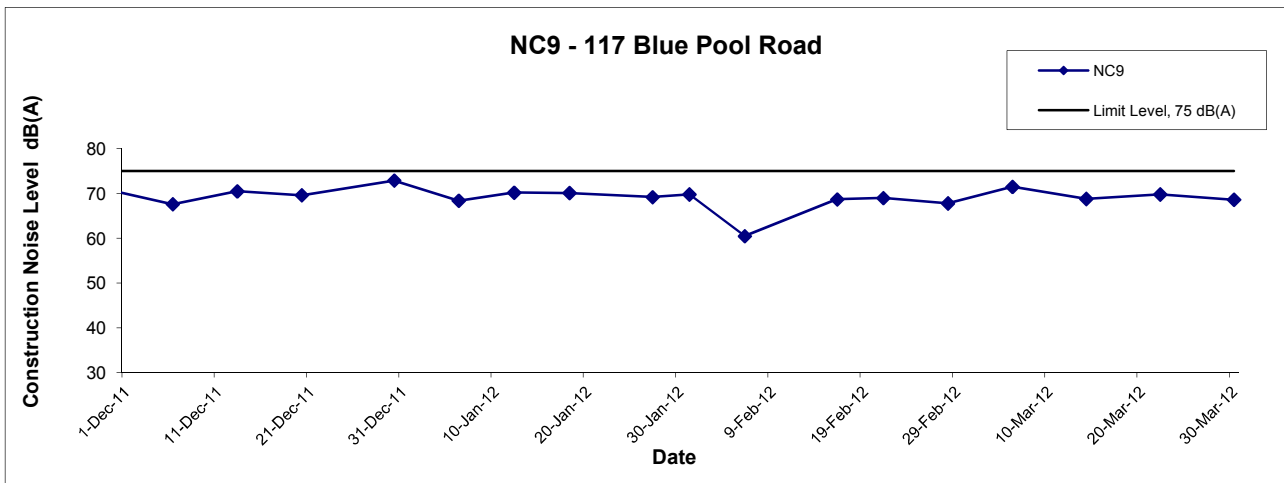
## Noise Levels

Title Contract No. DC/2007/10 Design and Construction of Hong Kong West Drainage Tunnel Graphical Presentation of Construction Noise Monitoring Results	Scale N.T.S	Project No. MA8001	CINOTECH
	Date Mar 12	Appendix G

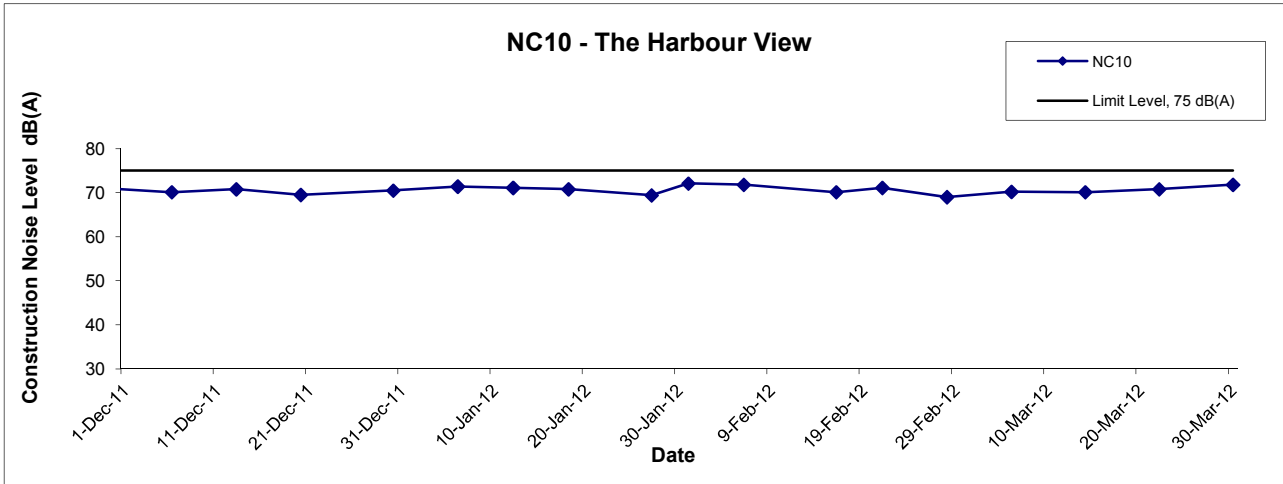
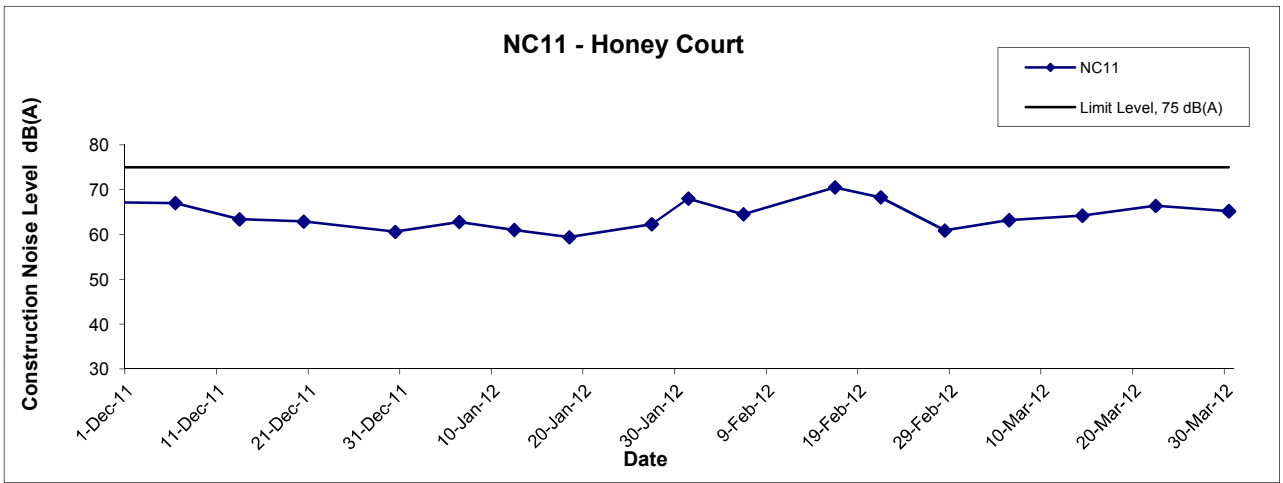
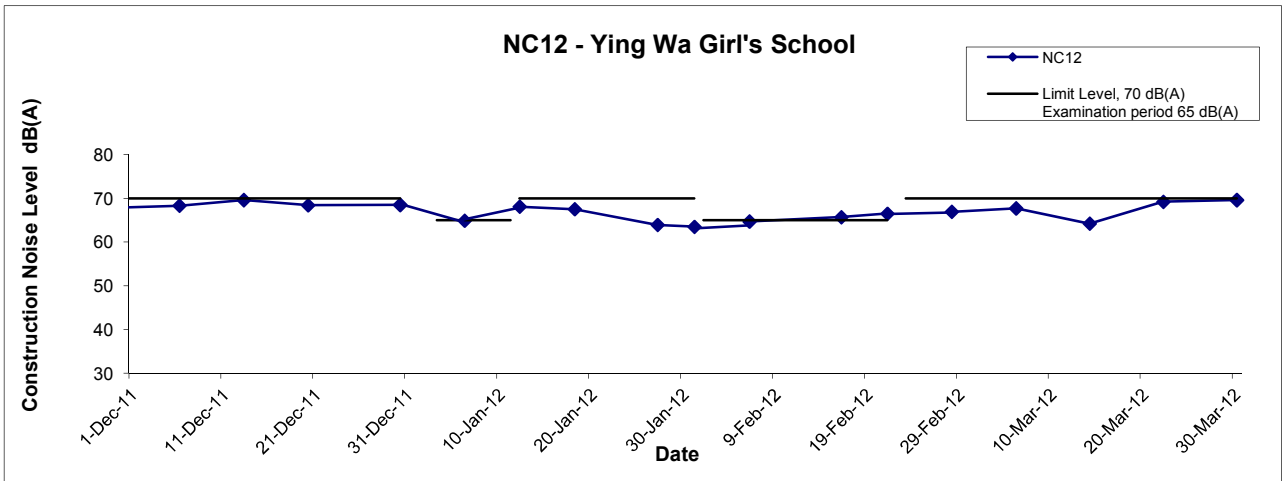
## Noise Levels

Title Contract No. DC/2007/10 Design and Construction of Hong Kong West Drainage Tunnel Graphical Presentation of Construction Noise Monitoring Results	Scale N.T.S	Project No. MA8001	CINOTECH
	Date Mar 12	Appendix G

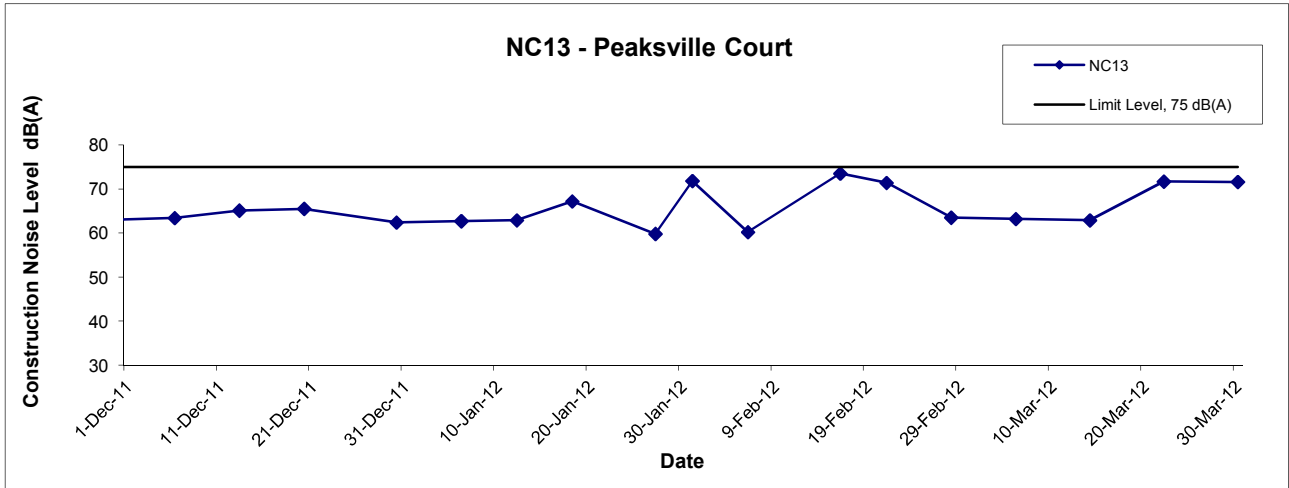
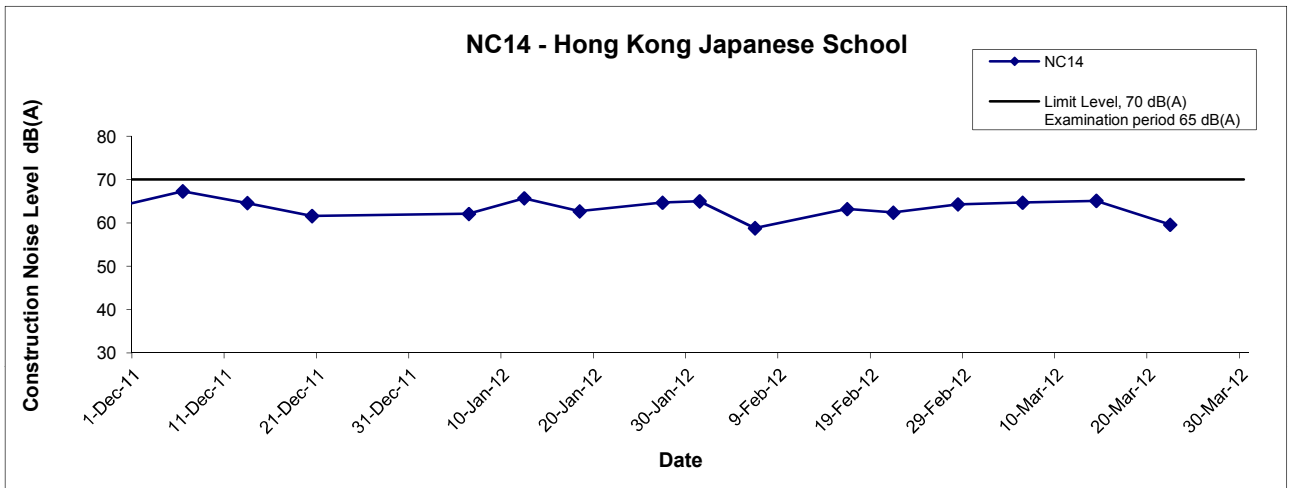
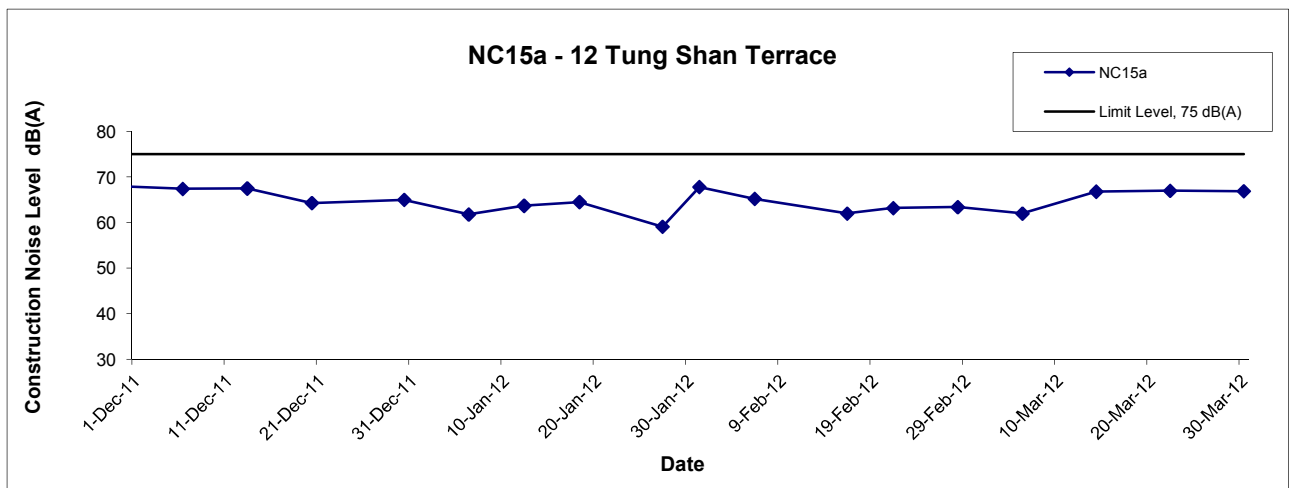
## Noise Levels

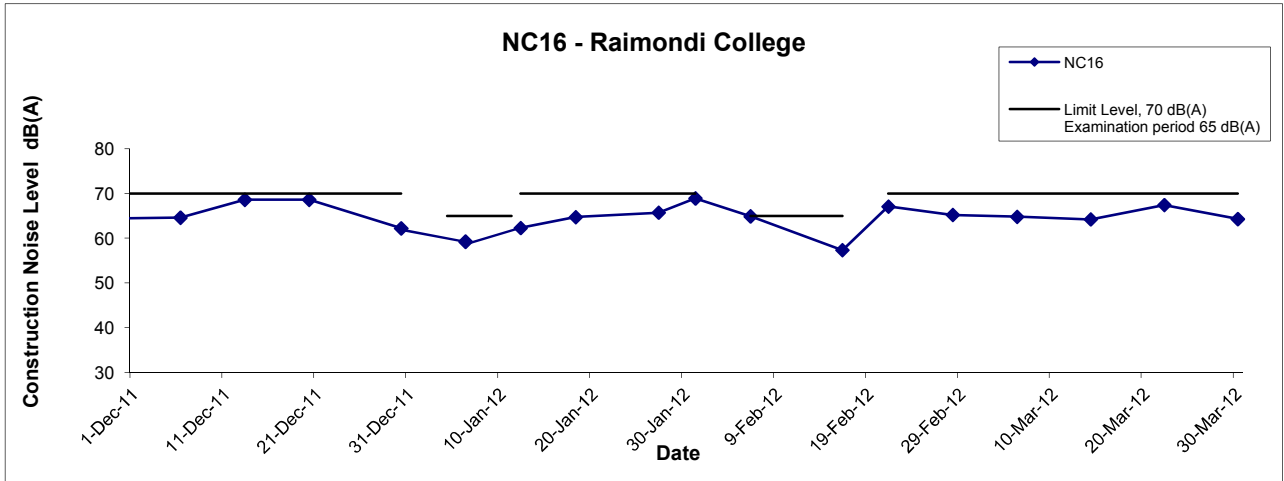
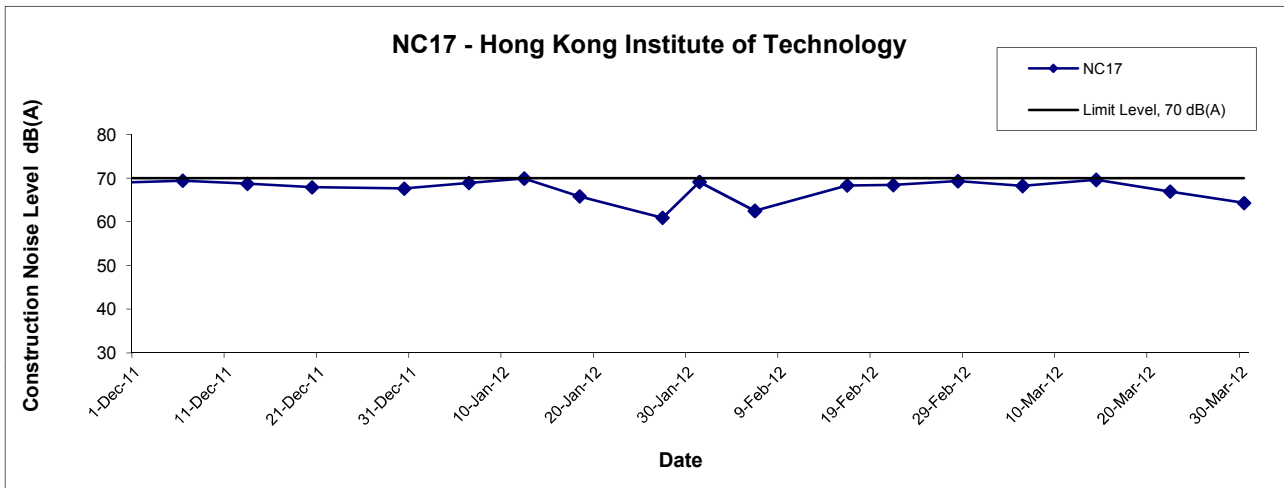
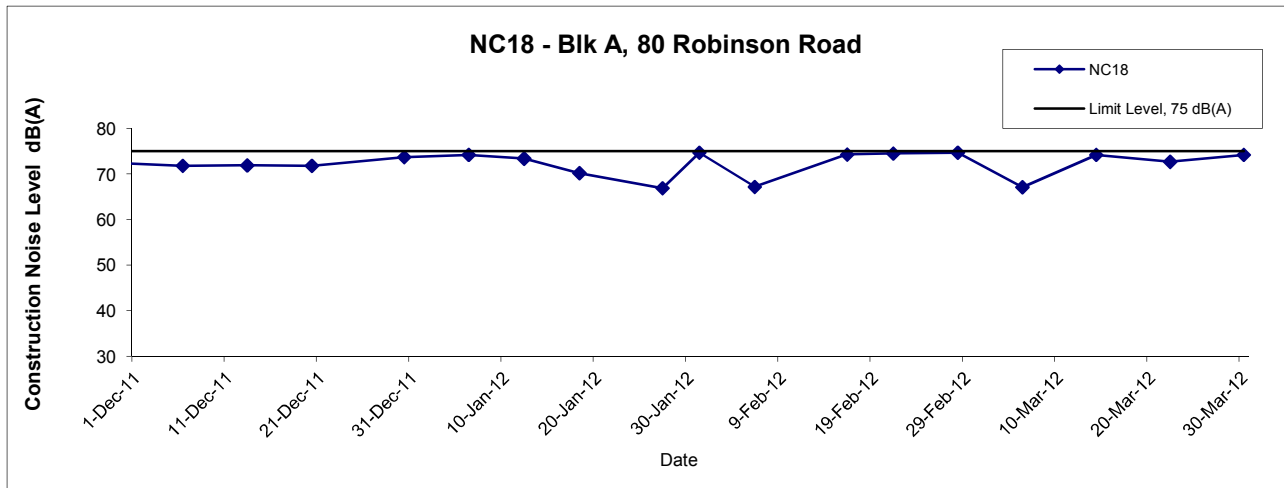
Title Contract No. DC/2007/10 Design and Construction of Hong Kong West Drainage Tunnel Graphical Presentation of Construction Noise Monitoring Results	Scale	N.T.S	Project No.	MA8001	CINOTECH
	Date	Mar 12	Appendix	G

## Noise Levels

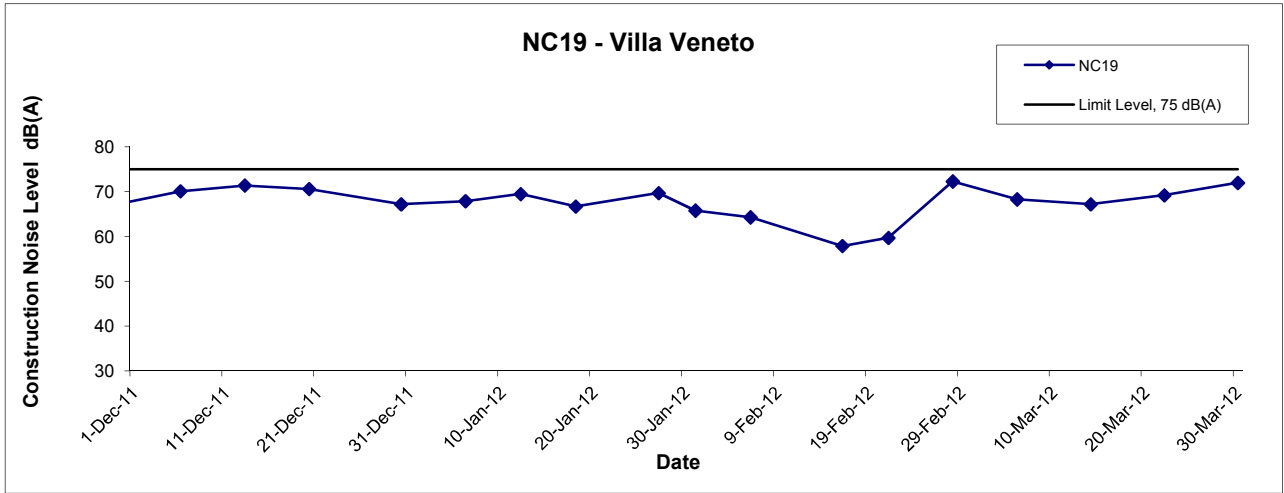
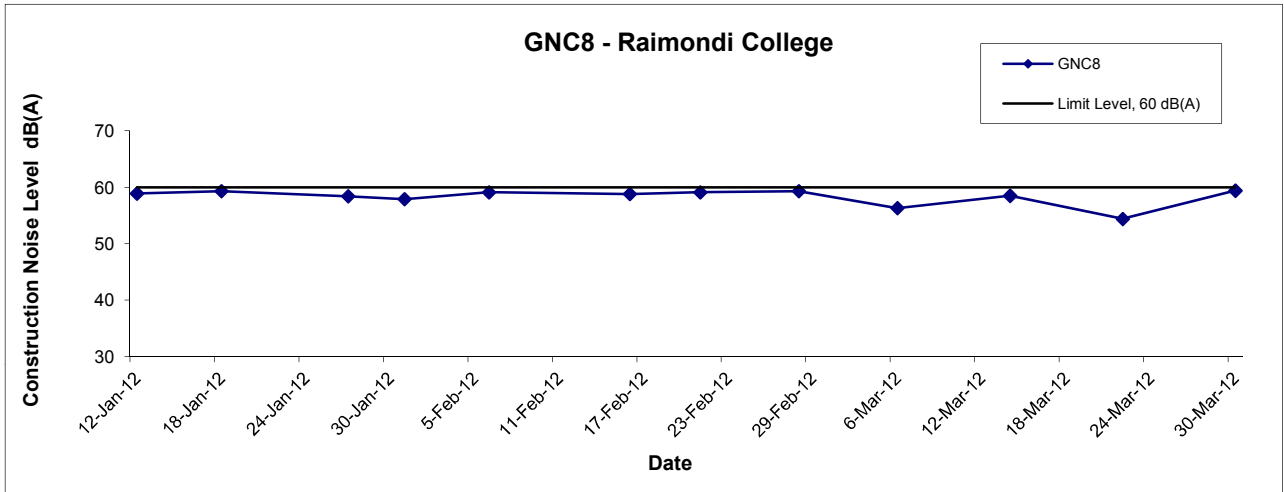
Title Contract No. DC/2007/10 Design and Construction of Hong Kong West Drainage Tunnel Graphical Presentation of Construction Noise Monitoring Results	Scale	N.T.S	Project No.	MA8001	CINOTECH
	Date	Mar 12	Appendix	G

## Noise Levels

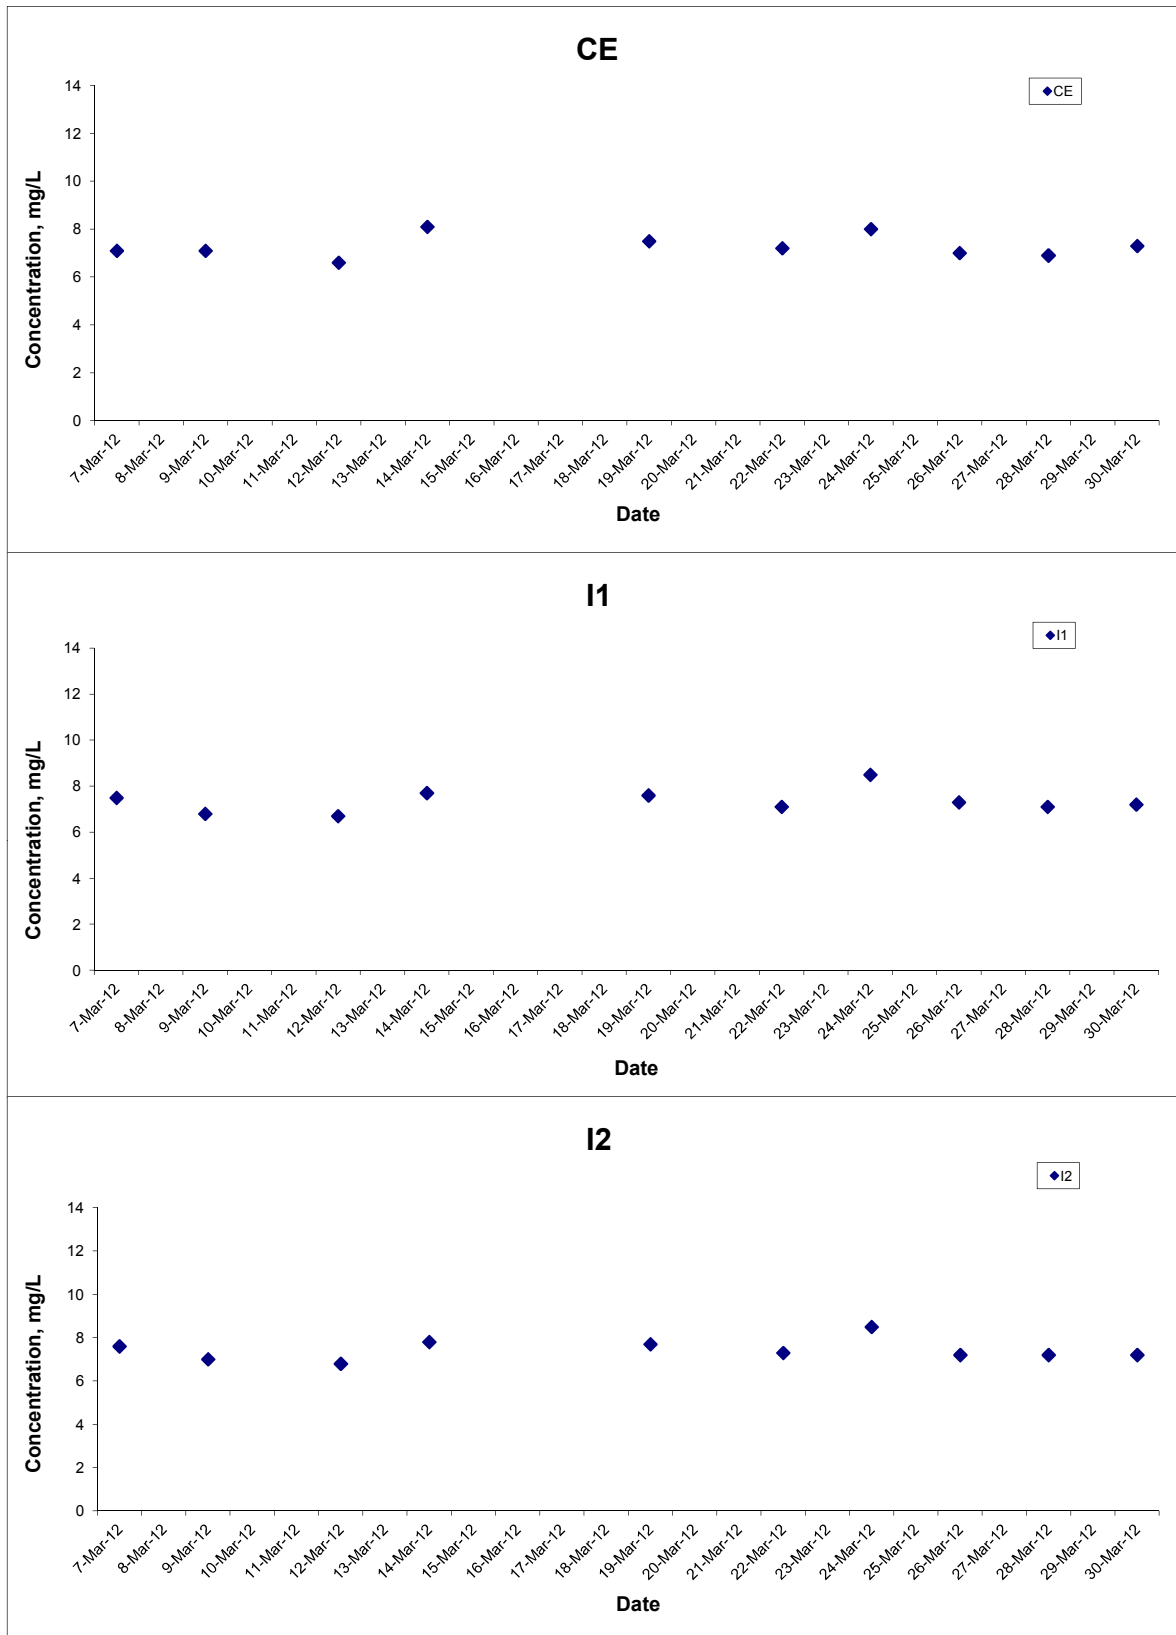
Title Contract No. DC/2007/10 Design and Construction of Hong Kong West Drainage Tunnel  Graphical Presentation of Water Quality Monitoring Results	Scale N.T.S	Project No. MA8001	
	Date Mar 12	Appendix P

## Dissolved Oxygen (Surface & Middle) at Mid-Ebb Tide

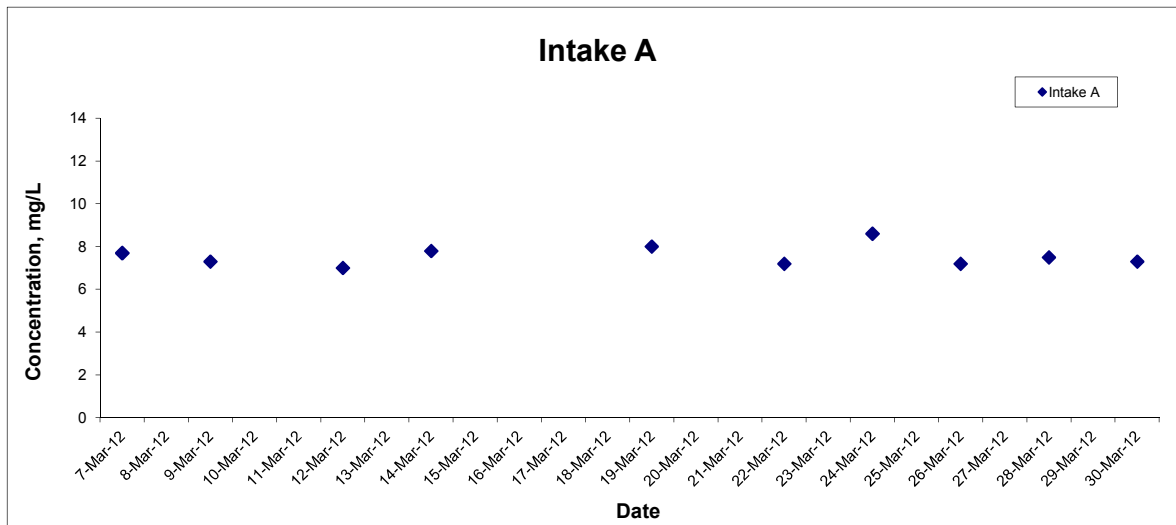
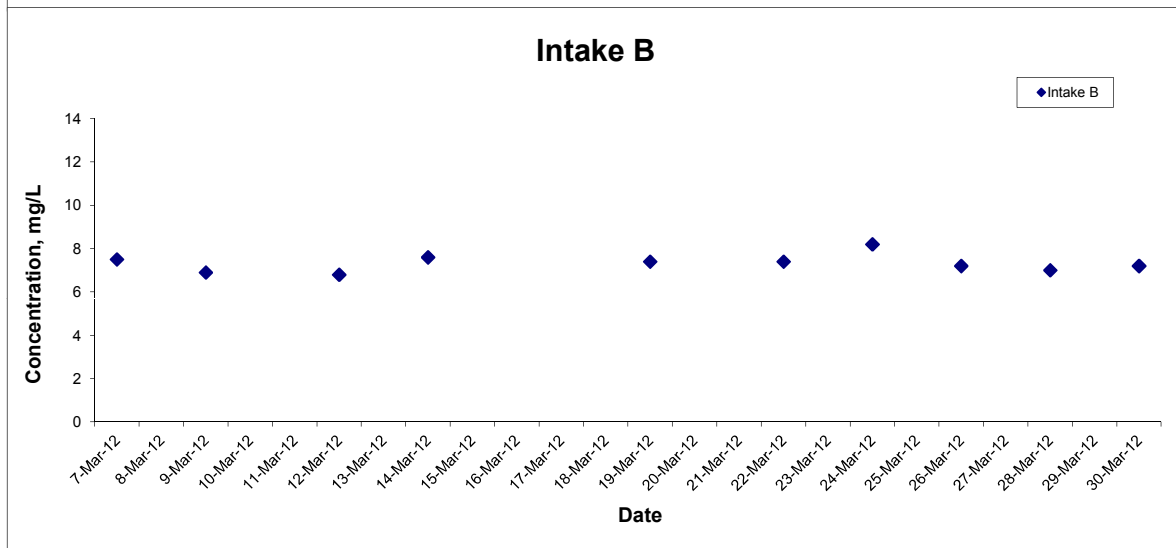
Title Contract No. DC/2007/10 Design and Construction of Hong Kong West Drainage Tunnel  Graphical Presentation of Water Quality Monitoring Results	Scale N.T.S	Project No. MA8001	
	Date Mar 12	Appendix P

## Dissolved Oxygen (Surface & Middle) at Mid-Ebb Tide
