# Dragages-Nishimatsu Joint Venture

**Contract No. DC/2007/10**  
**Design and Construction of**  
**Hong Kong West Drainage Tunnel**

Monthly EM&A Report

March 2012  
(version 2.0)

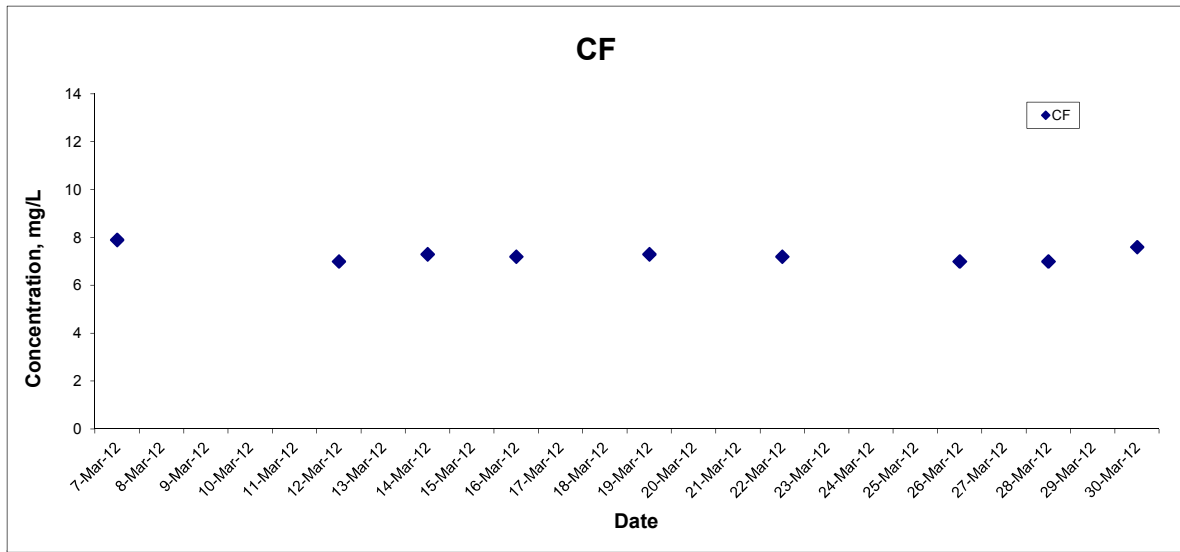
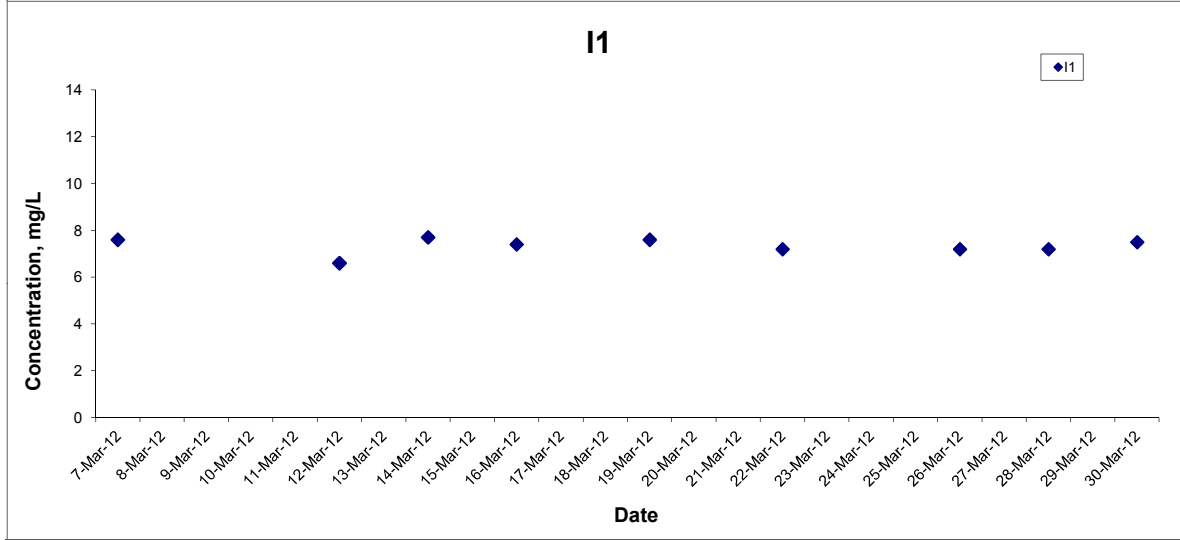
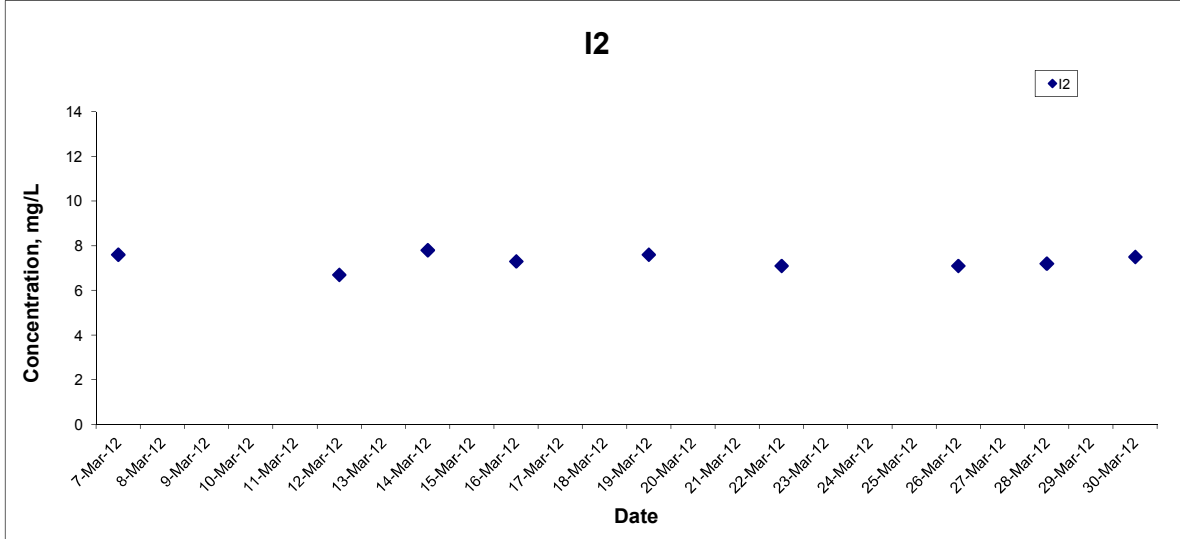
Title Contract No. DC/2007/10 Design and Construction of Hong Kong West Drainage Tunnel  Graphical Presentation of Water Quality Monitoring Results	Scale	N.T.S	Project No. MA8001	<b>CINOTECH</b>
	Date	Mar 12	Appendix P

## Dissolved Oxygen (Surface & Middle) at Mid-Flood Tide

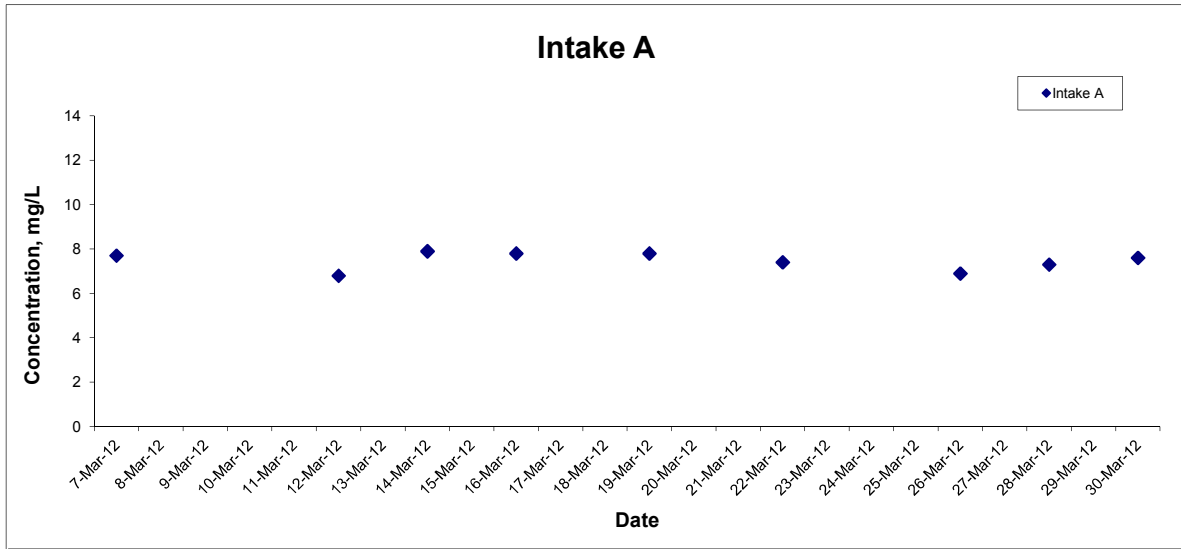
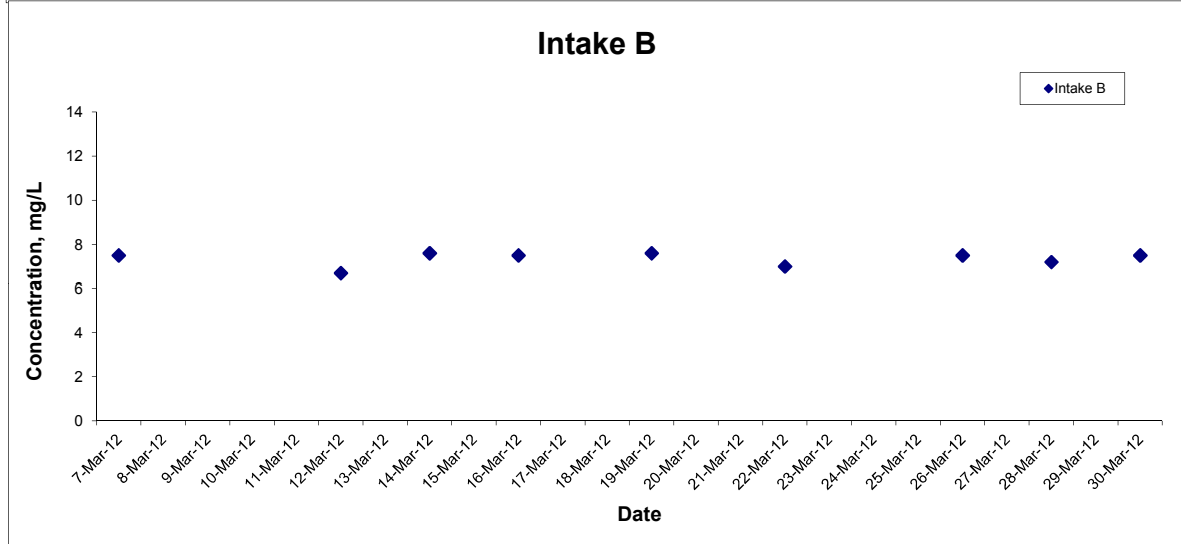
Title Contract No. DC/2007/10 Design and Construction of Hong Kong West Drainage Tunnel  Graphical Presentation of Water Quality Monitoring Results	Scale N.T.S	Project No. MA8001	<b>CINOTECH</b>
	Date Mar 12	Appendix P

## Dissolved Oxygen (Surface & Middle) at Mid-Flood Tide

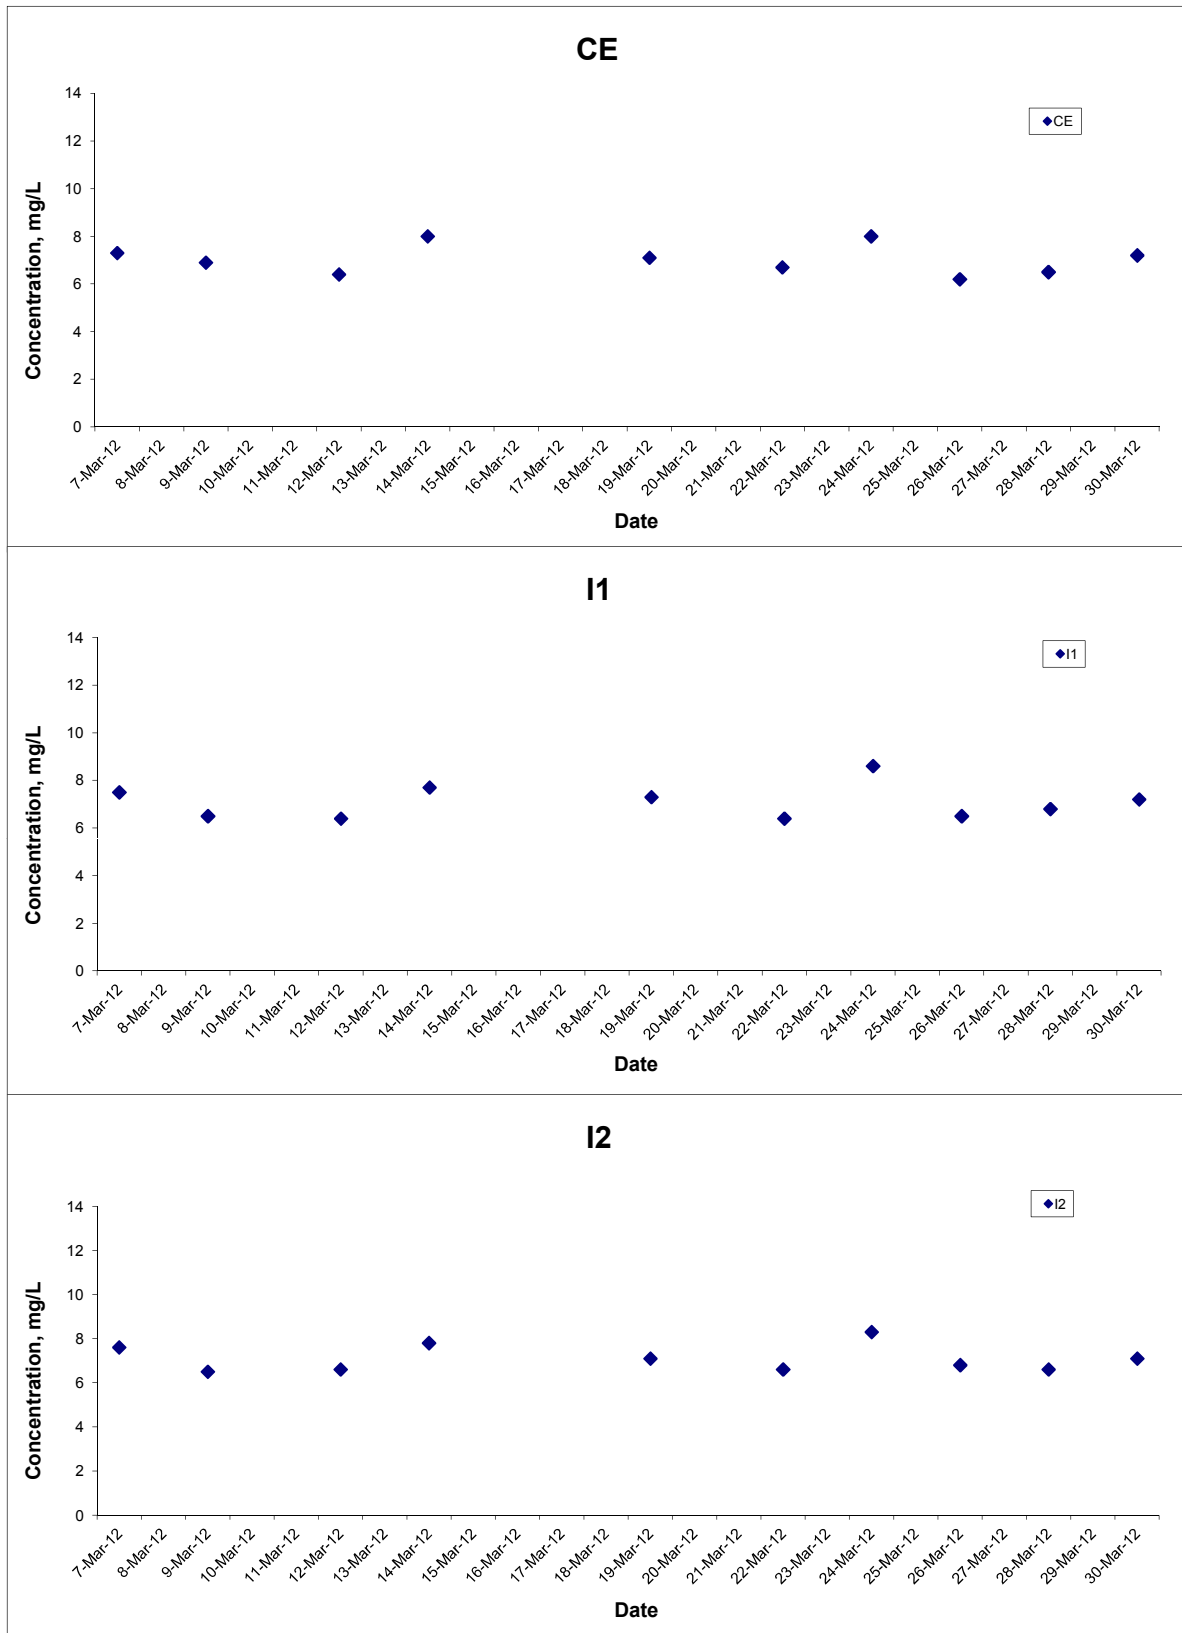
Title  
 Contract No. DC/2007/10  
 Design and Construction of Hong Kong West Drainage Tunnel  
 Graphical Presentation of Water Quality  
 Monitoring Results

## Dissolved Oxygen (Bottom) at Mid-Ebb Tide

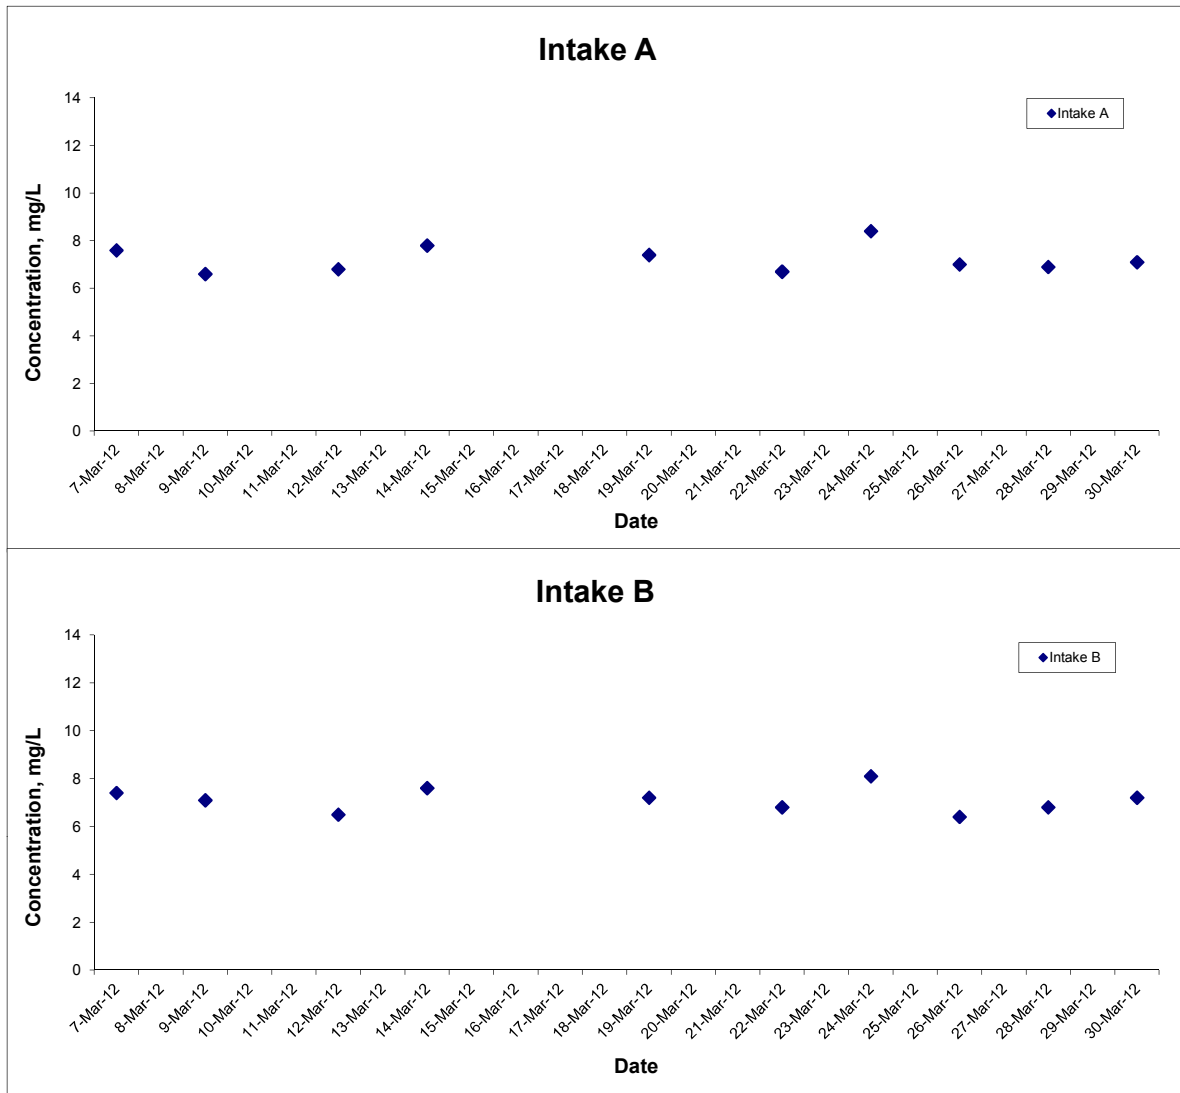
Title Contract No. DC/2007/10 Design and Construction of Hong Kong West Drainage Tunnel  Graphical Presentation of Water Quality Monitoring Results	Scale N.T.S	Project No. MA8001	
	Date Mar 12	Appendix P

## Dissolved Oxygen (Bottom) at Mid-Ebb Tide

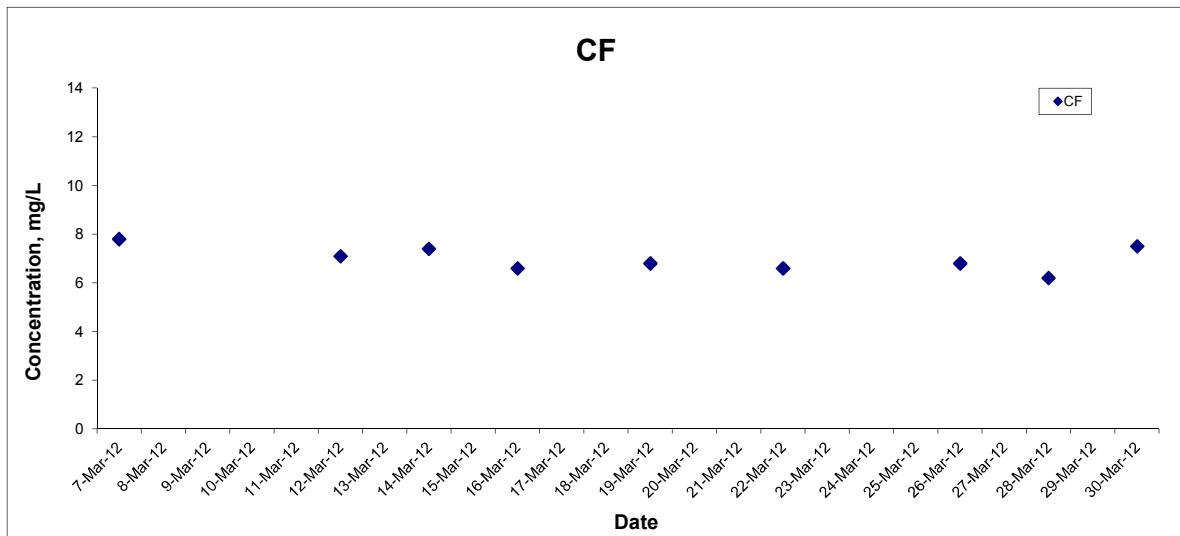
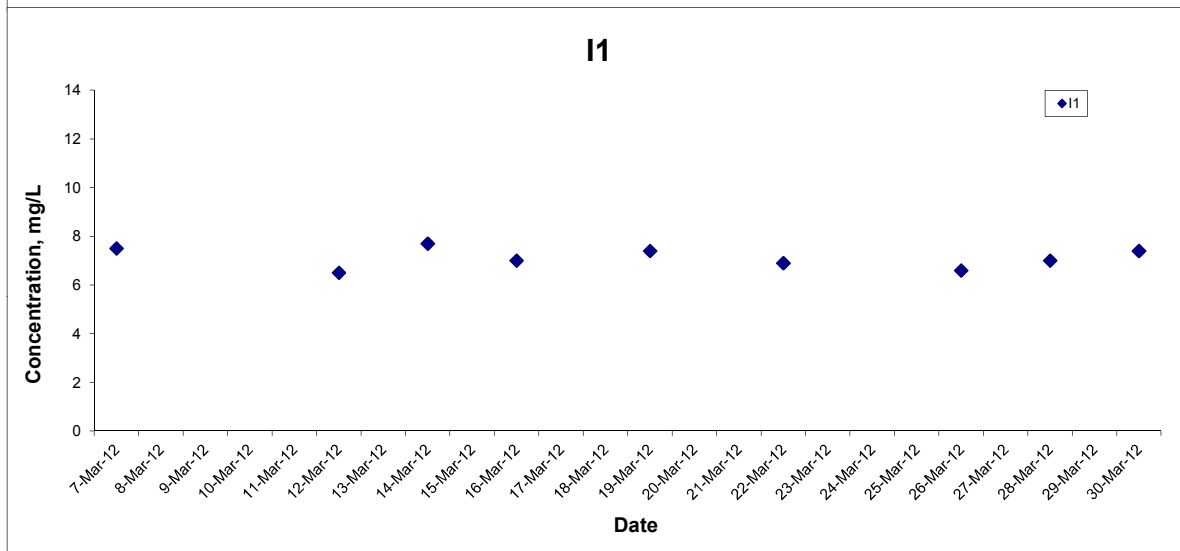
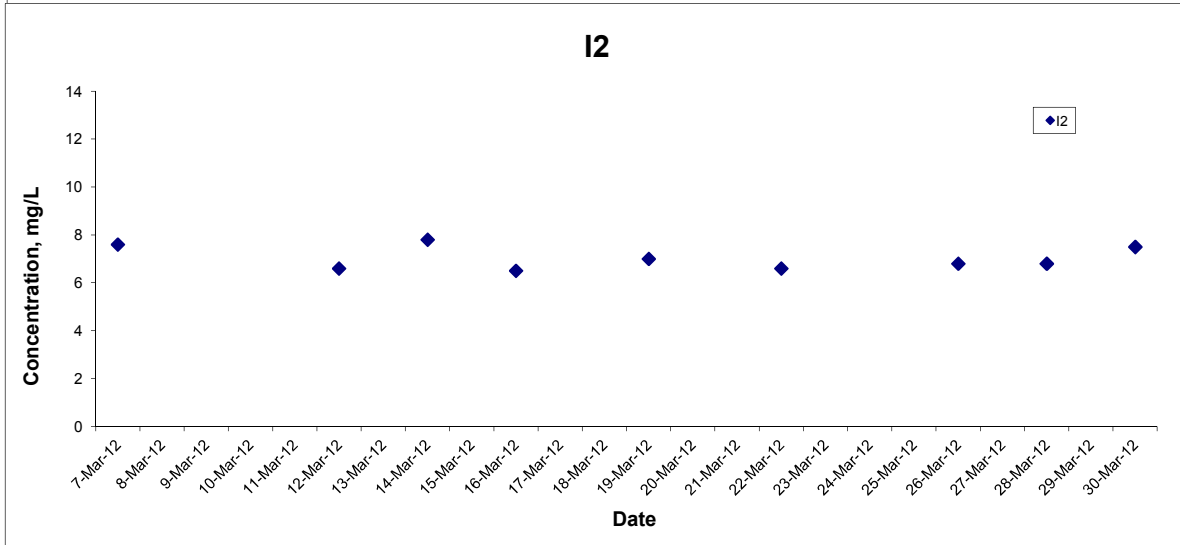
Title Contract No. DC/2007/10 Design and Construction of Hong Kong West Drainage Tunnel  Graphical Presentation of Water Quality Monitoring Results	Scale N.T.S	Project No. MA8001	
	Date Mar 12	Appendix P

## Dissolved Oxygen (Bottom) at Mid-Flood Tide

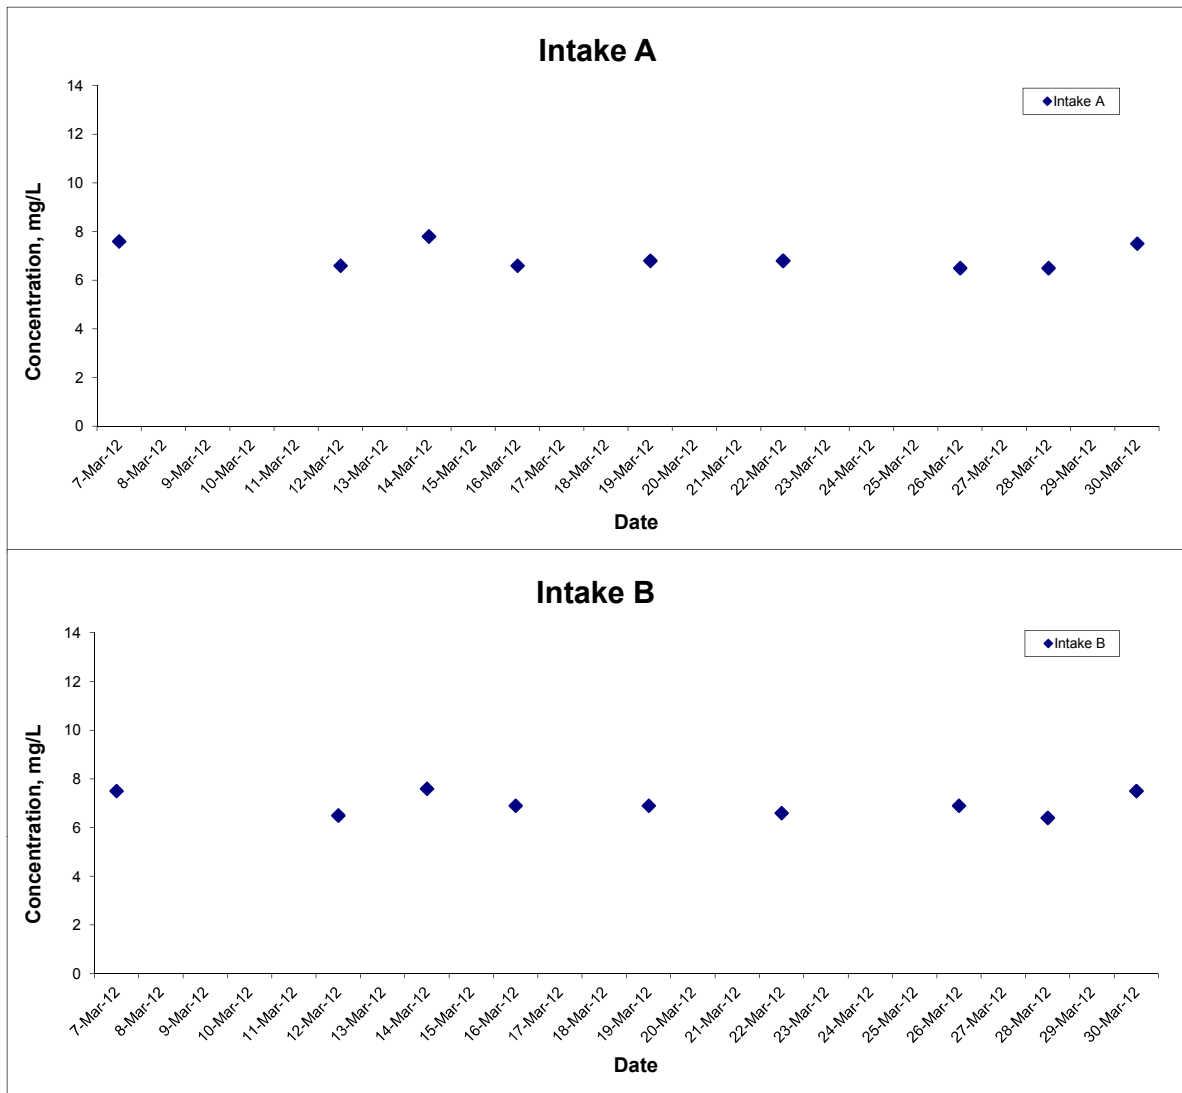
Title Contract No. DC/2007/10 Design and Construction of Hong Kong West Drainage Tunnel  Graphical Presentation of Water Quality Monitoring Results	Scale N.T.S	Project No. MA8001	
	Date Mar 12	Appendix P

## Dissolved Oxygen (Bottom) at Mid-Flood Tide

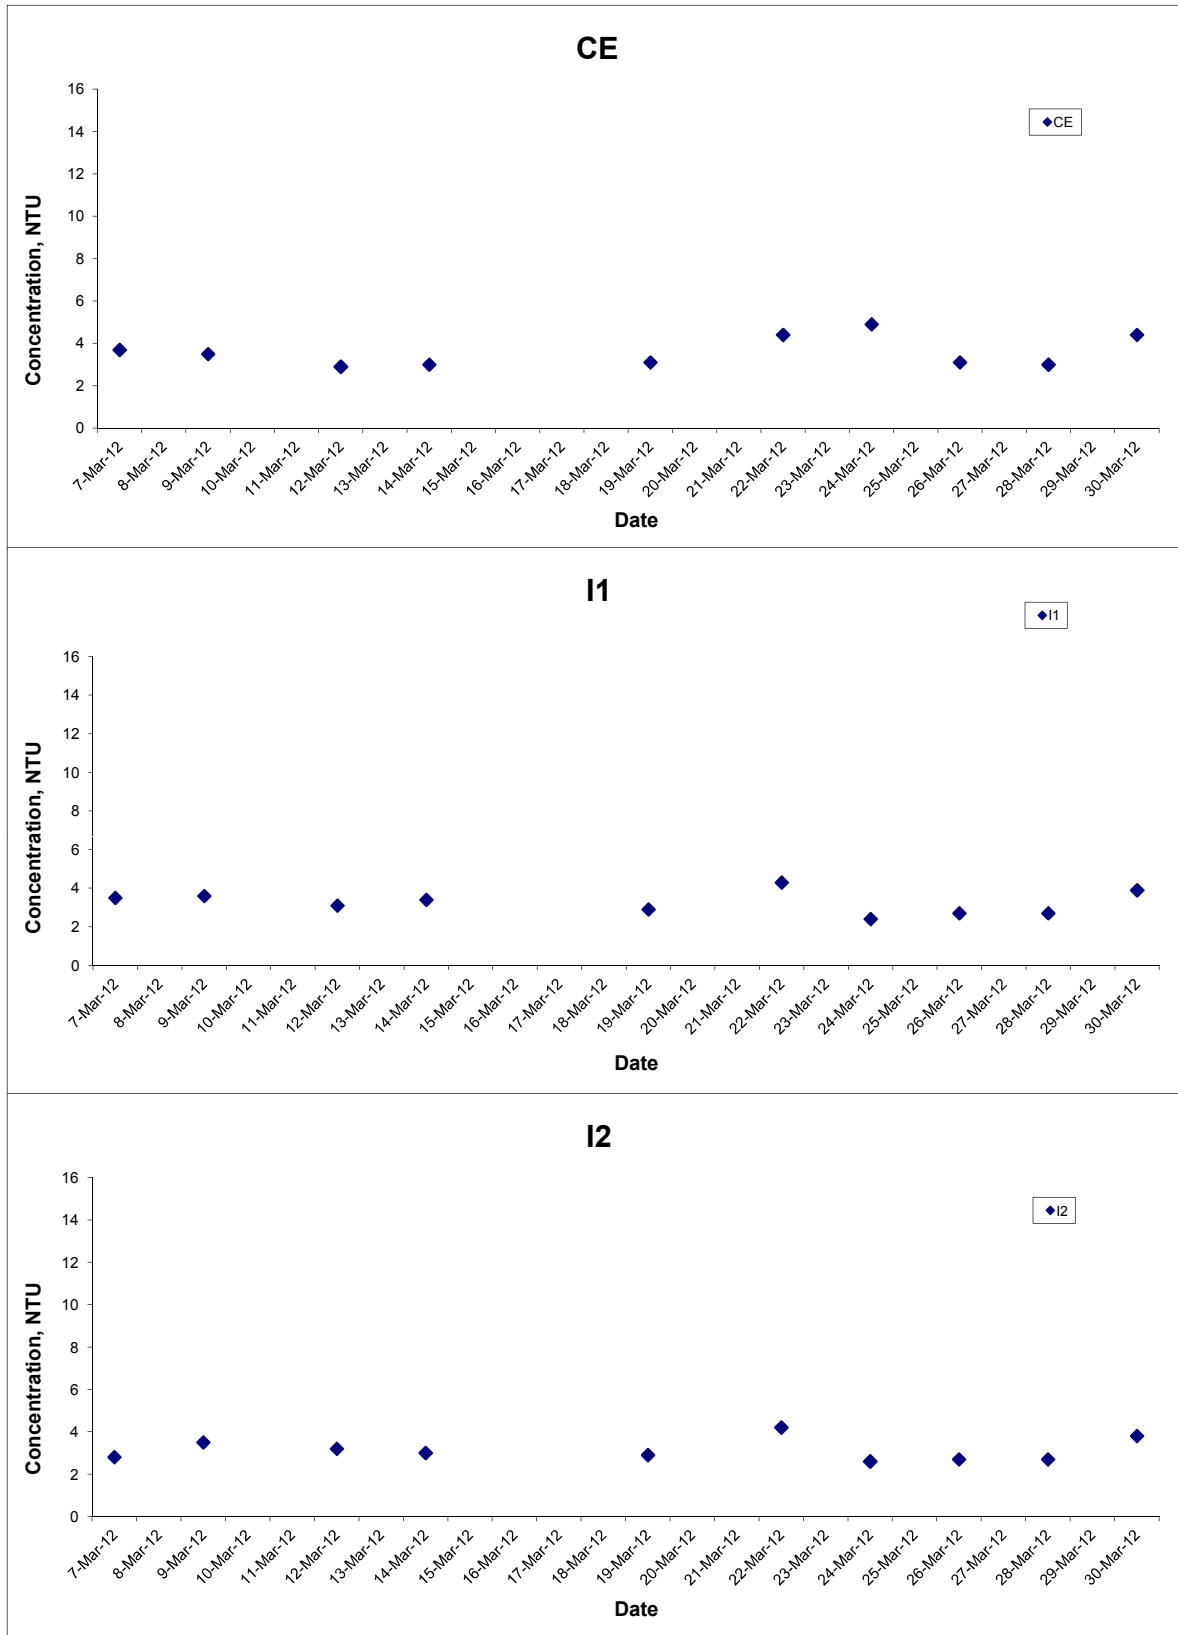
Title Contract No. DC/2007/10 Design and Construction of Hong Kong West Drainage Tunnel  Graphical Presentation of Water Quality Monitoring Results	Scale N.T.S	Project No. MA8001	CINOTECH
	Date Mar 12	Appendix P

## Turbidity (Depth-averaged) at Mid-Ebb Tide

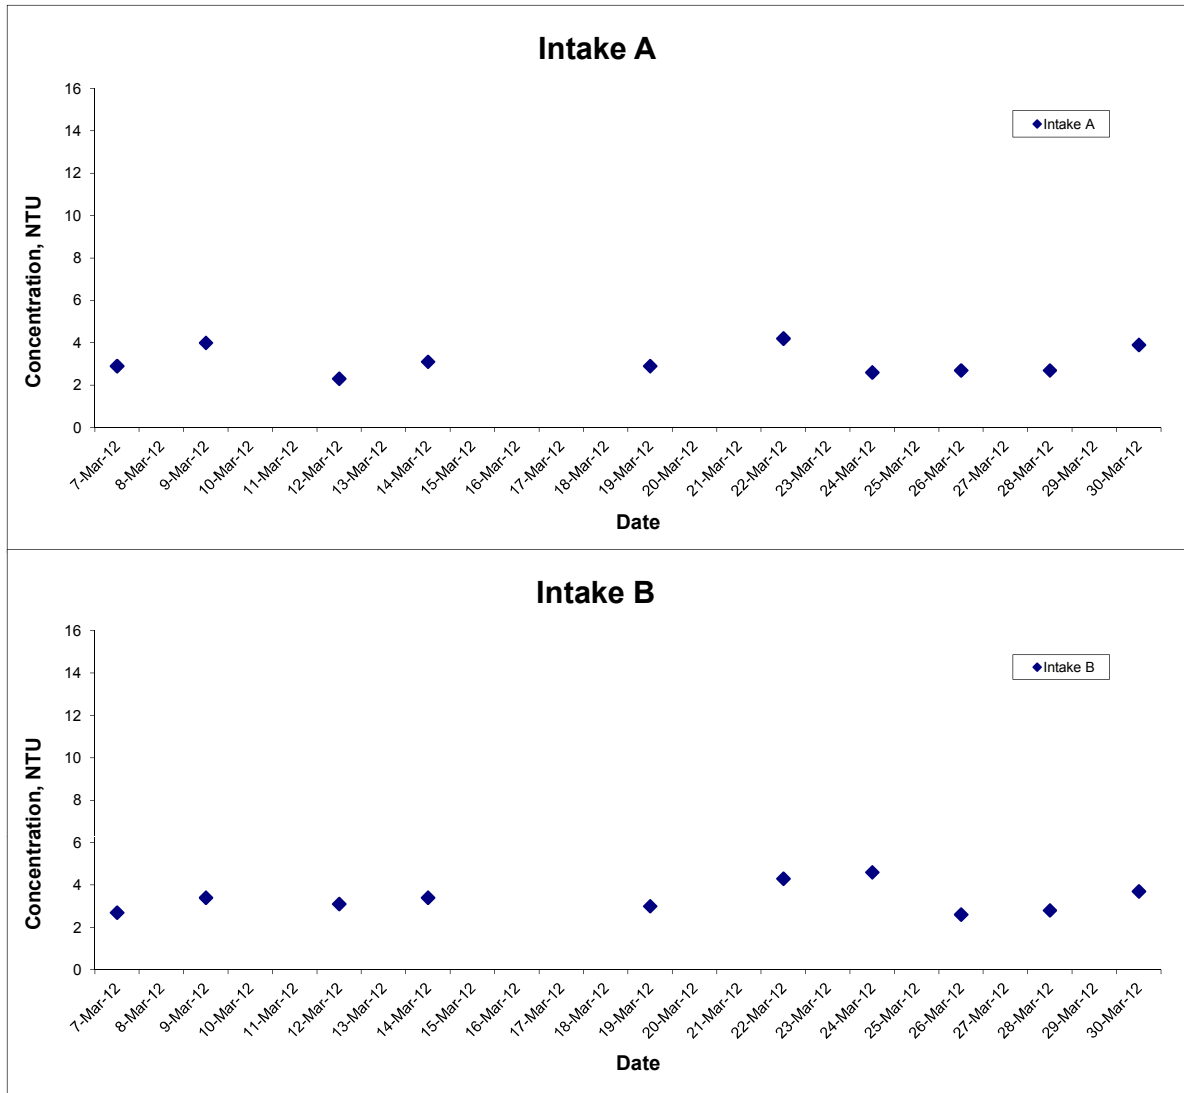
Title Contract No. DC/2007/10 Design and Construction of Hong Kong West Drainage Tunnel  Graphical Presentation of Water Quality Monitoring Results	Scale N.T.S	Project No. MA8001	
	Date Mar 12	Appendix P

## Turbidity (Depth-averaged) at Mid-Ebb Tide

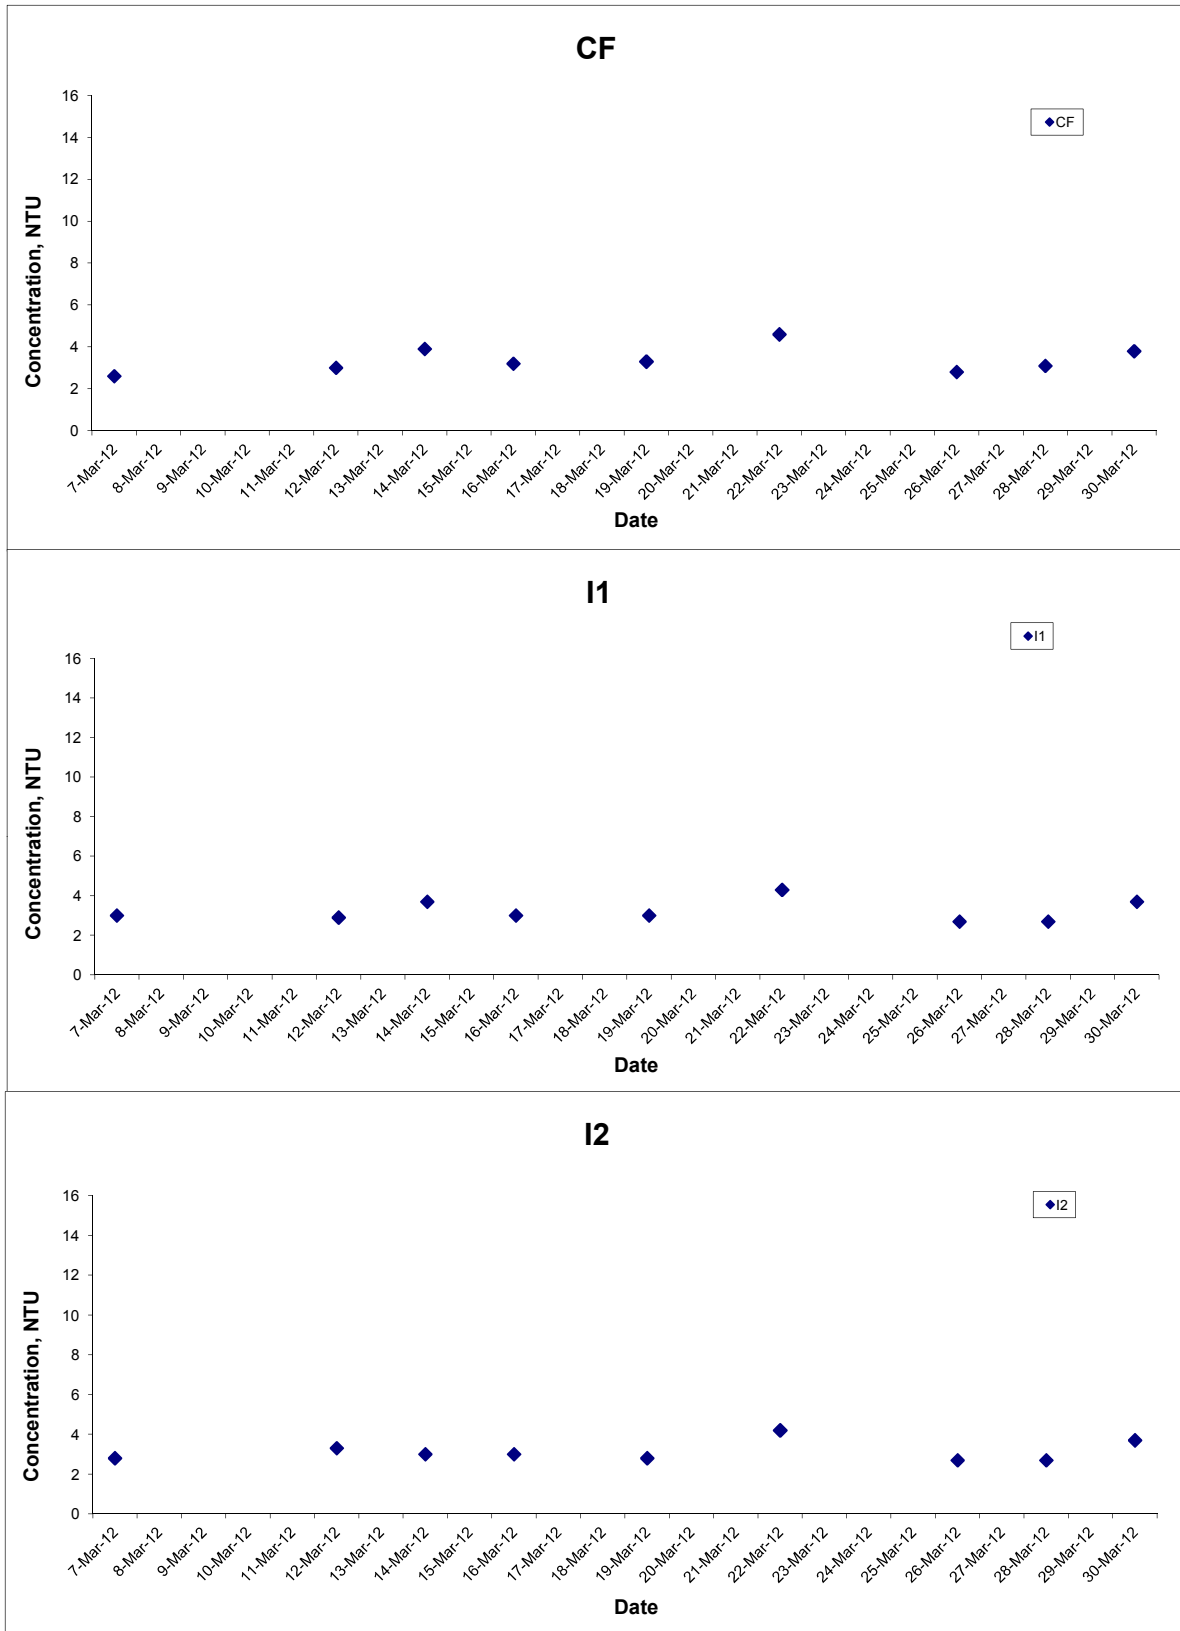
Title Contract No. DC/2007/10 Design and Construction of Hong Kong West Drainage Tunnel  Graphical Presentation of Water Quality Monitoring Results	Scale	N.T.S	Project No. MA8001	CINOTECH
	Date	Mar 12	Appendix P

## Turbidity (Depth-averaged) at Mid-Flood Tide

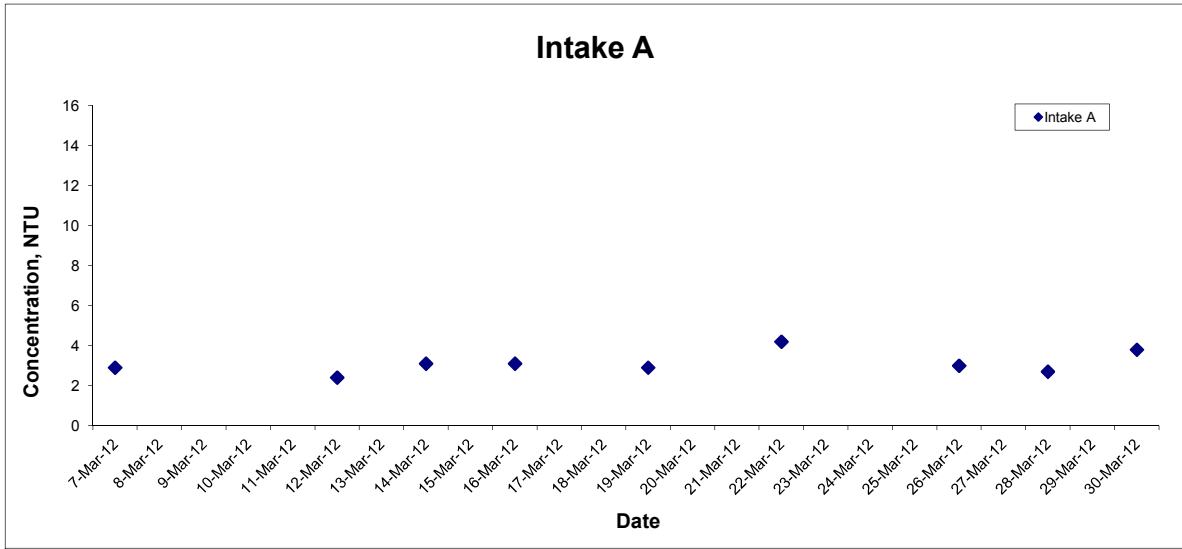
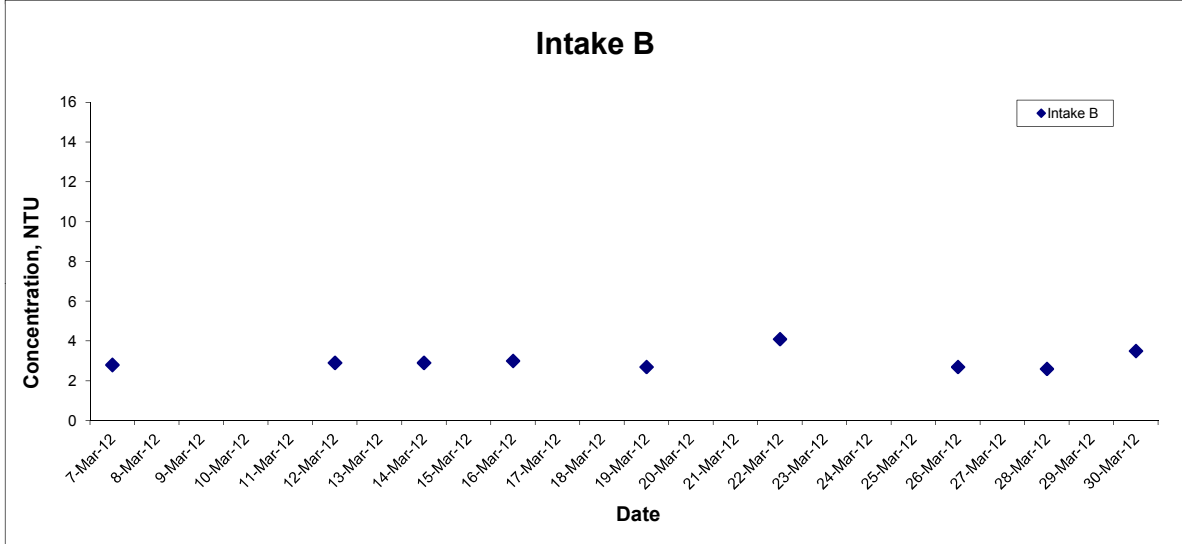
Title Contract No. DC/2007/10 Design and Construction of Hong Kong West Drainage Tunnel  Graphical Presentation of Water Quality Monitoring Results	Scale N.T.S	Project No. MA8001	
	Date Mar 12	Appendix P

## Turbidity (Depth-averaged) at Mid-Flood Tide

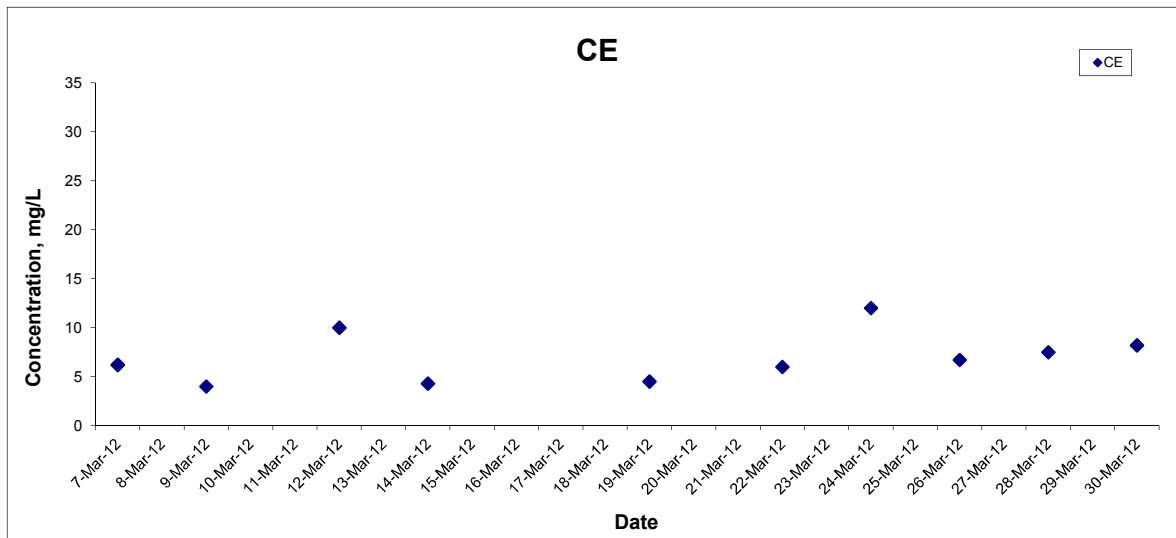
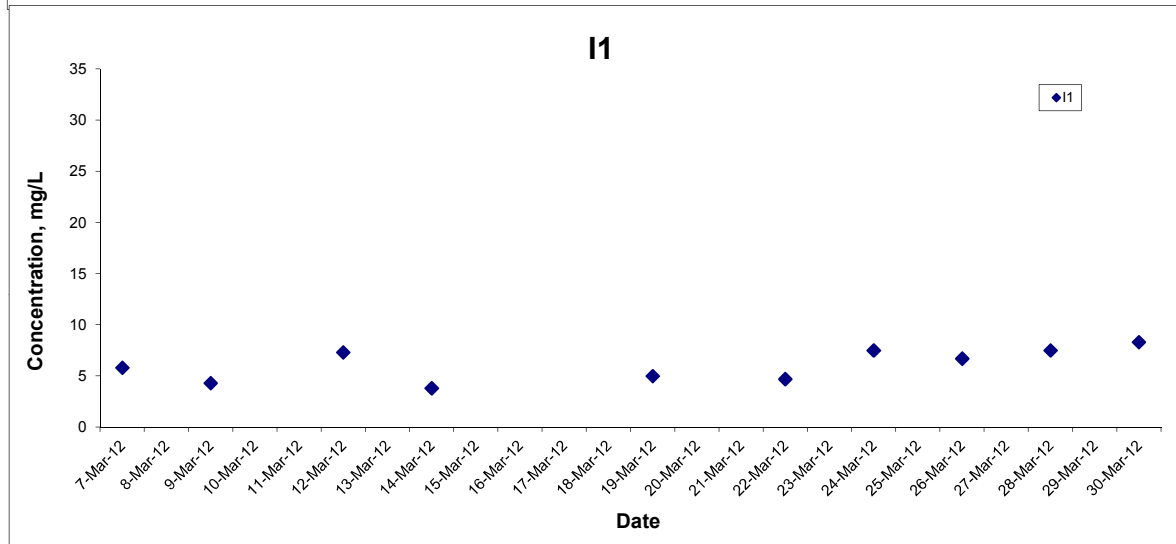
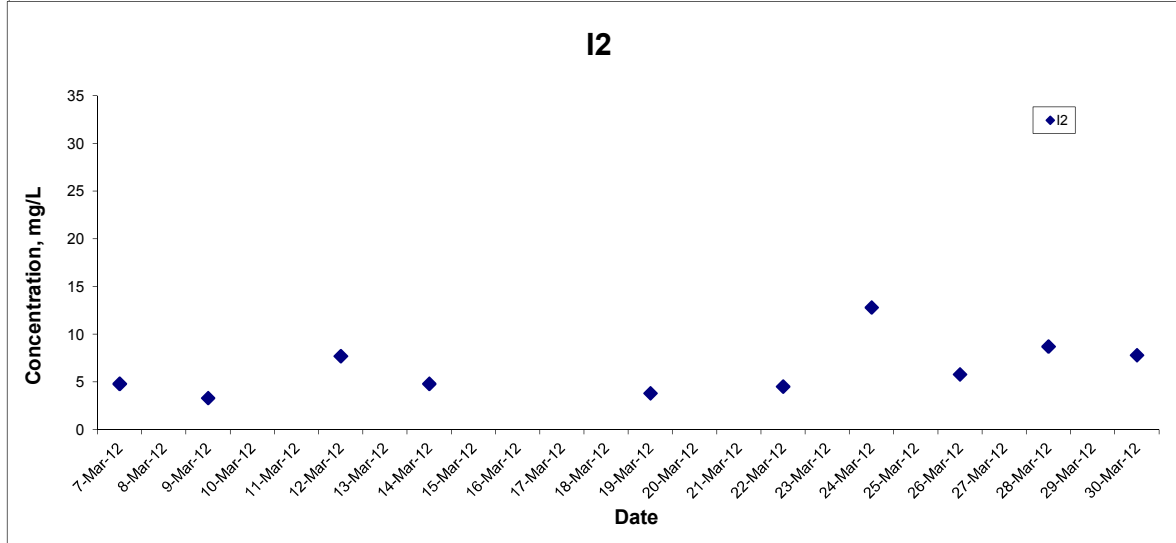
Title Contract No. DC/2007/10 Design and Construction of Hong Kong West Drainage Tunnel  Graphical Presentation of Water Quality Monitoring Results	Scale	N.T.S	Project No. MA8001	CINOTECH
	Date	Mar 12	Appendix P

## Suspended Solids (Depth-averaged) at Mid-Ebb Tide

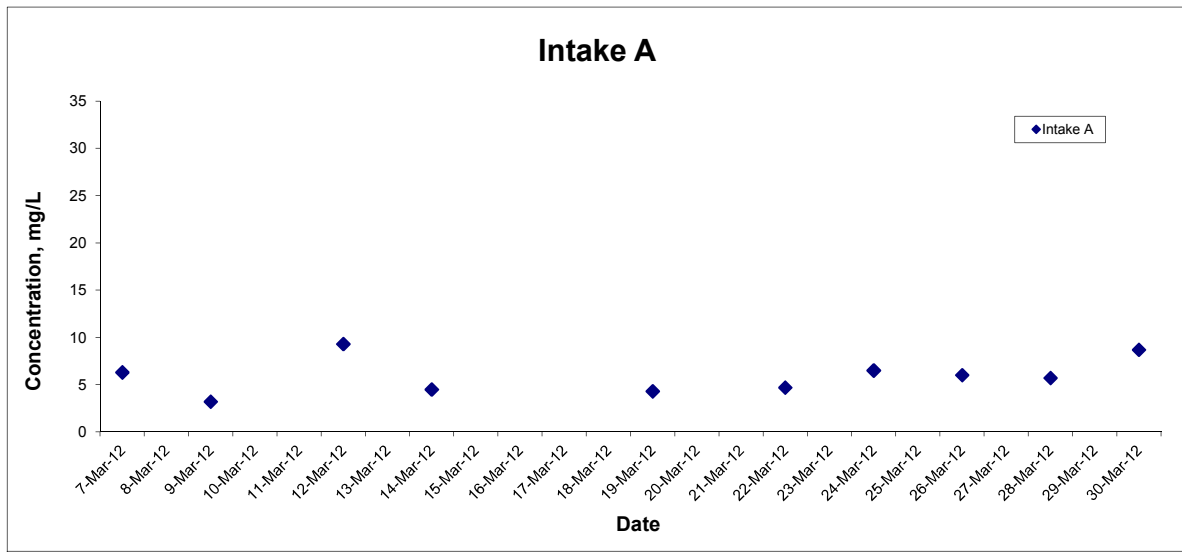
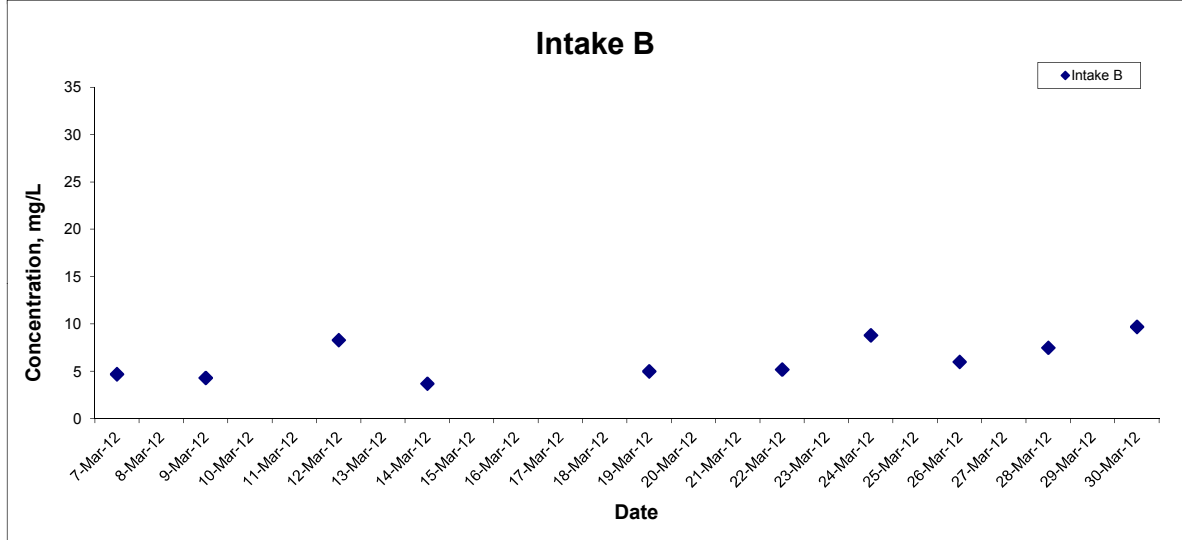
Title Contract No. DC/2007/10 Design and Construction of Hong Kong West Drainage Tunnel  Graphical Presentation of Water Quality Monitoring Results	Scale N.T.S	Project No. MA8001	
	Date Mar 12	Appendix P

## Suspended Solids (Depth-averaged) at Mid-Ebb Tide

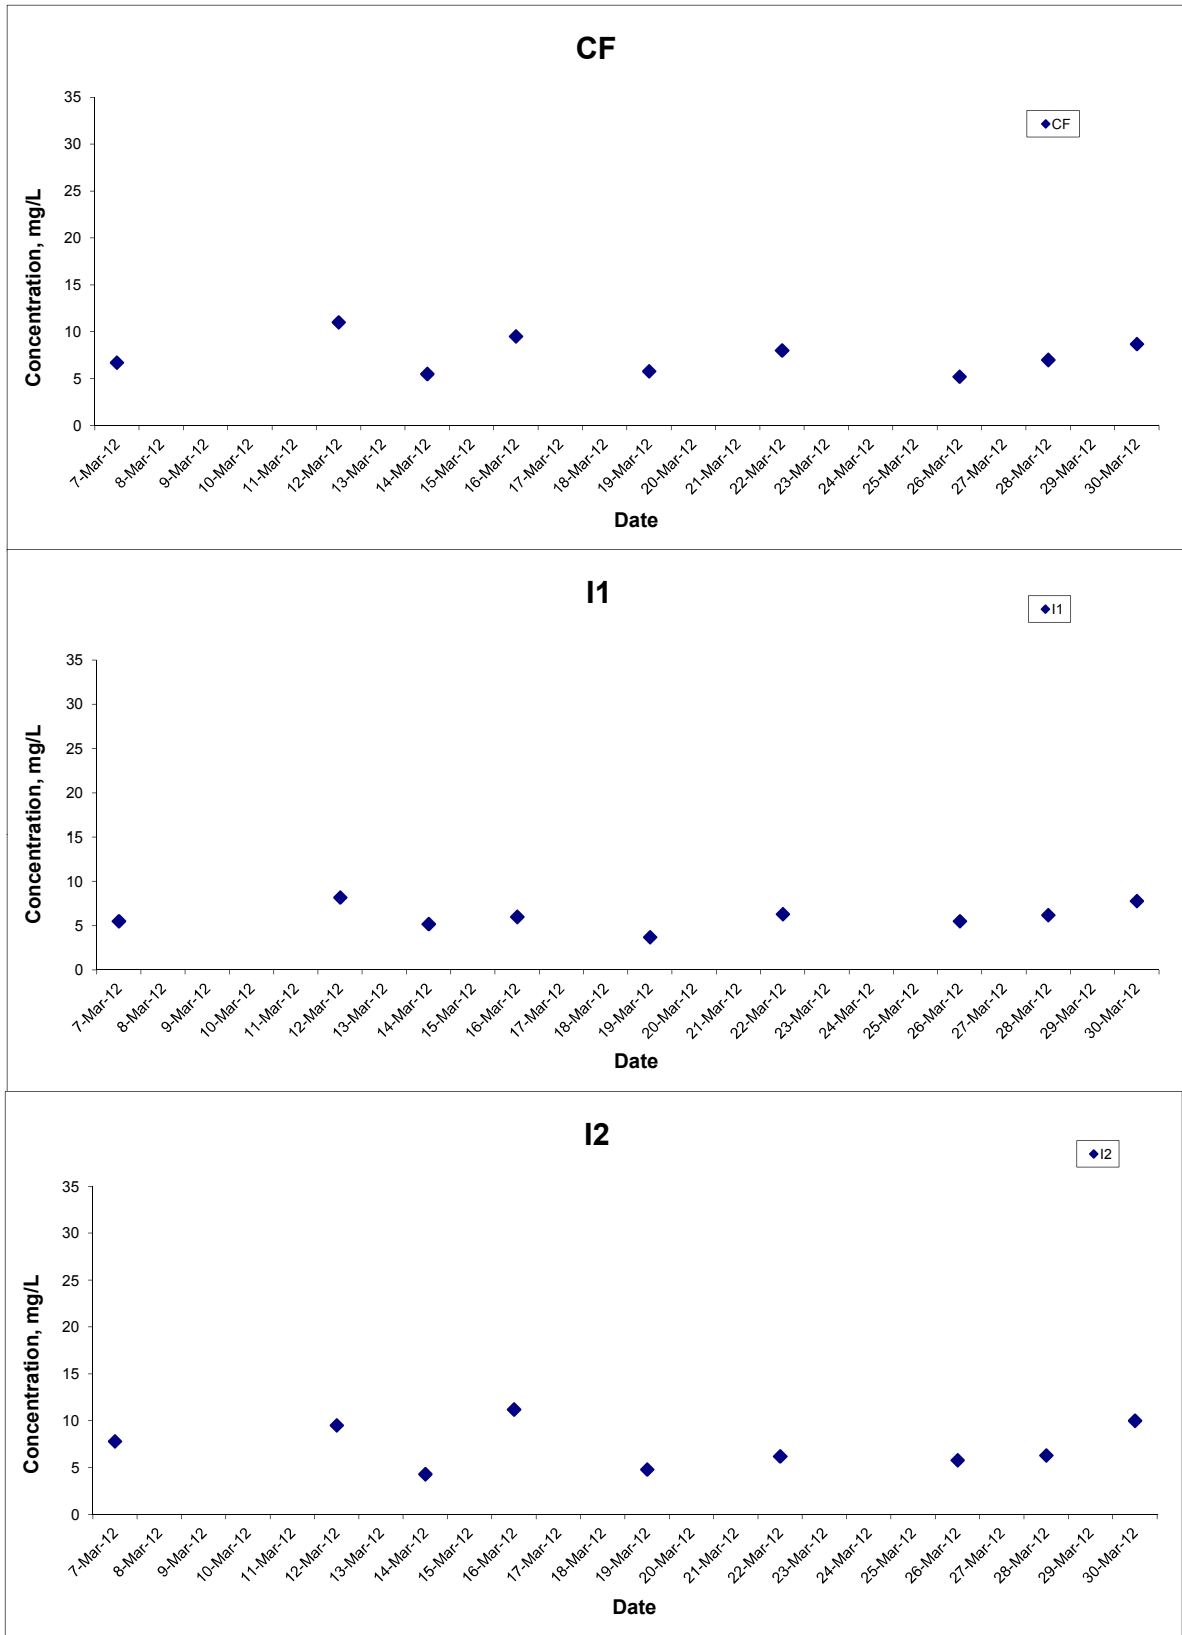
Title Contract No. DC/2007/10 Design and Construction of Hong Kong West Drainage Tunnel  Graphical Presentation of Water Quality Monitoring Results	Scale	N.T.S	Project No. MA8001	<b>CINOTECH</b>
	Date	Mar 12	Appendix P

## Suspended Solids (Depth-averaged) at Mid-Flood Tide
