# Dragages-Nishimatsu Joint Venture

**Contract No. DC/2007/10**  
**Design and Construction of**  
**Hong Kong West Drainage Tunnel**

Monthly EM&A Report

March 2012  
(version 2.0)

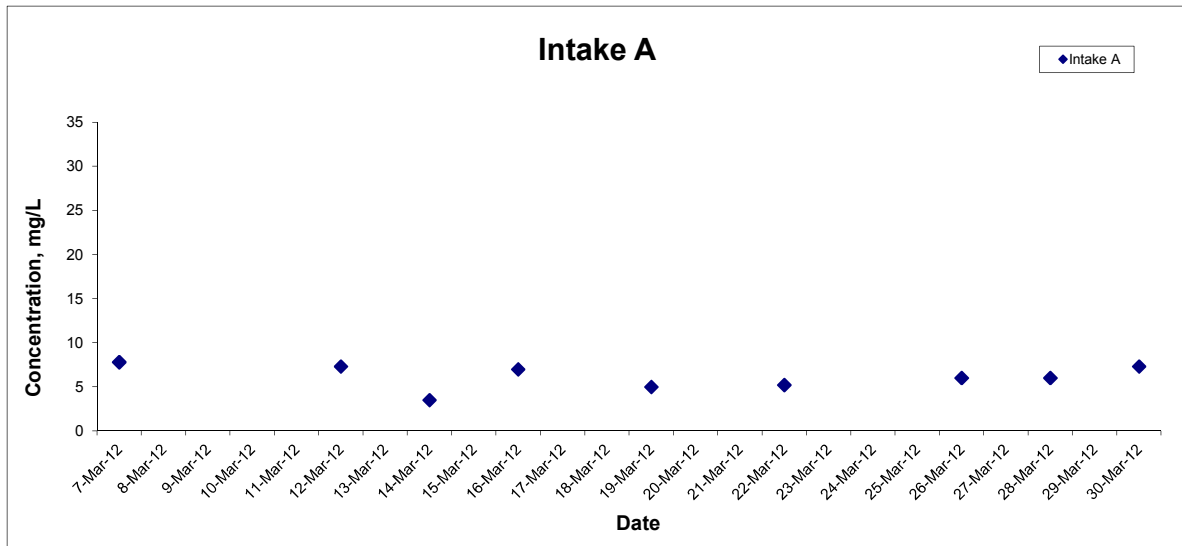
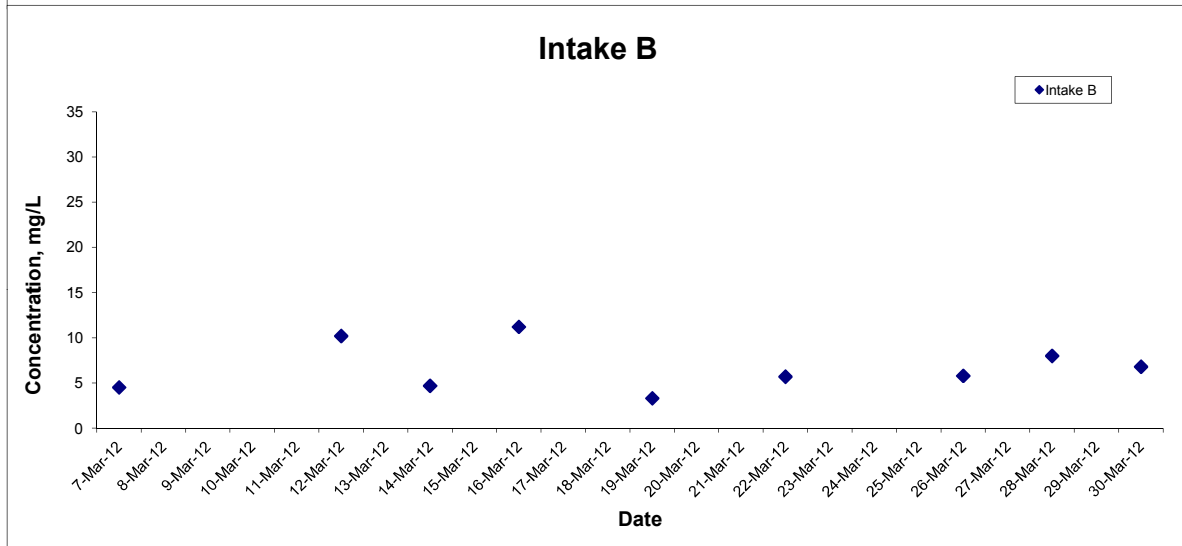
Title Contract No. DC/2007/10 Design and Construction of Hong Kong West Drainage Tunnel  Graphical Presentation of Water Quality Monitoring Results	Scale N.T.S	Project No. MA8001	
	Date Mar 12	Appendix P

## Suspended Solids (Depth-averaged) at Mid-Flood Tide

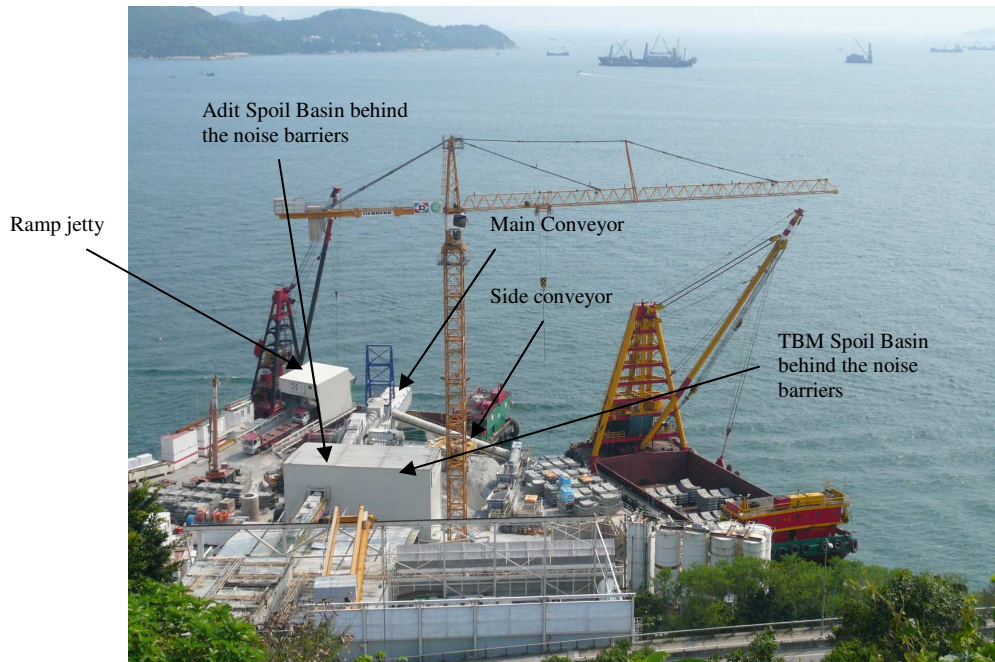
**Photo 1: View of the Western Portal**

When the next barge comes during daytime, the materials stored in the TBM Spoil Basin will be picked up by a backhoe and are transferred into a side conveyor. The side conveyor carried the materials to the main conveyor for discharge onto the barge (*Photo 1*).

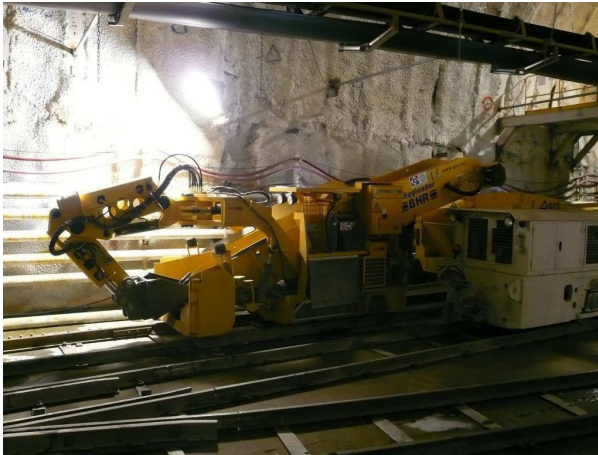
The materials are picked up by either the Häggloader (*Photo 2*) or the John Deere skid loader (*Photo 3*) at the adit face; and they are then transferred onto train cars (Shuttle Cars as in *Photo 4*). These Shuttle Cars will be brought to the Adit Spoil Basin at the tunnel portal (*Photo 5*). A backhoe is deployed at the surface adjacent to the Adit Spoil Basin transferring the excavated materials from the Adit Spoil Basin onto a 24-T dump truck that travels less than 100m within the Site from the Adit Spoil to the ramp jetty and vice versa.

**Photo 2: Hägglöader**

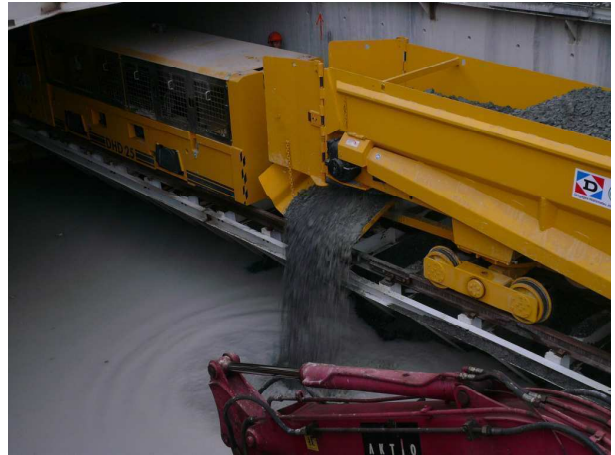
**Photo 5: Shuttle car discharging excavated materials at the Adit Spoil Basin**

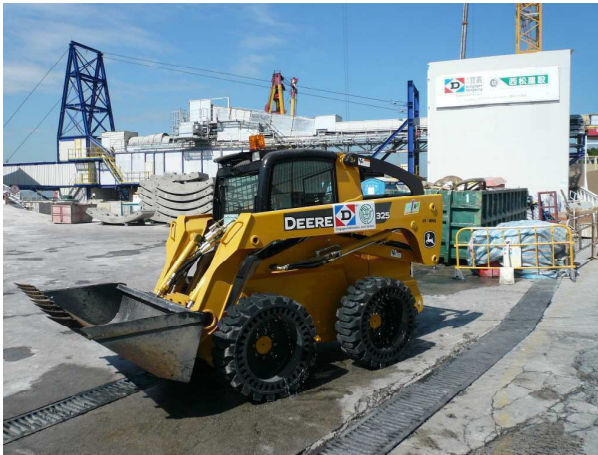
**Photo 3: John Deere Skid Loader**

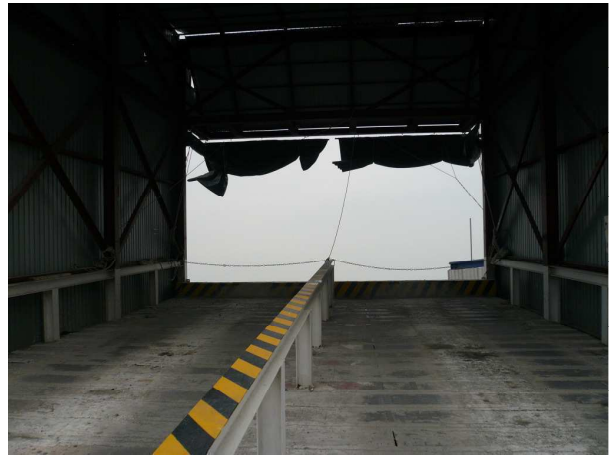
The ramp jetty is enclosed at 3 sides – the top and the lateral sides. It is equipped with curtains and water sprinkler system for dust suppression. (*Photo 6 & 7*)

**Photo 6: The Ramp Jetty**

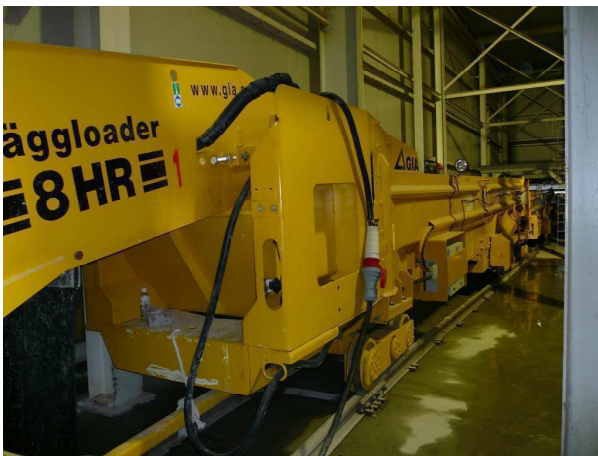
**Photo 4: Shuttle Car**

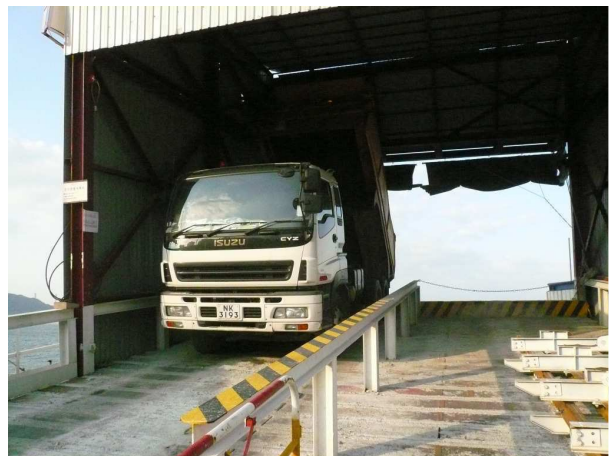
**Photo 7: Dump truck discharging excavated materials onto the barge at the ramp jetty**

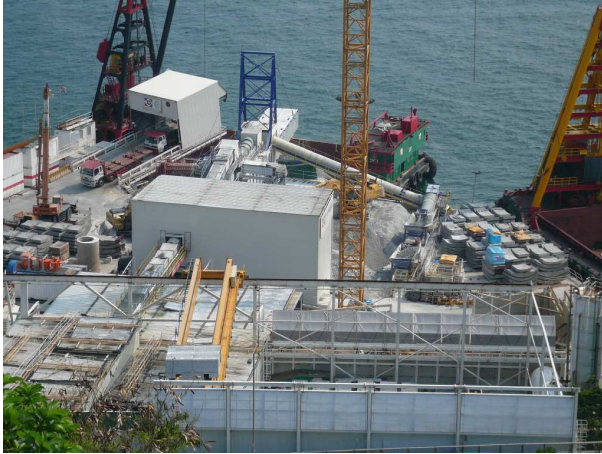
**Photo 8:** Covered Conveyors

Both the main and side conveyors (*Photo 8*) are entirely covered to mitigate noise propagation and avoid fugitive dust during the transportation of excavated materials.

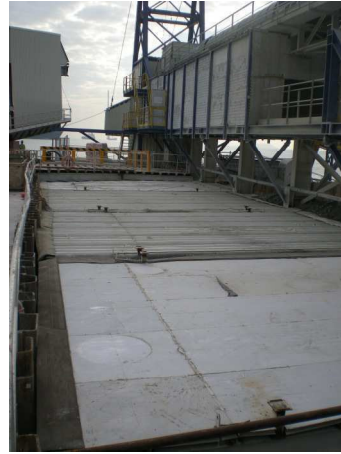
**Photo 11:** Noise covers at the Adit Spoil Basin

All logistics movements take place inside a sophisticated and purposely-built acoustic enclosure. Mobile plant such as locomotives and train cars are travelling inside the noise enclosure and into the tunnel under construction. In addition, movable noise covers (*Photo 11*) were provided in the Adit Spoil basin to block noise propagation during the unloading of excavated materials from the shuttle cars.

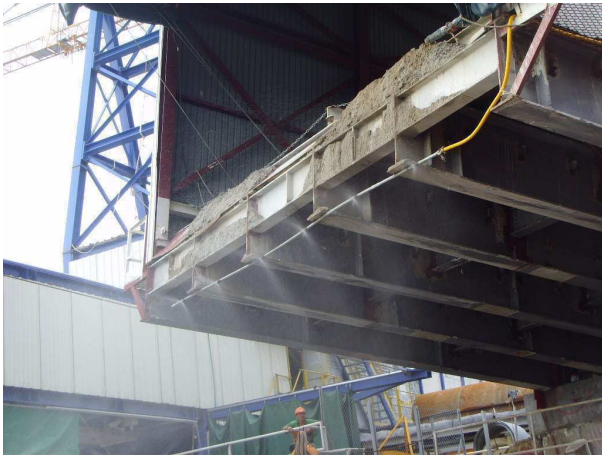
**Photo 9:** Sprinkler system installed at the ramp jetty

- A sprinkler system (*Photo 9*) was installed underneath the ramp jetty for dust suppression when excavated materials are being loaded onto the barge.
- Dust curtains (*Photo 10*) were also installed at the outer rims of the conveyor enclosure in order to shield fugitive dust, if any, arising from the discharge of excavated materials from the conveyor.
- The 24T dump truck transporting materials from the Adit Spoil Basin to the ramp jetty is fitted with mechanical covers.

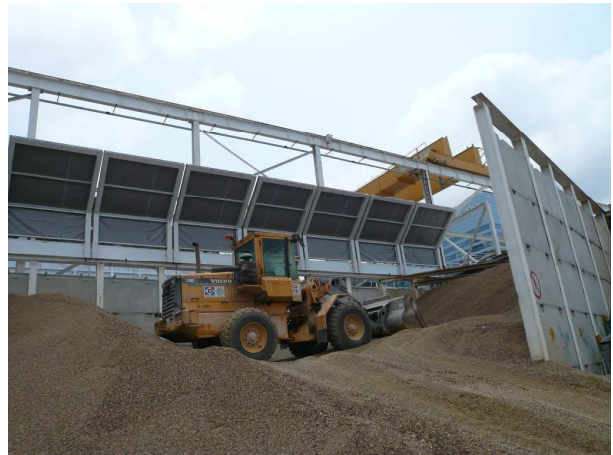
**Photo 12:** Noise barrier at the pea gravel storage yard at the side facing Aegean Terrace

In addition to the noise enclosure erected at the Western Portal, a row of noise barrier was built in the Western Portal adjacent the pea gravel storage yard (*Photo 12*). The barrier does not only screen the mobile plant at the pea gravel storage yard from the views of the Aegean Terrace residents, but it shields part of the noise generated from the operation of such plant. There is another row of barriers erected at the side abutting the Cyberport Road (*Photo 13*).

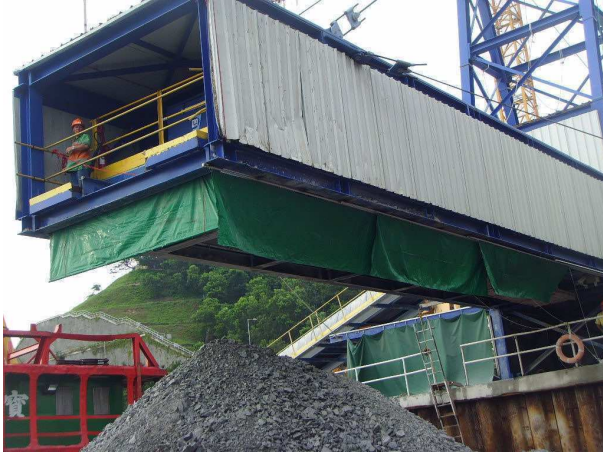
**Photo 10: Dust curtains at the discharge point**

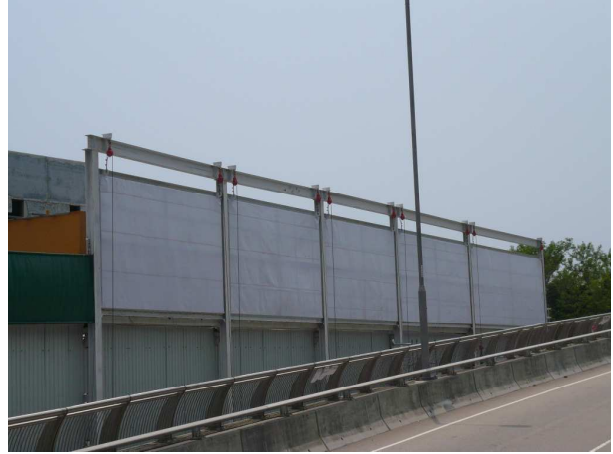
**Photo 13: Noise barrier along Cyberport Road**

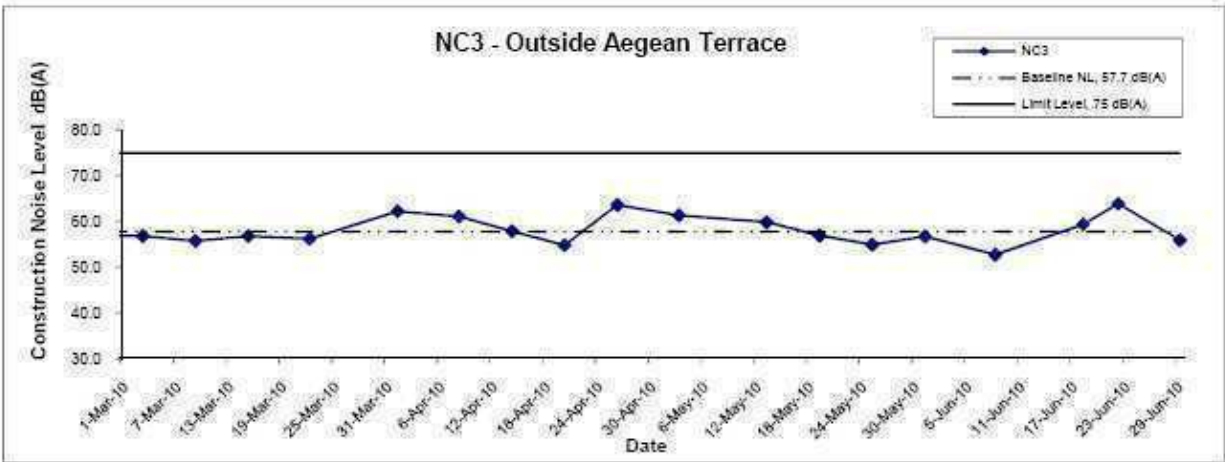
## Noise Levels

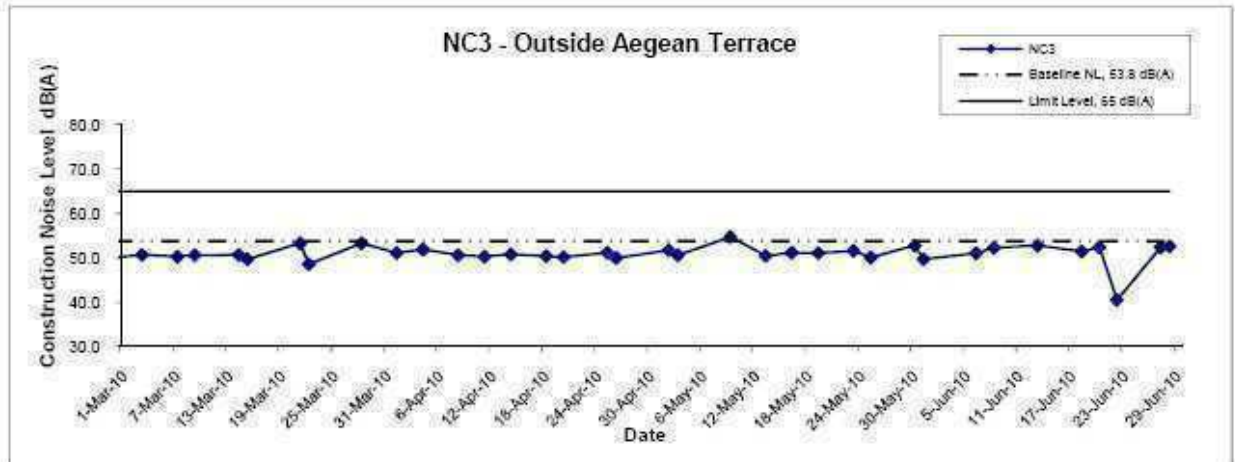
## Noise Levels (Restricted Hours - 07:00 - 23:00 holidays & 19:00 - 23:00 on all other days )

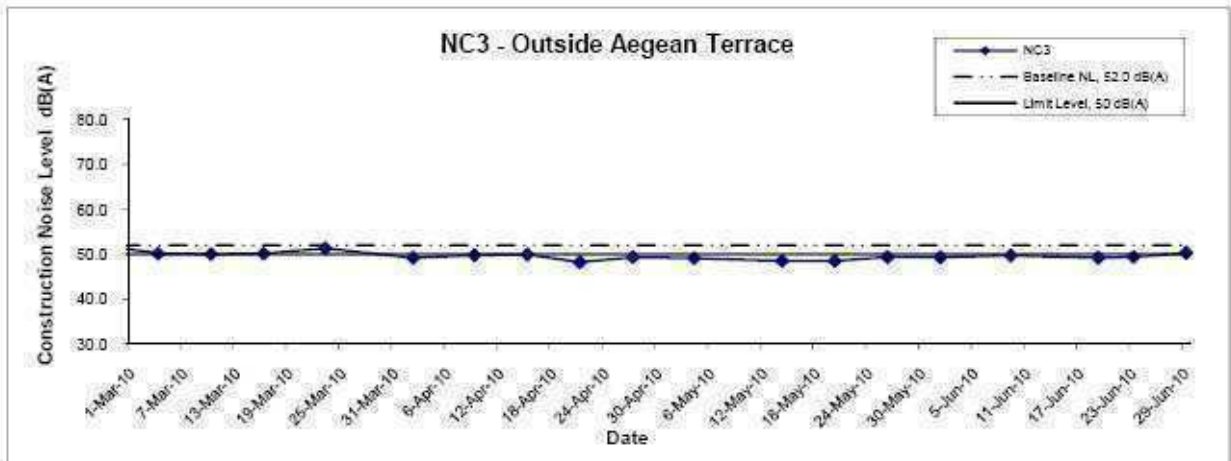
## Noise Levels (Restricted Hours - 23:00 to 07:00 on all days )
