Dragages-Nishimatsu Joint Venture

Contract No. DC/2007/10
Design and Construction of
Hong Kong West Drainage Tunnel

Monthly EM&A Report

May 2012
(version 2.0)

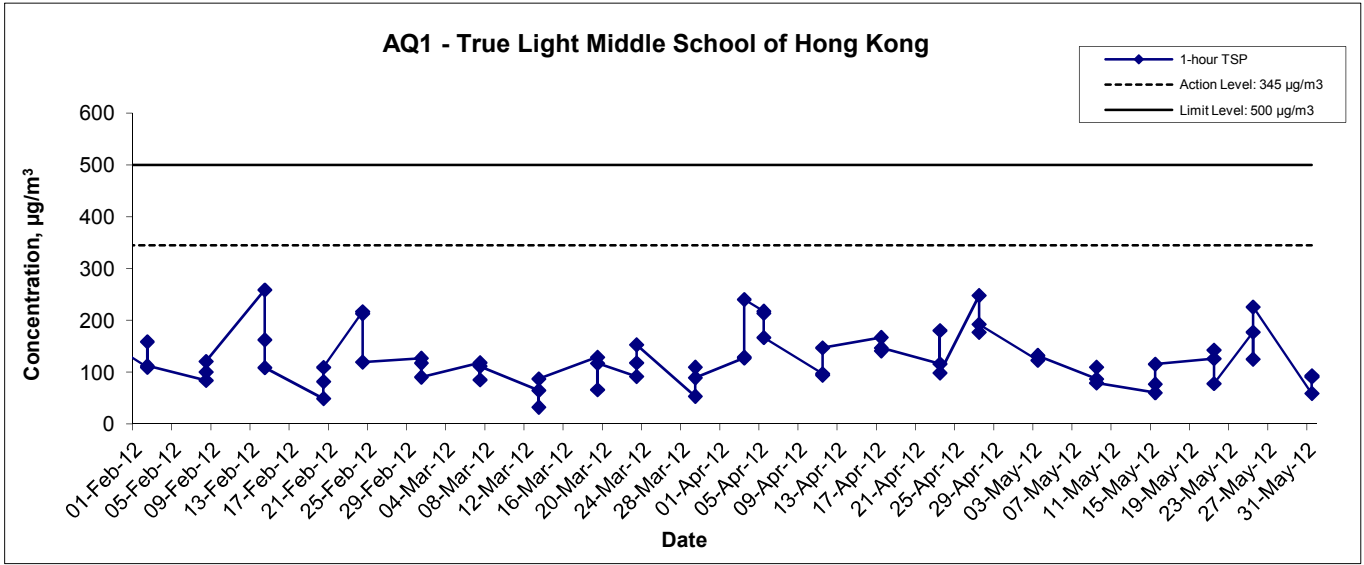
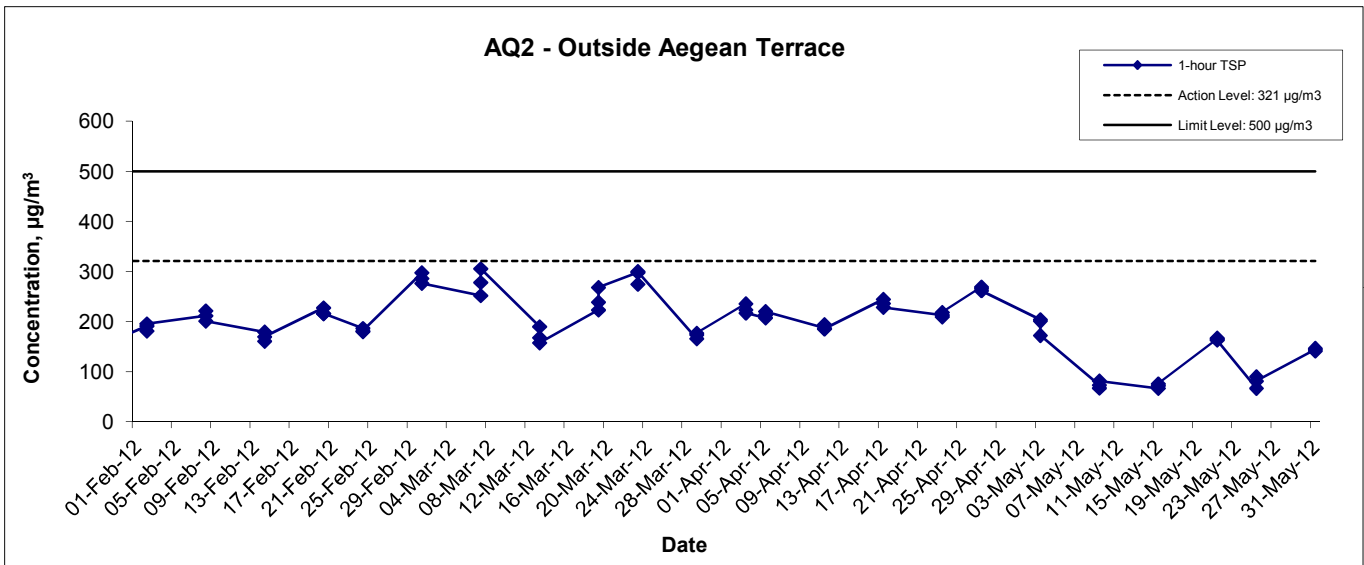
1-hr TSP Concentration Levels

Title Contract No. DC/2007/10 Design and Construction of Hong Kong West Drainage Tunnel Graphical Presentation of 1-hour TSP Monitoring Results	Scale N.T.S	Project No. MA8001	CINOTECH
	Date May 12	Appendix E

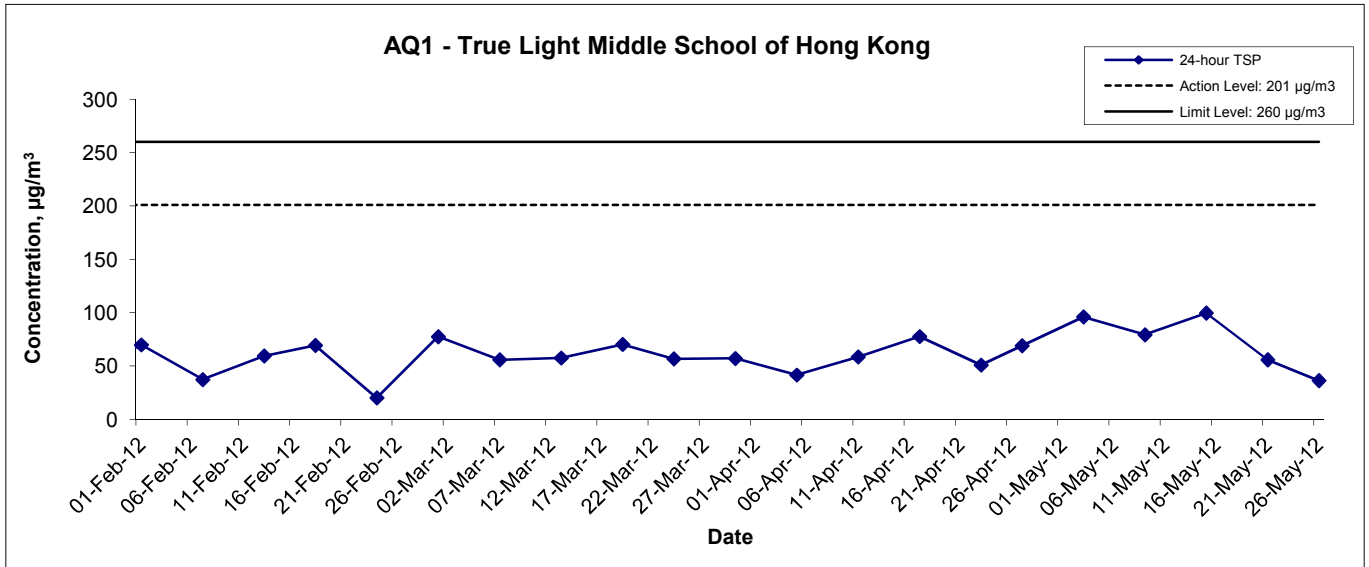
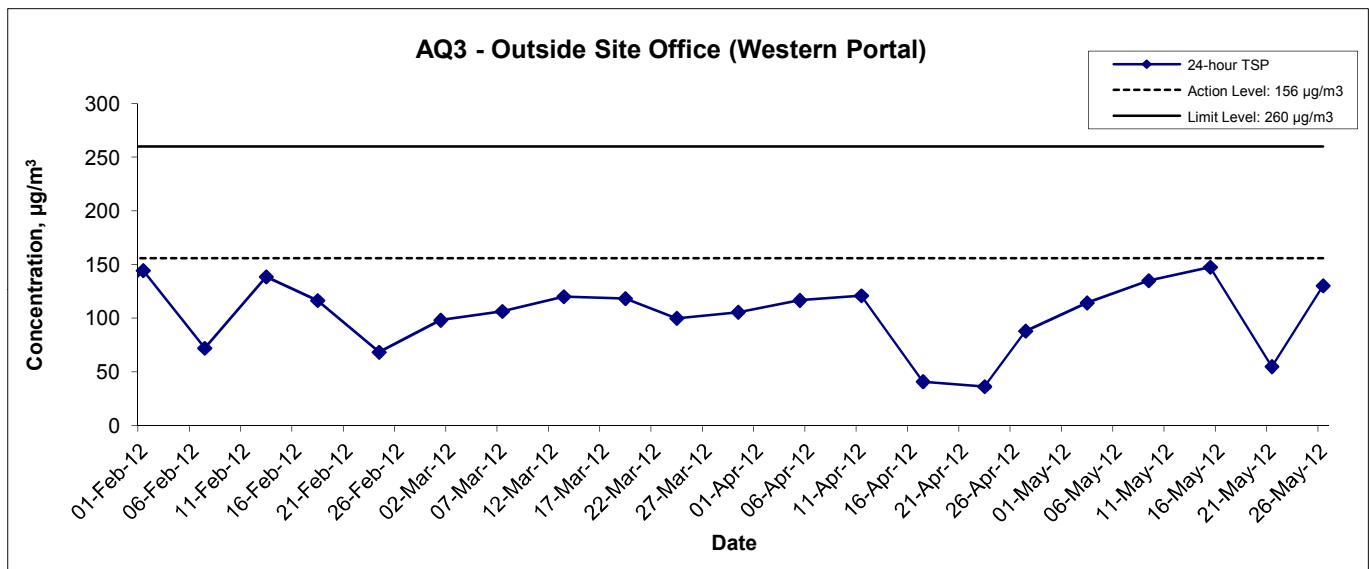
24-hr TSP Concentration Levels

Title Contract No. DC/2007/10 Design and Construction of Hong Kong West Drainage Tunnel Graphical Presentation of 24-hour TSP Monitoring Results	Scale	N.T.S	Project No.	MA8001	CINOTECH
	Date	May 12	Appendix	F
