Dragages-Nishimatsu Joint Venture

Contract No. DC/2007/10
Design and Construction of
Hong Kong West Drainage Tunnel

Monthly EM&A Report

June 2013
(version 2.0)

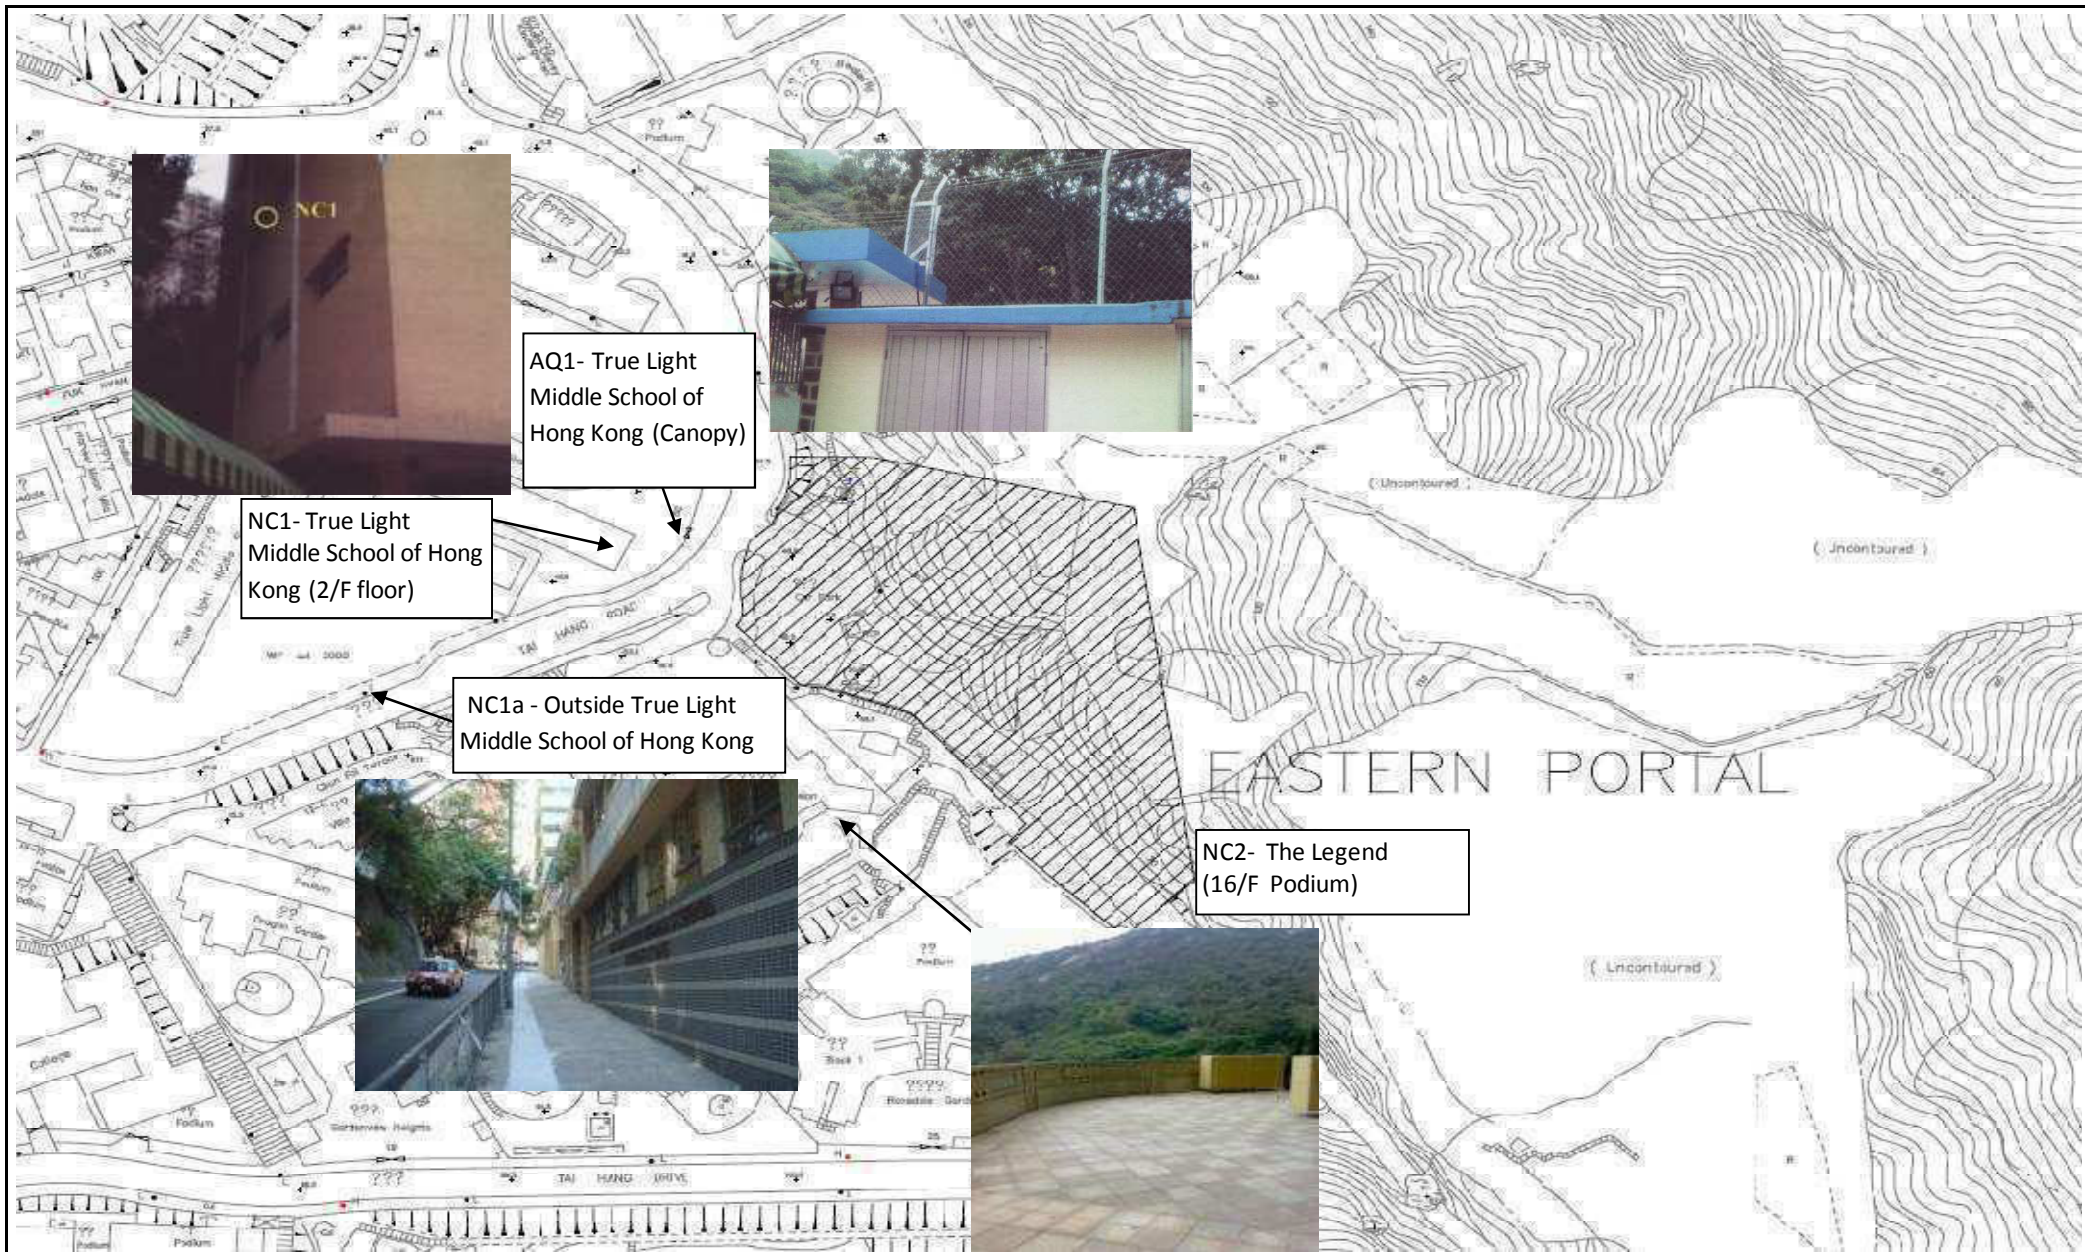
Scale	N.T.S	Project No.	MA 8001
Date	Sep-09	Figure	3.1a

Title
 Contract No. DC/2007/10
 Design and Construction of Hong Kong West Drainage Tunnel
 (Eastern Portal)
 Locations of Air Quality and Noise Monitoring Station
