**Contract No. DC/2007/10**

## **Design and Construction of Hong Kong West Drainage Tunnel**

Quarterly EM&A Report

April to June 2012

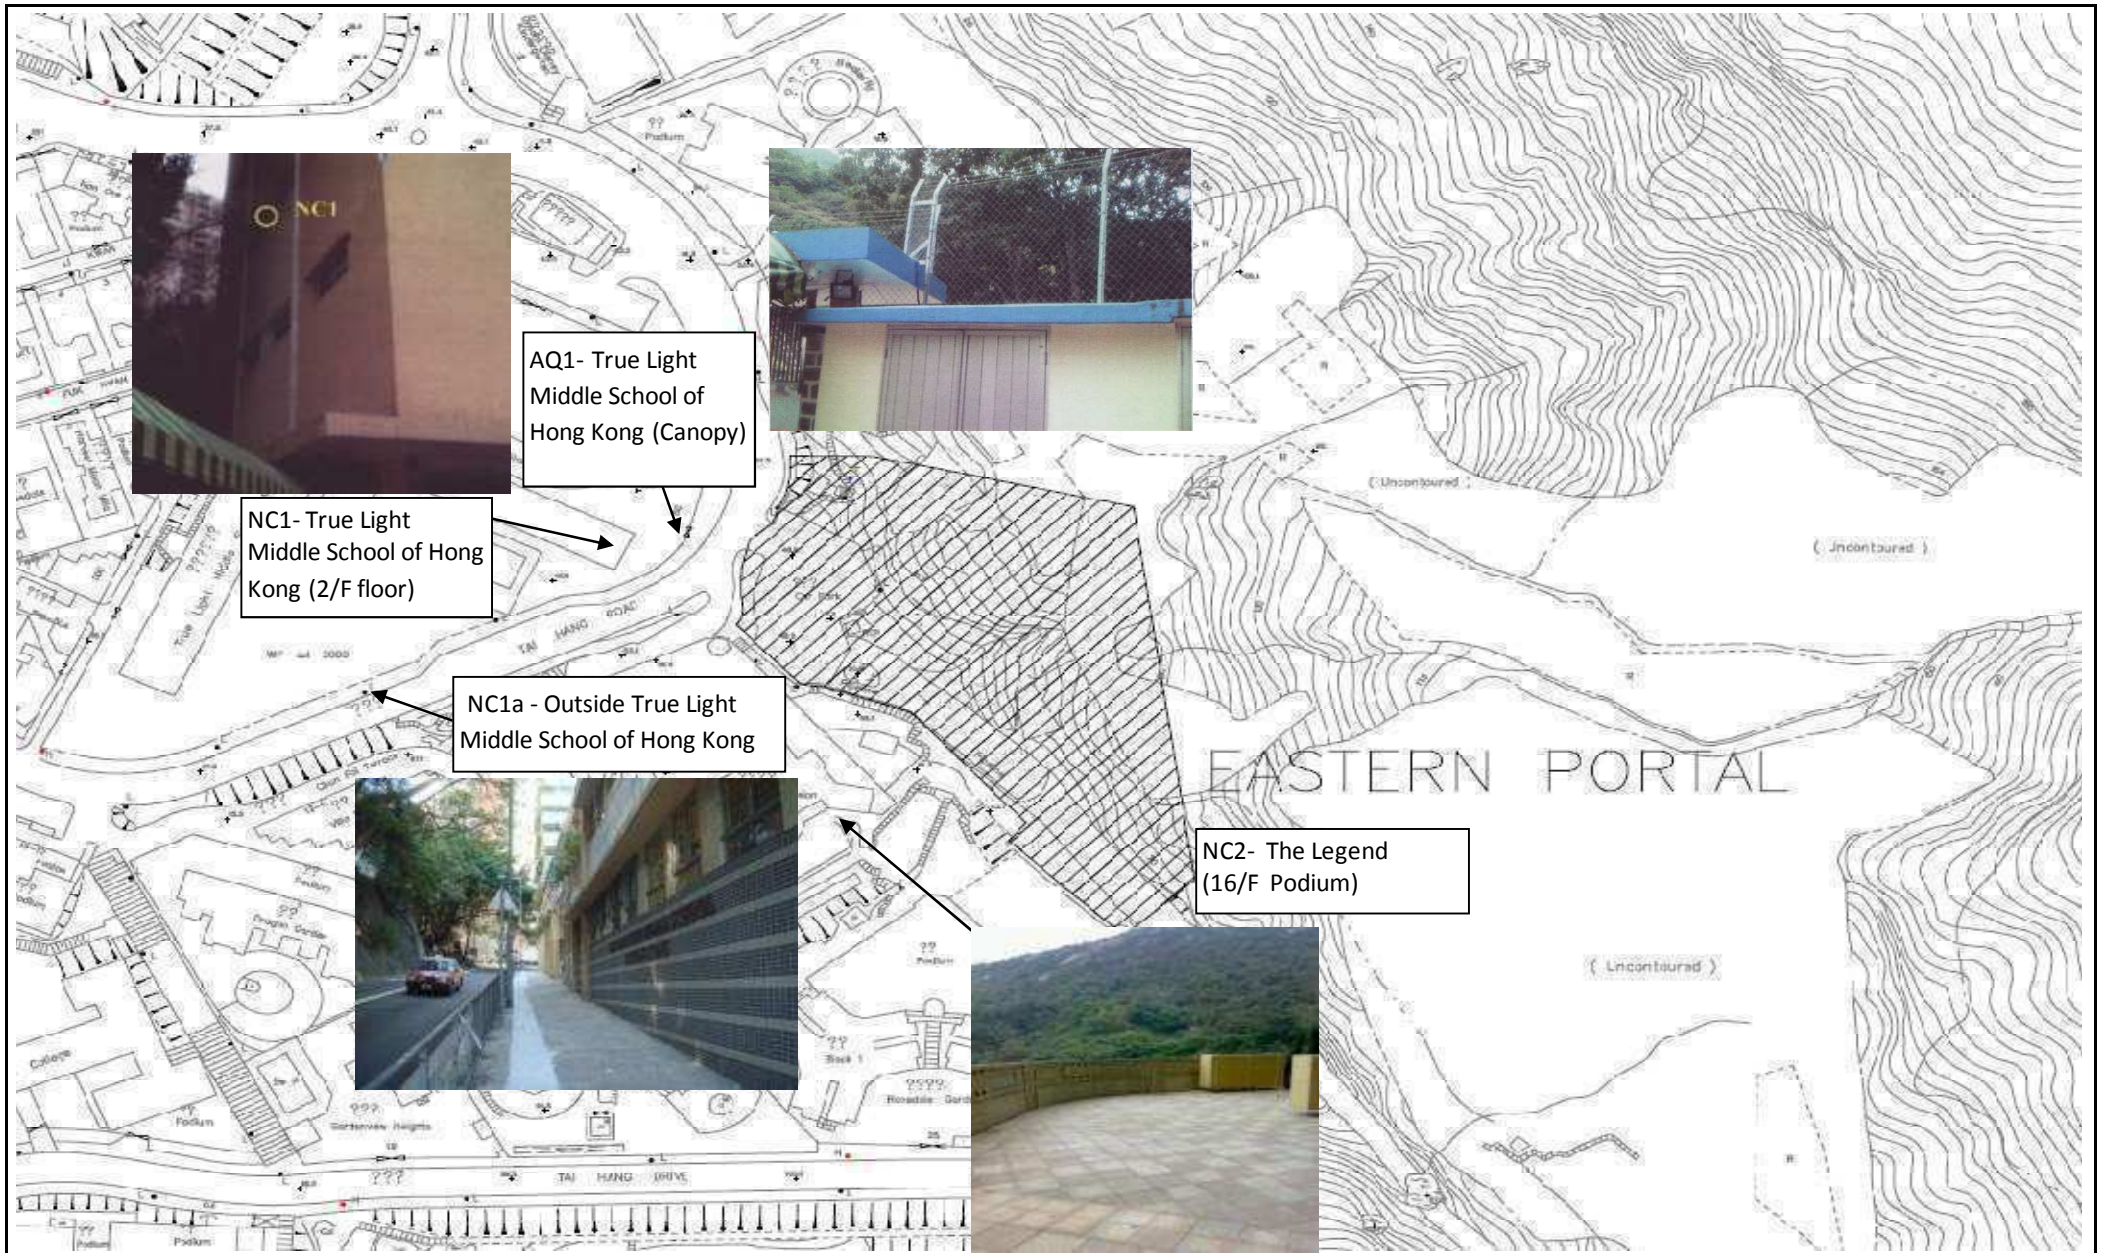
Project  
 No. MA 8001  
 Figure  
 3.1a

Title  
 Contract No. DC/2007/10  
 Design and Construction of Hong Kong West Drainage Tunnel  
 (Eastern Portal)  
 Locations of Air Quality and Noise Monitoring Station

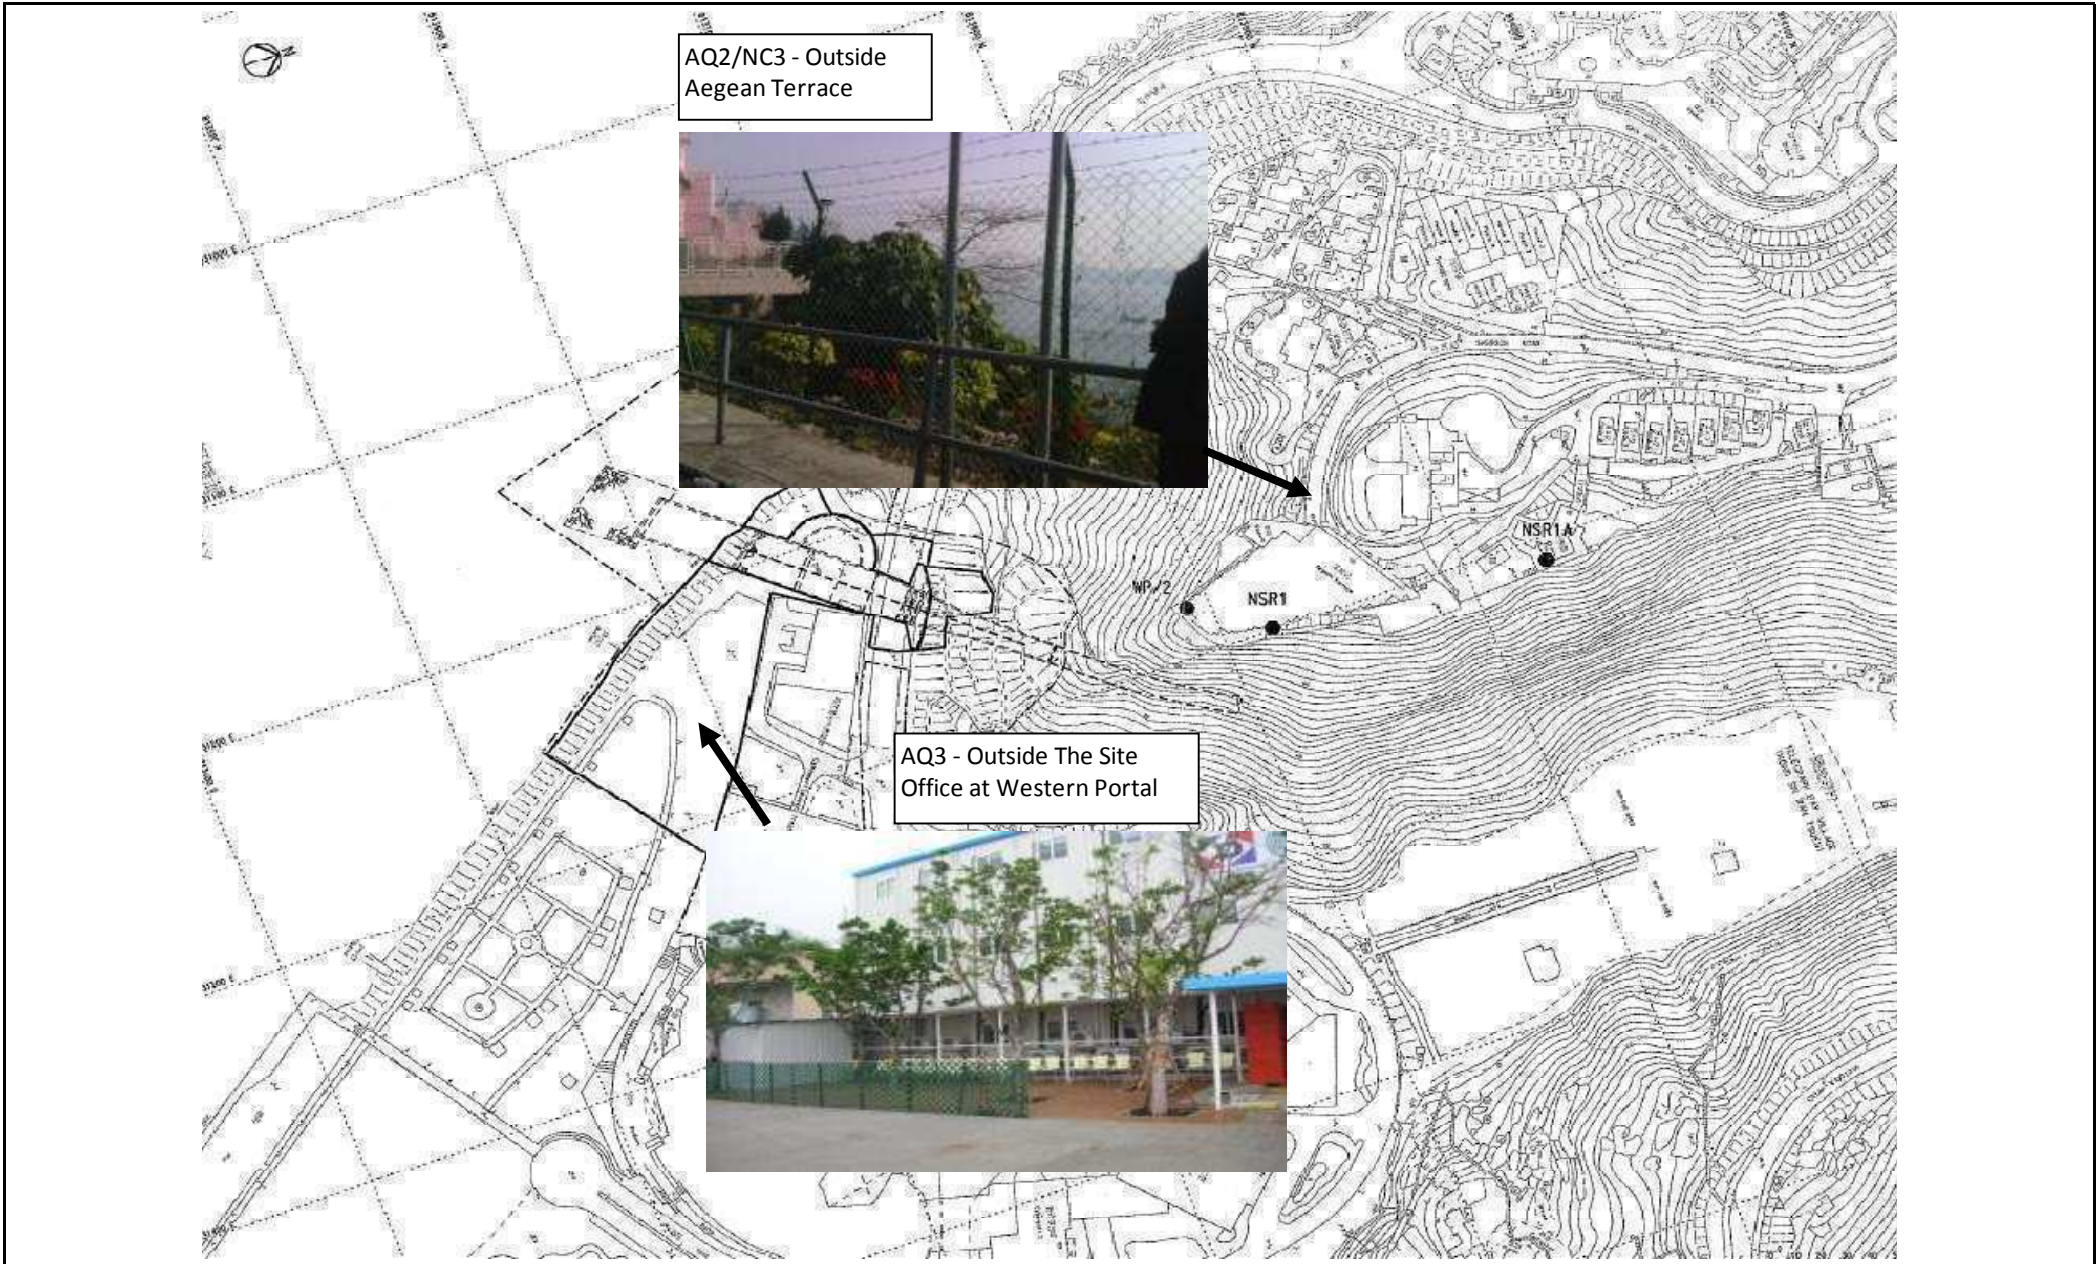
Title	Contract No. DC/2007/10		Scale	Project		CINOTECH
	Design and Construction of Hong Kong West Drainage Tunnel (Western Portal)		N.T.S	No.	MA 8001	
	Locations of Air Quality and Noise Monitoring Station		Date	Sep-09	Figure	3.1b

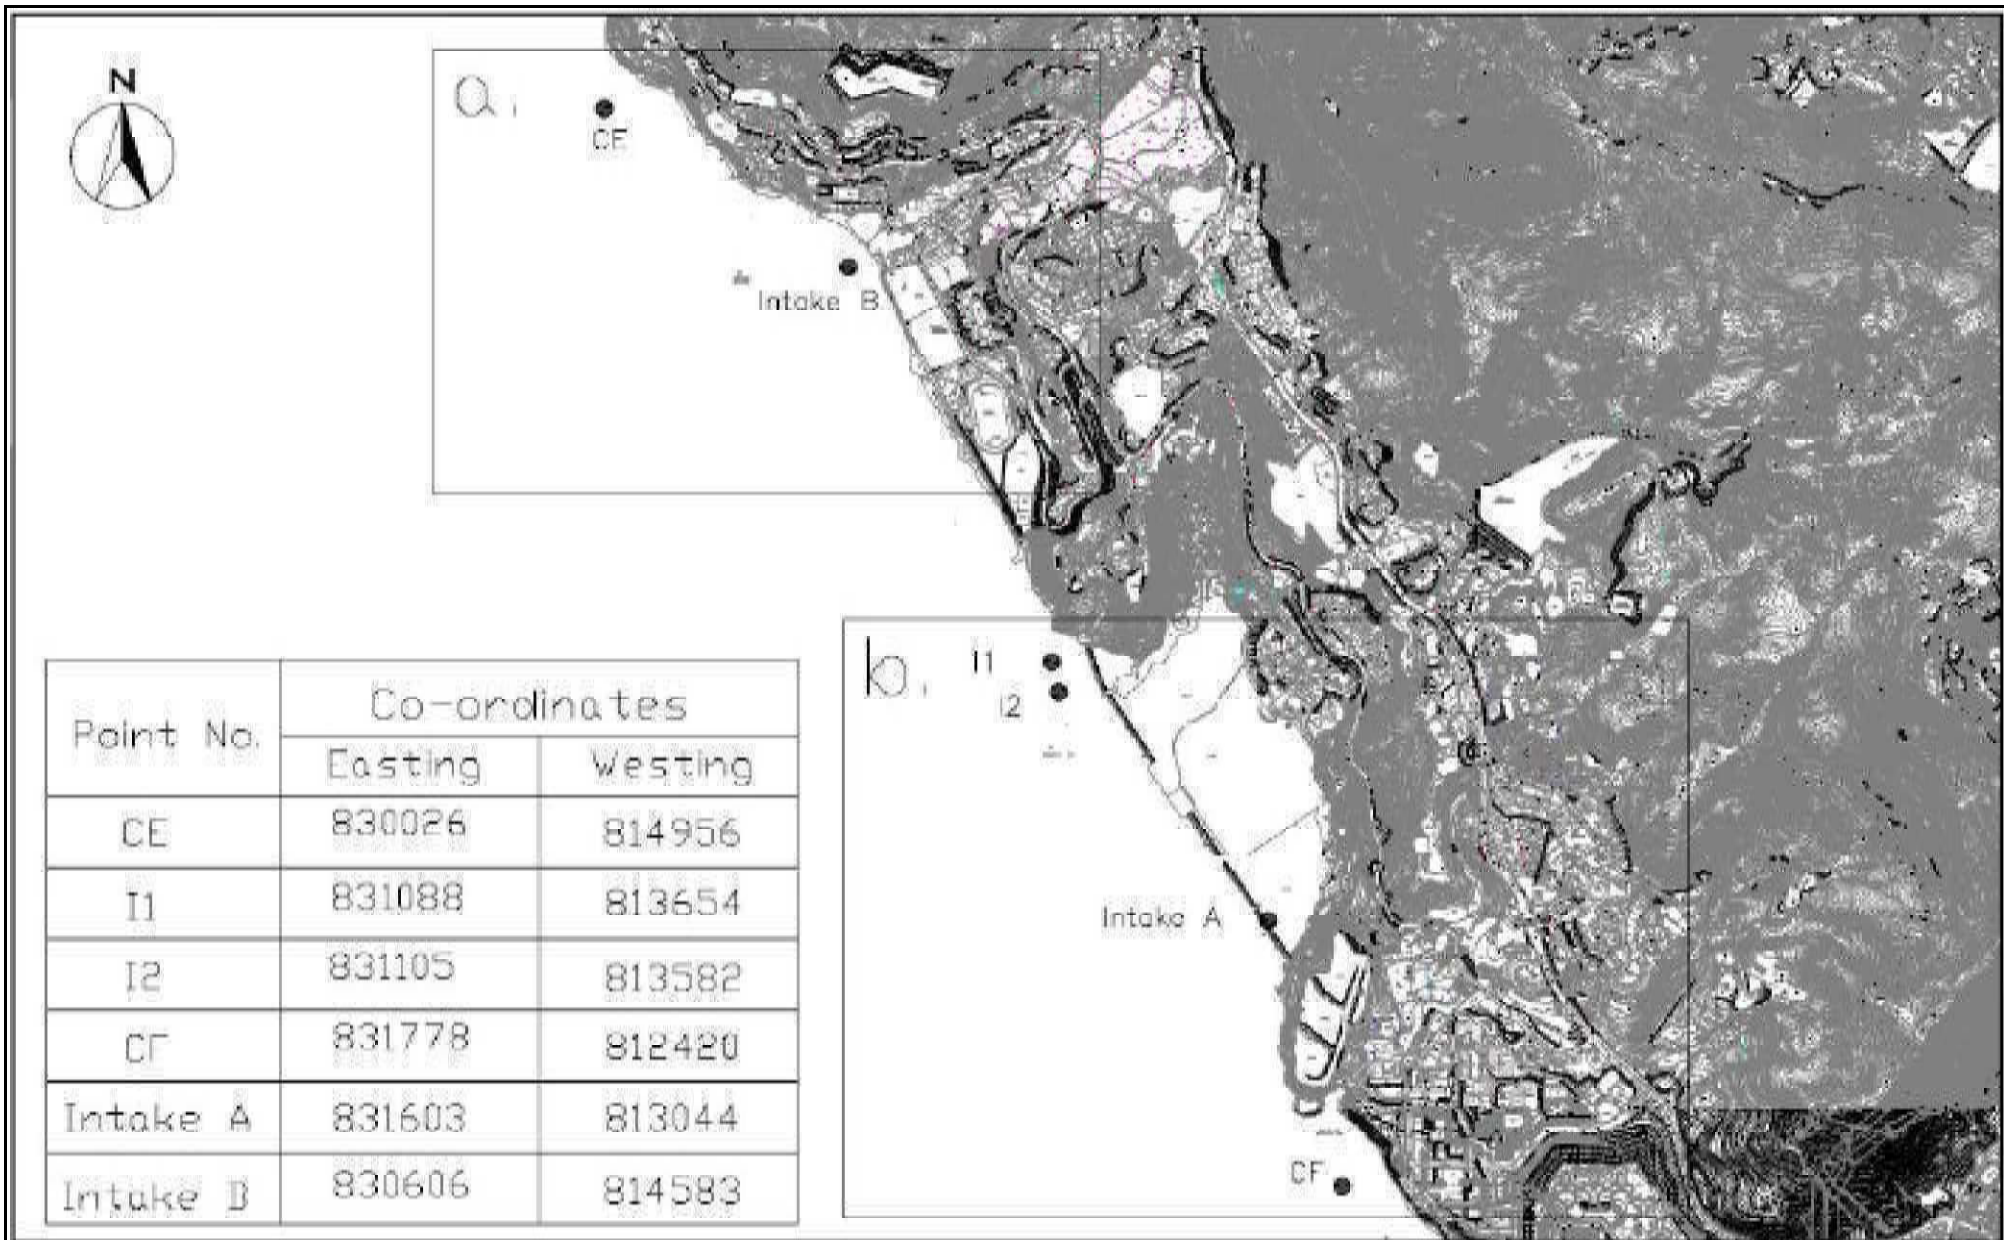
Title Contract No. DC/2007/10 Design and Construction of Hong Kong West Drainage Tunnel Locations of Water Quality Monitoring Stations	Scale	Project	
		N.T.S	
	Date	Figure	
	Jun-08	4.1

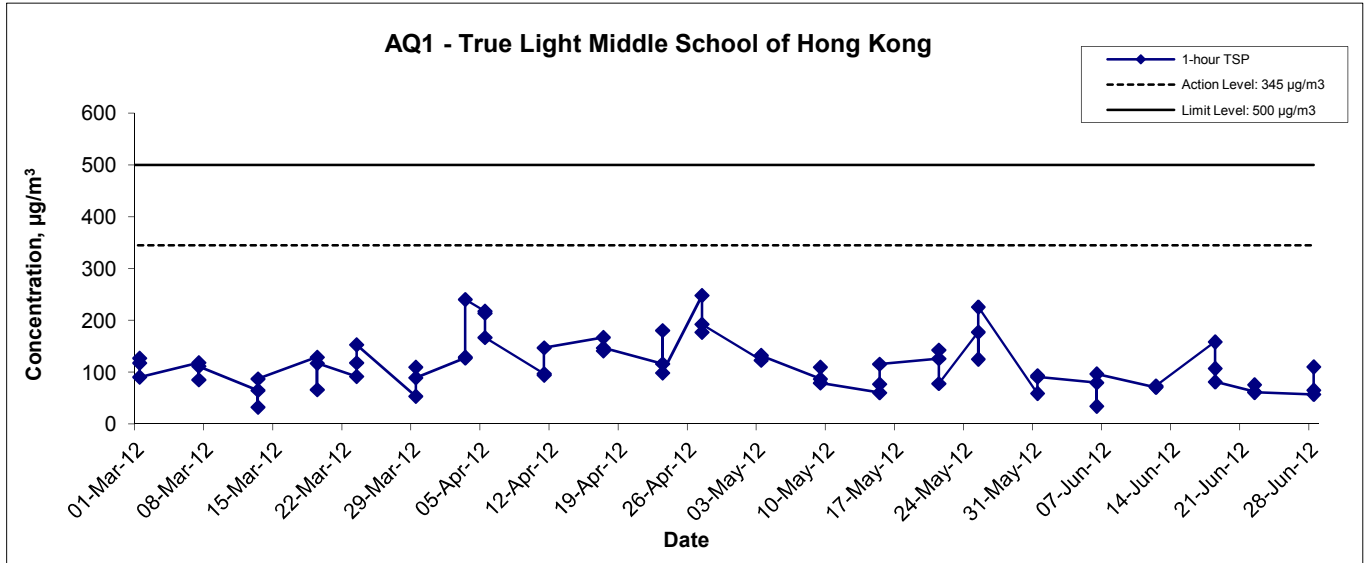
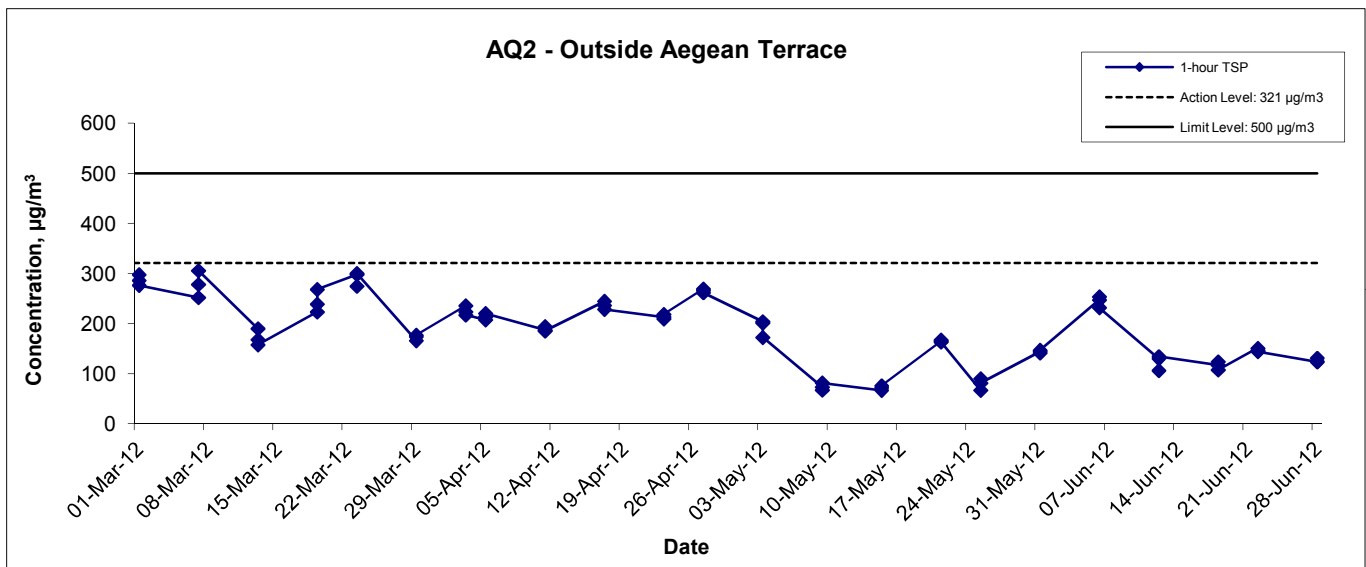
### 1-hr TSP Concentration Levels

Title Contract No. DC/2007/10 Design and Construction of Hong Kong West Drainage Tunnel Graphical Presentation of 1-hour TSP Monitoring Results	Scale N.T.S	Project No. MA8001	
	Date Jun 12	Appendix D

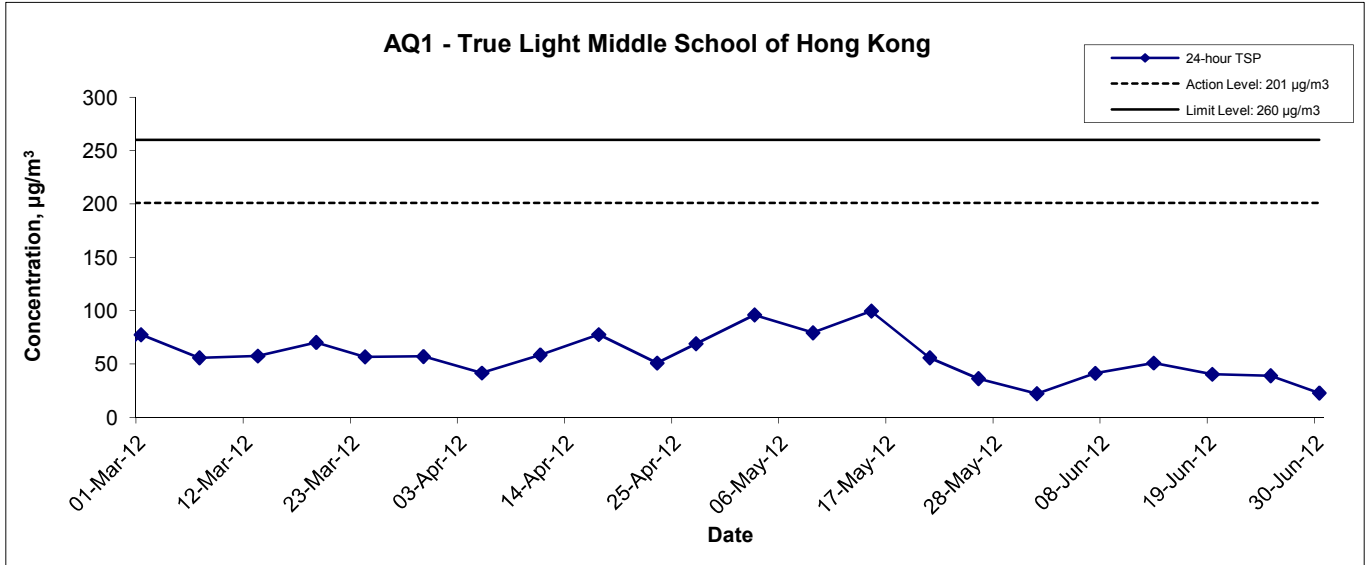
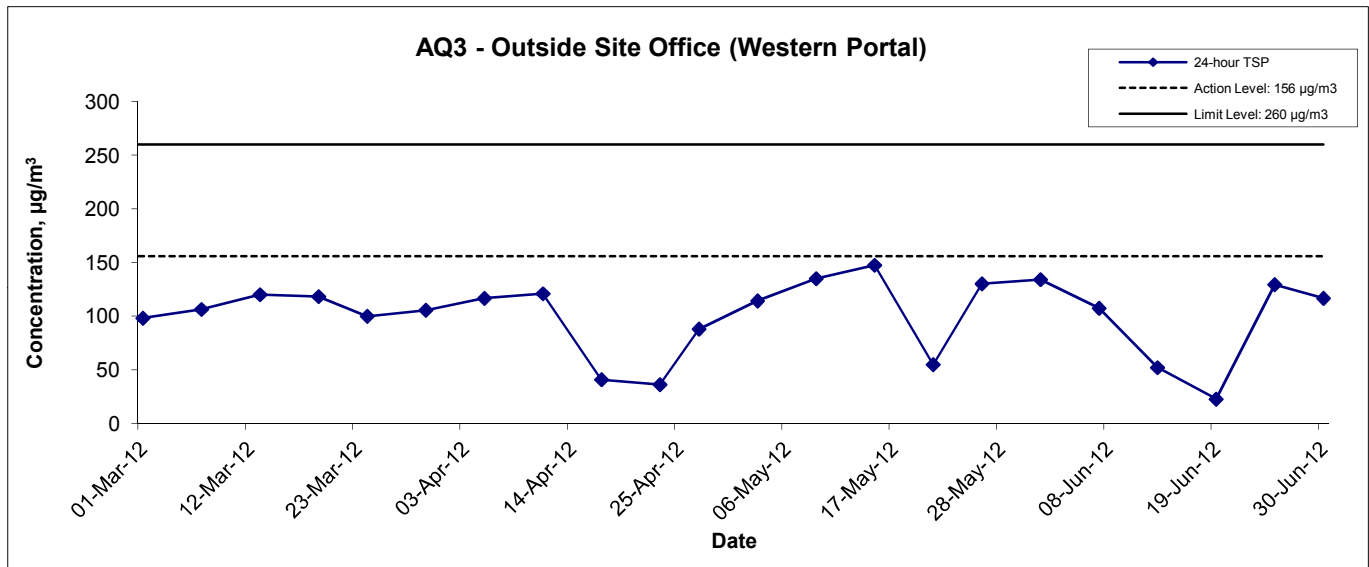
## 24-hr TSP Concentration Levels

Title Contract No. DC/2007/10 Design and Construction of Hong Kong West Drainage Tunnel  Graphical Presentation of 24-hour TSP Monitoring Results	Scale N.T.S	Project No. MA8001	CINOTECH
	Date Jun 12	Appendix D

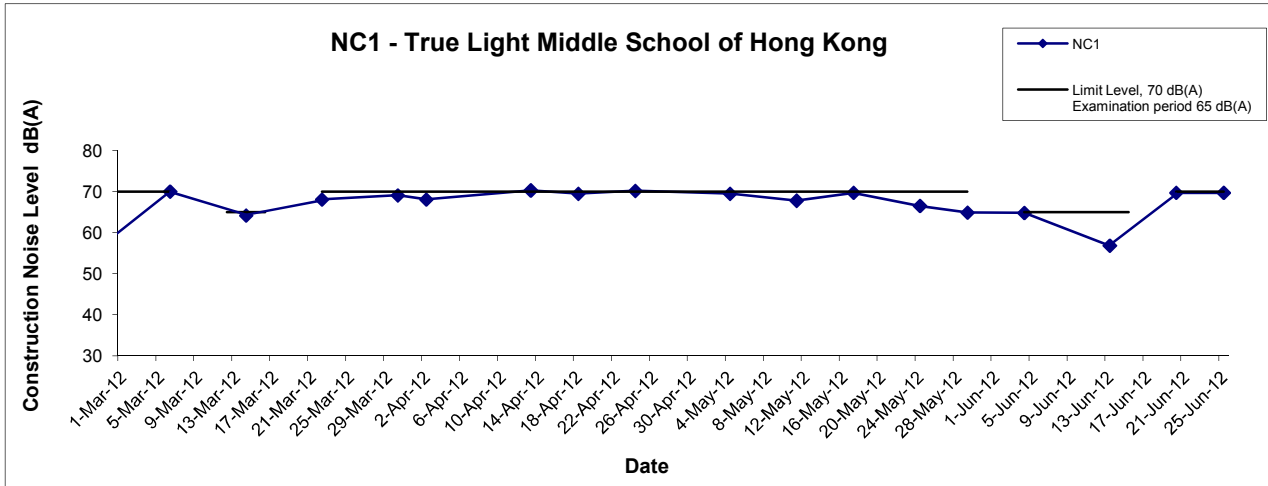
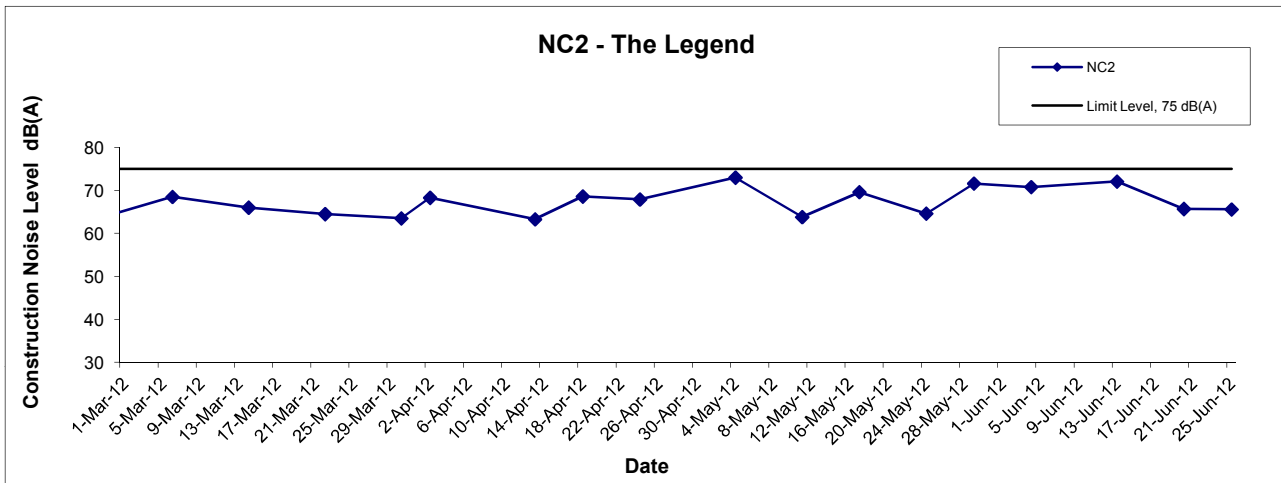
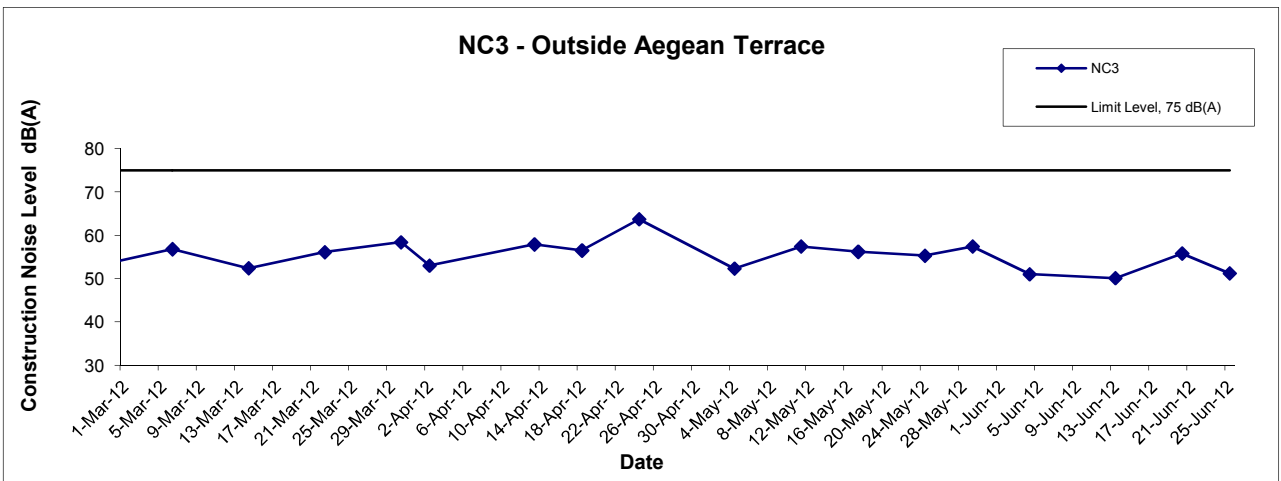
## Noise Levels

Title Contract No. DC/2007/10 Design and Construction of Hong Kong West Drainage Tunnel Graphical Presentation of Construction Noise Monitoring Results	Scale	N.T.S	Project No.	MA8001
	Date	Jun 12	Appendix	E

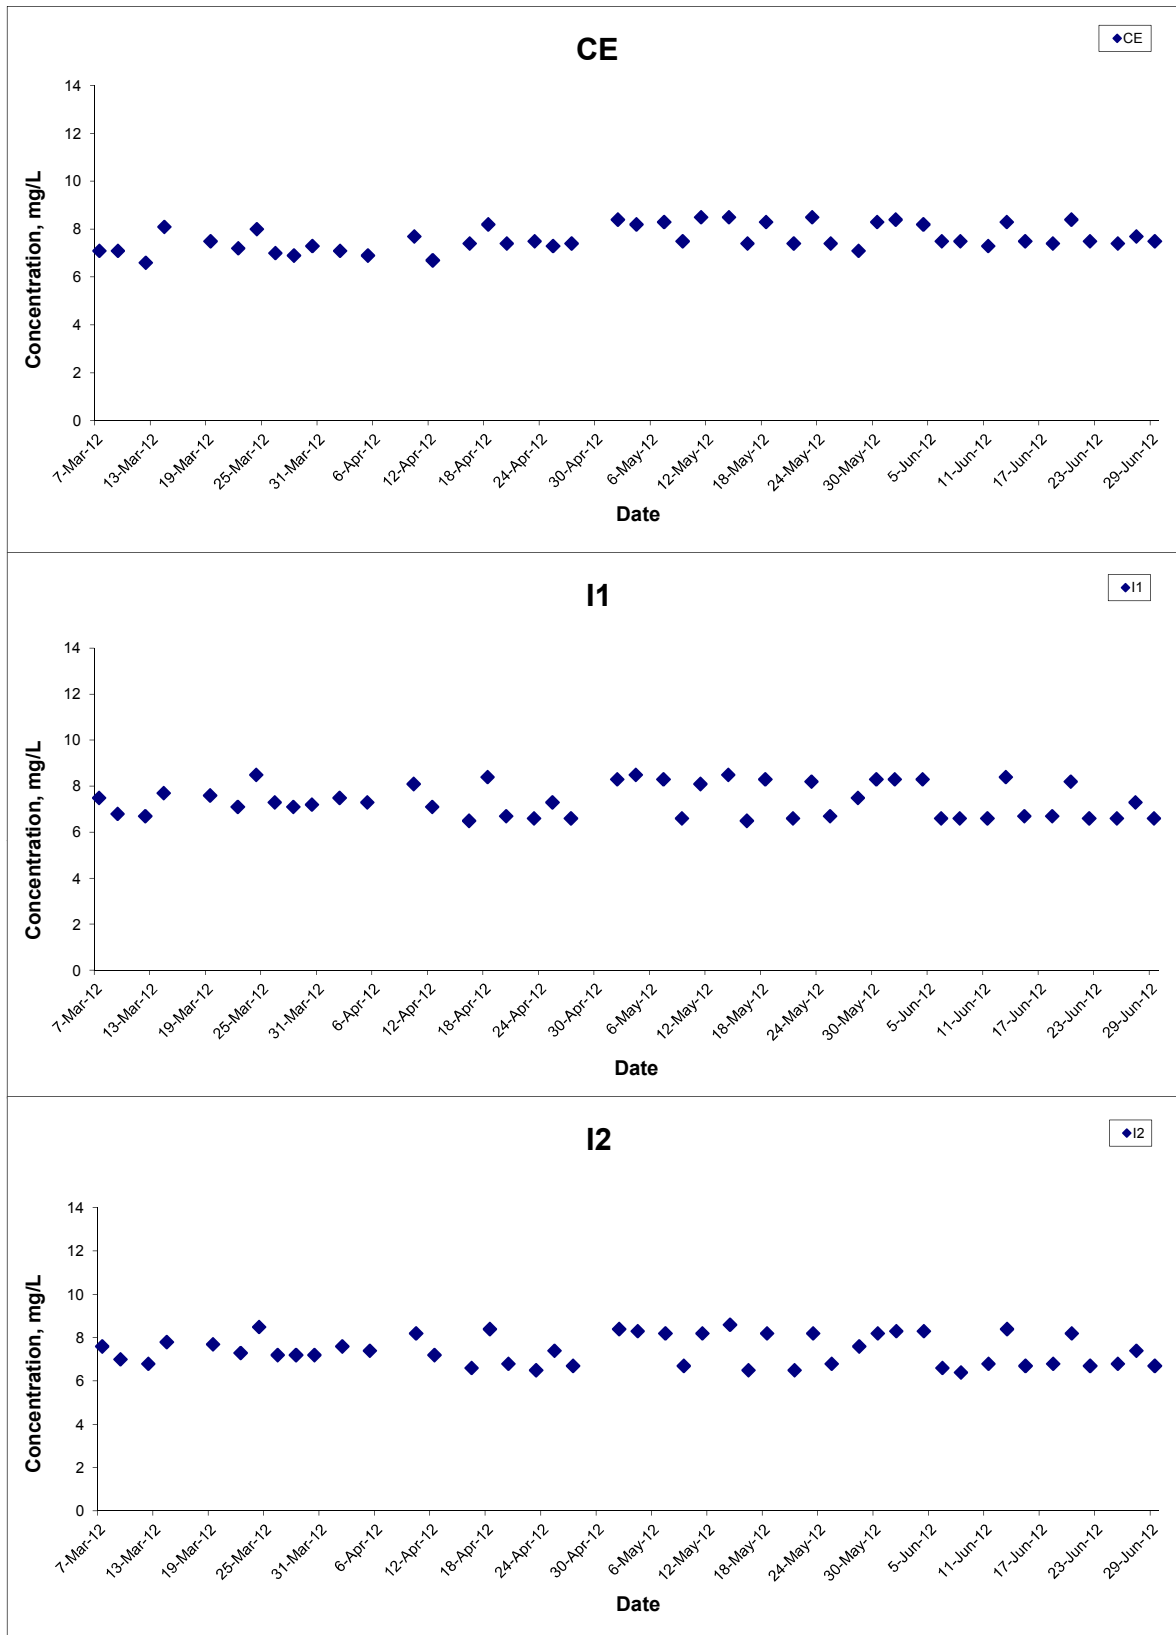
## Dissolved Oxygen (Surface & Middle) at Mid-Ebb Tide

Title Contract No. DC/2007/10 Design and Construction of Hong Kong West Drainage Tunnel  Graphical Presentation of Water Quality Monitoring Results	Scale	N.T.S	Project No. MA8001	CINOTECH
	Date	Jun 12	Appendix L

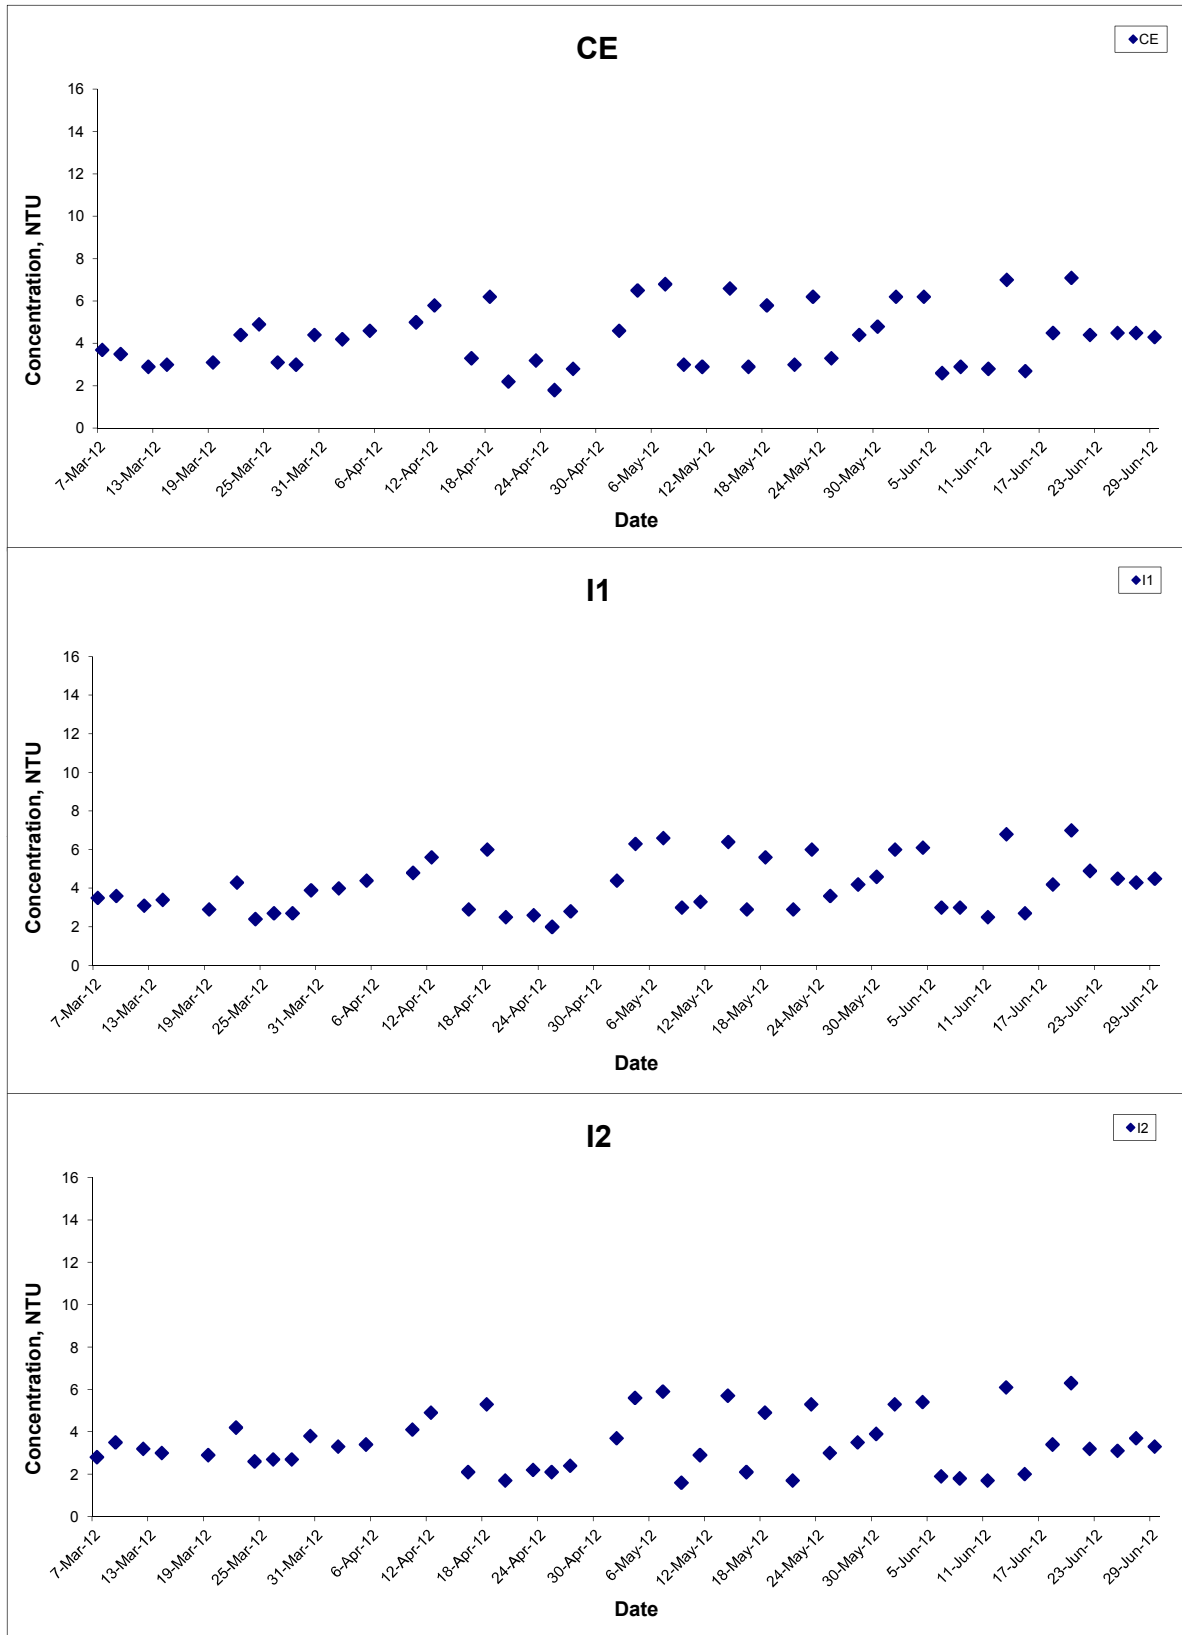
## Turbidity (Depth-averaged) at Mid-Ebb Tide

Title Contract No. DC/2007/10 Design and Construction of Hong Kong West Drainage Tunnel  Graphical Presentation of Water Quality Monitoring Results	Scale N.T.S	Project No. MA8001	CINOTECH
	Date Jun 12	Appendix L

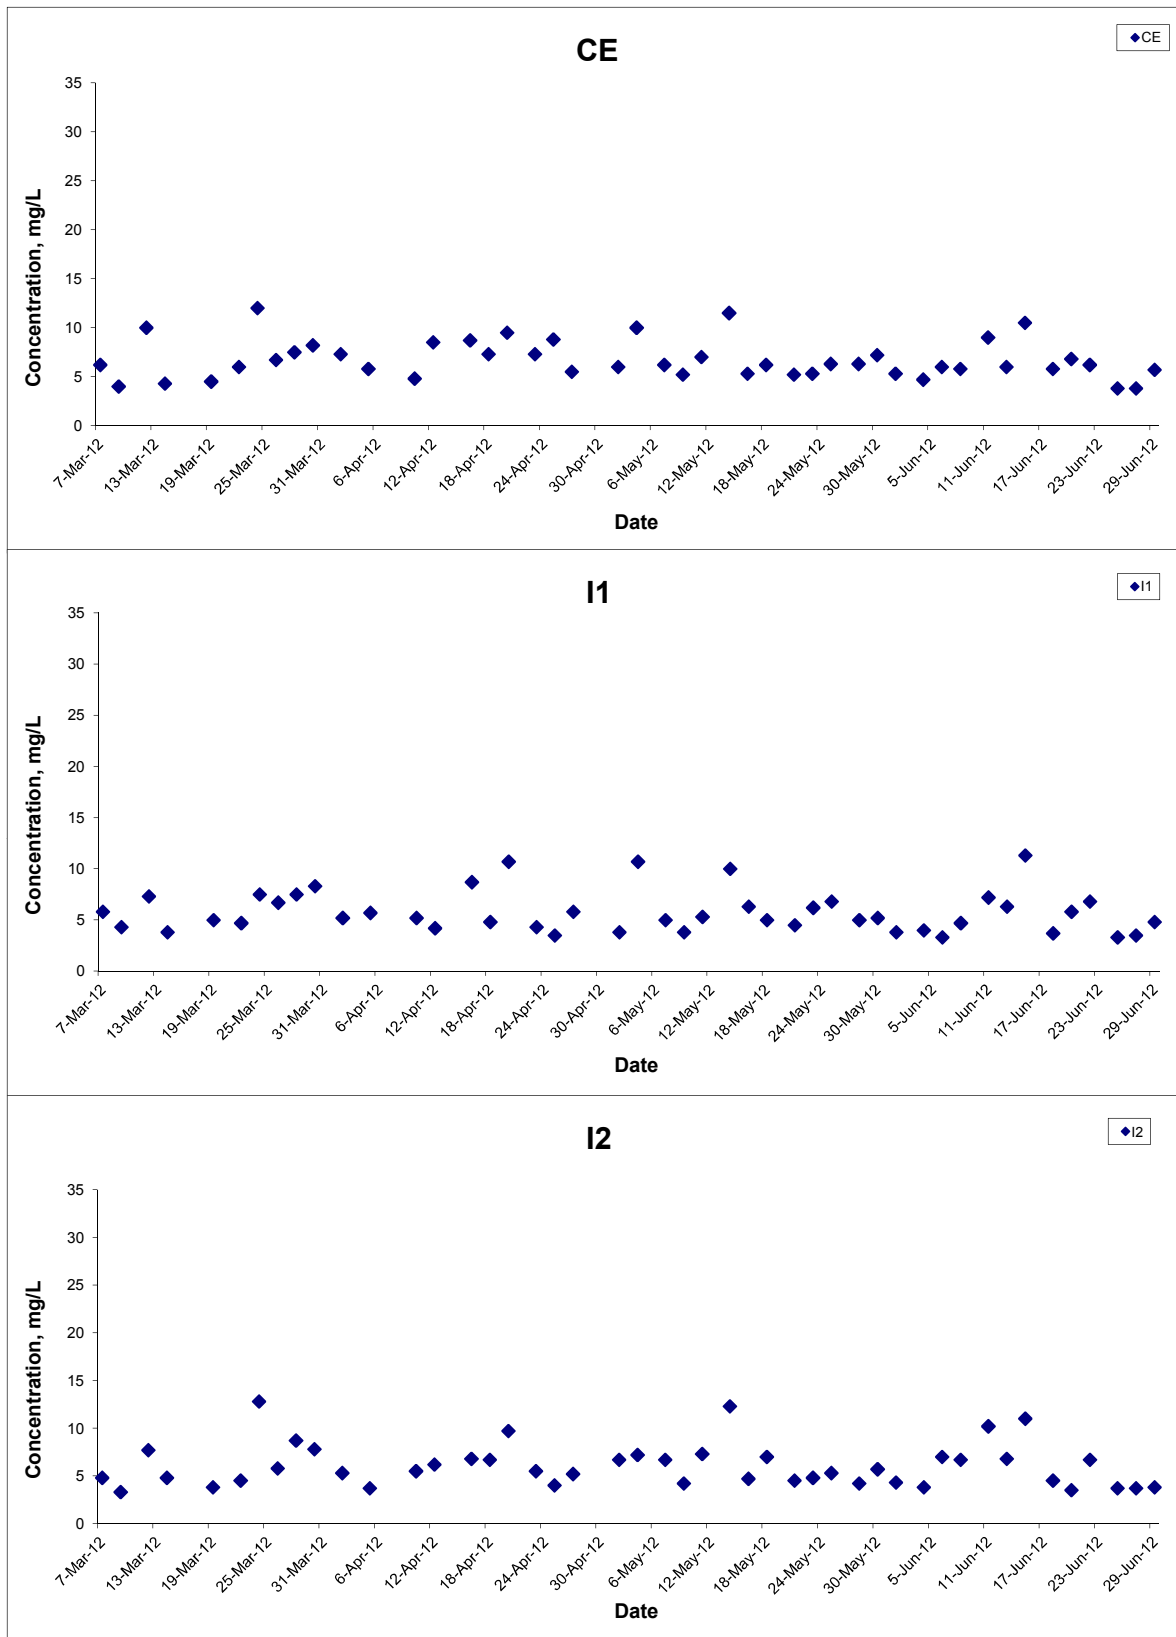
## Suspended Solids (Depth-averaged) at Mid-Ebb Tide

Title Contract No. DC/2007/10 Design and Construction of Hong Kong West Drainage Tunnel  Graphical Presentation of Water Quality Monitoring Results	Scale	N.T.S	Project No. MA8001	CINOTECH
	Date	Jun 12	Appendix L
