DSD CONTRACT No. DC/2009/13 CONSTRUCTION OF SEWAGE TREATMENT WORKS AT YUNG SHUE WAN AND SOK KWU WAN

SOK KWU WAN PORTION AREA
MONTHLY ENVIRONMENTAL MONITORING AND AUDIT
(EM&A) REPORT (No.4) – NOVEMBER 2010

Monthly Environmental Monitoring and Audit (EM&A) Report No. 4 (Nov 2010)

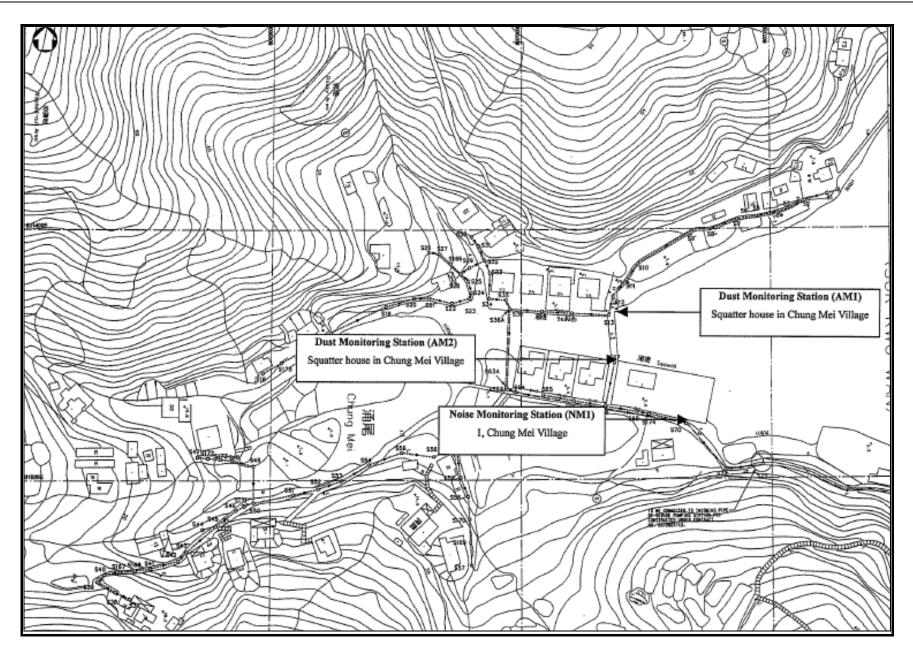
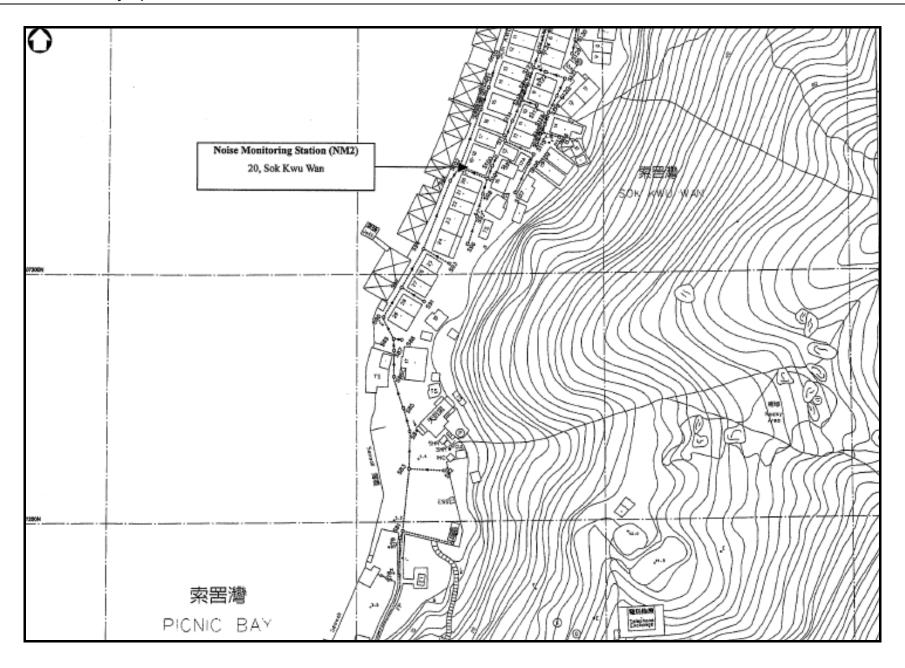
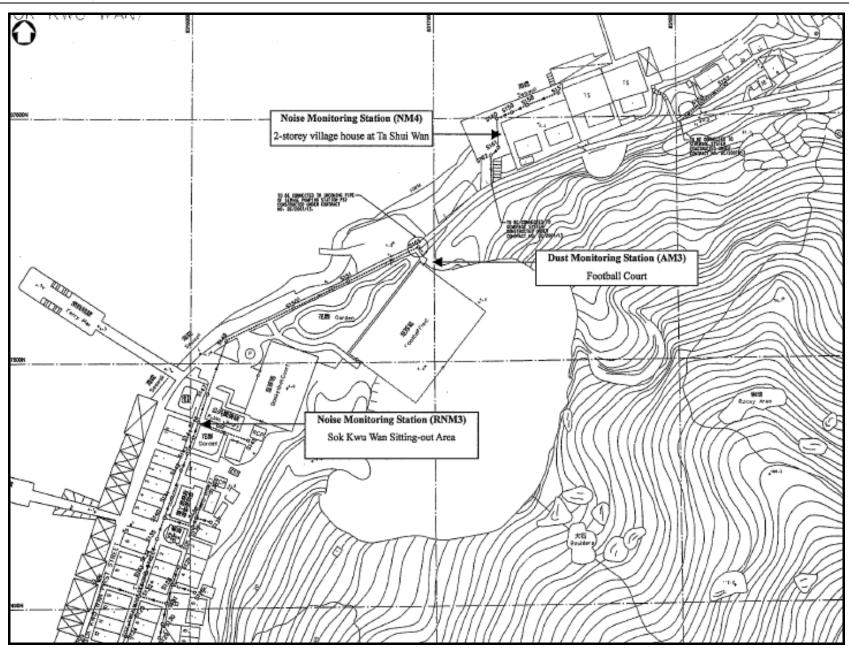
Location of Monitoring Stations
(Air Quality / Construction Noise / Water Quality)

3.05 According to *EM&A Manual Section 3.4* stipulations, there were four noise sensitive receivers (NM1-NM4) designated for the construction noise monitoring. NM1, NM2 and NM4 of the three designated monitoring stations were identified and are monitored by the current DSD contract DC/2007/18. However, the premises monitoring station NM3 was rejected by the owner of 1B Sok Kwu Wan and an alternative noise monitoring station RNM3 replacement was proposed by the contract DC/2007/18 ET and accepted by the IEC and EPD before the baseline monitoring commencement in April 2008. The location RNM3 is located at Sok Kwu Wan Sitting-out area which just 3m width footpath away from the original location house 1B. The detailed construction noise monitoring stations to also under the Project is described in *Table 3-3* and graphical is shown in *Appendix D*.

3.06 Three control stations (C1-C3) and three impact stations (W1-W3) were recommended in the *EM&A Manual Section 4.5*. Impact stations W1-W3 identified at the sensitive receivers (FCZ and secondary contact recreation subzone) to monitor the impacts from the construction of the submarine outfall as well as the effluent discharge from the proposed STW on water quality. Three control stations: C1, C2 & C3 were specified at locations representative of the project site in its undisturbed condition and located at upstream and downstream of the works area. Detailed and co-ordnance of marine water quality monitoring stations is described in *Table 3-4* and the graphical is shown in *Appendix D* and would be performed for EM&A programme.

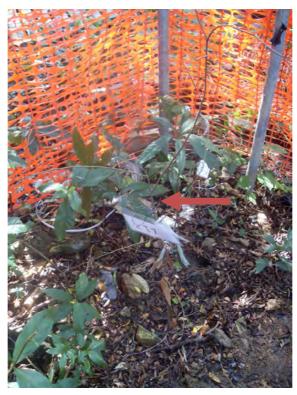
Photo 1 Overall view of CT7

The tree CT7 and CT8 have better recovery. The new buds and leaves show that they are adjusted to the environment. The tree CT9, CT10 should keep regular monitor. Watering for these plants should depend on the weather condition.
