DSD CONTRACT No. DC/2009/13 CONSTRUCTION OF SEWAGE TREATMENT WORKS AT YUNG SHUE WAN AND SOK KWU WAN

SOK KWU WAN PORTION AREA
MONTHLY ENVIRONMENTAL MONITORING AND AUDIT
(EM&A) REPORT (NO.28) – NOVEMBER 2012

Bi Weekly Tree Inspection Report for Celtis timorensis at Sok Kwu Wan Inspection Date: 15 November 2012

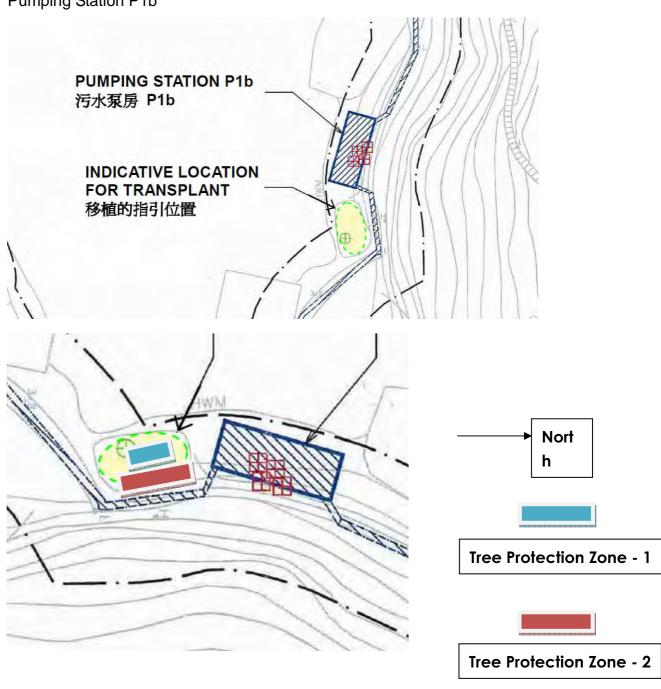
According to the requirement in the Environmental Permit EP-281/2007/A, the uncommon tree species, *Celtis timorensis*, found in the pumping station P1b area as shown in figure below shall be properly transplanted to the area immediately south of the Pumping Station P1b before commencement of construction of the Pumping Station P1b

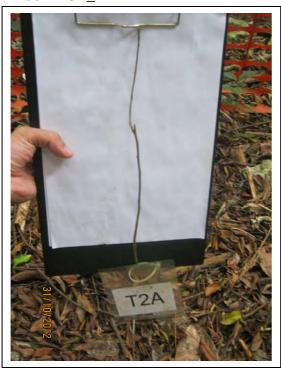
Tree ID:CT 2A

Current Status: Poor

Justification: Leaves were dry. The bark was also dry. No significant improvement in health. The plant was very weak.

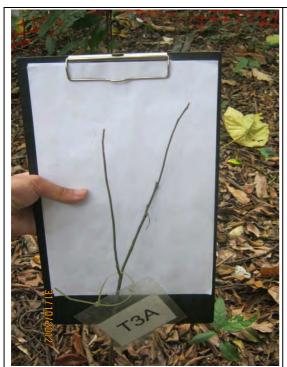
Tree ID: CT_3A

Current Status: Poor

Justification: Leaves were dry. The bark was also dry. No significant improvement in health. The plant was very weak.

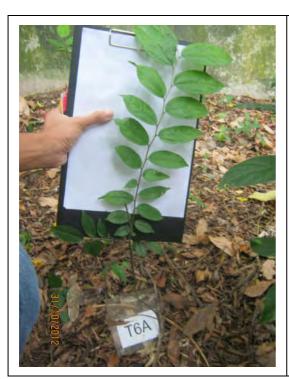
Tree ID: CT_6A

Current Status: Good

Justification: Significant improvement in health. The plant was healthy.

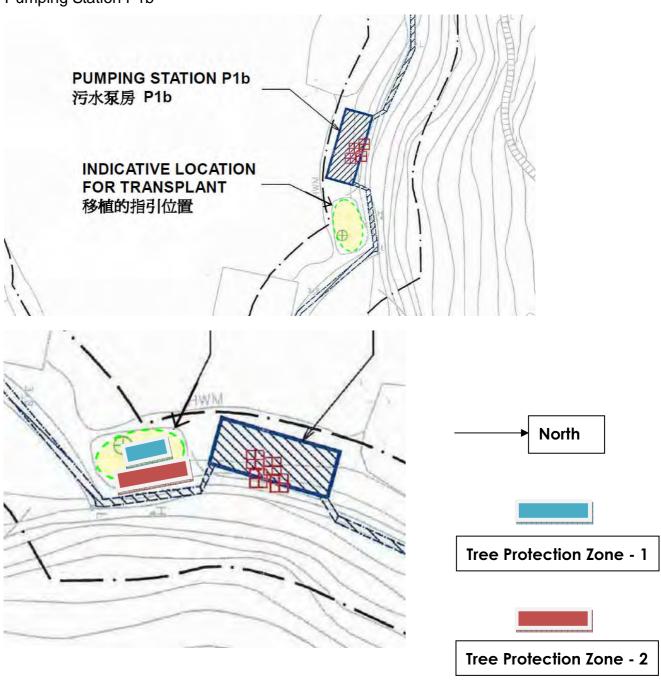
According to the requirement in the Environmental Permit EP-281/2007/A, the uncommon tree species, *Celtis timorensis*, found in the pumping station P1b area as shown in figure below shall be properly transplanted to the area immediately south of the Pumping Station P1b before commencement of construction of the Pumping Station P1b

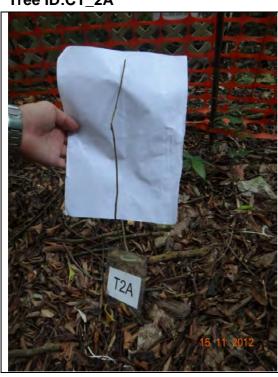
Tree ID:CT 2A

Current Status: Poor

Justification: Leaves were dry. The bark was also dry. No significant improvement in health. The plant was very weak.

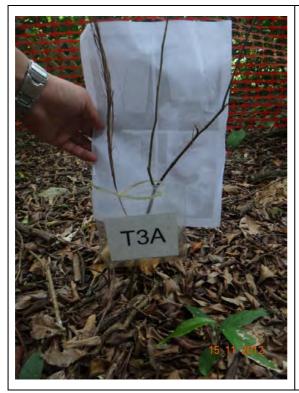
Tree ID: CT_3A

Current Status: Poor

Justification: Leaves were dry. The bark was also dry. No significant improvement in health. The plant was very weak.

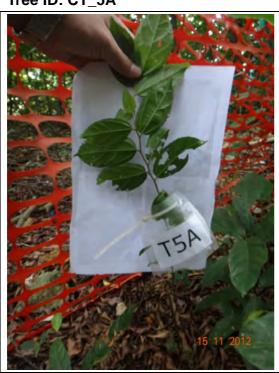
Tree ID: CT_5A

Current Status: Good

Justification: Significant improvement in health. The plant was healthy. Some leaves were damaged by insect.

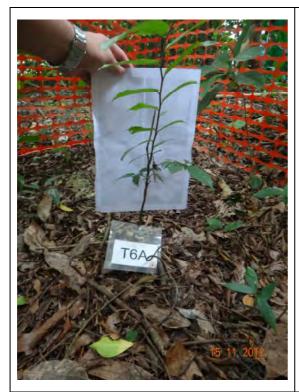
Tree ID: CT_6A

Current Status: Good

Justification: Significant
