PROJECT No.: TCS/00512/09

DSD CONTRACT No. DC/2009/13 CONSTRUCTION OF SEWAGE TREATMENT WORKS AT YUNG SHUE WAN AND SOK KWU WAN

SOK KWU WAN PORTION AREA MONTHLY ENVIRONMENTAL MONITORING AND AUDIT (EM&A) REPORT (No.46) – MAY 2014

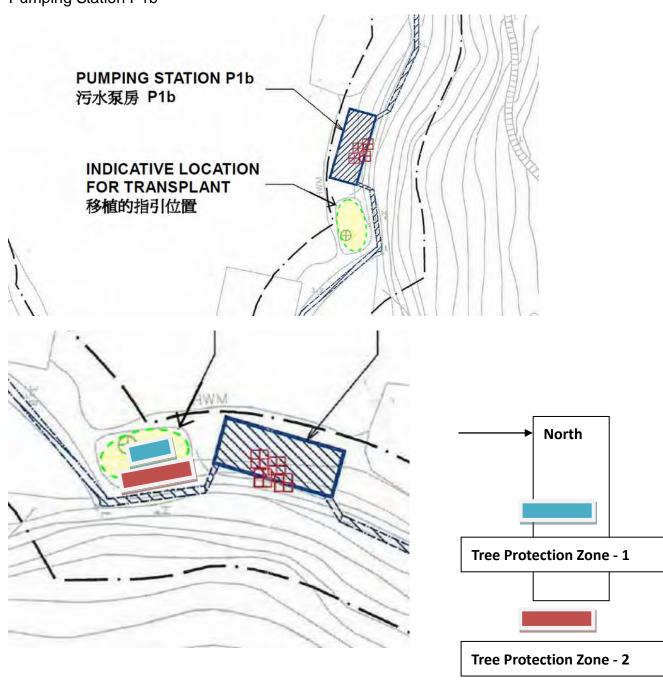
According to the requirement in the Environmental Permit EP-281/2007/A, the uncommon tree species, *Celtis timorensis*, found in the pumping station P1b area as shown in figure below shall be properly transplanted to the area immediately south of the Pumping Station P1b before commencement of construction of the Pumping Station P1b

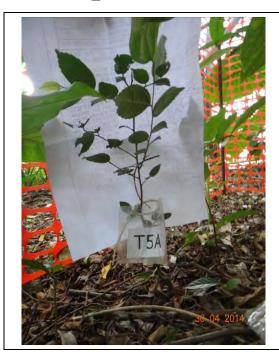
Tree ID: CT_5A

Current Status: Good

Justification: Significant improvement in health. The plant was healthy. Some leaves were damaged by insect.

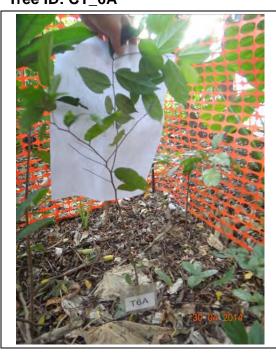
Tree ID: CT_6A

Current Status: Good

Justification: Significant improvement in health. The plant was healthy.

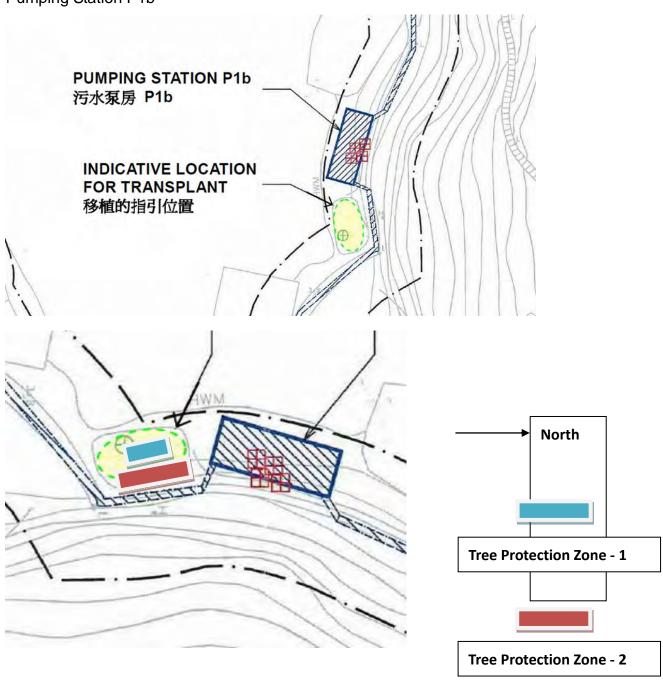
According to the requirement in the Environmental Permit EP-281/2007/A, the uncommon tree species, *Celtis timorensis*, found in the pumping station P1b area as shown in figure below shall be properly transplanted to the area immediately south of the Pumping Station P1b before commencement of construction of the Pumping Station P1b

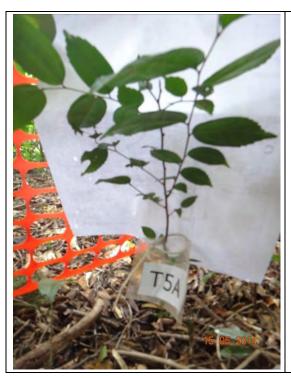
Tree ID: CT_5A

Current Status: Good

Justification: Significant improvement in health. The plant was healthy. Some leaves were damaged by insect.

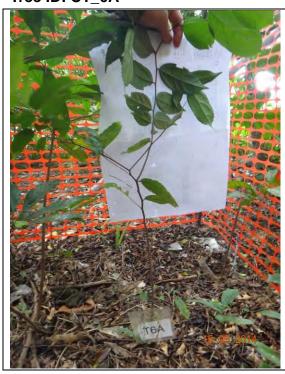
Tree ID: CT_6A

Current Status: Good

Justification: Significant
