DSD CONTRACT No. DC/2009/13 CONSTRUCTION OF SEWAGE TREATMENT WORKS AT YUNG SHUE WAN AND SOK KWU WAN

SOK KWU WAN PORTION AREA MONTHLY ENVIRONMENTAL MONITORING AND AUDIT (EM&A) REPORT (No.49) – AUGUST 2014

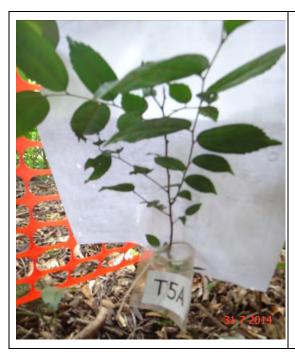
Tree ID: CT_5A

Current Status: Good

Justification: Significant improvement in health. The plant was healthy. Some leaves were damaged by insect.

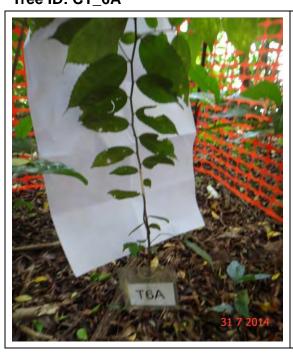
Tree ID: CT_6A

Current Status: Good

Justification: Significant

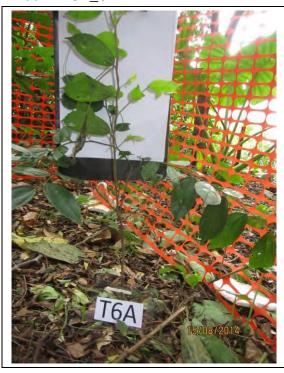
Tree ID: CT_6A

Current Status: Good

Justification: Significant improvement in health. The plant was healthy.
