PROJECT NO.: TCS00409/08

DSD CONTRACT NO. DC/2007/08
DRAINAGE IMPROVEMENTS WORKS IN TAI PO TIN,
PING CHE, MAN UK PIN AND LIN MA HANG

13TH MONTHLY ENVIRONMENTAL MONITORING & AUDIT REPORT FOR THE DESIGNATED WORKS UNDER THE PROJECT – MARCH 2010
CHANNELS MUP03A&B, MUP04A&B, MUP05 AND LMH01

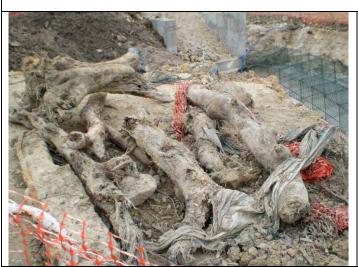
Photo A: The debris of tree trunk or branch was observed within the site, as reminded contractor properly to maintain the site tidiness and removed the waste regularly.

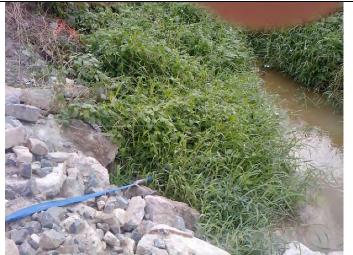
Photo B: Leakage of discharge observed, proper de-silting facilities are recommended for reduction of SS levels in effluent.

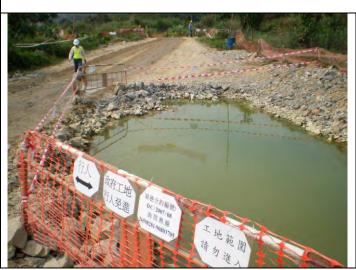
Remark 1: Ponding water was observed during the site inspection. Larvidical oil or removal of water should be undertaken to prevent mosquitoes breeding

The ponding water was removed.

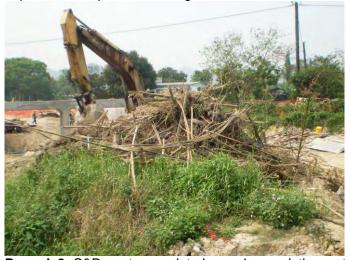
Remark 2: C&D waste cumulated was observed, the contractor was reminded to clean in regular basis.

C&D waste was removed.
