PROJECT NO.: TCS00409/08

DSD CONTRACT NO. DC/2007/08
DRAINAGE IMPROVEMENTS WORKS IN TAI PO TIN,
PING CHE, MAN UK PIN AND LIN MA HANG

14TH MONTHLY ENVIRONMENTAL MONITORING & AUDIT REPORT FOR THE DESIGNATED WORKS UNDER THE PROJECT – APRIL 2010 CHANNELS MUP03A&B, MUP04A&B, MUP05 AND LMH01

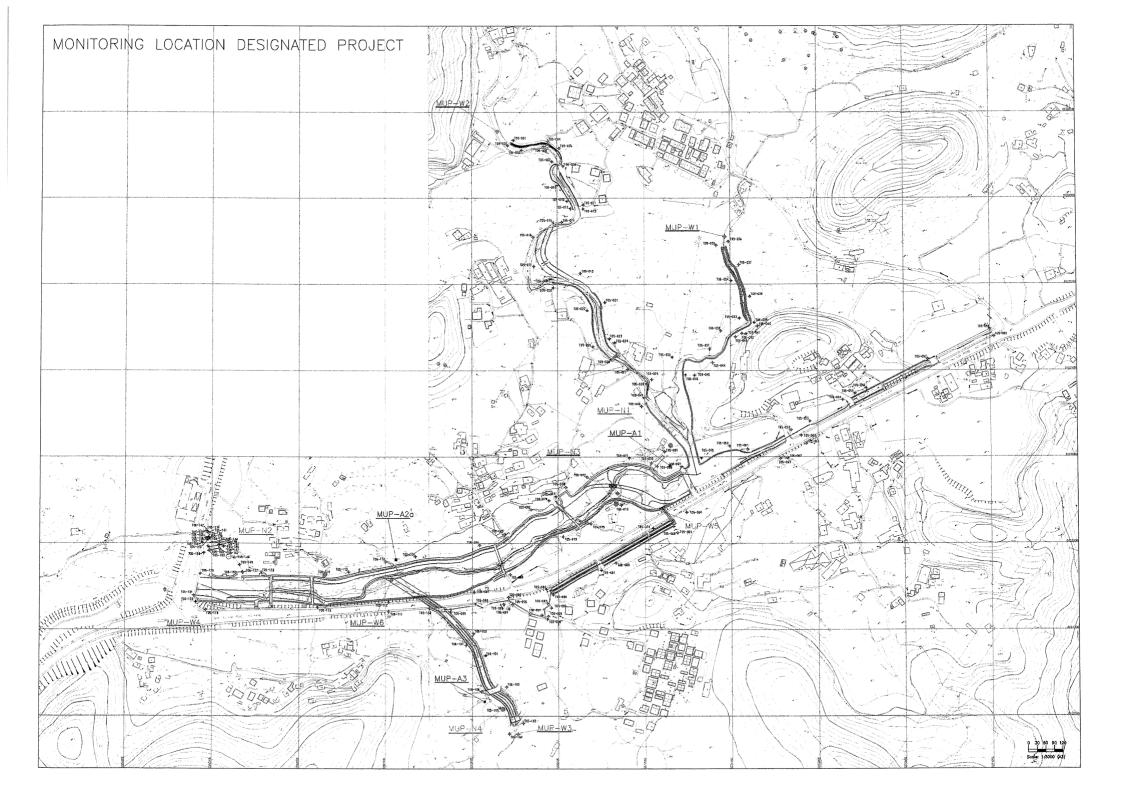
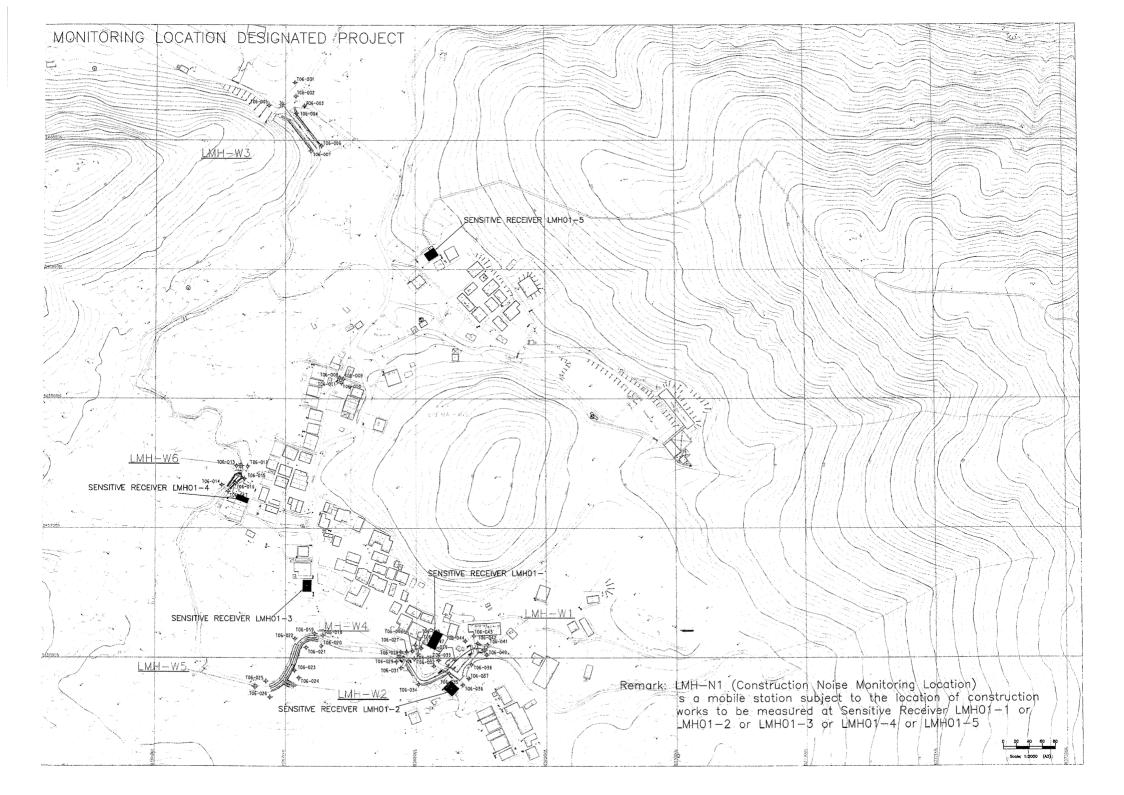
Environmental Monitoring Locations

Access to the original air quality monitoring location MUP-A2 has been denied. The nearby air quality sensitive receiver MUP05-4 is recommended to be the replacement of the denied MUP-A2 and named MUP-A2a for ease of reference.

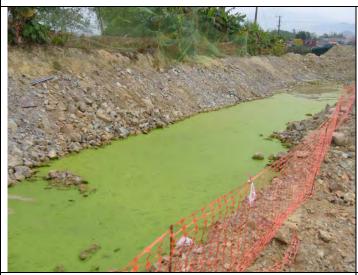
Date	Findings / Deficiencies	Follow-Up Status
1 st April 2010	 Dead of stagnant water were observed during the site inspection. Larvidical oil or pumped out should be undertaken to prevent mosquitoes breeding Dry haul road was observed, water spraying should be applied more frequently. The contractor was reminded to maintain the haul road is moist. 	The deficiencies have been improved during site inspection on 8 th April 2010
8 th April 2010	 The filtration rock barrier at channel MUP01 did not function properly. The contractor was reminded to repair the filtering system. Tree inside the construction area of channel MUP05 without protection was observed, the Contractor was reminded to provide proper protection for tree. As an observation, the oily sediment was observed at the upstream of TKL 07, as it was recognised that the sediment was not come from the contractor works. 	The deficiencies have been improved during site inspection on 14 th April 2010

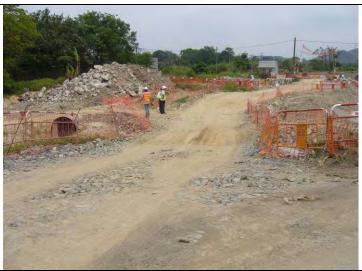
2. Dry haul road was observed, water spraying should be applied more frequently. The contractor was reminded to maintain the haul road is moist.

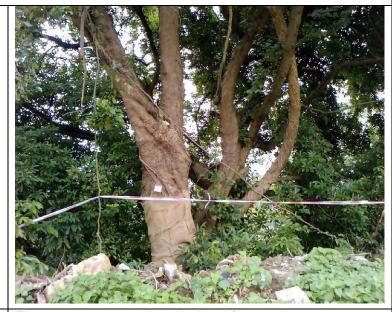
The rock barrier was repaired at channel MUP01

The tree was protected and isolated from work area

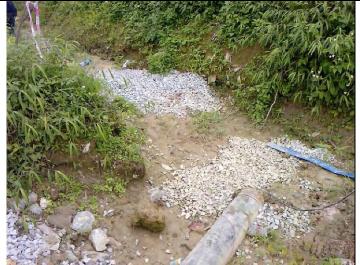
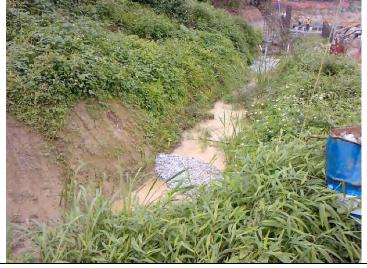
The rock barrier was applied to filter turbidity water.

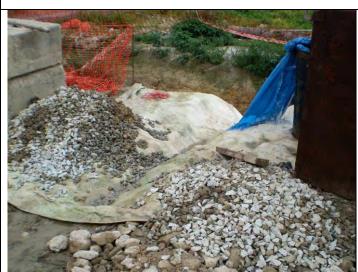
1. Stragnant water was accumulated near the sediment tank at TKL 07, the contractor was reminded to improve the de-silting facility to direct discharging water into channel.

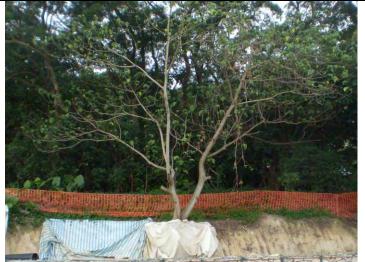
2. Tree inside the construction site without protection was observed at TKL07, the Contractor was reminded to provide proper protection for tree.
