DSD CONTRACT NO. DC/2007/08
DRAINAGE IMPROVEMENTS WORKS IN TAI PO TIN,
PING CHE, MAN UK PIN AND LIN MA HANG

23<sup>RD</sup> MONTHLY ENVIRONMENTAL MONITORING & AUDIT REPORT FOR THE DESIGNATED WORKS UNDER THE PROJECT – JANUARY 2011 CHANNELS MUP03A&B, MUP04A&B, MUP05 AND LMH01

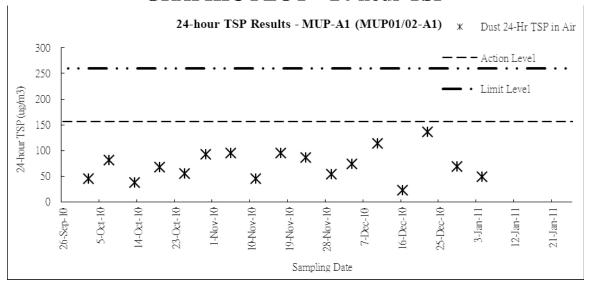
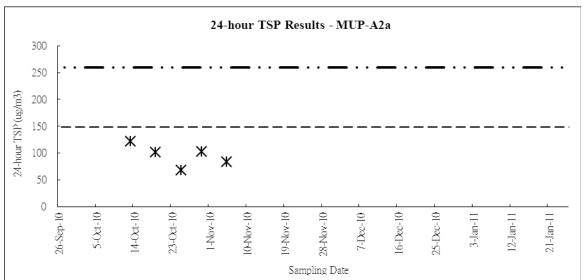
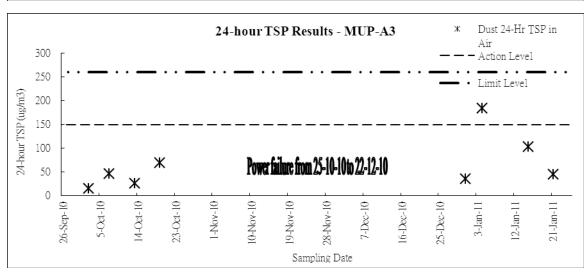
# **Graphic Plot of Monitoring - Air Quality GRAPHIC PLOT – 24-hour TSP**

As shown in *Tables 5-1* and *5-2*, there was 1 Action level exceedance recorded in 24-hour TSP during this reporting period. It is noted that no construction activities was being carried out at the vicinity of MUP-A3 on the exceedance day. As a reminder, the Contractor is advised to increase the frequency of water spraying especially in the dry and windy season. We would conclude that the exceedances were not work related under the project. There were total 10 power failures incident recorded at Location MUP-A1, MUP-A2a and MUP-A3. It is noted by the Contractor they have tried to fix the problem from power supplier. However, they could not get contact to the residents of power supply all the time. We have liaised with the Contractor to rectify the power supply or deploy another power source as soon as possible. On the other hands, it is shown that there is no works near those locations in recent months. It is believed that the site area would not cause exceeding for monitoring results or significant impact for air quality
