DSD CONTRACT NO. DC/2007/08
DRAINAGE IMPROVEMENTS WORKS IN TAI PO TIN,
PING CHE, MAN UK PIN AND LIN MA HANG

25TH MONTHLY ENVIRONMENTAL MONITORING & AUDIT REPORT FOR THE DESIGNATED WORKS UNDER THE PROJECT – MARCH 2011 CHANNELS MUP03A&B, MUP04A&B, MUP05 AND LMH01

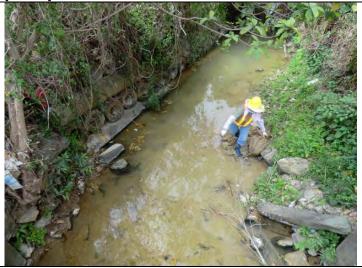
The waste in the stream was removed. [MUP05]

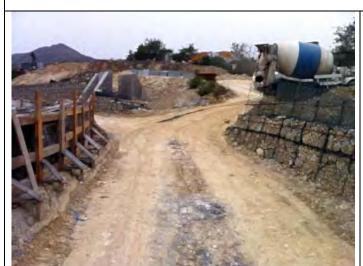
Remark 1: The Contractor was reminded to maintain regular dust suppression measures on site haul roads. [General]

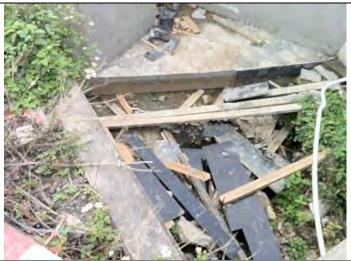
Remark 2: Dismantled formwork materials were observed. The Contractor was reminded to properly stack and store the materials in order to prevent inducing adverse impact to the river course nearby. [TKL07]

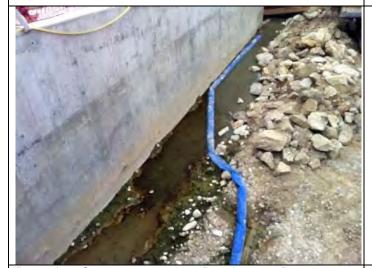
Remark 3: Stagnant water was found near a flow diversion channel. The Contractor was reminded to implement mosquitoes breeding prevention measures to minimize the nuisance to the surrounding households.

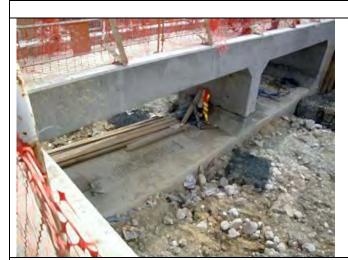
Remark 1: Some construction materials were observed. The contractor was reminded to maintain a good housekeeping practice. [TKL 02]

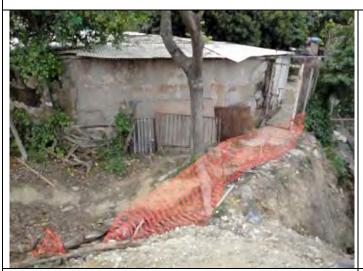
Remark 1: The safety mesh has been found collapsed. The Contractor was reminded to maintain proper tree protection measures to the trees managed under the Project.[TKL07]

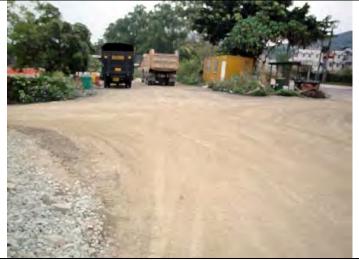
Remark 2: The Contractor was reminded to implement sufficient dust suppression measures on site access.[MUP05]
