PROJECT NO.: TCS00409/08

DSD CONTRACT NO. DC/2007/08
DRAINAGE IMPROVEMENTS WORKS IN TAI PO TIN,
PING CHE, MAN UK PIN AND LIN MA HANG

26TH MONTHLY ENVIRONMENTAL MONITORING & AUDIT REPORT FOR THE DESIGNATED WORKS UNDER THE PROJECT – APRIL 2011 CHANNELS MUP03A&B, MUP04A&B, MUP05 AND LMH01

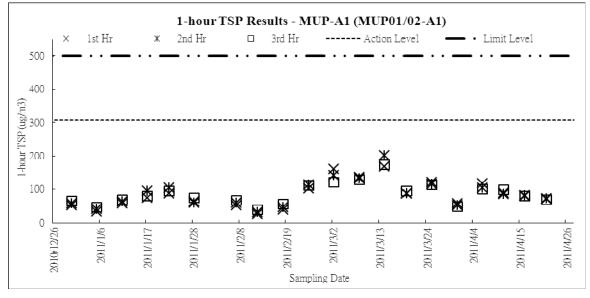
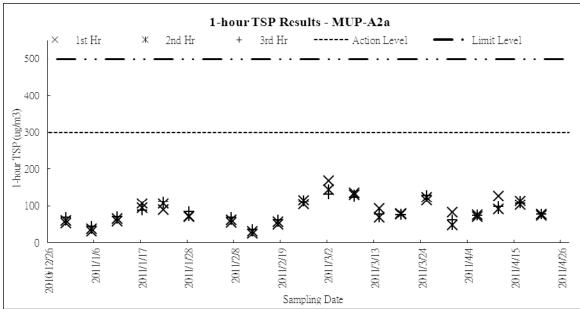
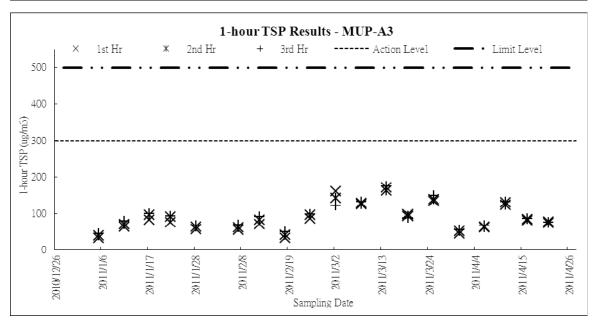
GRAPHIC PLOT – 1-hour TSP

As shown in *Tables 5-1* and *5-2*, there was no exceedance recorded in 1-hour TSP and 24-hour TSP during this reporting period. As a reminder, the Contractor is advised to increase the frequency of water spraying especially in the sunny and dry days. There were total 10 power failures incident recorded at Location MUP-A1 and MUP-A2a. It is noted by the Contractor they have tried to fix the problem from power supplier. However, they could not get contact to the residents who supply power all the time. We have constantly liaised with the Contractor to rectify the power supply problem or deploy another power source as soon as possible. On the other hands, it is shown that there is no works near those locations in recent months. It is believed that the site area would not cause exceeding for monitoring results or significant impact for air quality

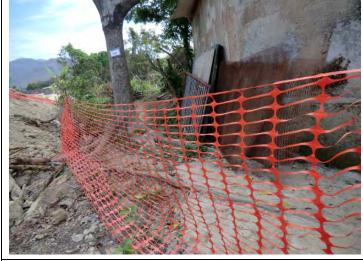
Remark 1: The safety mesh was properly maintained for tree protection measures.[TKL07]

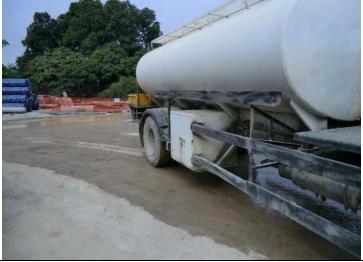
Remark 2: Dust suppression measures was observed on site access.[MUP05]

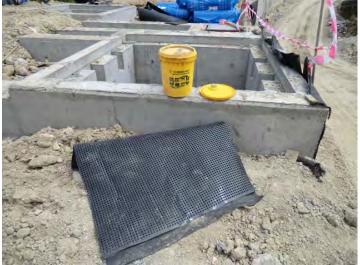
Remark 2: Some general refuse and construction materials were found scattered around the site. The contractor was reminded to maintain good site cleanness and housekeeping practice.

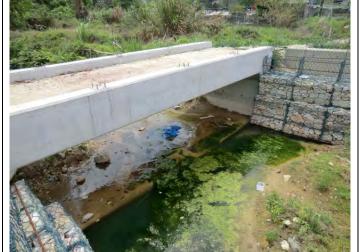
Remark 3: C&D materials should be removed from drainage channel in order to maintain water quality in good condition. [MUP02, General]

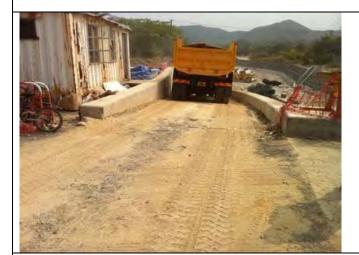
Remark 1: In view of the hot and dry weather, the Contractor was reminded to maintain regular and sufficient dust suppression measures to be applied on site, especially on site haul roads. [General]

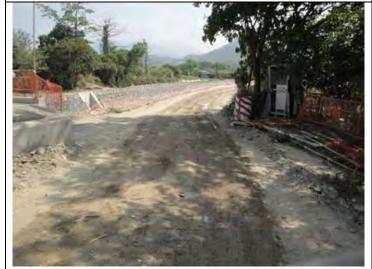
Water spraying on haul roads was observed

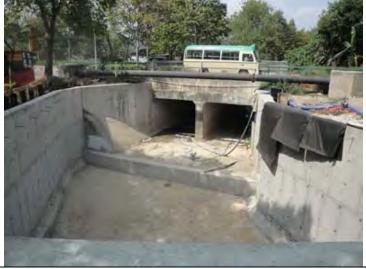
The construction materials found at the outlet of the channel was removed.

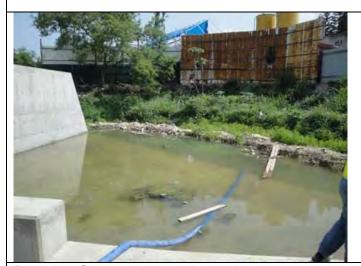
Remark 1: Construction materials and stagnant water was found accumulating. The contractor was reminded to regularly clear the water ponding accumulated within the site and keep well storage of the construction materials on site. [TKL02]

14 April 2011	 Construction materials and stagnant water was found accumulating. The contractor was reminded to regularly clear the water ponding accumulated within the site and keep well storage of the construction materials on site. [TKL02] The Contractor was reminded to provide proper measures to prevent potential impact to the water quality of the existing stream, as the rainy season is approaching [MUP05] The Contractor was reminded to provide proper measures to the exposed slope in order to prevent soil erosion and potential impacts to the water quality. [MUP05] 	The deficiencies have been found improved on the following site inspection.
21 April 2011	 Some general refuse was found scattered around the site. The Contractor was reminded to clear the site regularly A fallen tree branch was found in the stream course. The contractor was reminded to maintain a continuous flow of the channel 	The deficiencies have been found improved on the following site inspection.

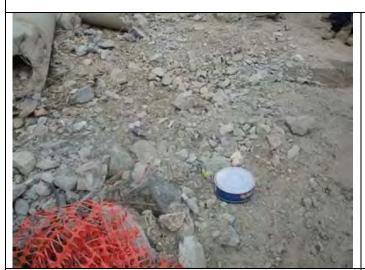
Remark 1: Some general refuse was found scattered around the site. The Contractor was reminded to clear the site regularly
