**PROJECT NO.: TCS00409/08**

DSD CONTRACT NO. DC/2007/08
DRAINAGE IMPROVEMENTS WORKS IN TAI PO TIN,
PING CHE, MAN UK PIN AND LIN MA HANG

37<sup>TH</sup> MONTHLY ENVIRONMENTAL MONITORING & AUDIT REPORT FOR THE DESIGNATED WORKS UNDER THE PROJECT – MARCH 2012
CHANNELS MUP03A&B, MUP04A&B, MUP05 AND LMH01

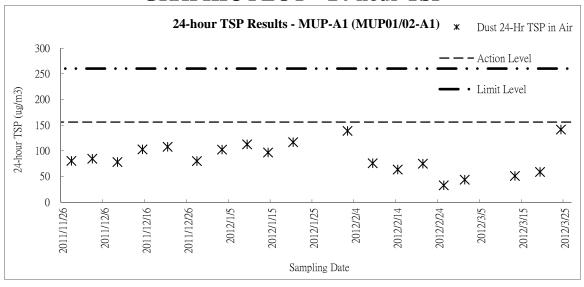
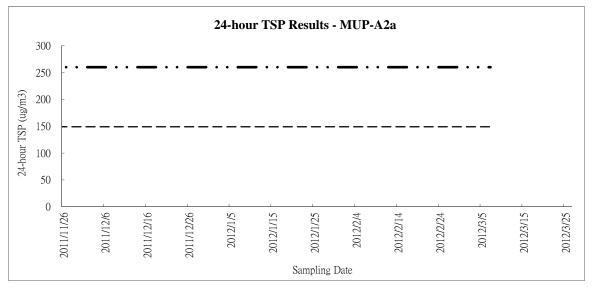
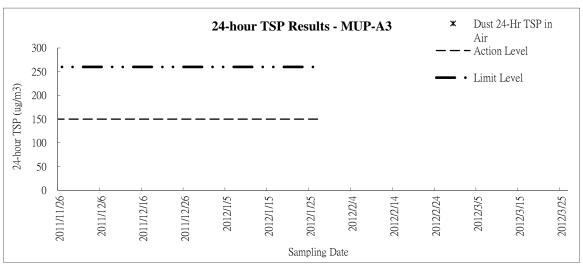
# **Graphic Plot of Monitoring - Air Quality GRAPHIC PLOT – 24-hour TSP**

As shown in *Tables 5-1* and *5-2*, there was no exceedance recorded in 1-hour TSP and 24-hour TSP during this reporting period. As a reminder, the Contractor is advised to increase the frequency of water spraying especially in the sunny and dry days. There were total 11 power failures incident recorded at Location MUP-A2a and MUP-A3. It is noted by the Contractor they have tried to fix the problem from power supplier. However, they could not get contact to the residents who supply power all the time. And recently, monitoring location MUP-A1 has been resumed. We have constantly liaised with the Contractor to rectify the power supply problem and Contractor will deploy another stable power source. On the other hands, it is shown that there is no works near those locations in recent months. It is believed that the site area would not cause exceeding for monitoring results or significant impact for air quality. However, the Contractor is needed to resume the power supply as soon as possible.

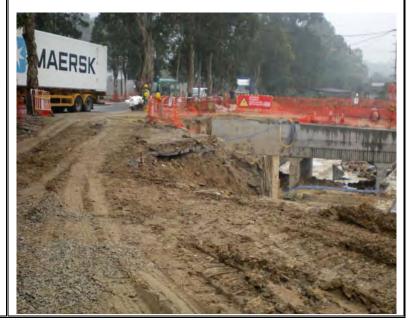
# Findings of Site Inspection on 9 March 2012:

- Dusty haul road were observed within the site.
   Full implementation of the required
   environmental mitigation measures, in particular
   watering of the dusty surface is reminded during
   vehicle movement under dry and windy
   conditions.
- **2.** In addition, wheel washing of the vehicles prior to exit the site to public roads is reminded.

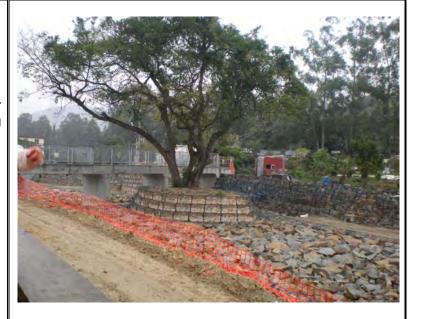
# Findings of Site Inspection on 13 March 2012:

- No adverse environmental impacts were observed during the site inspection. However, full implementation of the required environmental mitigation measures, in particular watering of the dusty surface is reminded during vehicle movement under dry and windy conditions.
- **2.** In addition, wheel washing of the vehicles prior to exit the site to public roads is reminded.

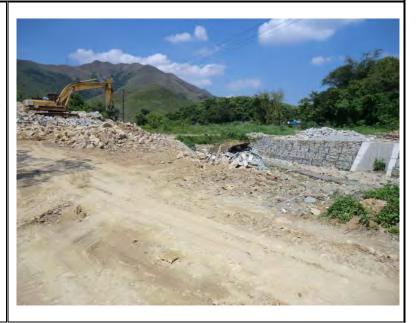
# Findings of Site Inspection on 13 March 2012:

- No adverse environmental impacts were observed during the site inspection. However, full implementation of the required environmental mitigation measures, in particular watering of the dusty surface is reminded during vehicle movement under dry and windy conditions.
- **2.** In addition, wheel washing of the vehicles prior to exit the site to public roads is reminded.
