PROJECT NO.: TCS00409/08

DSD CONTRACT NO. DC/2007/08
DRAINAGE IMPROVEMENTS WORKS IN TAI PO TIN,
PING CHE, MAN UK PIN AND LIN MA HANG

39TH MONTHLY ENVIRONMENTAL MONITORING & AUDIT REPORT FOR THE DESIGNATED WORKS UNDER THE PROJECT – MAY 2012 CHANNELS MUP03A&B, MUP04A&B, MUP05 AND LMH01

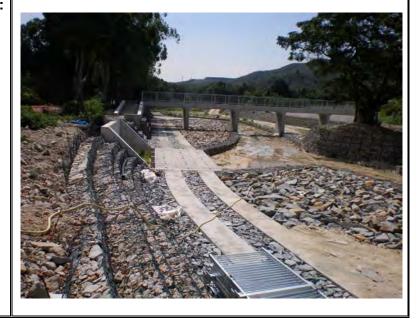
Findings of Site Inspection on 2 May 2012:

1. No adverse environmental impacts were observed during the site inspection. Full implementation of the required environmental mitigation measures is reminded particularly watering of the dusty surfaces during dusty construction including vehicle movement under dry and windy conditions.

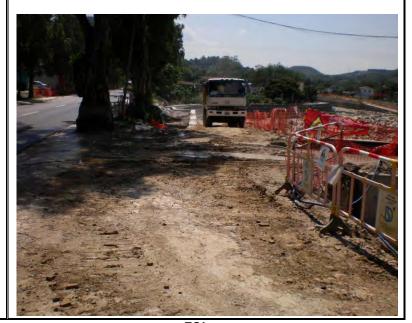
Findings of Site Inspection on 9 May 2012:

1. Dusty construction activities were observed during the site inspection. Full implementation of the required environmental mitigation measures is reminded particularly watering of the dusty surfaces during dusty construction including vehicle movement under dry and windy conditions.

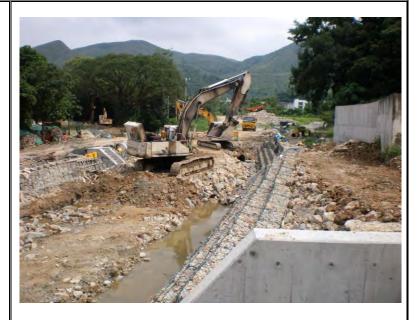
Findings of Site Inspection on 17 May 2012:

No adverse environmental impacts were observed during the site inspection. However, full implementation of the required environmental mitigation measures is reminded particularly watering of the dusty surfaces during dusty construction including vehicle movement under dry and windy conditions.

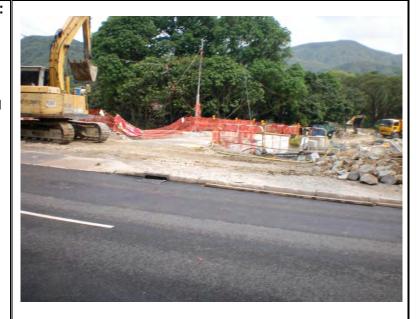
Findings of Site Inspection on 24 May 2012:

1. No adverse environmental impacts were observed during the site inspection. However, full implementation of the required environmental mitigation measures is reminded particularly watering of the dusty surfaces during dusty construction including vehicle movement under dry and windy conditions.
