Construction of a Secondary Boundary Fence and  
New Sections of Primary Boundary Fence and  
Boundary Patrol Road

Improvement Works for Mai Po, Lok Ma Chau, Sha  
Tau Kok and Planting Works at Tak Yuet Lau –  
Monthly EM&A Report for September 2015

October 2015  
Architectural Services Department

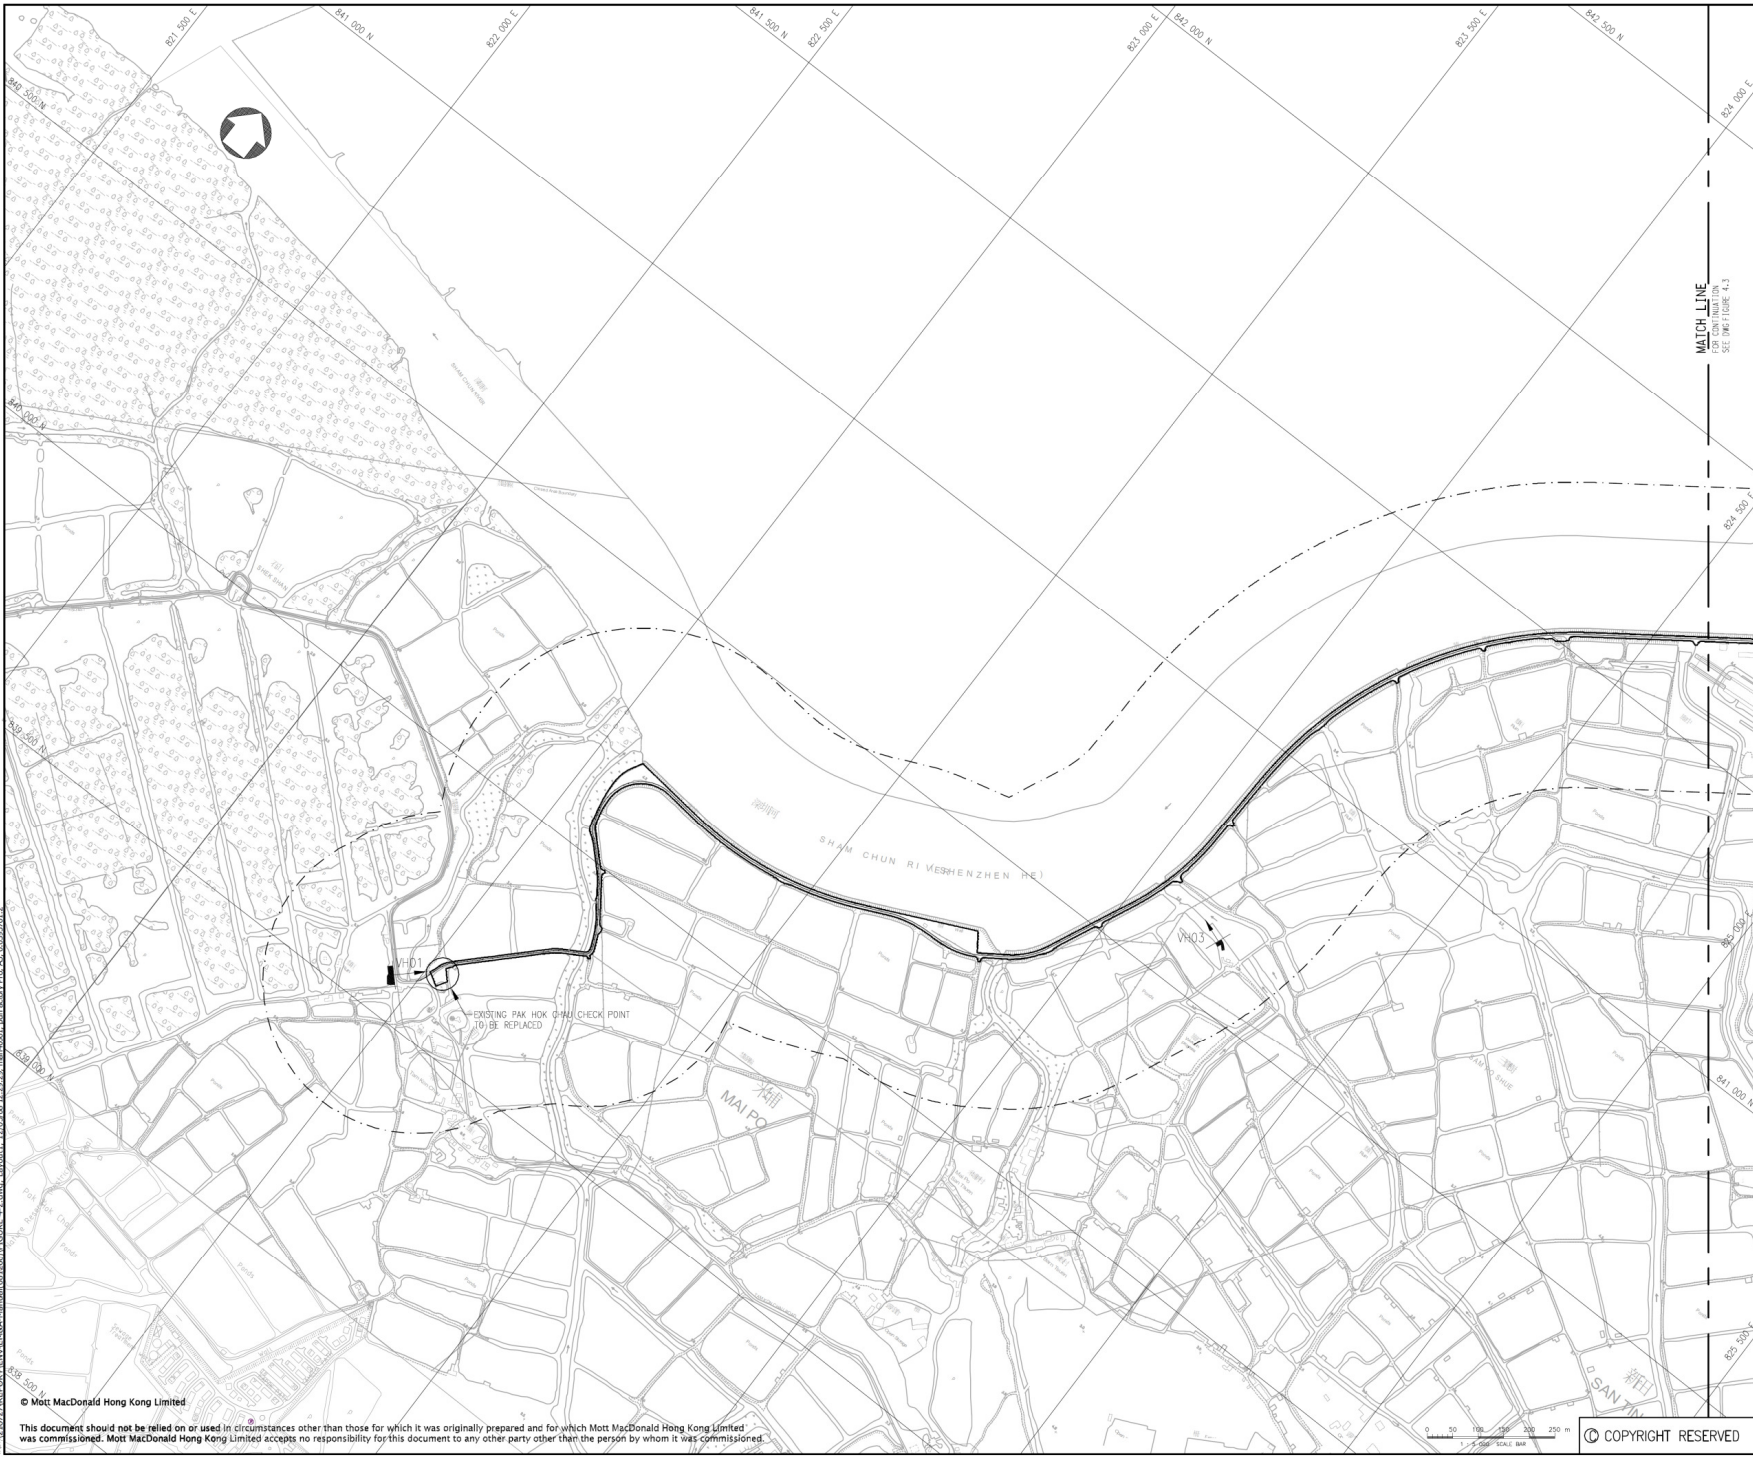
- 300m ASSESSMENT AREA
- NOISE SENSITIVE RECEIVER
- FACADE FACING

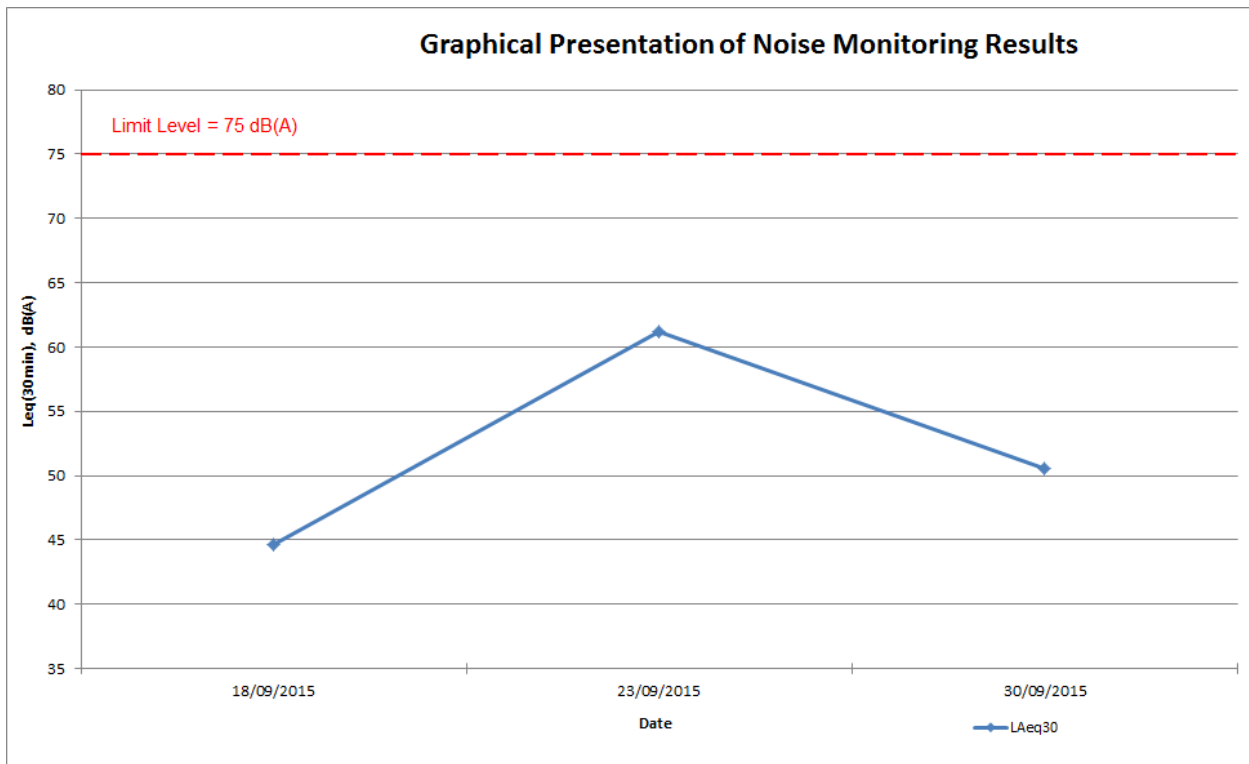
# Appendix H. Noise Monitoring Results and Graphical Presentation

Daytime Noise Monitoring Results at Station VH03											
Date	Weather Conditions	Wind Speed, m/s	Noise Level for 30-min, dB(A)					Major Construction Noise Sources during monitoring	Other Noise Sources during monitoring	Remarks	
			Start Time	End Time	Leq	L10	L90				
18-Sep-15	Cloudy	2.2	10:08	10:38	45	46	42	Nil	Traffic noise, wild life (not Project-related)	Nil	
23-Sep-15	Cloudy	1.9	10:19	10:49	61	62	61	Nil	Traffic noise, wild life, running water (not Project-related)	Nil	
30-Sep-15	Cloudy	2.2	10:34	11:04	51	55	39	Nil	Traffic noise, wild life (not Project-related)	Nil	
					Min.	45					
					Max.	61

The graphical presentations of the measured construction noise level of the reporting month of noise impact monitoring are presented in [Appendix H](#). The general weather conditions and graphical presentation are presented in **Appendix K**.
