Construction of a Secondary Boundary Fence and  
New Sections of Primary Boundary Fence and  
Boundary Patrol Road

Improvement Works for Mai Po, Lok Ma Chau, Sha  
Tau Kok, Planting Works at Tak Yuet Lau and  
Demolition Work at Shek Chung Au – Monthly  
EM&A Report for December 2015

January 2016  
Architectural Services Department

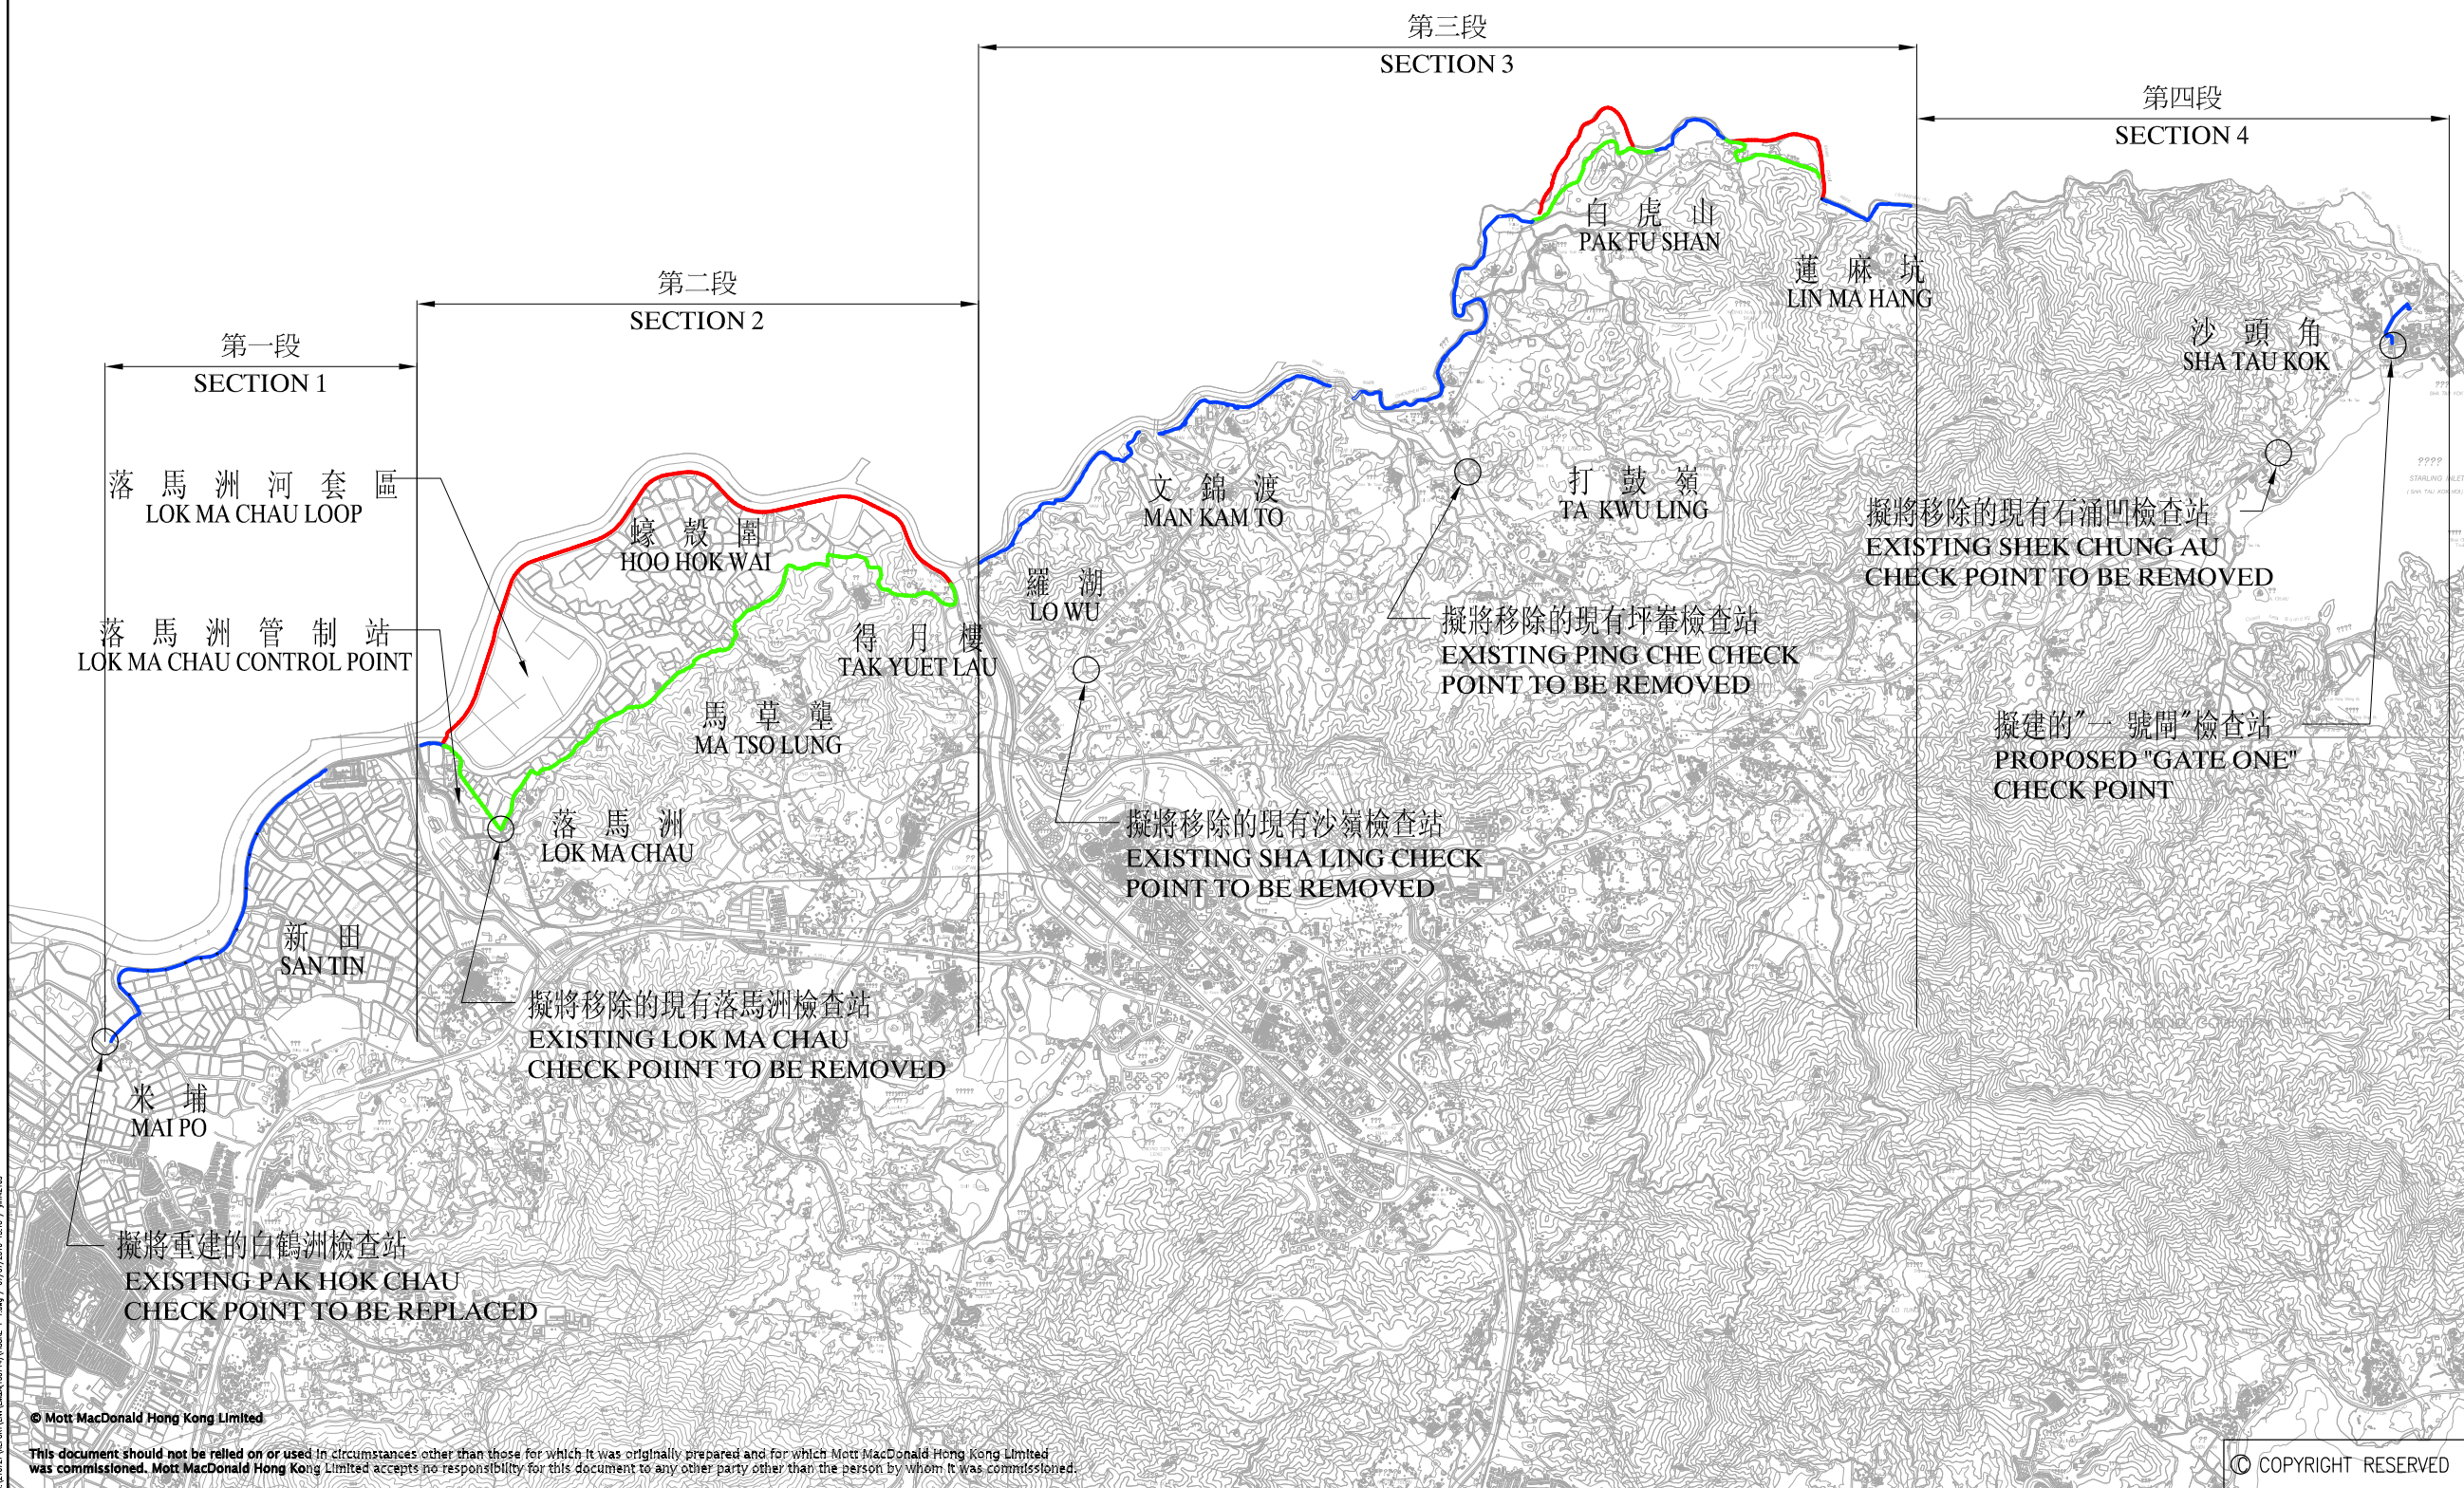
Designed	WHC	Eng.Chk.	WHC	
Drawn	MCL	Coordination	WHC	
Dwg.Chk.	WHC	Approved	TI	
Scale	Project 216727		Status	
	N.T.S.		CAD File	INF
Drawing No.	FIGURE 1.1 (圖 1.1)			Rev
	COPYRIGHT RESERVED			P1

Title  
概覽圖  
GENERAL LAYOUT PLAN

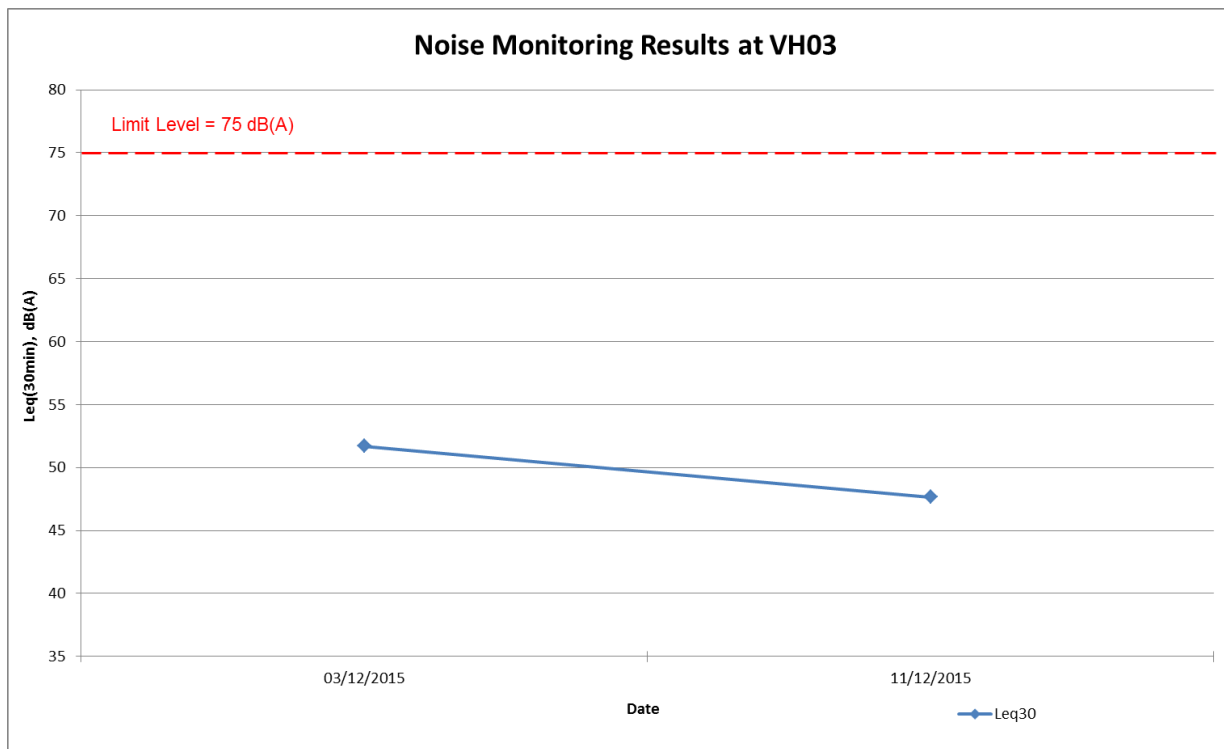
**Daytime Noise Monitoring Results at Station VH03**

Date	Weather Conditions	Wind Speed, m/s	Noise Level for 30-min, dB(A)				Major Construction Noise Sources during monitoring	Other Noise Sources during monitoring	Remarks	
			Start Time	End Time	Leq	L10				L90
03-Dec-15	Fine	2.2	11:14	11:44	52	53	50	Nil	Road traffic noise (not Project-related)	Nil
11-Dec-15	Sunny	2.2	08:55	09:25	48	50	45	Nil	Road traffic noise (not Project-related)	Nil
					Min.	48				
					Max.	52

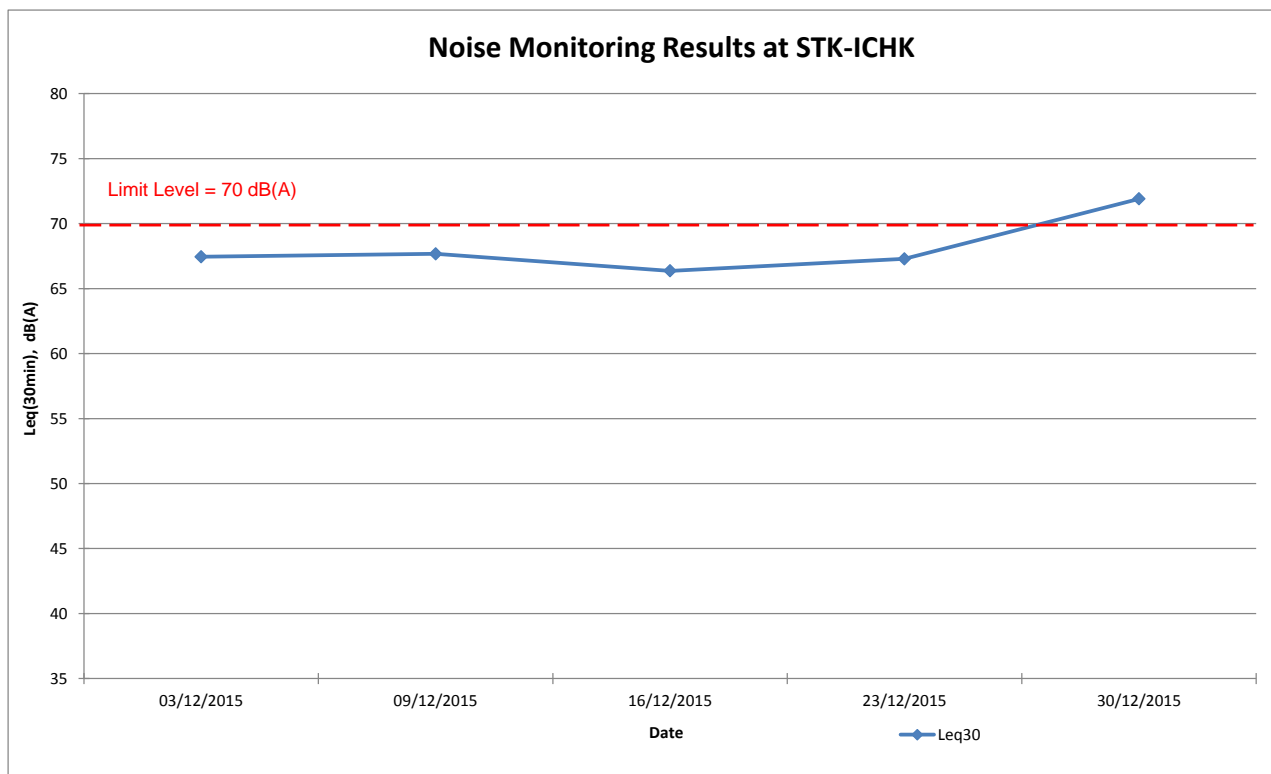
Date	Weather Conditions	Wind Speed,	Noise Level for 30-min, dB(A)				Major Construction Noise Sources	Other Noise Sources during monitoring	Remarks	
			Start	End	Leq	L10				L90
03-Dec-15	Fine	1.7	09:20	09:50	67	71	58	Demolition work	Road traffic noise, nearby construction site <b>(not Project-related)</b>	Nil
09-Dec-15	Cloudy	1.4	09:15	09:45	68	71	61	Demolition work, site clearance	Road traffic noise, nearby construction site <b>(not Project-related)</b>	Nil
16-Dec-15	Sunny	3.6	12:45	13:15	66	70	53	Nil	Road traffic noise, nearby construction site <b>(not Project-related)</b>	Nil
23-Dec-15	Fine	2.5	09:15	09:45	67	71	54	Nil	Road traffic noise, nearby construction site <b>(not Project-related)</b>	Road work, grass/tree cutting
30-Dec-15	Cloudy	3.1	10:05	10:35	72	74	68	site clearance	Road traffic noise, nearby construction sites with powered mechanical equipment in operation <b>(not Project-related)</b>	Major noise source observed was from construction site opposite STK-ICHK (concreting work involving use of PMEs including vibratory poker)

Min.	66				
					Max.	72

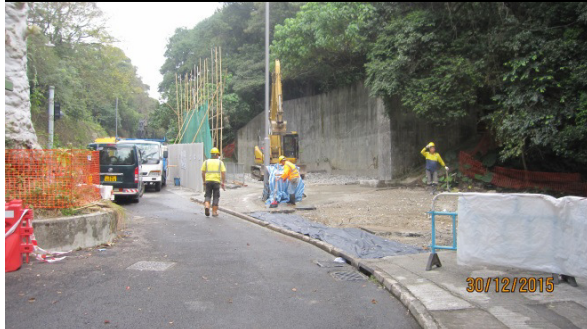
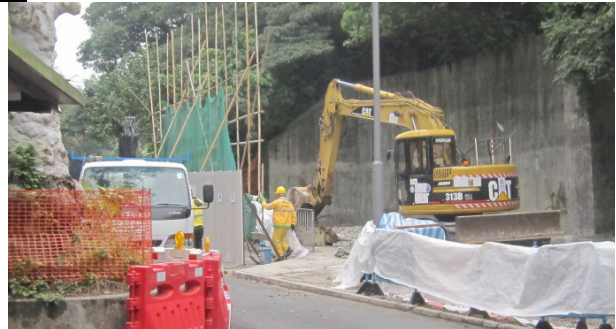
**Photos of site activities observed on 30 December 2015**

Site preparation for pavement work at Project site at Shek Chung Au

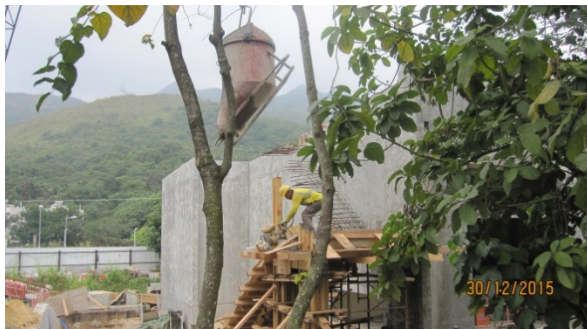
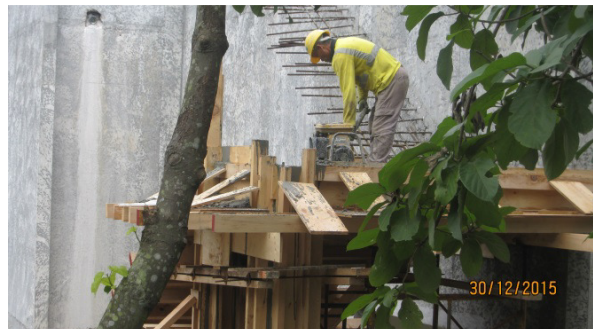
Concreting work (involving use of PME including vibratory poker) at construction site opposite STK-IC HK

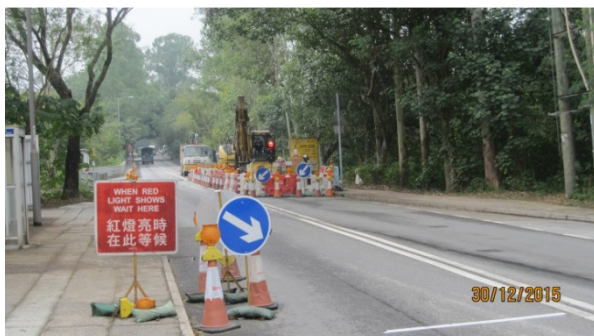
Excavation work using excavator at nearby works site with temporary traffic arrangements on Sha Tau Kok Road
