Construction of a Secondary Boundary Fence and
New Sections of Primary Boundary Fence and
Boundary Patrol Road

Improvement Works for Mai Po, Lok Ma Chau, Sha
Tau Kok, Planting Works at Tak Yuet Lau and
Demolition Work at Shek Chung Au, Lo Wu to Sha
Tau Kok – Monthly EM&A Report for June 2016

July 2016

Architectural Services Department

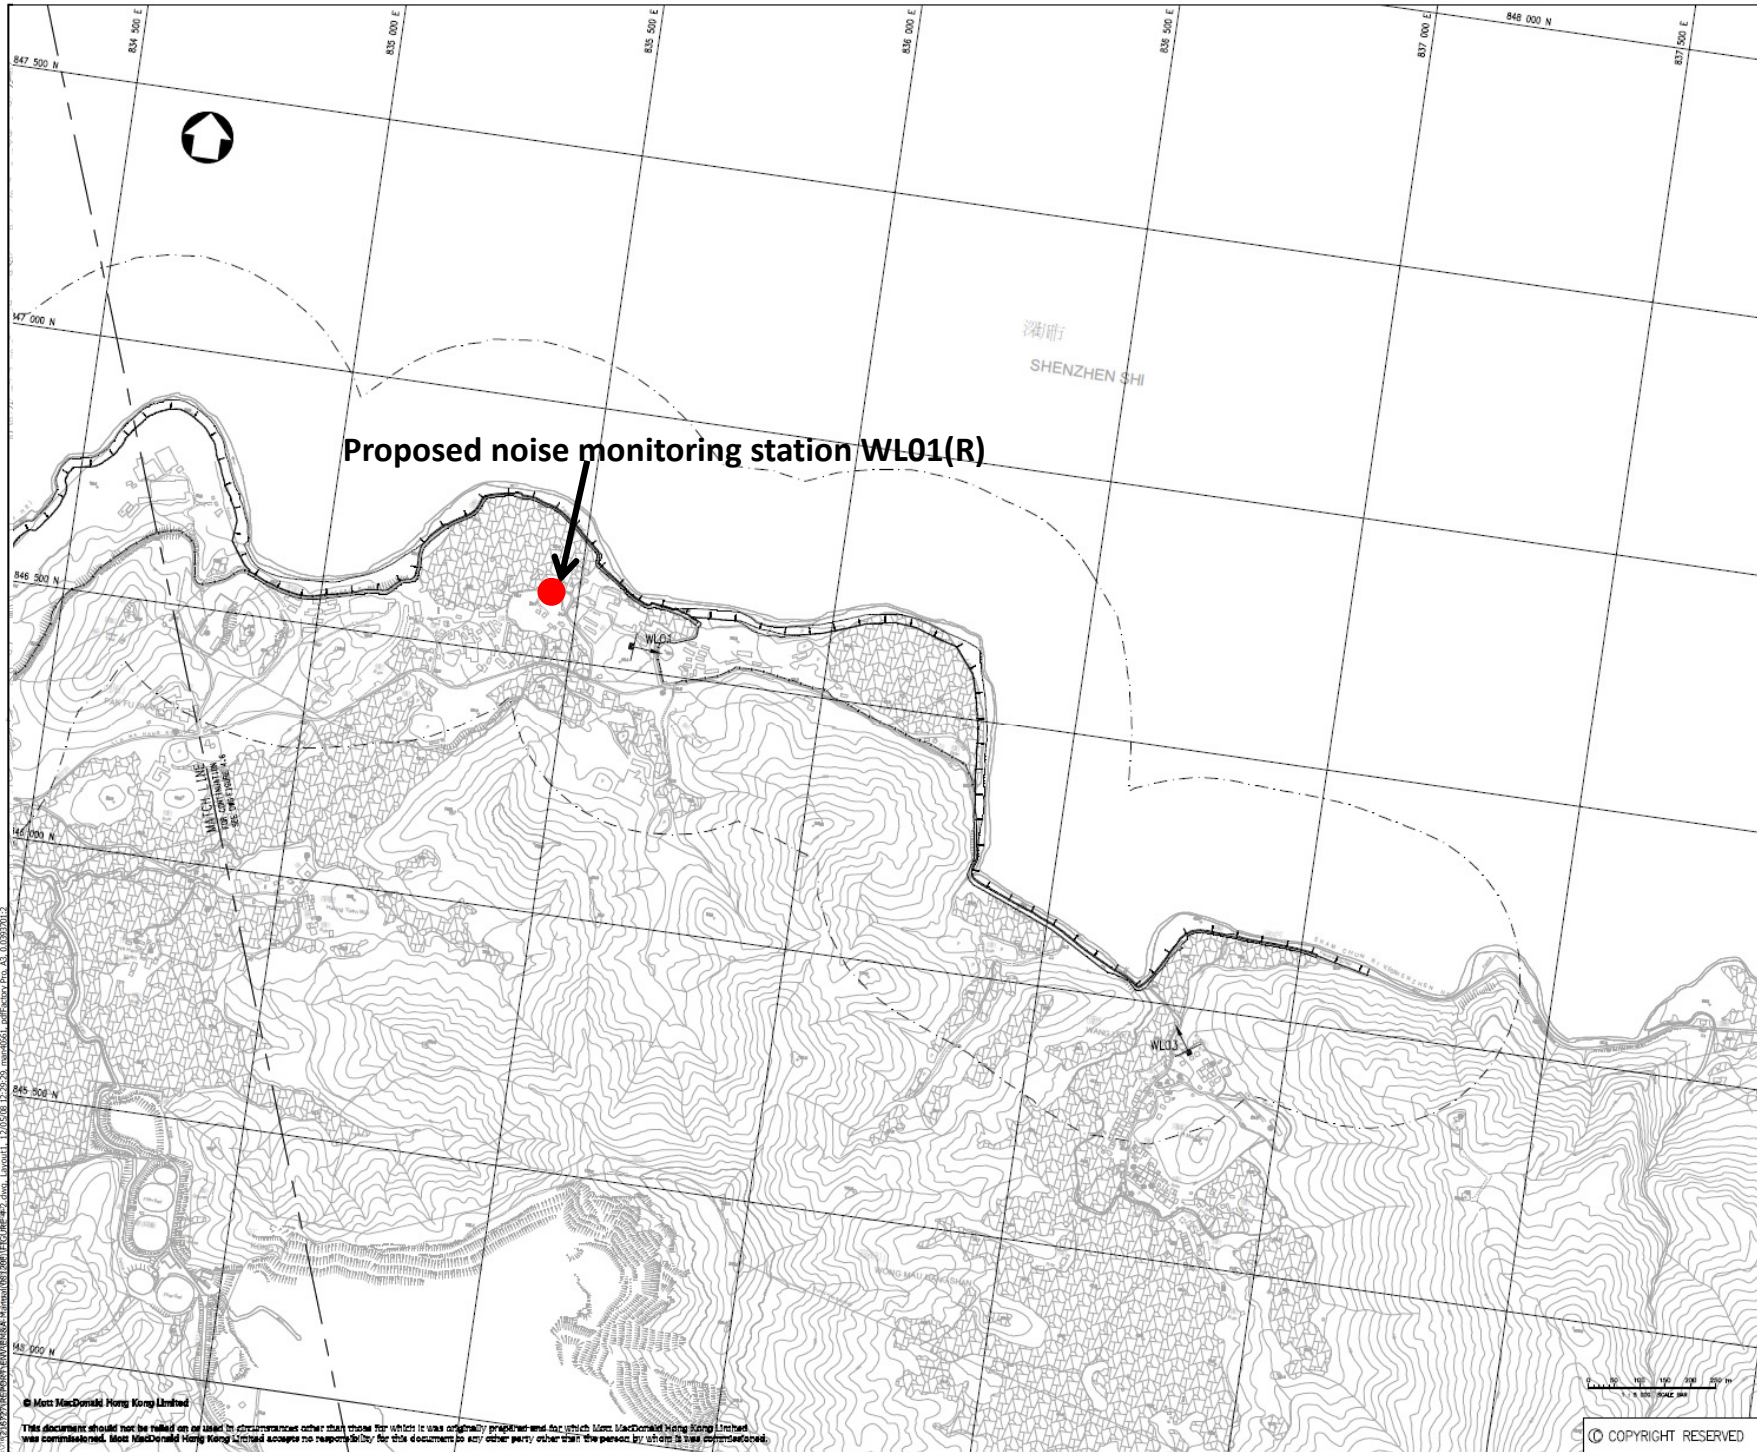
Figure 2.2

Proposed noise monitoring station WL01(R)

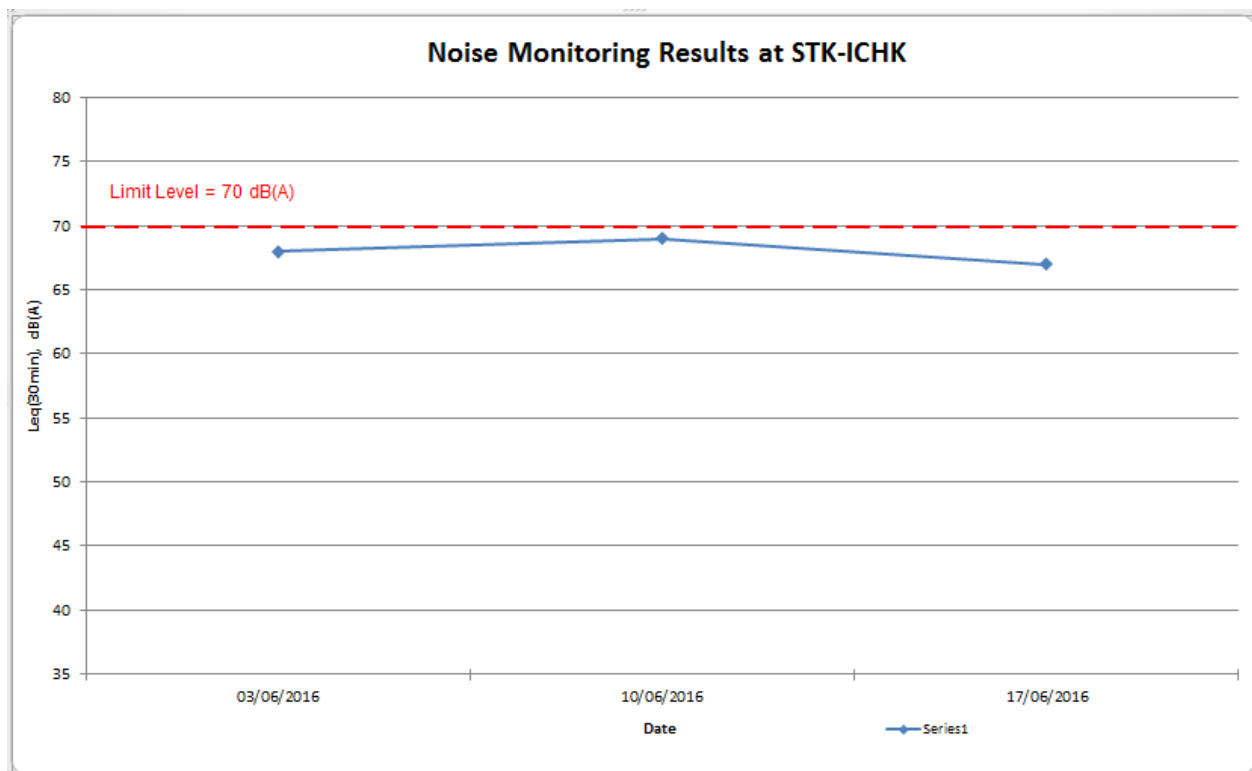
Daytime Noise Monitoring Results at Station STK-IC HK

Date	Weather Conditions	Wind Speed, m/s	Noise Level for 30-min, dB(A)					Major Construction Noise Sources	Other Noise Sources during monitoring	Remarks
			Start	End	Leq	L10	L90			
03-Jun-16	Sunny	1.7	10:03	10:33	68	72	60	Nil	Road traffic noise, DSD site opposite STK-IC HK (operation of hand-held breaker) (not Project-related)	No demolition or construction work at Project site
10-Jun-16	Sunny	1.4	09:43	10:13	69	72	64	Nil	Road traffic noise, DSD site opposite STK-IC HK (operation of Crane and excavator) (not Project-related)	No demolition or construction work at Project site
17-Jun-16	Sunny	1.4	09:29	09:59	67	71	55	Nil	Road traffic noise (not Project-related)	No demolition or construction work at Project site
					Min.	67				
					Max.	69

The graphical presentations of the measured construction noise level of the reporting month of noise impact monitoring are presented in [Appendix H](#). The general weather conditions and graphical presentation are presented in **Appendix K**.
