Construction of a Secondary Boundary Fence and New Sections of Primary Boundary Fence and Boundary Patrol Road

Improvement Works for Mai Po, Lok Ma Chau, Sha Tau Kok, Planting Works at Tak Yuet Lau and Demolition Work at Shek Chung Au and Lo Wu to Sha Tau Kok – Monthly EM&A Report for September 2016

October 2016
Architectural Services Department

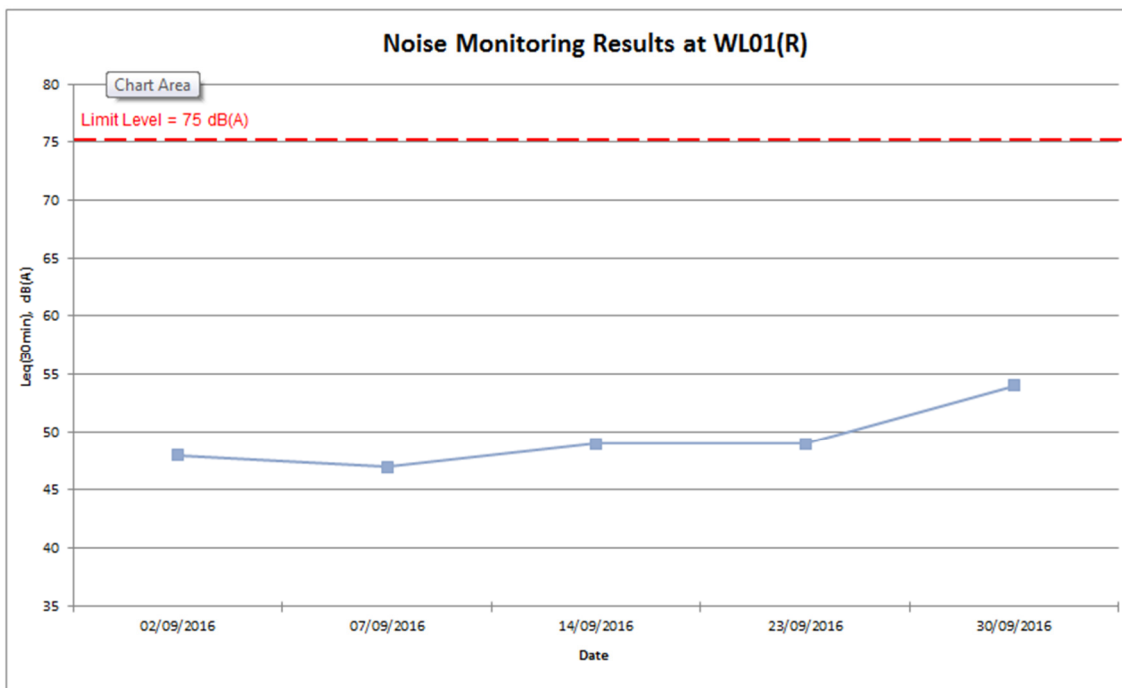
Daytime Noise Monitoring Results at Station WL01(R)

Date	Weather Conditions	Wind Speed, m/s	Noise Level for 30-min, dB(A)					Major Construction Noise Sources	Other Noise Sources during monitoring	Remarks
			Start	End	Leq	L10	L90			
02-Sep-16	Cloudy	1.1	10:40	11:10	48	49	46	Nil	Road traffic (not Project-related)	No demolition or construction work at Project site
07-Sep-16	Cloudy	1.1	13:32	14:02	47	48	44	Nil	Dog barks, Road traffic (not Project-related)	No demolition or construction work at Project site
14-Sep-16	Sunny	0.8	10:42	11:12	49	50	47	Nil	Nearby storage area activities (not Project-related)	No demolition or construction work at Project site
23-Sep-16	Sunny	3.3	10:46	11:16	49	50	45	Nil	Dog barks, Road traffic (not Project-related)	No demolition or construction work at Project site
30-Sep-16	Cloudy	2.2	10:17	10:47	54	55	47	Nil	Dog barks, Road traffic (not Project-related)	No demolition or construction work at Project site
					Min.	47				
					Max.	54

The graphical presentations of the measured construction noise level of the reporting month of noise impact monitoring are presented in **Appendix H**. The general weather conditions and graphical presentation are presented in **Appendix K**.
