Construction of a Secondary Boundary Fence and New Sections of Primary Boundary Fence and Boundary Patrol Road

Improvement Works for Mai Po, Lok Ma Chau, Sha Tau Kok, Planting Works at Tak Yuet Lau and Demolition Work at Shek Chung Au and Lo Wu to Sha Tau Kok – Monthly EM&A Report for November 2016

December 2016
Architectural Services Department

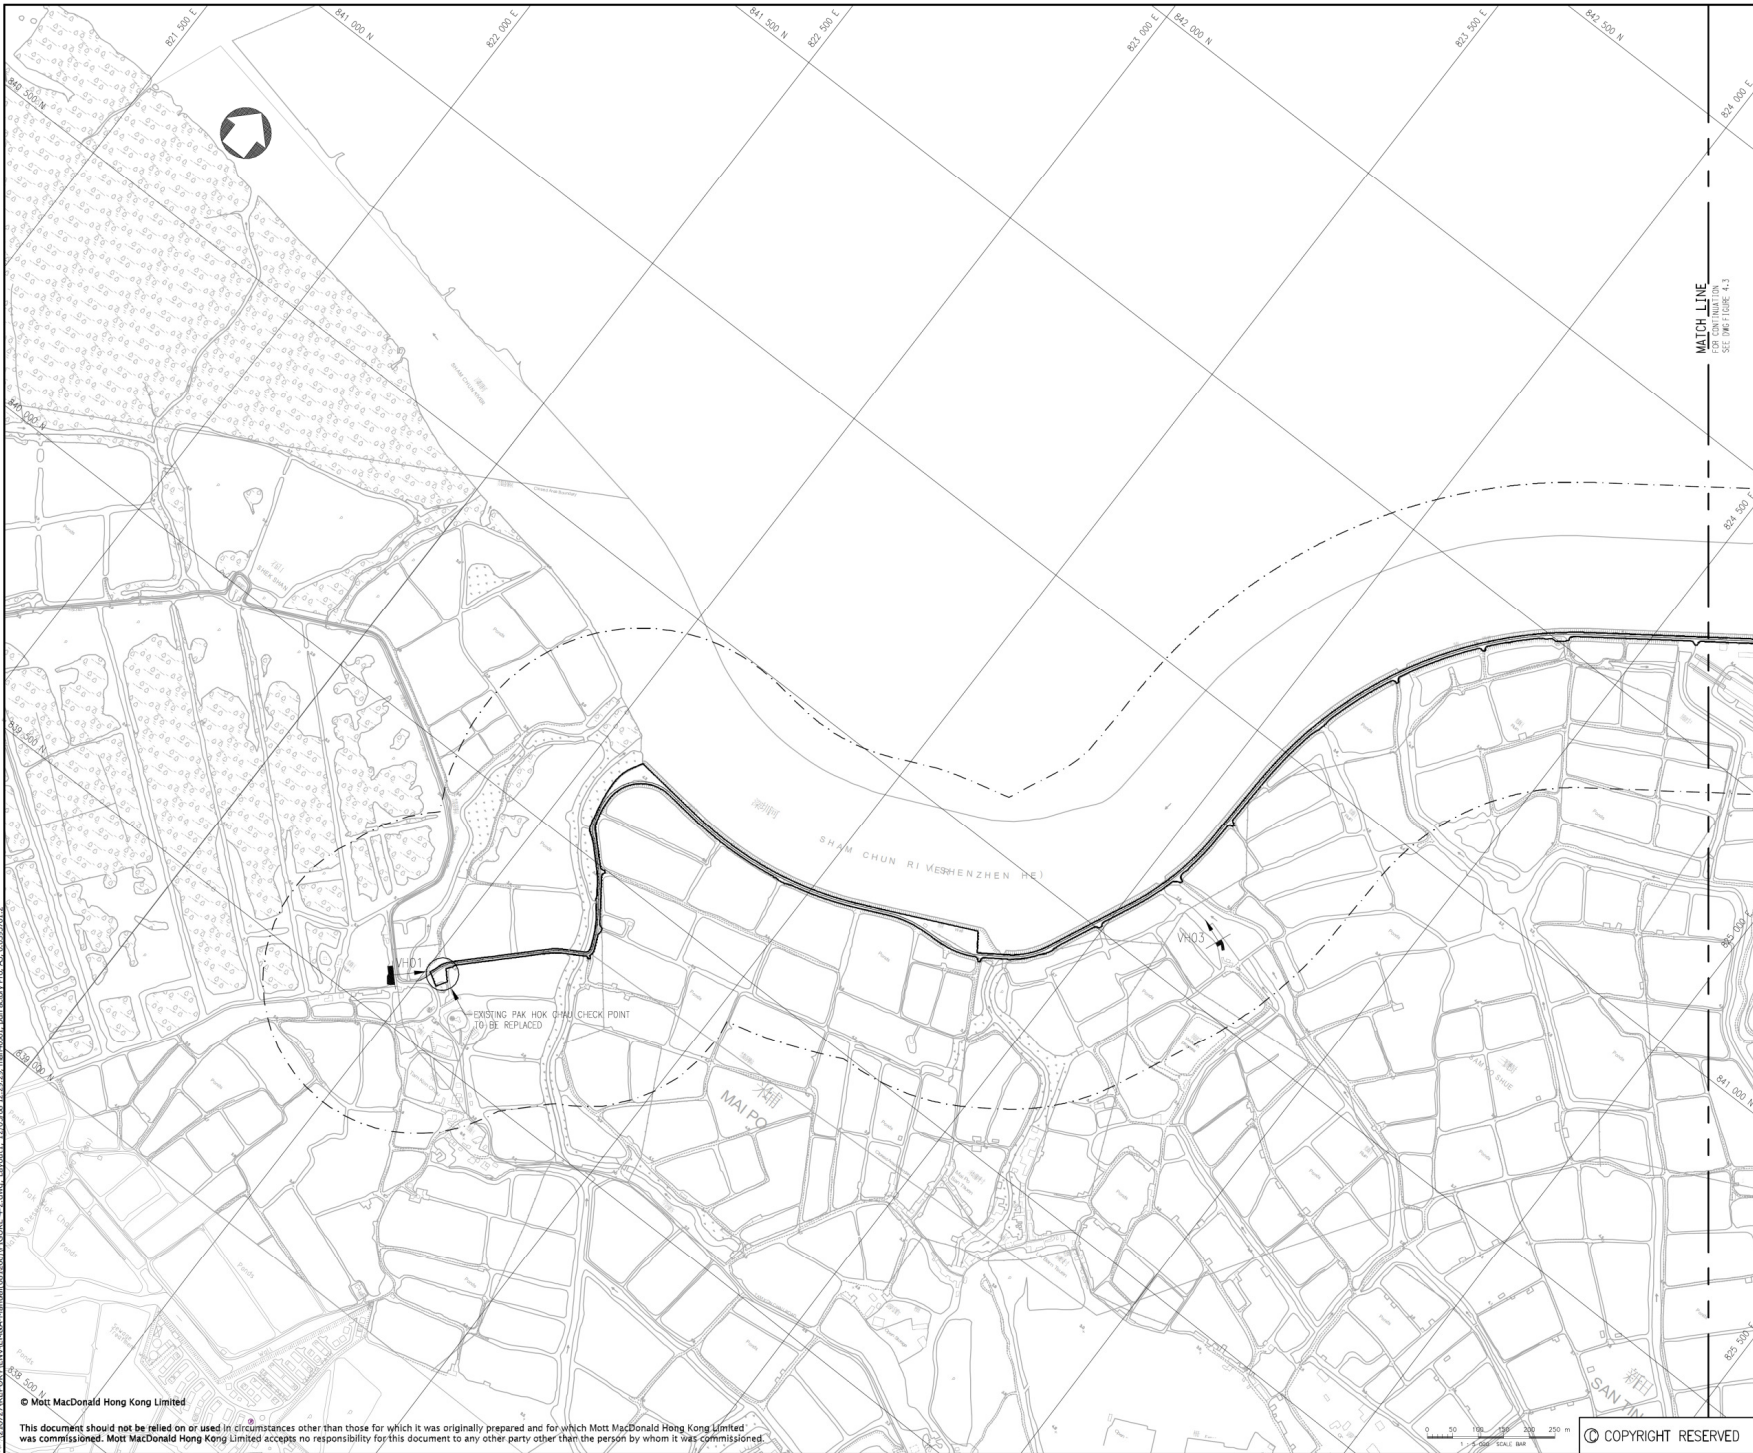
FIGURE 2.1

- LEGEND :
- 300m ASSESSMENT AREA
 - NOISE SENSITIVE RECEIVER
 - ▲ FACADE FACING

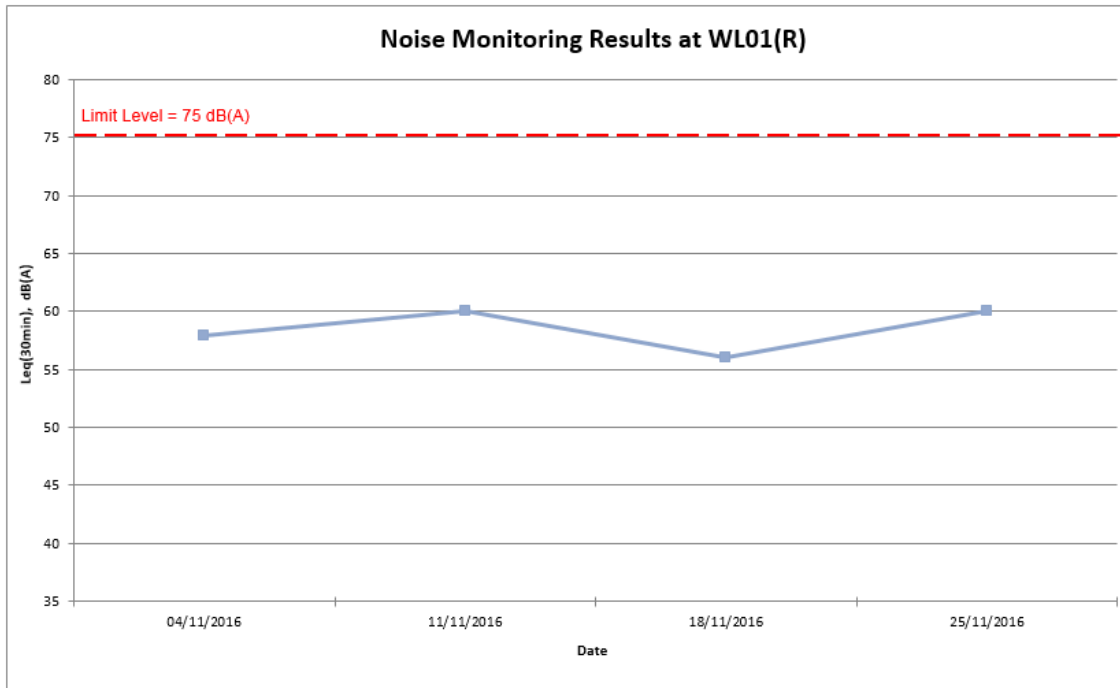
Daytime Noise Monitoring Results at Station WL01(R)

Date	Weather Conditions	Wind Speed, m/s	Noise Level for 30-min, dB(A)					Major Construction Noise Sources	Other Noise Sources during monitoring	Remarks	
			Start	End	Leq	L10	L90				
04-Nov-16	Cloudy	2.2	10:44	11:14	58	58	57	Nil	Road traffic, dog barks (not Project-related)	No demolition or construction work at Project site	
11-Nov-16	Cloudy	2.8	10:46	11:16	60	60	60	Nil	Road traffic, dog barks (not Project-related)	No demolition or construction work at Project site	
18-Nov-16	Cloudy	5.0	10:37	11:07	56	58	53	Nil	Road traffic, dog barks (not Project-related)	No demolition or construction work at Project site	
25-Nov-16	Cloudy	1.7	11:20	11:50	60	61	58	Nil	Road traffic, dog barks (not Project-related)	No demolition or construction work at Project site	
					Min.	56					
					Max.	60

The graphical presentations of the measured construction noise level of the reporting month of noise impact monitoring are presented in **Appendix H**. The general weather conditions and graphical presentation are presented in **Appendix K**.
