Construction of a Secondary Boundary Fence and New Sections of Primary Boundary Fence and Boundary Patrol Road

Improvement Works for Mai Po, Lok Ma Chau, Sha Tau Kok, Planting Works at Tak Yuet Lau and Demolition Work at Shek Chung Au and Lo Wu to Sha Tau Kok – Monthly EM&A Report for December 2016

January 2017
Architectural Services Department

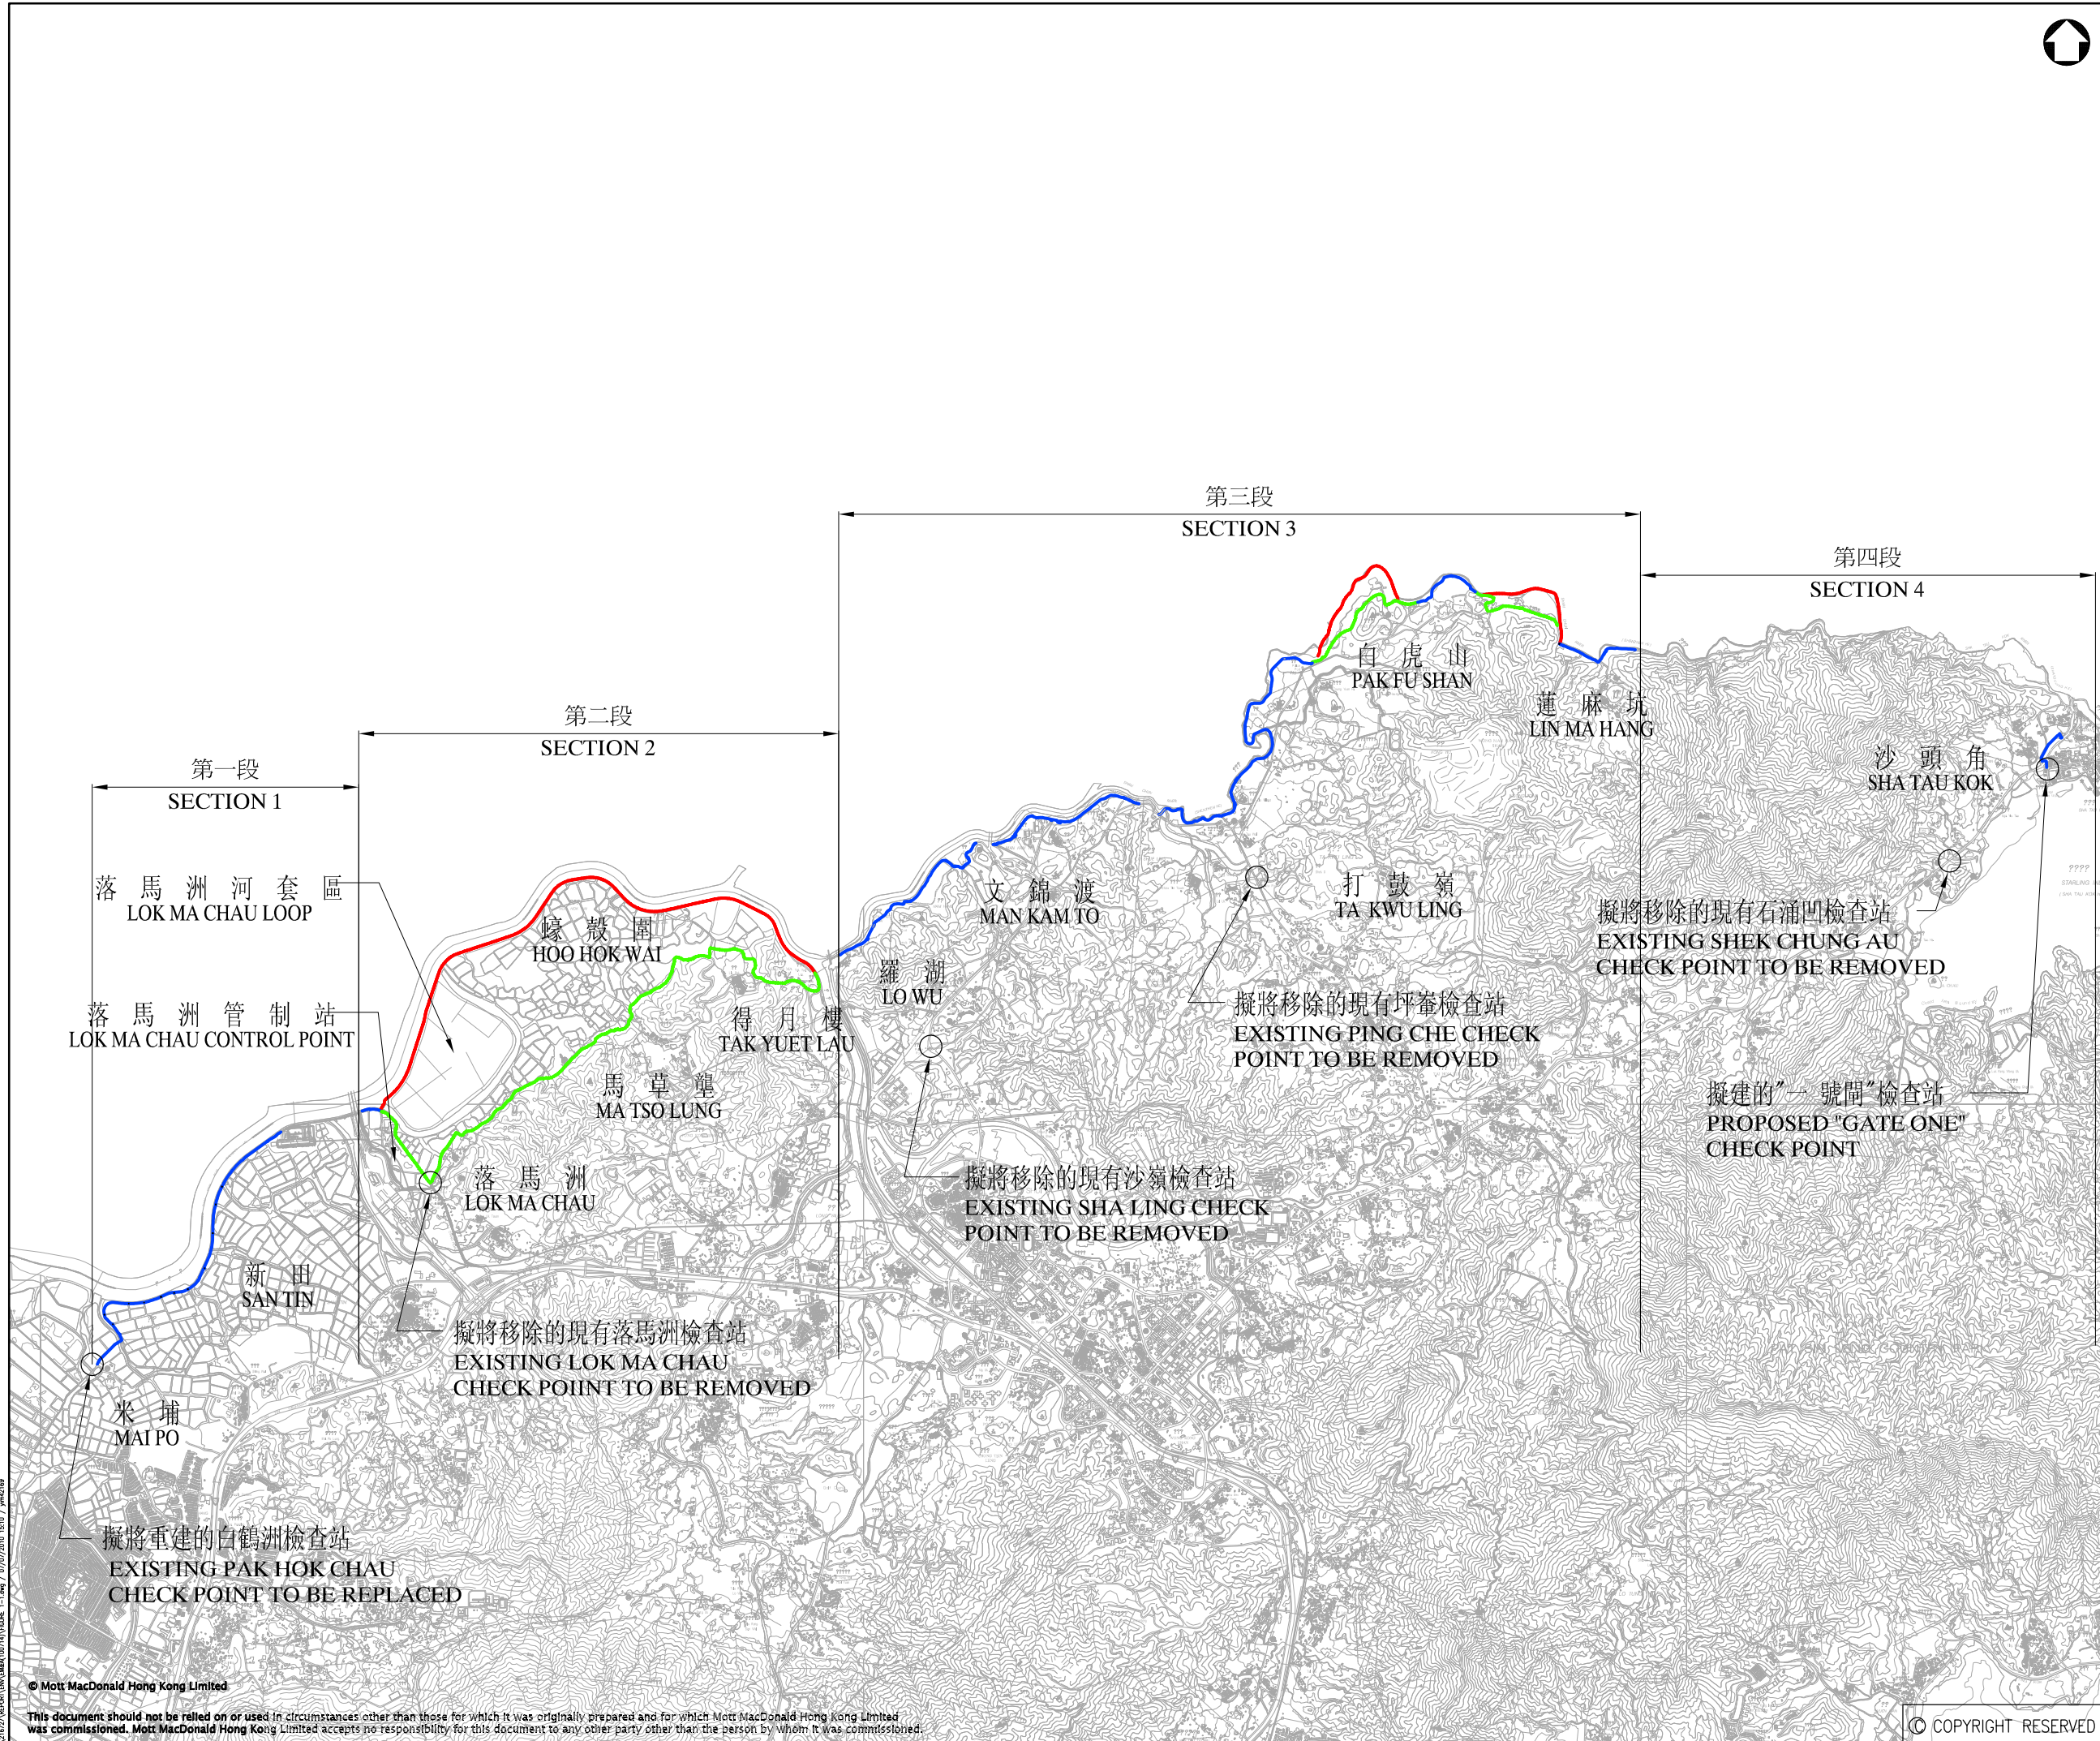
Designed	WHC	Eng.Chk.	WHC	
Drawn	MCL	Coordination	WHC	
Dwg.Chk.	WHC	Approved	TI	
Scale	Project 216727		Status	
	N.T.S.		INF	
Drawing No.	FIGURE 1.1 (圖 1.1)			Rev P1

Title
概覽圖
GENERAL LAYOUT PLAN

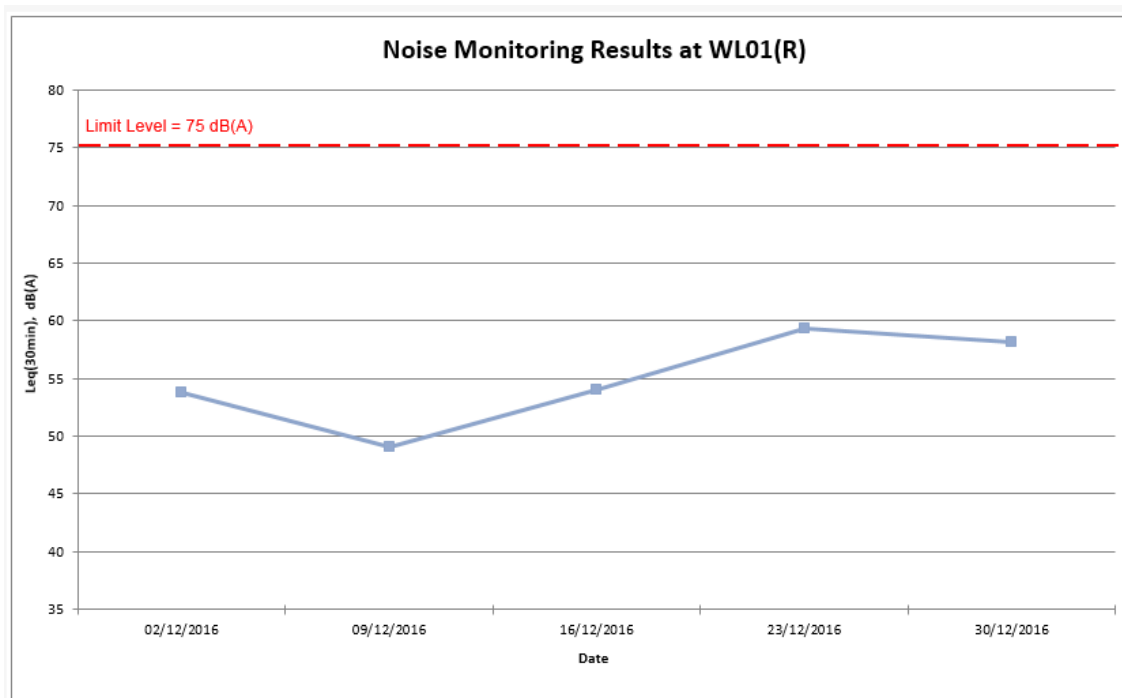
Date	Weather Conditions	Wind Speed, m/s	Noise Level for 30-min, dB(A)					Major Construction Noise Sources	Other Noise Sources during monitoring	Remarks
			Start	End	Leq	L10	L90			
02-Dec-16	Cloudy	2.2	11:34	12:04	54	57	49	Nil	Road traffic, dog barks (not Project-related)	No demolition or construction work at Project site
09-Dec-16	Cloudy	2.5	09:50	10:20	49	50	47	Nil	Road traffic, dog barks (not Project-related)	No demolition or construction work at Project site
16-Dec-16	Cloudy	2.8	10:37	11:07	54	55	51	Nil	Road traffic, dog barks (not Project-related)	No demolition or construction work at Project site
23-Dec-16	Cloudy	1.9	15:00	15:30	59	61	57	Nil	Road traffic, dog barks (not Project-related)	No demolition or construction work at Project site
30-Dec-16	Cloudy	2.5	15:27	15:57	58	59	57	Nil	Dog barks, Road traffic (not Project-related)	No demolition or construction work at Project site
					Min.	49

The graphical presentations of the measured construction noise level of the reporting month of noise impact monitoring are presented in **Appendix H**. The general weather conditions and graphical presentation are presented in **Appendix K**.
