Construction of a Secondary Boundary Fence and New Sections of Primary Boundary Fence and Boundary Patrol Road

Improvement Works for Mai Po, Lok Ma Chau, Sha Tau Kok, Planting Works at Tak Yuet Lau and Demolition Work at Shek Chung Au and Lo Wu to Sha Tau Kok – Monthly EM&A Report for February 2017

March 2017
Architectural Services Department

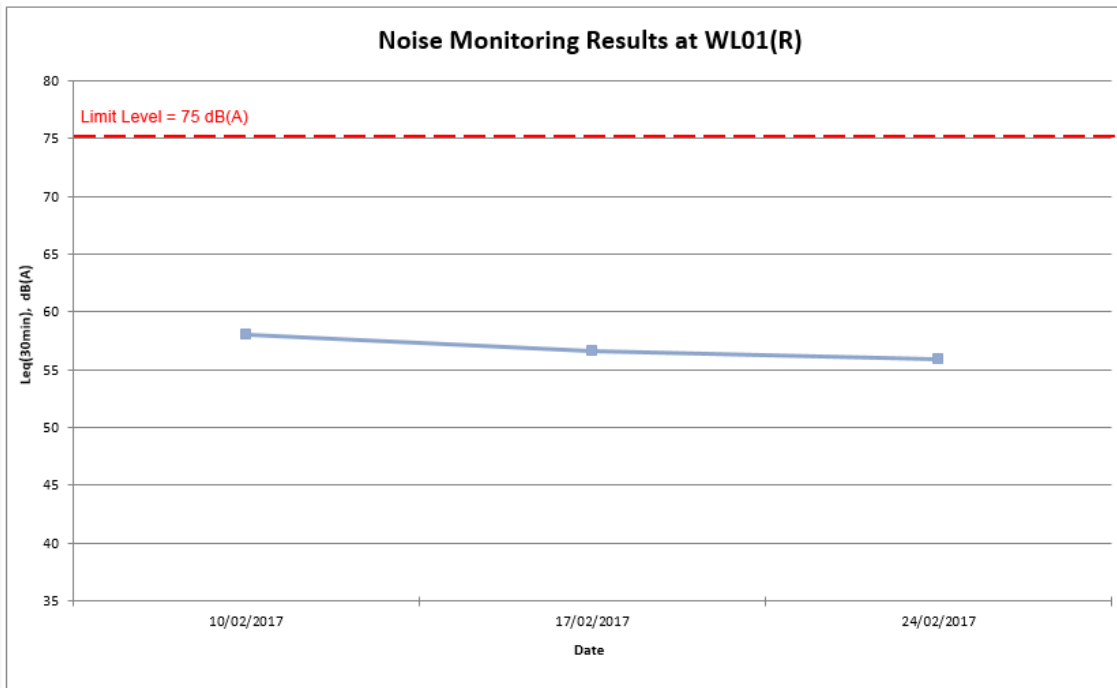
Daytime Noise Monitoring Results at Station WL01(R)

Date	Weather Conditions	Wind Speed, m/s	Noise Level for 30-min, dB(A)					Major Construction Noise Sources	Other Noise Sources during monitoring	Remarks	
			Start	End	Leq	L10	L90				
10-Feb-17	Cloudy	2.8	10:39	11:09	58	59	57	Nil	Road traffic, dog barks (not Project-related)	No demolition or construction work at Project site	
17-Feb-17	Cloudy	1.9	10:43	11:13	57	57	56	Nil	Road traffic, dog barks (not Project-related)	No demolition or construction work at Project site	
24-Feb-17	Cloudy	2.8	10:35	11:05	56	58	53	Nil	Road traffic, dog barks (not Project-related)	No demolition or construction work at Project site	
					Min.	56					
					Max.	58
