**Agreement No. CE 63/2016 (EP)
Environmental Monitoring and Audit
for Disposal Facility to the East of
Sha Chau (2017-2020) – Investigation**

**Monthly EM&A Report for Contaminated
Mud Pits to the East of Sha Chau and the
South of The Brothers – October 2017**

Revision 0

13 November 2017

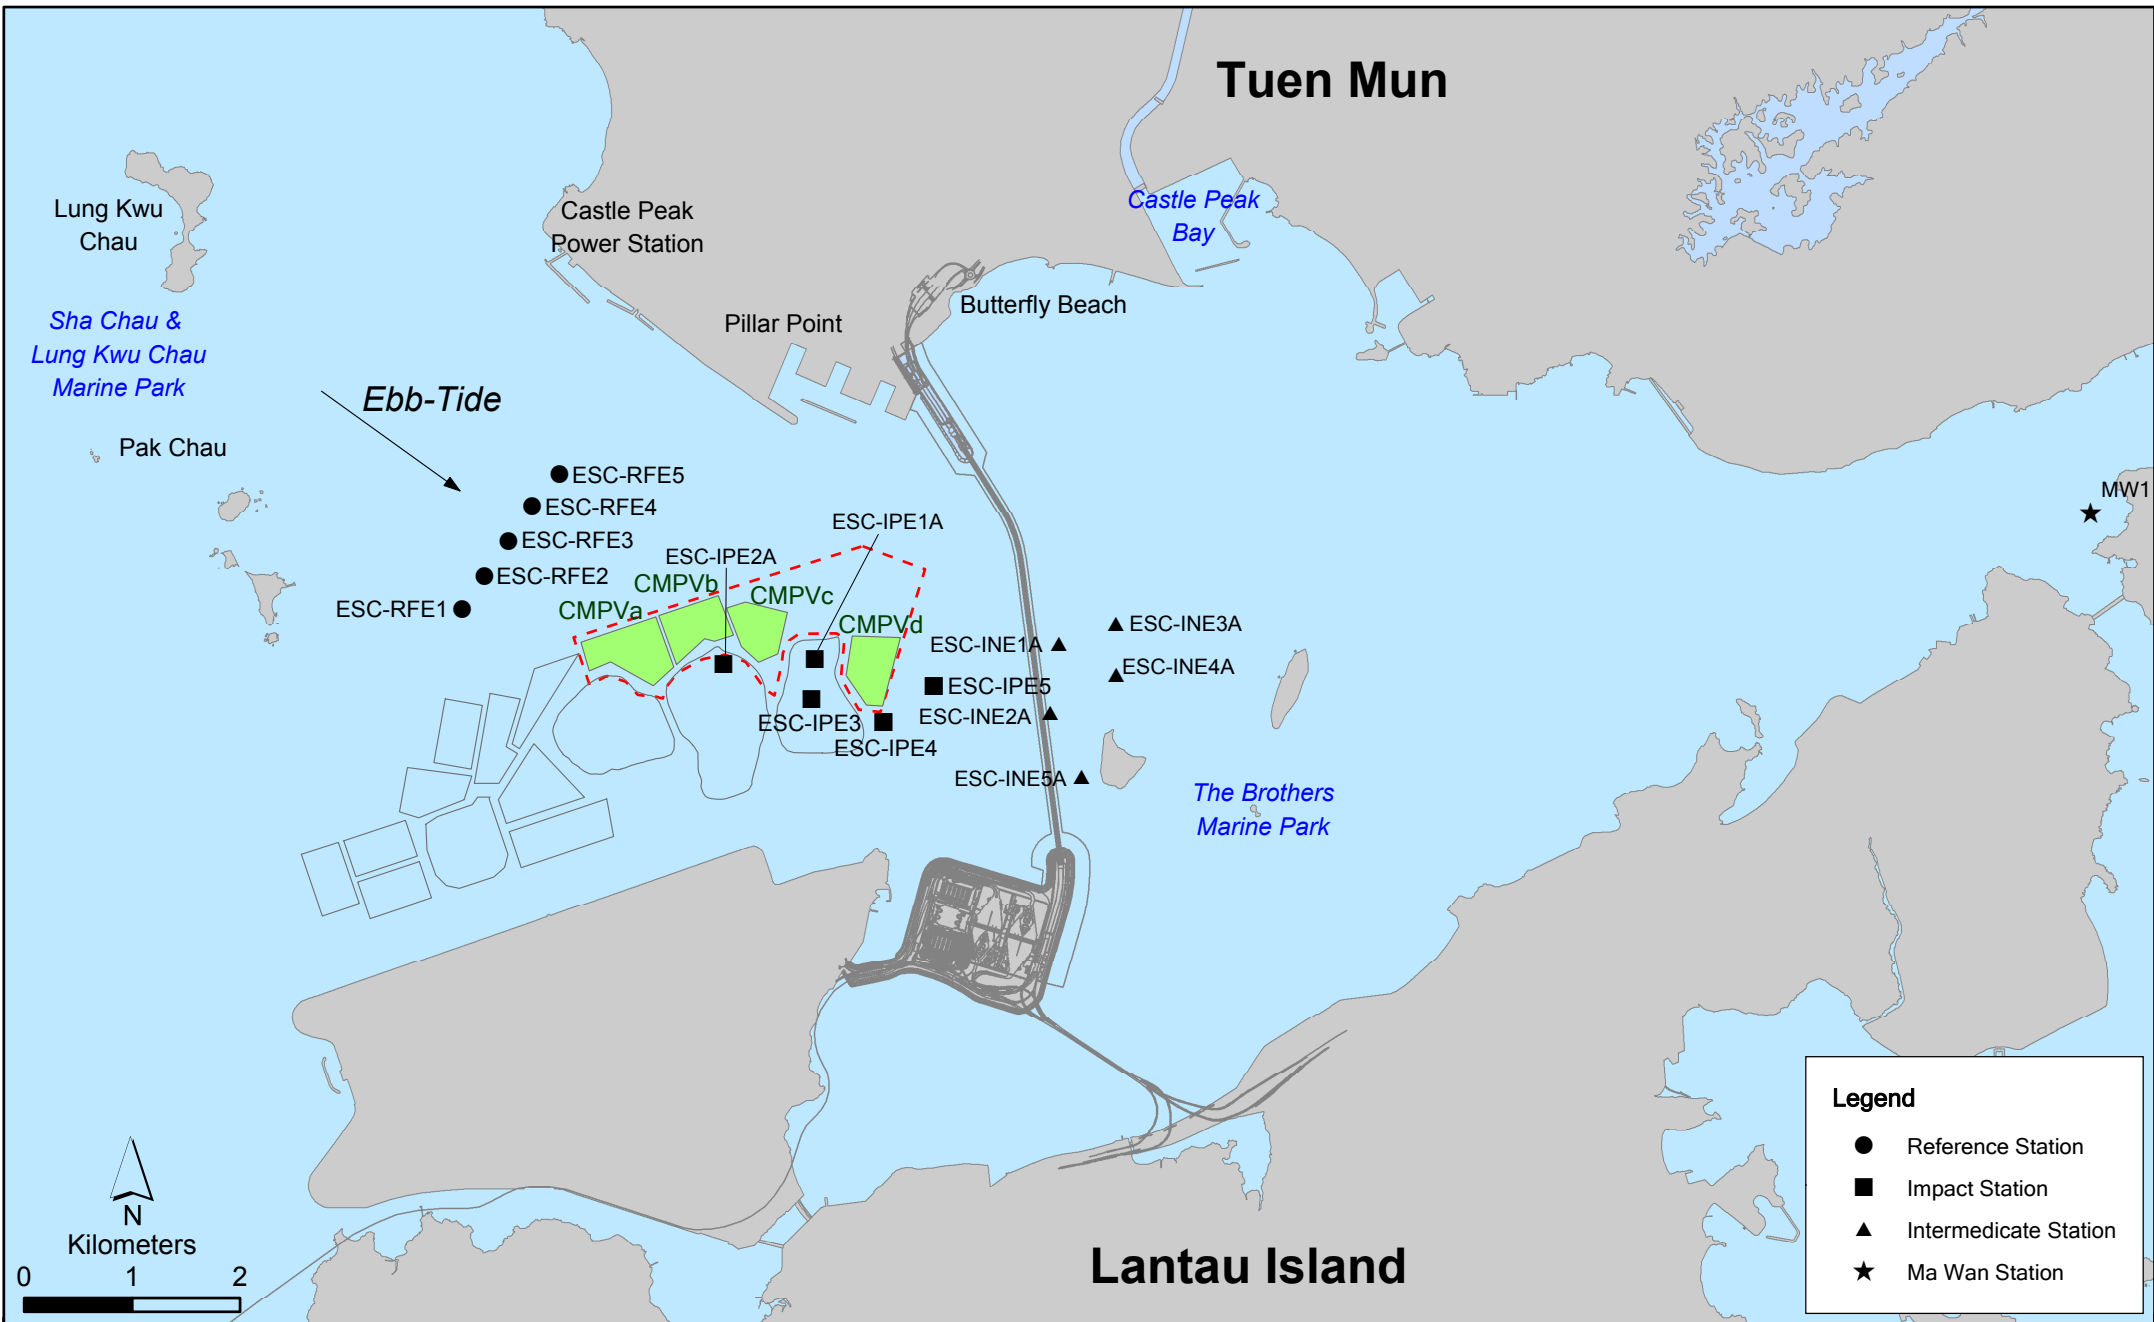
Figure 1.2

Routine & Capping Water Quality Sampling Stations (Ebb-Tide) for ESC CMPs

1.5.8 *Routine Water Quality Monitoring of ESC CMP V* was undertaken on 4 October 2017. The monitoring results have been assessed for compliance with the WQOs (see *Section 1.5.3* for details). The monitoring results are shown in *Tables B3 and B4 of Annex B* and *Figures 1 - 10 of Annex C*. A total of sixteen (16) monitoring stations were sampled in October 2017 as shown in *Figure 1.2*.

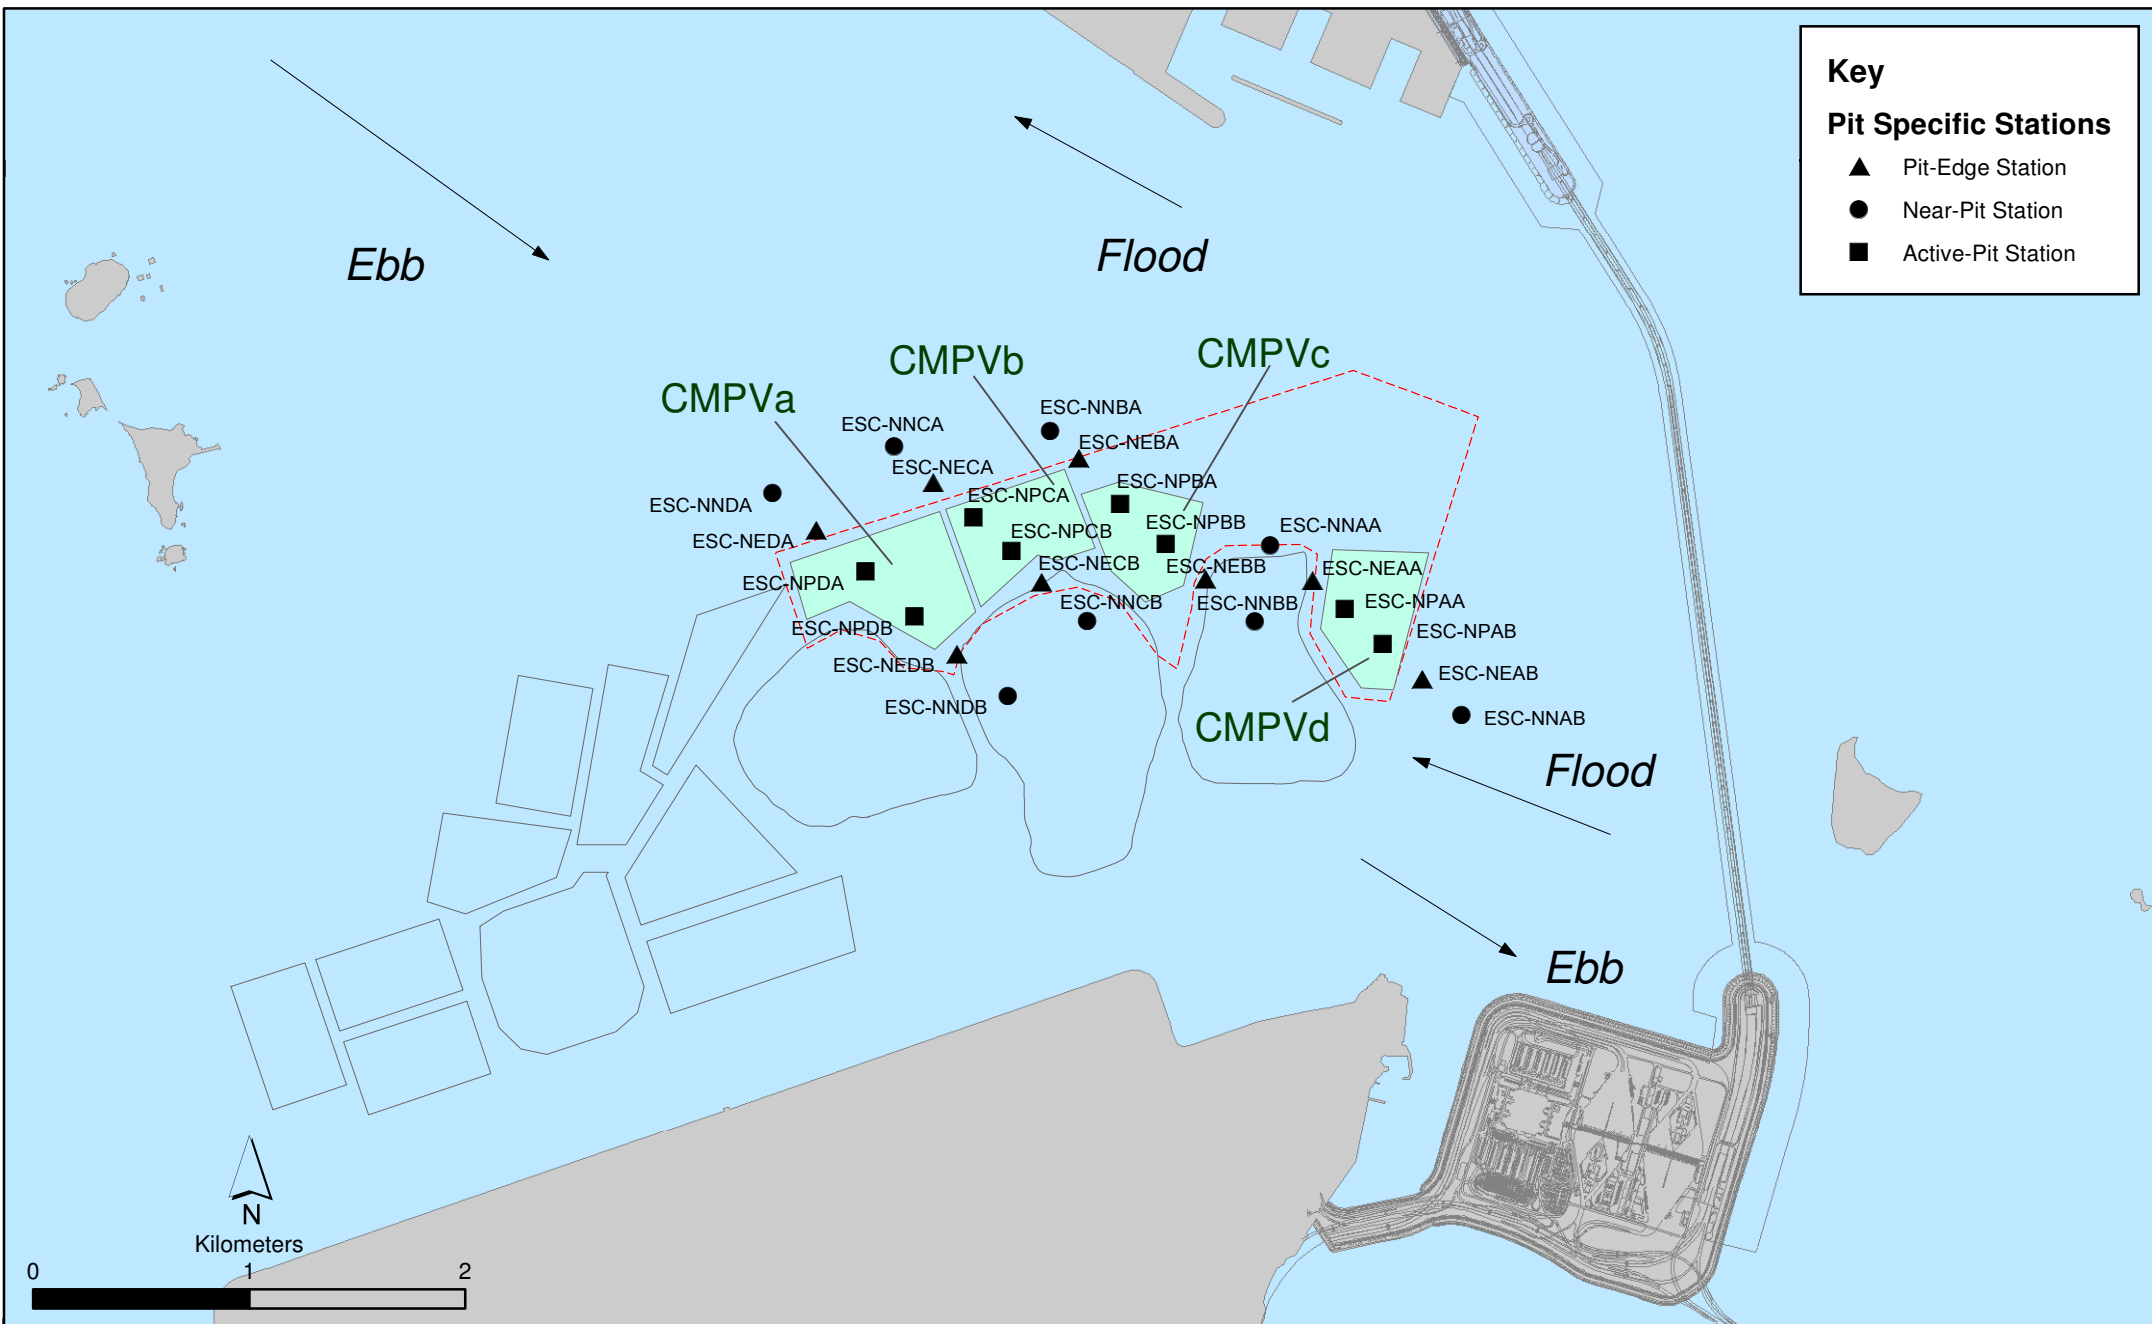
Figure 1.3

Pit Specific Sediment Quality Monitoring Stations for CMPV

- 1.5.16 ***Pit Specific Sediment Chemistry of ESC CMP Vd – September and October 2017***
- 1.5.17 Monitoring locations for *Pit Specific Sediment Chemistry for ESC CMP Vd* are shown in *Figure 1.3*. A total of six (6) monitoring stations were sampled in September and October 2017.

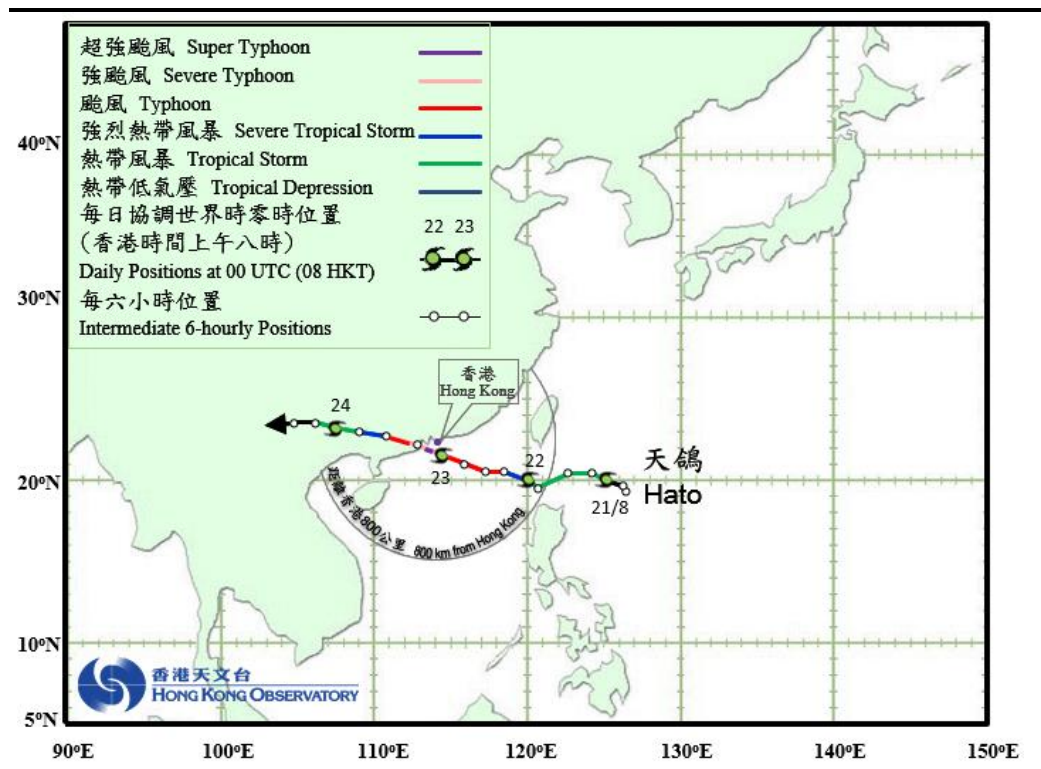
Figure 1.5 *Track of Tropical Cyclone Hato from 20 to 24 August 2017 (Source: Hong Kong Observatory)*

- 1.5.23 *Sediment Chemistry after a Major Storm of ESC CMP V – August and October 2017*
- 1.5.24 Sampling for Sediment Chemistry after a Major Storm Event was conducted at nine (9) monitoring stations (*Figure 1.4*) on 31 August 2017 and 19 October 2017 after the visit of tropical cyclones Hato and Khanun, which led to the issue of No. 10 Hurricane Signal on 23 August 2017 and No. 8 Northeast Gale or Storm Signal on 15 October 2017, respectively. The tracks of Hato and Khanun are shown in *Figures 1.5 and 1.6*.

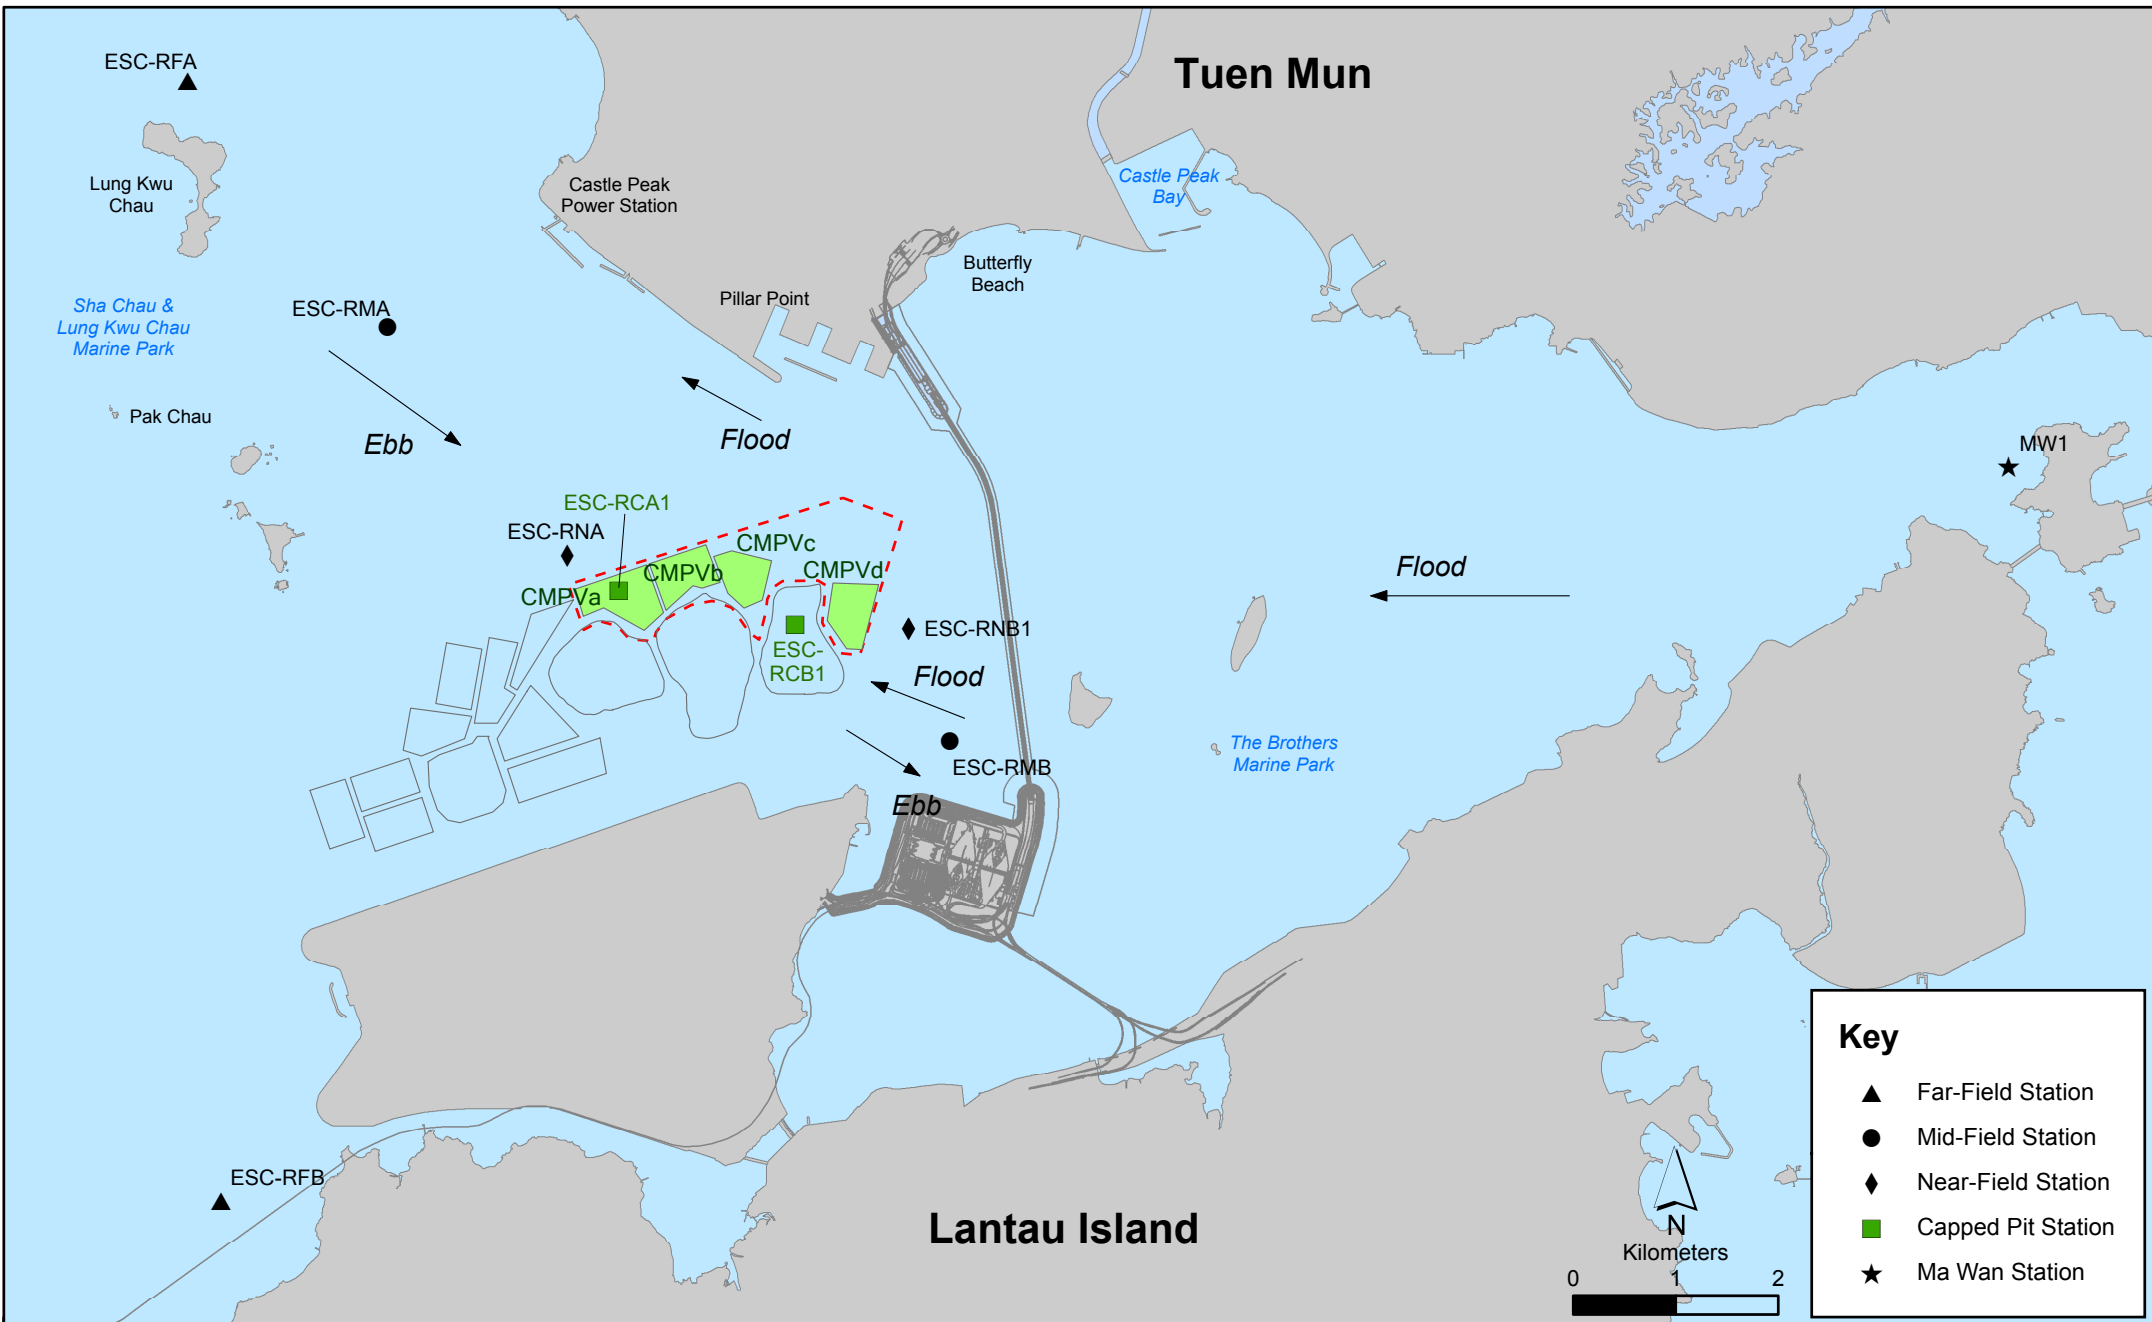
Figure 1.4

Cumulative Impacts Sediment Quality Monitoring Stations for ESC CMPs

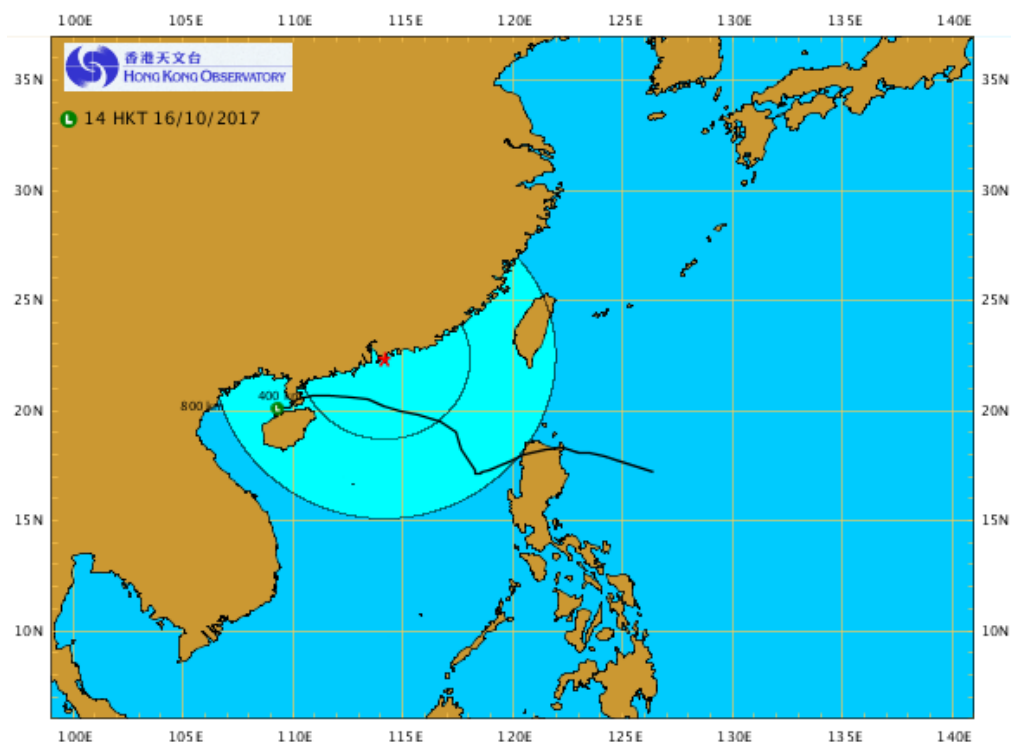
Figure 1.6 Track of Tropical Cyclone Khanun from 12 to 16 October 2017 (Source: Hong Kong Observatory)

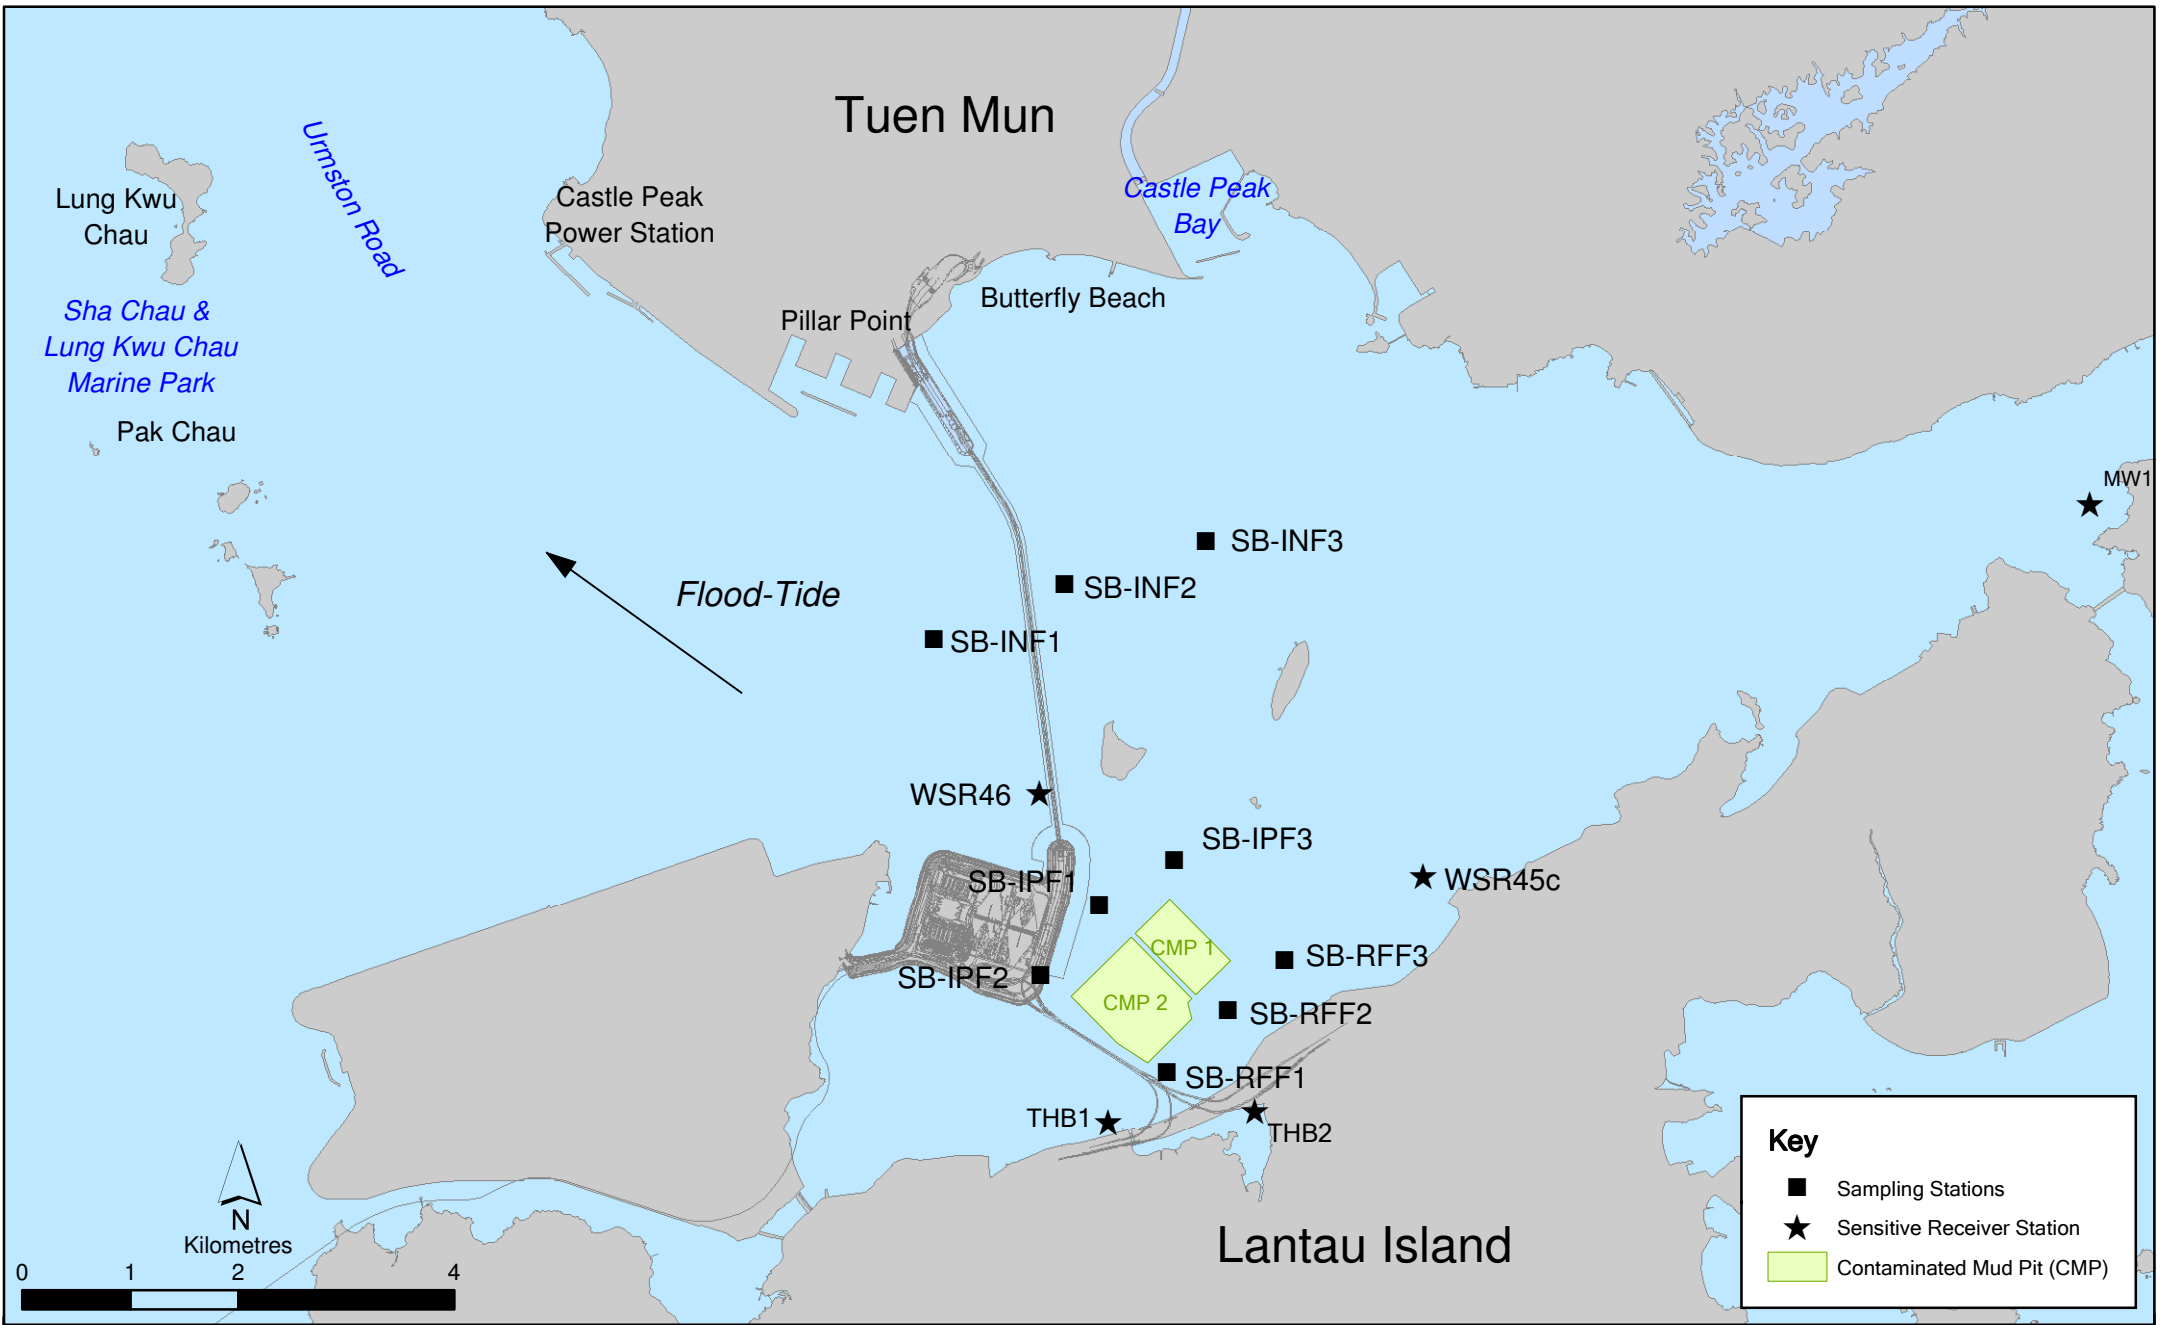
Figure 1.7

Routine & Capping Water Quality Sampling Stations (Flood-Tide) for South Brothers Facility

1.6.3 Capping works at SB CMP 2 were conducted in September 2017 to supplement and revert the portion of consolidated capping layer to design level and was completed in September 2017. Post-water quality monitoring was then conducted on 29 September 2017 after the completion of capping works at SB CMP 2. The monitoring results obtained have been assessed for compliance with the WQOs (see *Section 1.5.3* for details). A total of fourteen (14) monitoring stations were sampled in September 2017 as shown in *Figure 1.7*. Results of *in-situ* measurements were presented in the *Monthly EM&A Report for September 2017*. The results of laboratory measurements are presented in the section below. Graphical presentation of the laboratory monitoring results is shown in *Figures 23 - 26 of Annex C*.

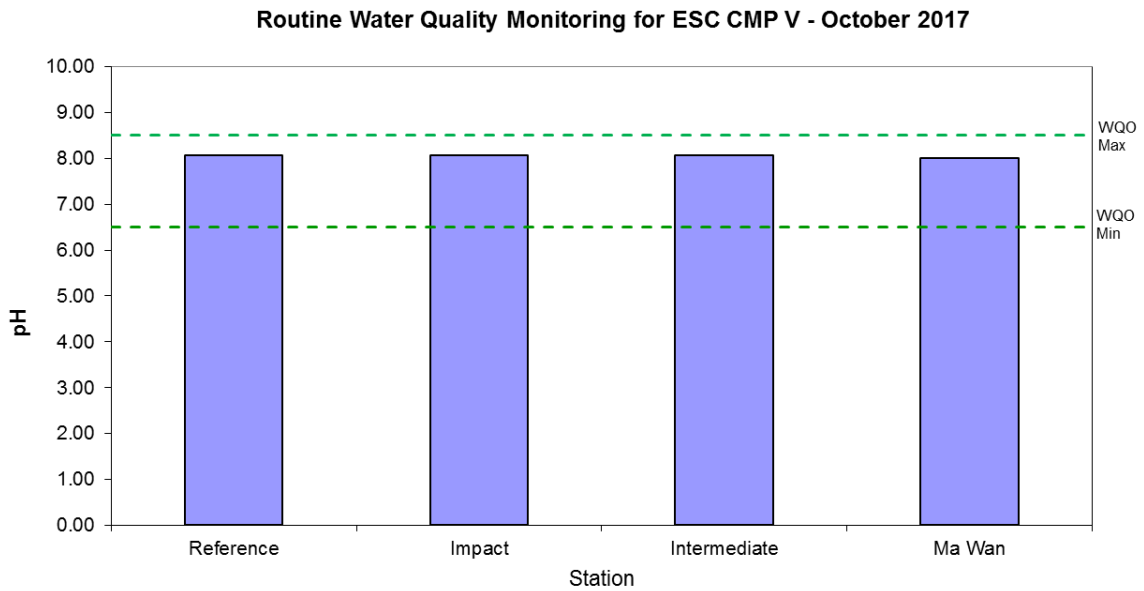
Figure 1: Level of pH recorded during Routine Water Quality Monitoring for disposal operations at ESC CMP V in October 2017.

1.5.9 Graphical presentation of the monitoring results (Temperature, DO, pH, Salinity and Turbidity) is shown in *Figures 1 - 6 of Annex C*. Analyses of results for October 2017 indicated that the levels of pH, Salinity and DO complied with the WQOs at all stations (Impact, Intermediate, Reference and Ma Wan stations) in October 2017 (*Table B3 of Annex B; Figures 1, 3 and 5 of Annex C*).

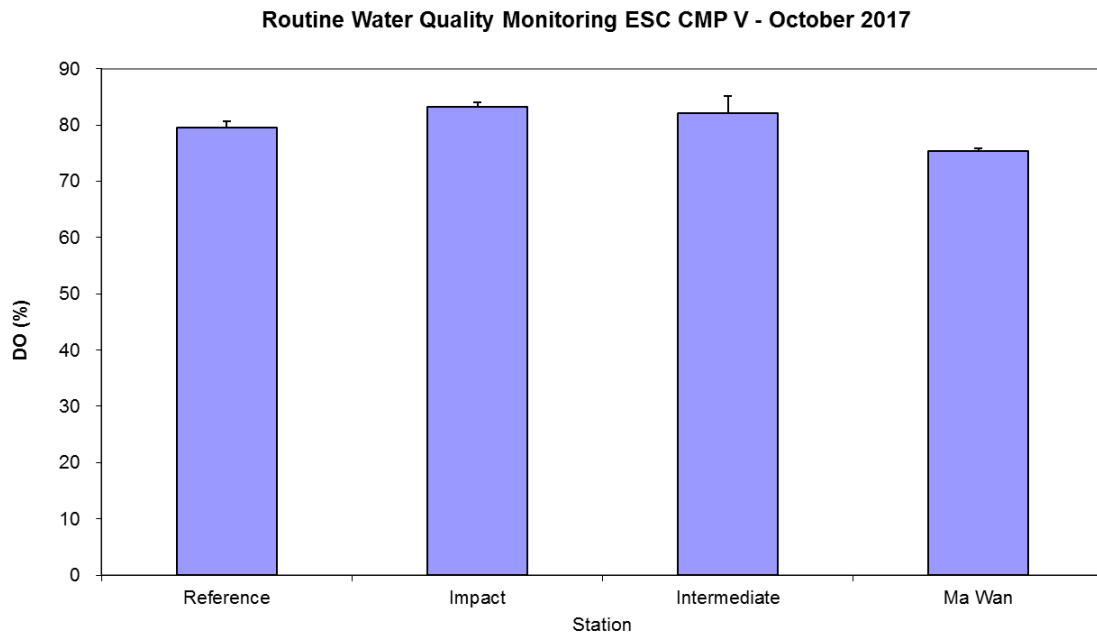
Figure 2: Level of Dissolved Oxygen (DO) (% saturation; mean + SD) recorded during Routine Water Quality Monitoring for disposal operations at ESC CMP V in October 2017.

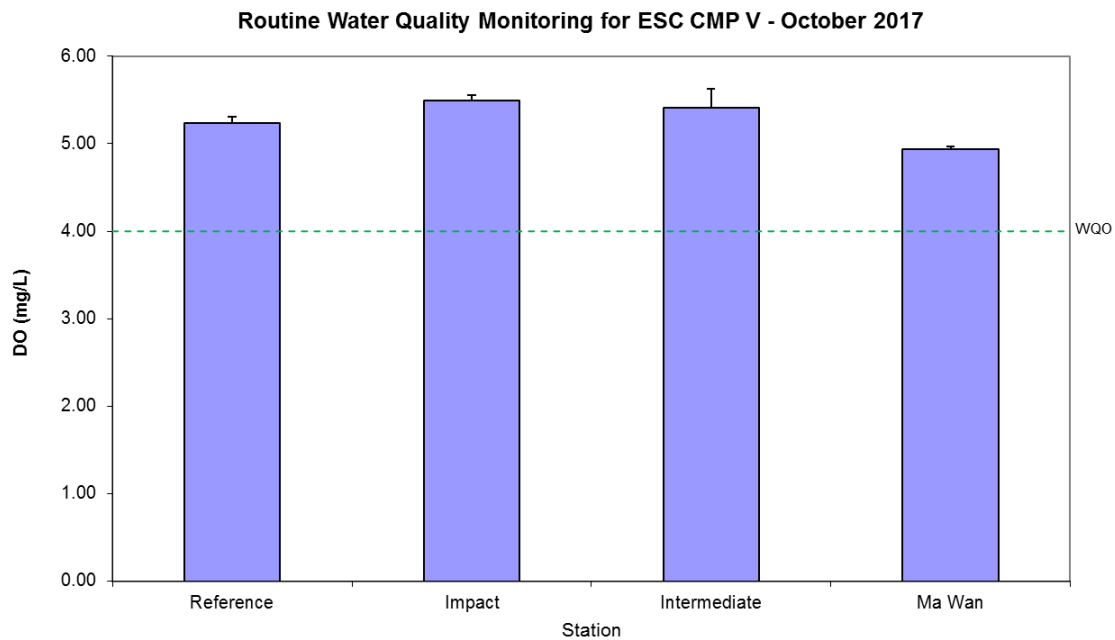
Figure 3: Concentration of Dissolved Oxygen (DO) (mg/L; mean + SD) recorded during Routine Water Quality Monitoring for disposal operations at ESC CMP V in October 2017.

1.5.10 The levels of DO and Turbidity complied with the Action and Limit Levels at all stations (*Table B3 of Annex B; Figures 3 and 6 of Annex C*).

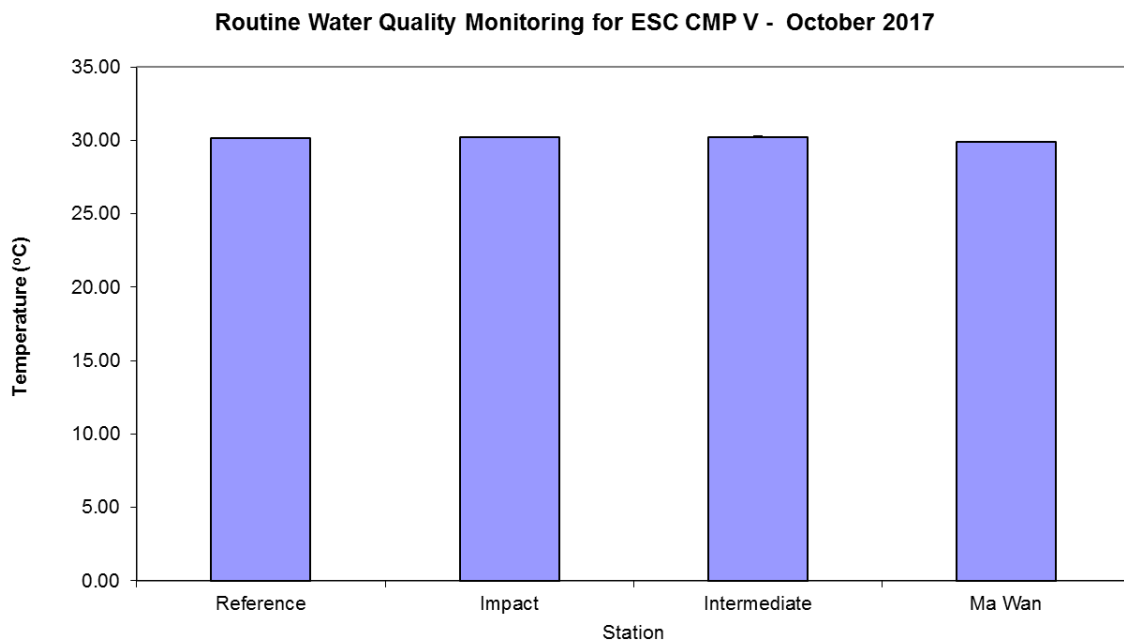
Figure 4: Level of Temperature (°C; mean + SD) recorded during Routine Water Quality Monitoring for disposal operations at ESC CMP V in October 2017.

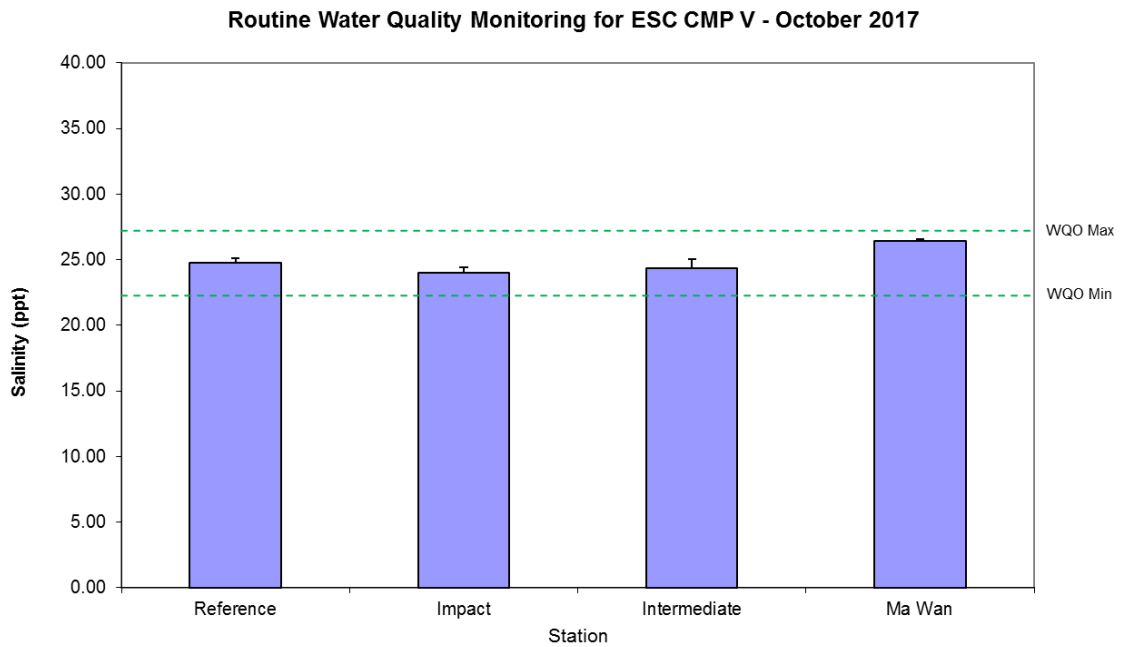
Figure 5: Level of Salinity (ppt; mean + SD) recorded during Routine Water Quality Monitoring for disposal operations at ESC CMP V in October 2017.

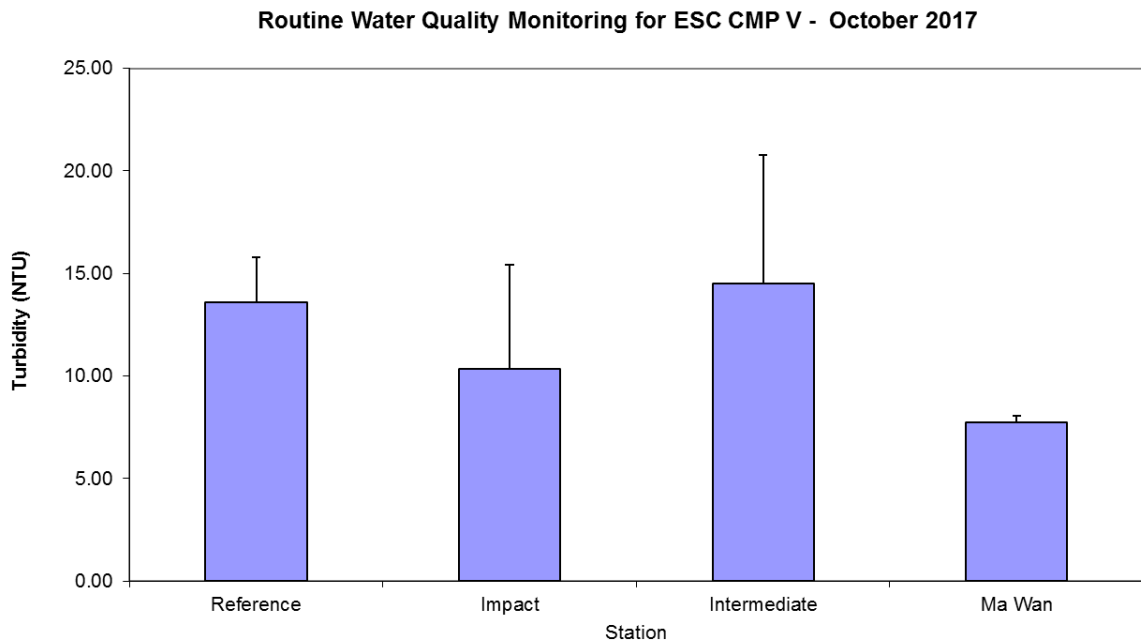
Figure 6: Levels of Turbidity (NTU; mean + SD) recorded during Routine Water Quality Monitoring for disposal operations at ESC CMP V in October 2017.

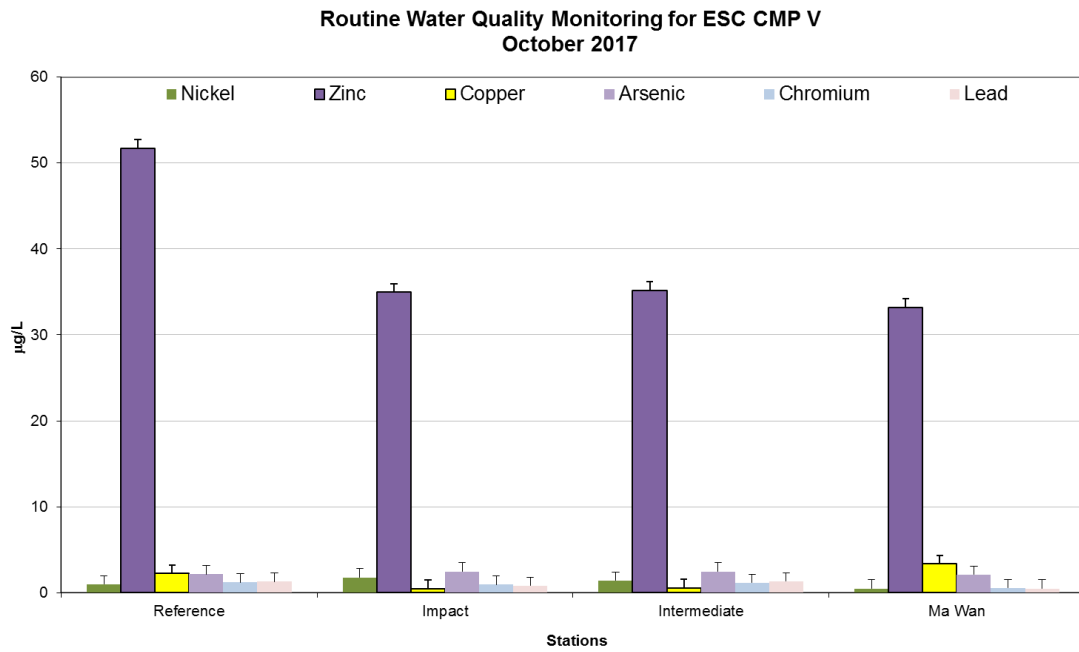
Figure 7: Concentration of Arsenic, Chromium, Nickel, Lead, Copper and Zinc ($\mu\text{g/L}$; mean + SD) in water samples collected from Routine Water Quality Monitoring for disposal operations at ESC CMP V in October 2017.

1.5.12 Laboratory analysis of October 2017 results indicated that concentrations of Cadmium, Silver and Mercury were below their limit of reporting at all stations. Arsenic, Chromium, Nickel, Lead, Copper and Zinc were detected in October 2017 samples and the concentrations of these metals and metalloids were similar amongst stations (*Table B4 of Annex B; Figure 7 of Annex C*).

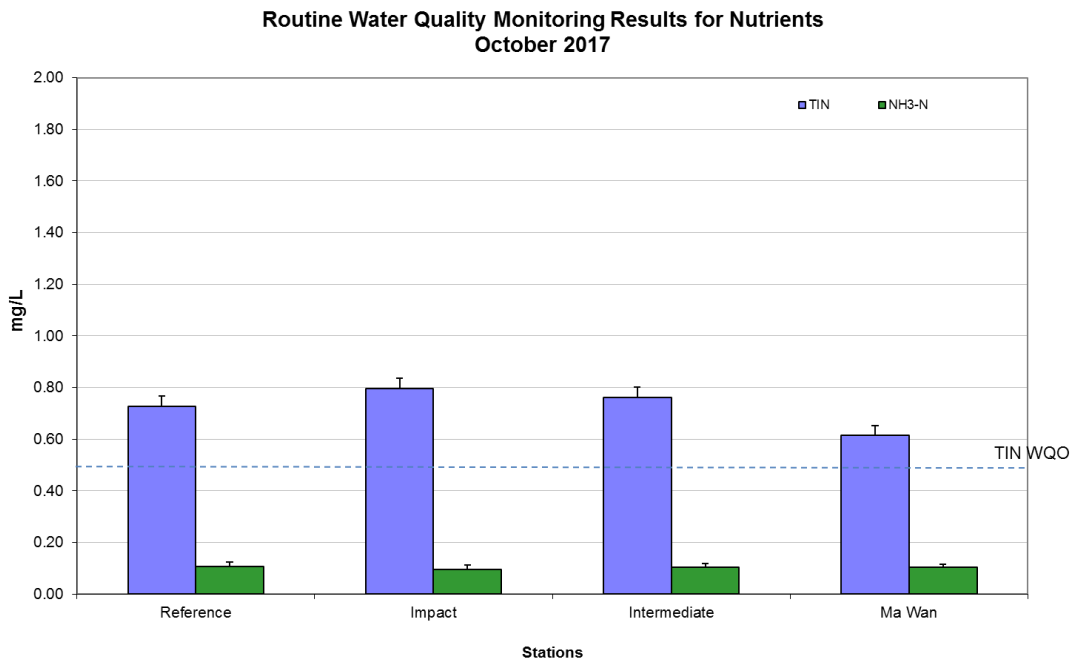
Figure 8: Concentration of Total Inorganic Nitrogen (TIN) and Ammonia Nitrogen ($\text{NH}_3\text{-N}$) ($\mu\text{g/L}$; mean + SD) in water samples collected from Routine Water Quality Monitoring for disposal operations at ESC CMP V in October 2017.

1.5.13 For nutrients, concentrations of Total Inorganic Nitrogen (TIN) at all stations in October 2017 were higher than the WQO (0.5 mg/L) (*Table B4 of Annex B; Figure 8 of Annex C*). It should be noted that due to the effect of Pearl River, the North Western WCZ has historically experienced higher levels of TIN⁽¹⁾. Therefore, the exceedances of TIN WQO at these stations are unlikely to be caused by the disposal operation at ESC CMP Vd. Concentrations of Ammonia Nitrogen (NH₃-N) were similar amongst all stations in October 2017 (*Table B4 of Annex B; Figure 8 of Annex C*). Levels of 5-day Biochemical Oxygen Demand (BOD₅) were relatively similar amongst all stations in October 2017 (*Table B4 of Annex B; Figure 9 of Annex C*).

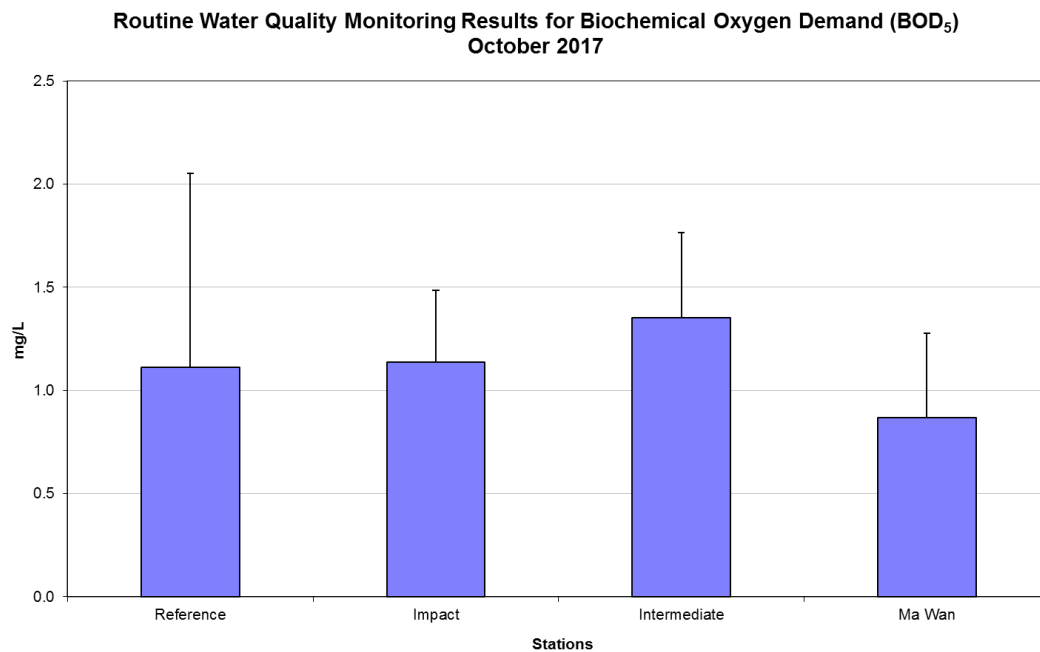
Figure 9: Level of Biochemical Oxygen Demand (BOD₅) (mg/L; mean + SD) in water samples collected from Routine Water Quality Monitoring for disposal operations at ESC CMP V in October 2017.

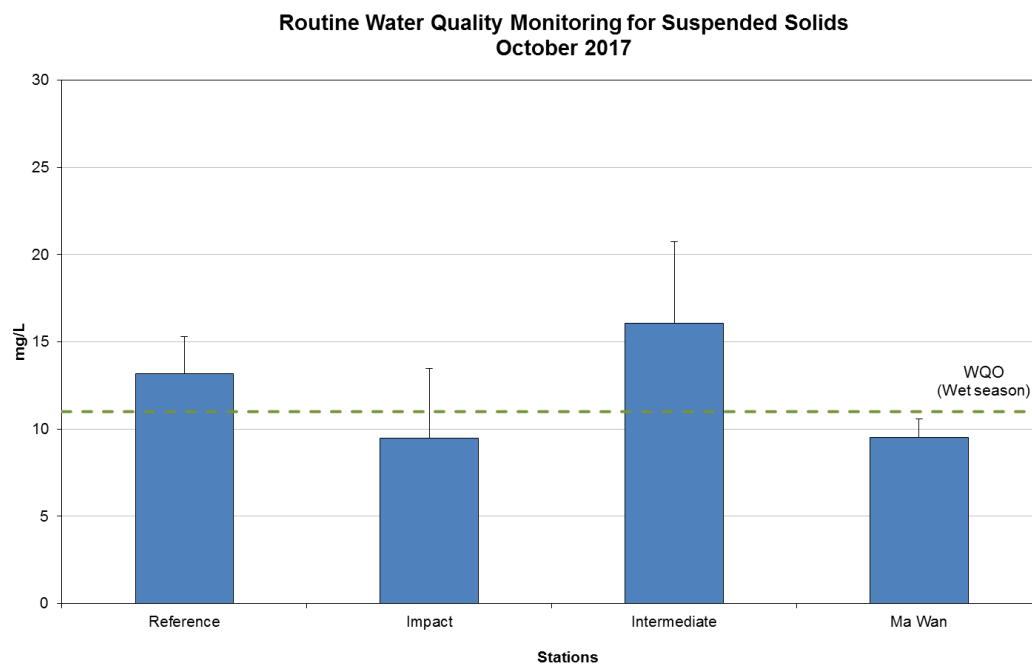
Figure 10: Concentration of Suspended Solids (SS) (mg/L; mean + SD) in water samples collected from Routine Water Quality Monitoring for disposal operations at ESC CMP V in October 2017.

1.5.14 Analyses of results for October 2017 indicated that the SS levels at Reference and Intermediate stations were higher than the WQO (11.0 mg/L for wet season), however SS levels complied with the Action and Limit Levels at all stations (*Tables B1 and B4 of Annex B; Figure 10 of Annex C*).

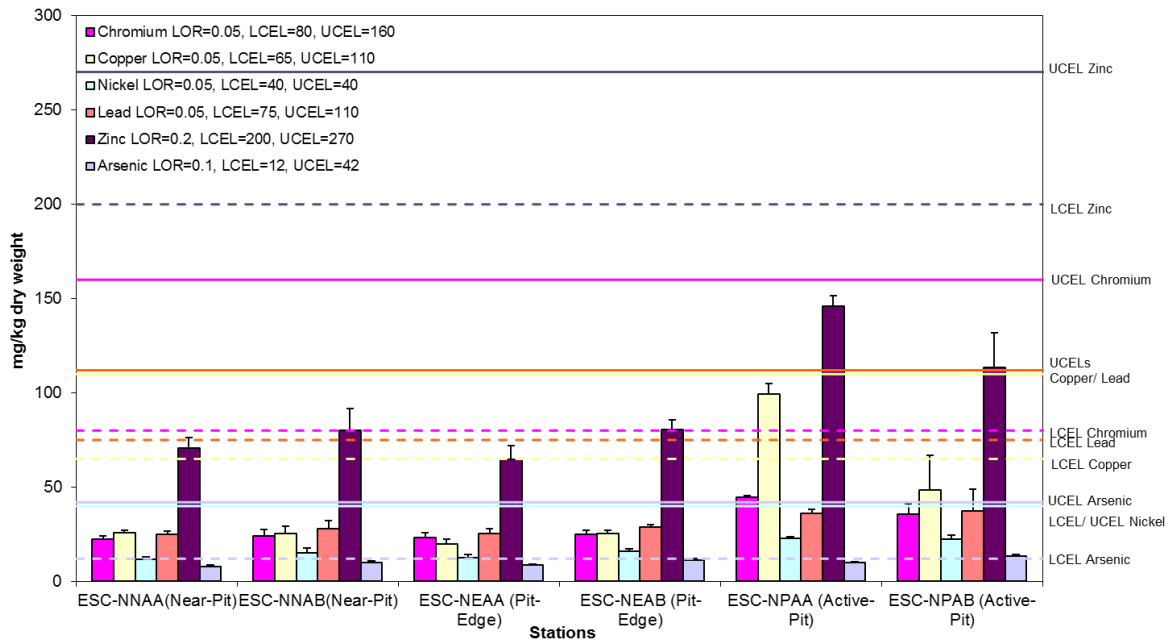
Figure 11: Concentration of Metals and Metalloid (Cr, Cu, Ni, Pb, Zn, As; mg/kg dry weight; mean +SD) in sediment samples collected from Pit Specific Sediment Chemistry Monitoring for ESC CMP Vd in September 2017.

- 1.5.18 The concentrations of most inorganic contaminants were lower than the Lower Chemical Exceedance Level (LCEL) at all stations in September and October 2017, except Arsenic, Copper and Silver in September 2017 and Arsenic in October 2017 (*Figures 11, 12, 15 and 16 of Annex C*). In September 2017, concentrations of Arsenic exceeded the LCEL at Active Pit station ESC-NPAB while concentrations of Copper and Silver exceeded the LCEL at Active Pit station ESC-NPAA (*Figures 11 and 12 of Annex C*). In October 2017, concentrations of Arsenic exceeded the LCEL at Active Pit station ESC-NPAB (*Figure 15 of Annex C*).
