**Agreement No. CE 63/2016 (EP)
Environmental Monitoring and Audit
for Disposal Facility to the East of
Sha Chau (2017-2020) – Investigation**

**Monthly EM&A Report for Contaminated
Mud Pits to the East of Sha Chau and the
South of The Brothers – October 2017**

Revision 0

13 November 2017

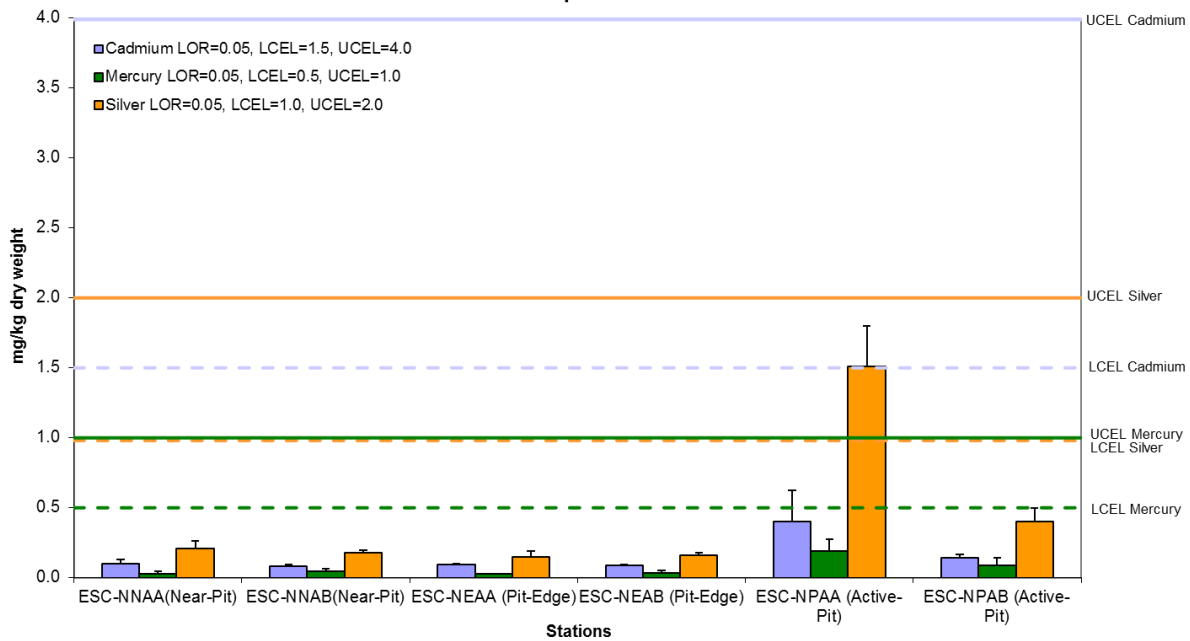
Figure 12: Concentration of Metals (Cd, Hg, Ag; mg/kg dry weight; mean +SD) in sediment samples collected from Pit Specific Sediment Chemistry Monitoring for ESC CMP Vd in September 2017.

- 1.5.18 The concentrations of most inorganic contaminants were lower than the Lower Chemical Exceedance Level (LCEL) at all stations in September and October 2017, except Arsenic, Copper and Silver in September 2017 and Arsenic in October 2017 (*Figures 11, 12, 15 and 16 of Annex C*). In September 2017, concentrations of Arsenic exceeded the LCEL at Active Pit station ESC-NPAB while concentrations of Copper and Silver exceeded the LCEL at Active Pit station ESC-NPAA (*Figures 11 and 12 of Annex C*). In October 2017, concentrations of Arsenic exceeded the LCEL at Active Pit station ESC-NPAB (*Figure 15 of Annex C*).

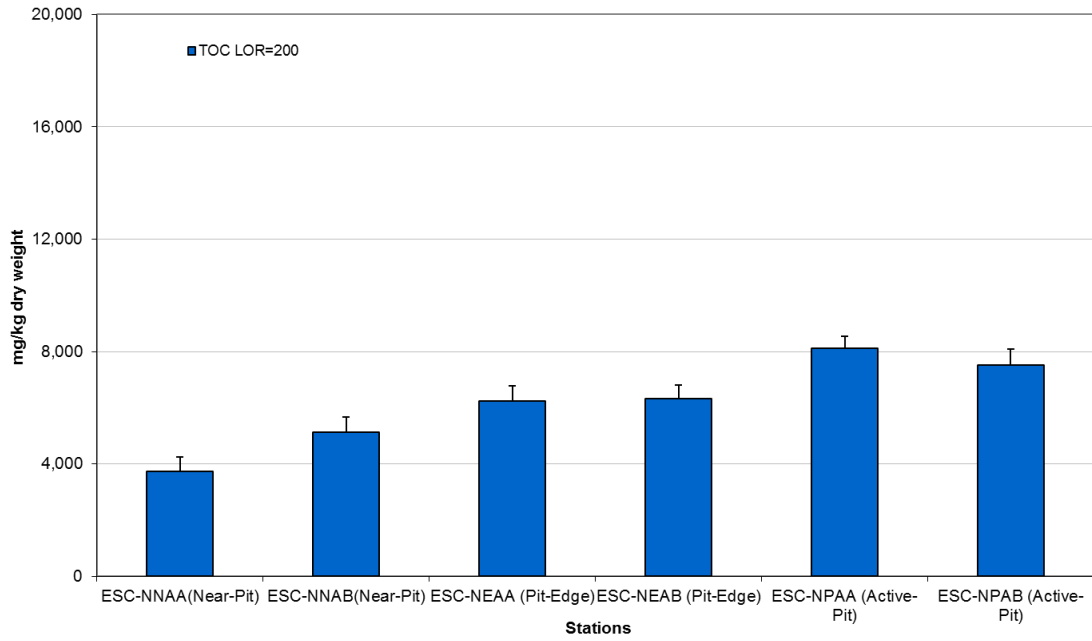
Figure 13: Concentration of Total Organic Carbon (TOC) (mg/kg dry weight; mean +SD) in sediment samples collected from Pit Specific Sediment Chemistry Monitoring for ESC CMP Vd in September 2017.

- 1.5.21 For organic contaminants, the concentrations of Total Organic Carbon (TOC) were similar in September and October 2017 (*Figures 13 and 17 of Annex C*). The concentrations of Tributyltin (TBT) were higher at Active Pit station ESC-NPAA in September and October 2017 (*Figures 14 and 18 of Annex C*). Low and High Molecular Weight Polycyclic Aromatic Hydrocarbons (PAHs), Total Polychlorinated Biphenyls (PCBs), Total dichloro-diphenyl-trichloroethane (DDT) and 4,4'-dichlorodipenyldichloroethylene (DDE) concentrations were below the limit of reporting at all stations in September and October 2017.

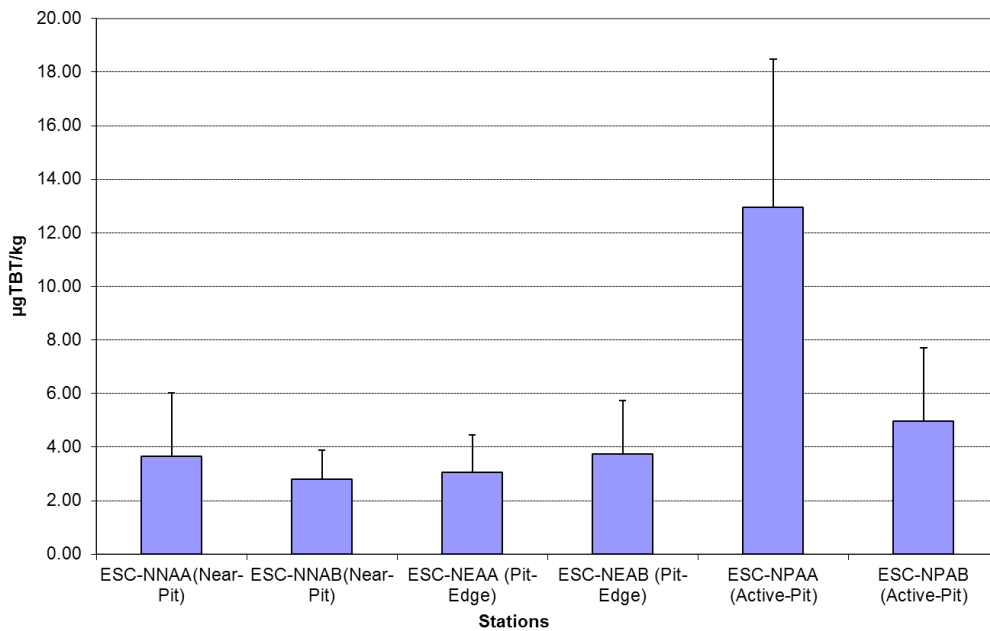
Figure 14: Concentration of Tributyltin (TBT) (µg TBT/kg; mean +SD) in sediment samples collected from Pit Specific Sediment Chemistry Monitoring for ESC CMP Vd in September 2017.

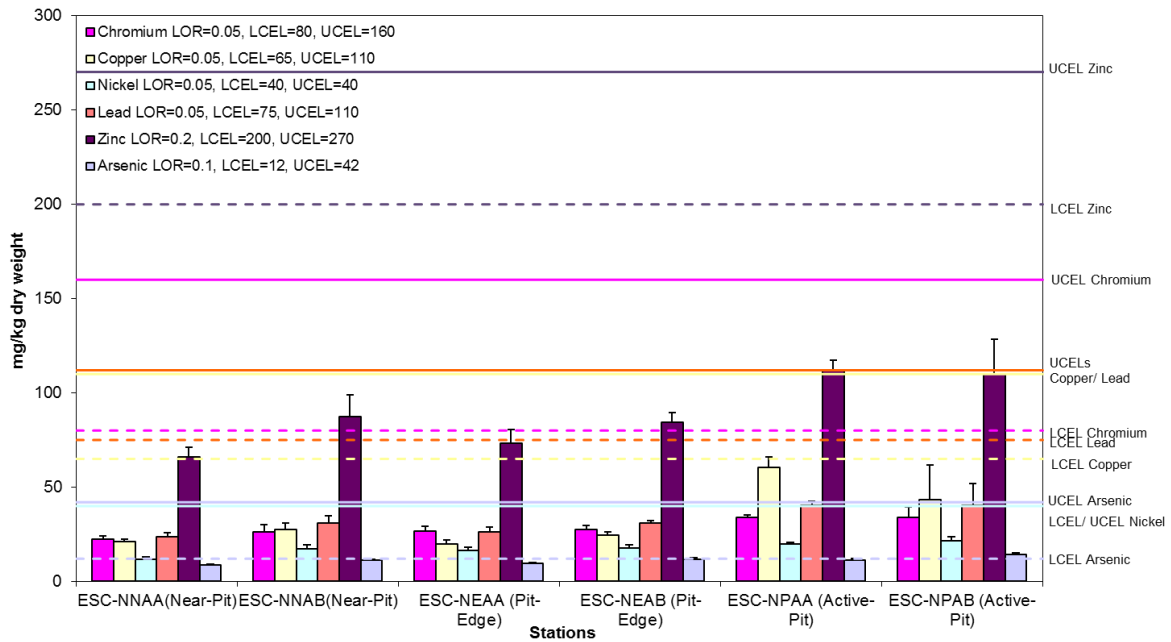
Figure 15: Concentration of Metals and Metalloid (Cr, Cu, Ni, Pb, Zn, As; mg/kg dry weight; mean +SD) in sediment samples collected from Pit Specific Sediment Chemistry Monitoring for ESC CMP Vd in October 2017.

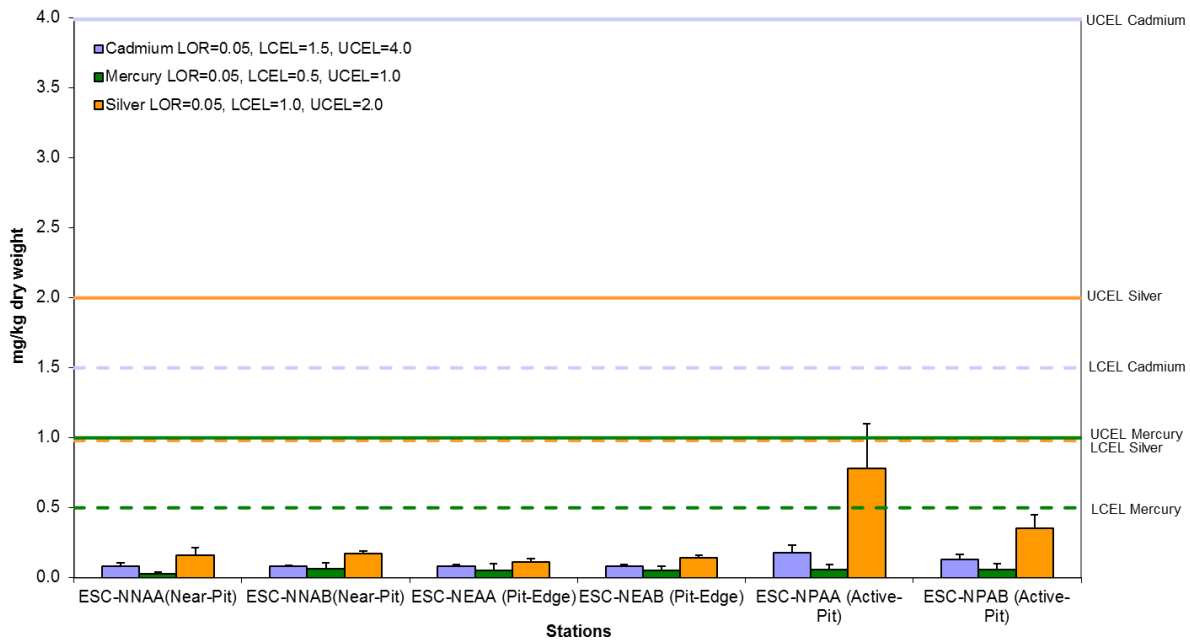
Figure 16: Concentration of Metals (Cd, Hg, Ag; mg/kg dry weight; mean +SD) in sediment samples collected from Pit Specific Sediment Chemistry Monitoring for ESC CMP Vd in October 2017.

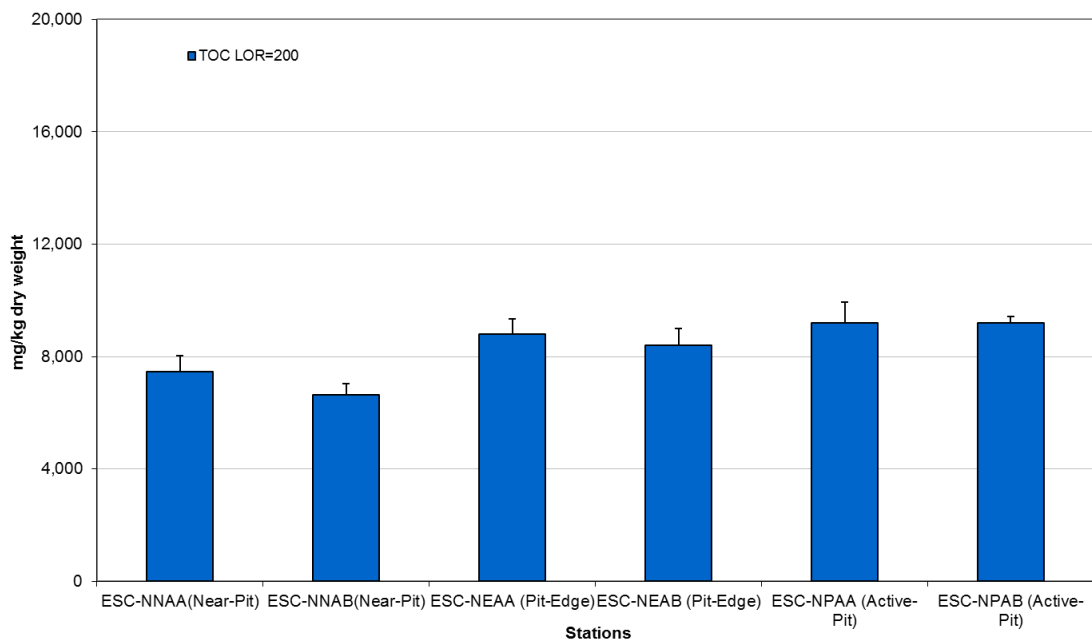
Figure 17: Concentration of Total Organic Carbon (TOC) (mg/kg dry weight; mean +SD) in sediment samples collected from Pit Specific Sediment Chemistry Monitoring for ESC CMP Vd in October 2017.

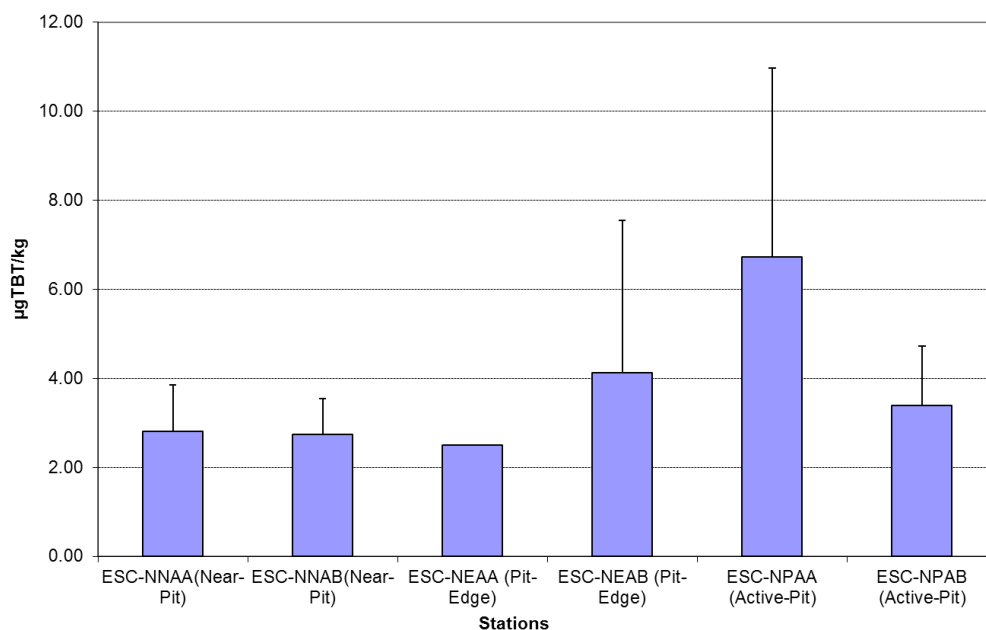
Figure 18: Concentration of Tributyltin (TBT) (µg TBT/kg; mean +SD) in sediment samples collected from Pit Specific Sediment Chemistry Monitoring for ESC CMP Vd in October 2017.

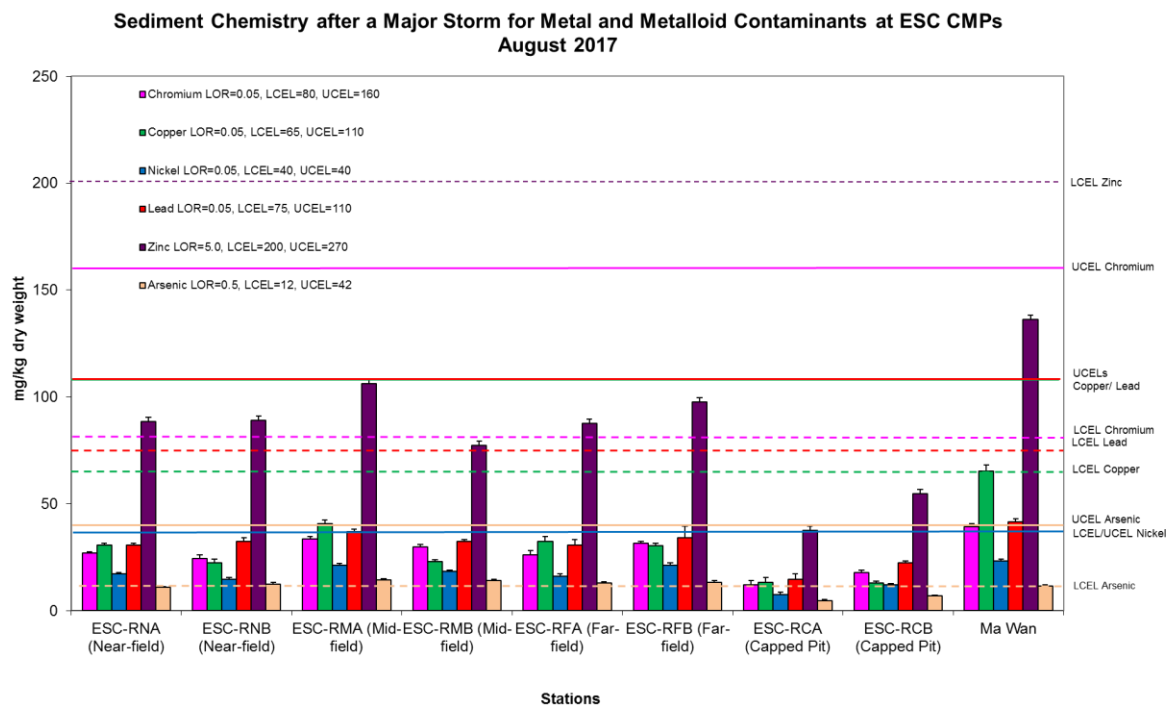
Figure 19: Concentration of Metals (Cr, Cu, Ni, Pb, Zn, As; mean +SD) in sediment samples collected from Sediment Chemistry after a Major Storm for ESC CMPs in August 2017.

1.5.25 Analyses of results for the *Sediment Chemistry after a Major Storm* indicated that the concentrations of most inorganic contaminants were below the LCEL, except Arsenic at Near-field station ESC-RNB, Mid-field stations ESC-RMA and ESC-RMB, Far-field stations ESC-RFA and ESC-RFB and Copper at Ma Wan station in August 2017 (Figures 19 and 20 of Annex C). In October 2017, the concentrations of most inorganic contaminants were below the LCEL, except Arsenic at Mid-field stations ESC-RMA and ESC-RMB and Far-field station ESC-RFB (Figures 21 and 22 of Annex C).

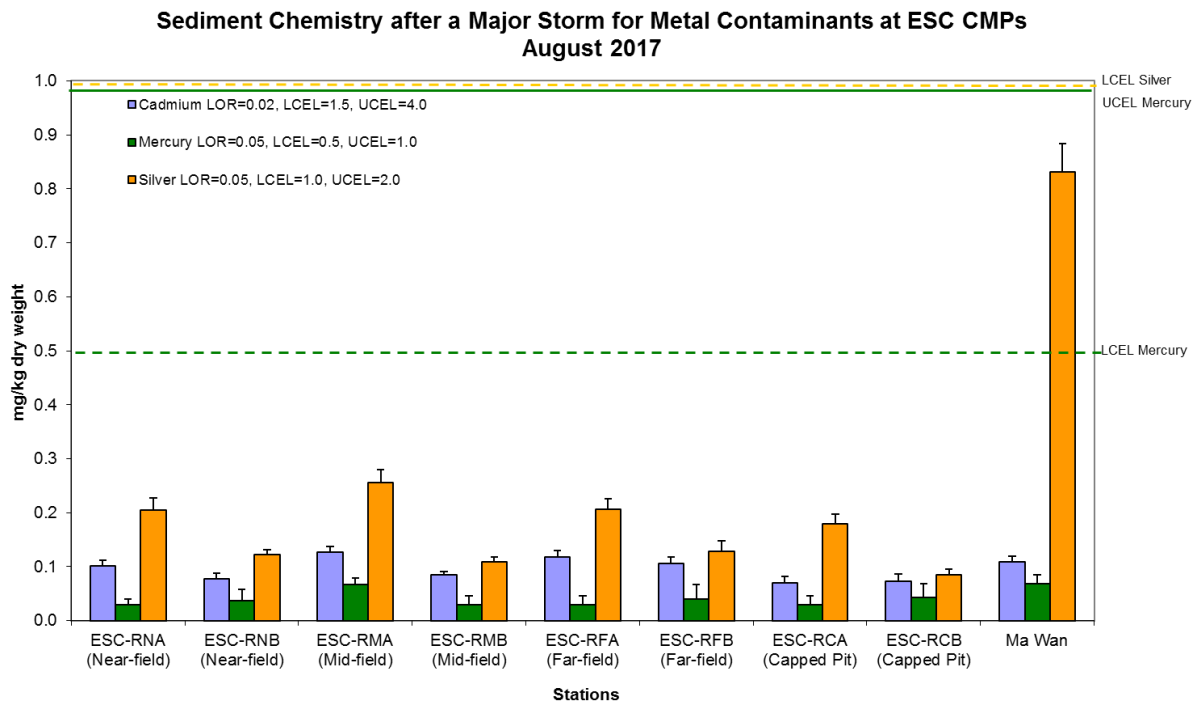
Figure 20: Concentration of Metals (Cd, Hg, Ag; mean +SD) in sediment samples collected from Sediment Chemistry after a Major Storm for ESC CMPs in August 2017.

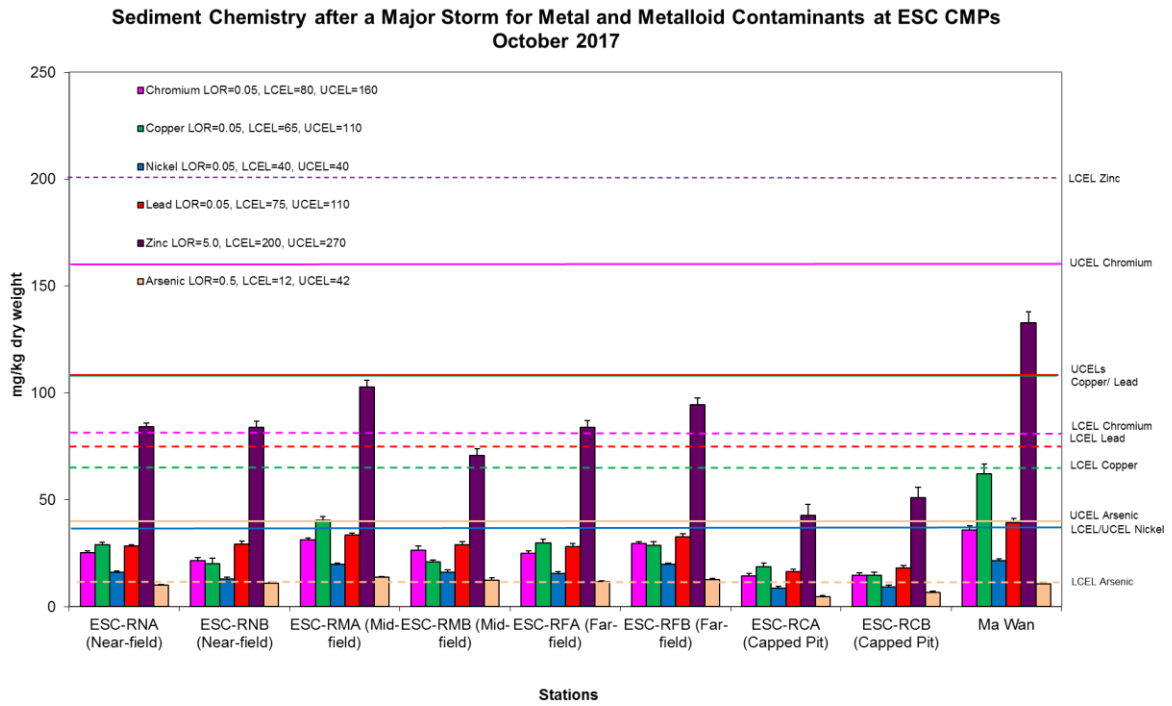
Figure 21: Concentration of Metals (Cr, Cu, Ni, Pb, Zn, As; mean +SD) in sediment samples collected from Sediment Chemistry after a Major Storm for ESC CMPs in October 2017.

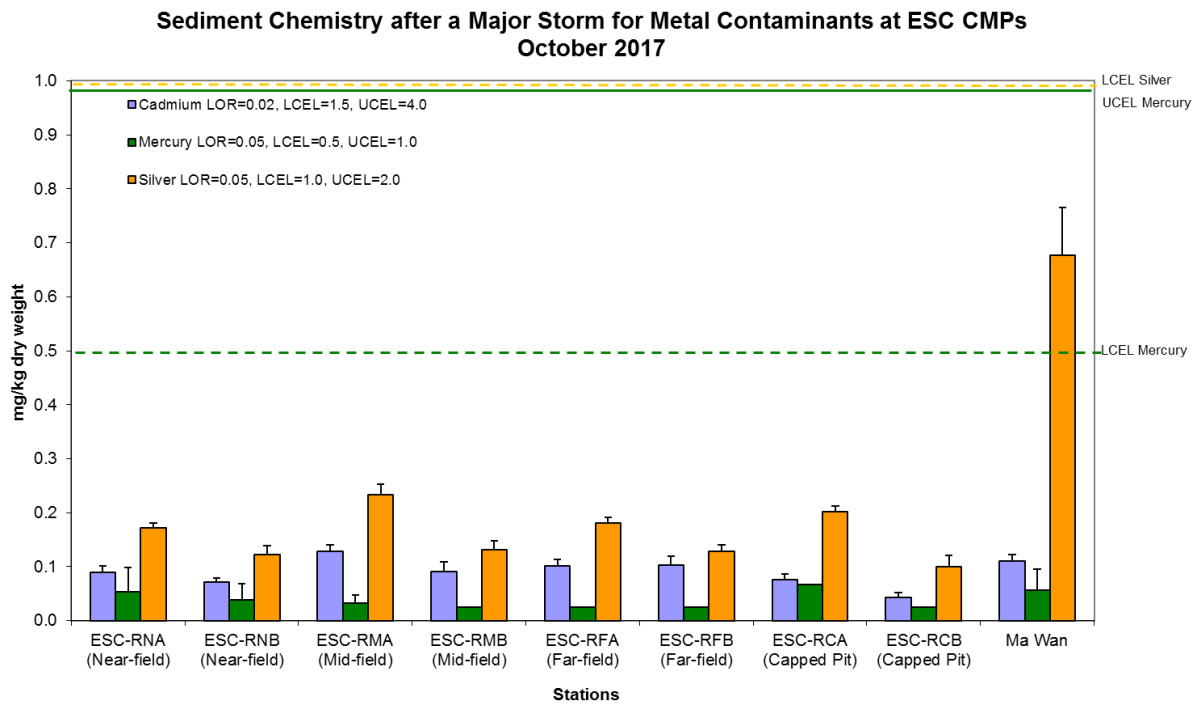
Figure 22: Concentration of Metals (Cd, Hg, Ag; mean +SD) in sediment samples collected from Sediment Chemistry after a Major Storm for ESC CMPs in October 2017.

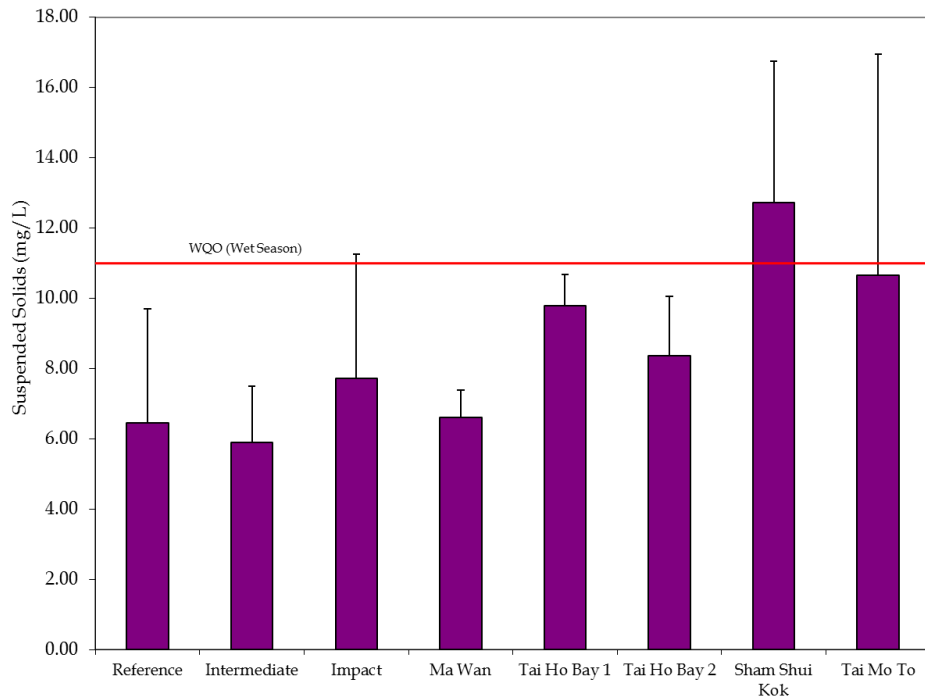
Figure 23: Levels of Suspended Solids (mg/L; mean +SD) recorded from Water Quality Monitoring during Capping of SB CMP 2 in September 2017

- 1.6.4 The concentrations of SS were higher than the WQO (11.0 mg/L for wet season) at Sham Shui Kok station in September 2017 (*Table B6 of Annex B; Figure 23 of Annex C*). However, levels of SS at all stations complied with the Action and Limit Levels (*Tables B5 and B6 of Annex B*).

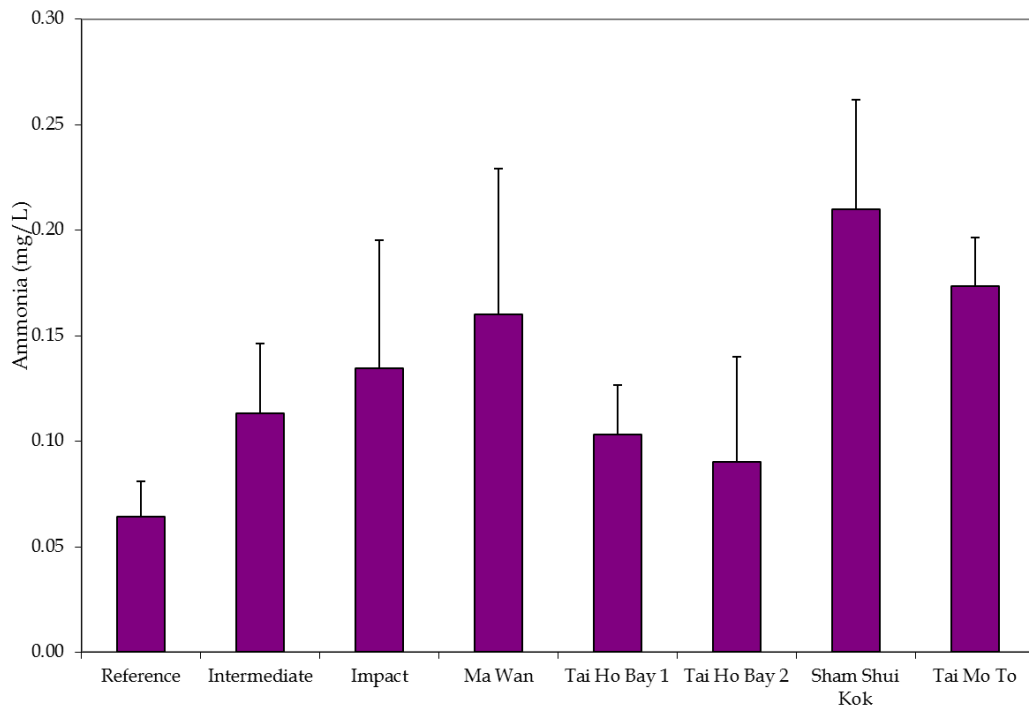
Figure 24: Level of Ammonia (mg/L; mean + SD) recorded from Water Quality Monitoring during Capping for SB CMP 2 in September 2017.

- 1.6.5 For nutrients, concentrations of NH₃-N were lower at Reference, Tai Ho Bay 1 and Tai Ho Bay 2 stations (*Table B6 of Annex B; Figure 24 of Annex C*). The levels of TIN at most stations were higher than WQO of 0.5 mg/L, except for Ma Wan station (*Table B6 of Annex B; Figure 25 of Annex C*). As discussed in *Section 1.5.13*, the North Western WCZ has historically experienced higher levels of TIN⁽¹⁾. The exceedances of TIN WQO at these stations are unlikely to be caused by the capping operation at CMP 2. Levels of BOD₅ were higher at Tai Ho Bay 2 station in September 2017 (*Table B6 of Annex B; Figure 26 of Annex C*).

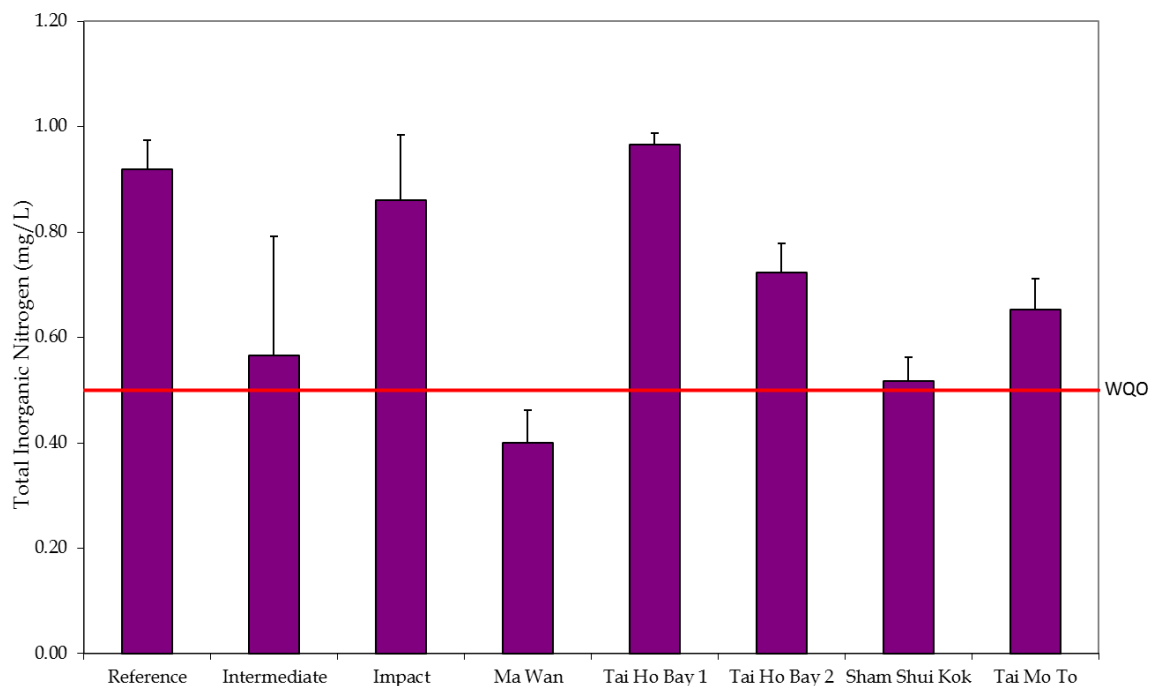
Figure 25: Level of TIN (mg/L; mean + SD) recorded from Water Quality Monitoring during Capping for SB CMP 2 in September 2017

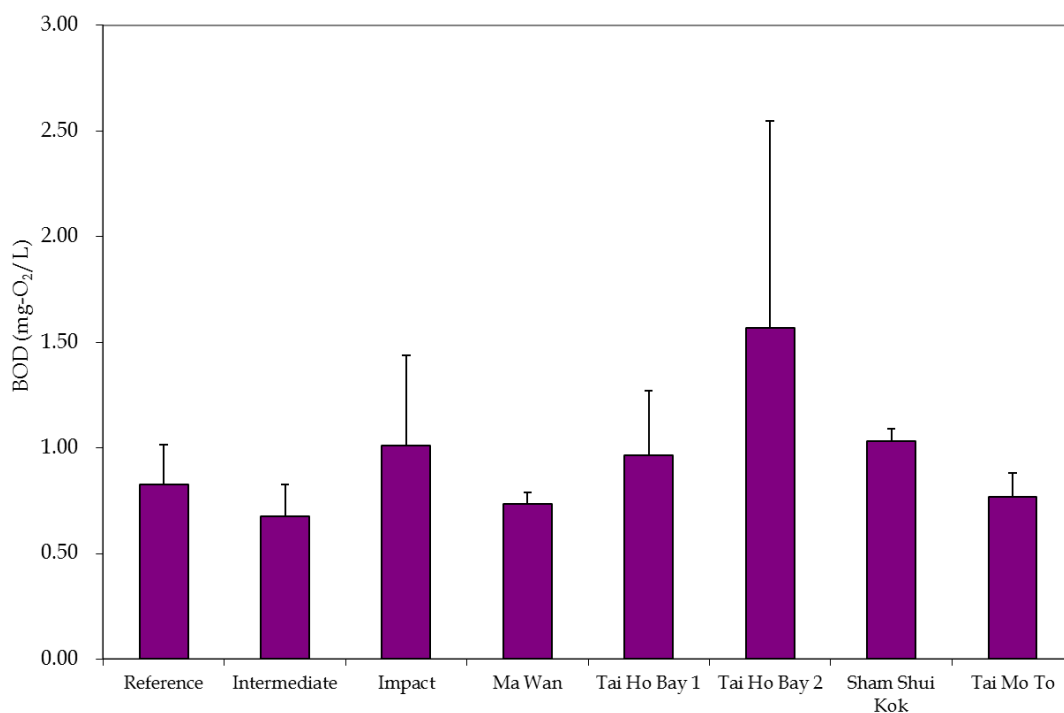
Figure 26: Level of BOD₅ (mg-O₂/L; mean + SD) recorded from Water Quality Monitoring during Capping for SB CMP 2 in September 2017.
