Entrusted Portion of Widening of Tolo Highway / Fanling Highway between Island House Interchange and Fanling Stage 2

Monthly EM&A Report

December 2013

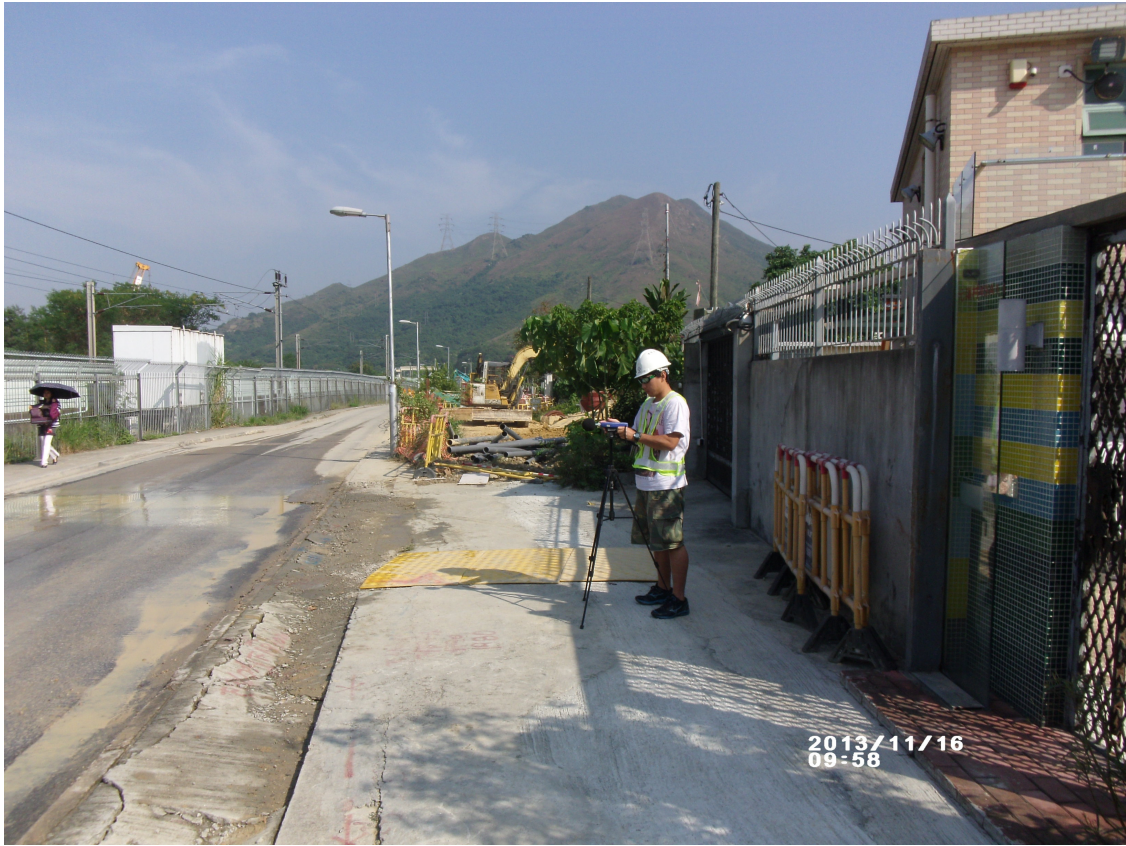
Date: 16 November 2013

Date	16 November 2013
Time	-
Monitoring Location	SR77
Parameter	24 hour TSP
Action / Limit Levels	Action Level: 170.3 µg/m ³ Limit Level: 260 µg/m ³
Measured Level	220 µg/m ³ (Action level being exceeded)
Possible reason for the exceedance	<p>It was noticed that there were construction works being undertaken by another Contractor which then occurred in very close proximity (within 1m) to the High Volume Sampler (HVS) of the air quality monitoring station at SR77 (refer to the attached photo).</p> <p>Such works mainly involved excavation of earth materials, operation of excavator (with exhaust emission), handling and moving of earth materials, etc. As the ET staff also observed there was no watering or other dust dampening mitigation measures being implemented, it is anticipated to have caused dusty environment that may lead high TSP levels as have been measured by the nearby HVS.</p> <p>On the other hand, as there were no records of large scale excavation and earth movement works carried out for the Entrusted Works. Only the extension of box culverts were undertaken in November 2013, which were at a much farther distance from the air quality monitoring station at SR77 (refer to the attached location plan showing the works activities of the entrusted portion in November 2013).</p> <p>To conclude, the exceedance was unlikely due to the project.</p>

Action taken / to be taken	As the exceedance was non-projected, no further investigation and specific remedial measure(s) would be recommended for the Entrusted Works.
Remarks	-

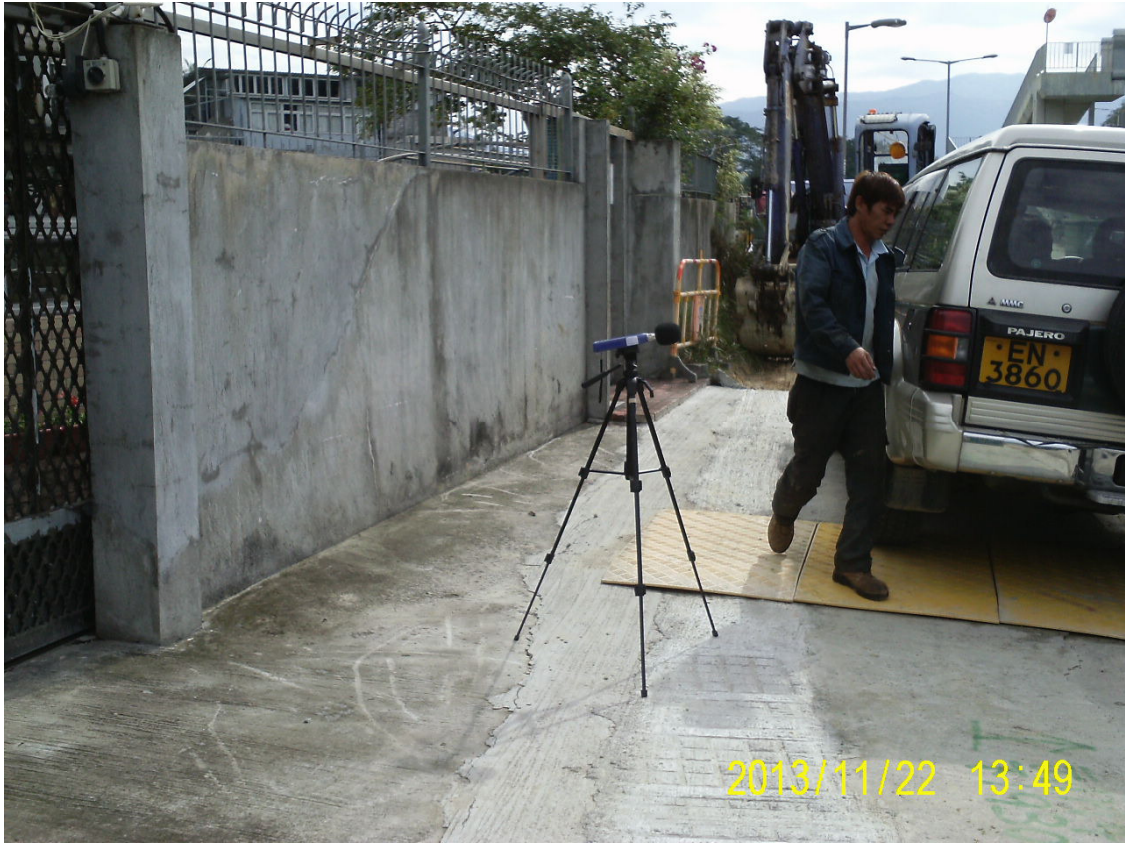
Date: 22 November 2013

Date	22 November 2013
Time	-
Monitoring Location	SR77
Parameter	24 hour TSP
Action / Limit Levels	Action Level: 170.3 µg/m ³ Limit Level: 260 µg/m ³
Measured Level	182.9 µg/m ³ (Action level being exceeded)
Possible reason for the exceedance	<p>It was noticed that there were construction works being undertaken by another Contractor which then occurred in very close proximity (within 1m) to the High Volume Sampler (HVS) of the air quality monitoring station at SR77 (refer to the attached photo).</p> <p>Such works mainly involved excavation of earth materials, operation of excavator (with exhaust emission), handling and moving of earth materials, etc. As the ET staff also observed there was no watering or other dust dampening mitigation measures being implemented, it is anticipated to have caused dusty environment that may lead high TSP levels as have been measured by the nearby HVS.</p> <p>On the other hand, as there were no records of large scale excavation and earth movement works carried out for the Entrusted Works. Only the extension of box culverts were undertaken in November 2013, which were at a much farther distance from the air quality monitoring station at SR77 (refer to the attached location plan showing the works activities of the entrusted portion in November 2013).</p> <p>To conclude, the exceedance was unlikely due to the project.</p>

Action taken / to be taken	As the exceedance was non-projected, no further investigation and specific remedial measure(s) would be recommended for the Entrusted Works.
Remarks	-

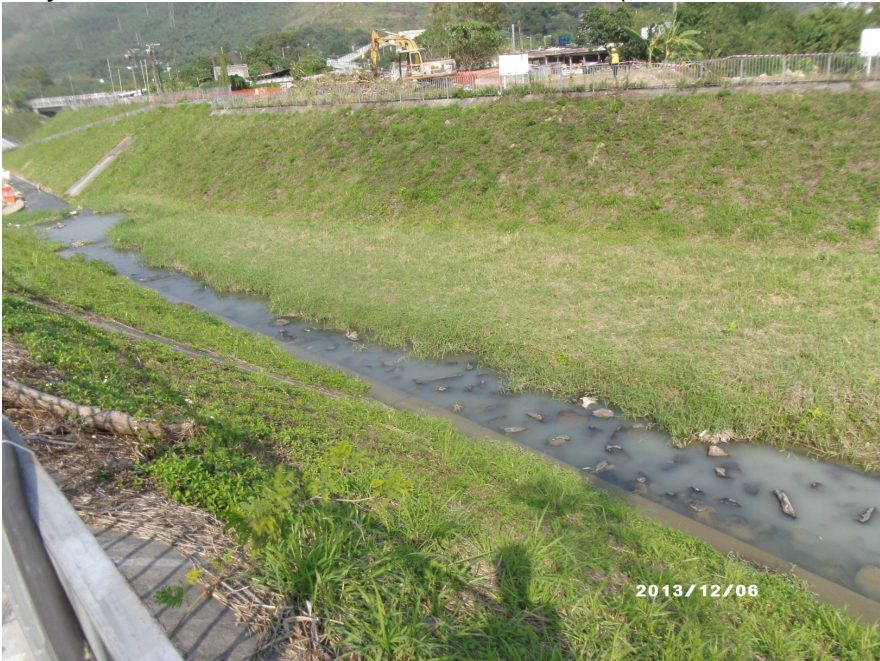
Silty water observed at Control Station C3b. (Date: 6 December 2013)

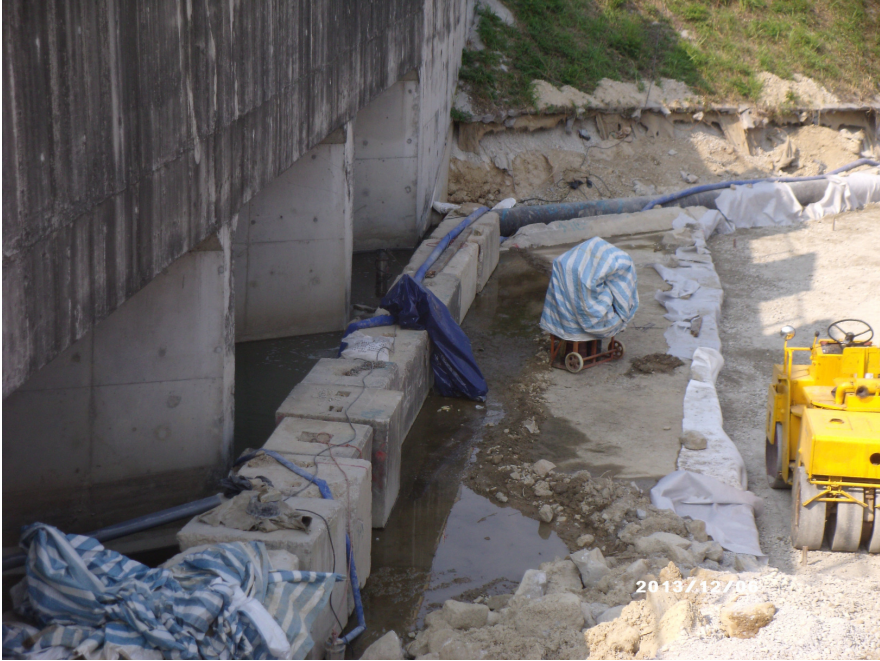
No leakage observed at Box Culvert ID4. (Date: 6 December 2013)

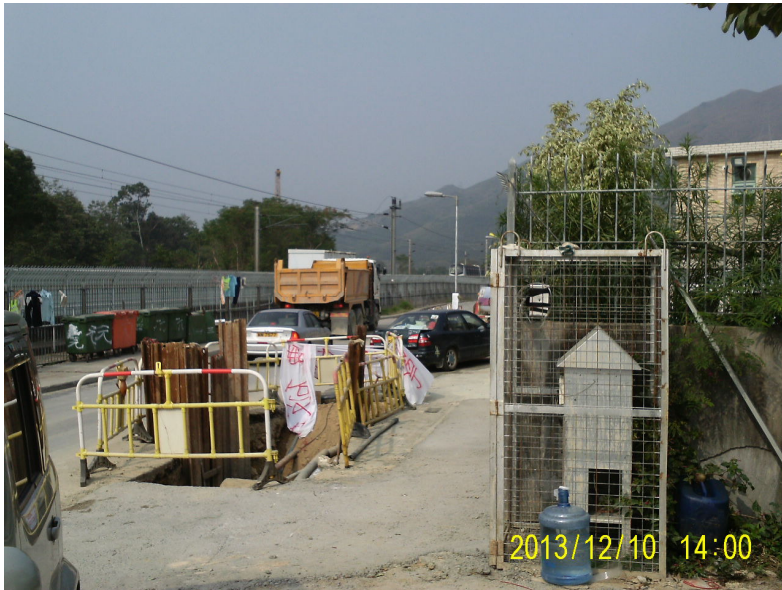
Construction works observed within close proximity of SR77 (Date: 10 December 2013)

Action taken / to be taken	<p>As the exceedance was non-project related, no further investigation and specific remedial measure(s) would be recommended for the Entrusted Works.</p> <p>Nevertheless, the following mitigation measures had been implemented on-site for dust suppression:</p> <ol style="list-style-type: none"> 1. Exposed slopes near the river were covered with impervious sheets; 2. Any open stockpile of construction materials were covered with impervious sheet; 3. Sufficient watering was applied along the haul road.
Remarks	-

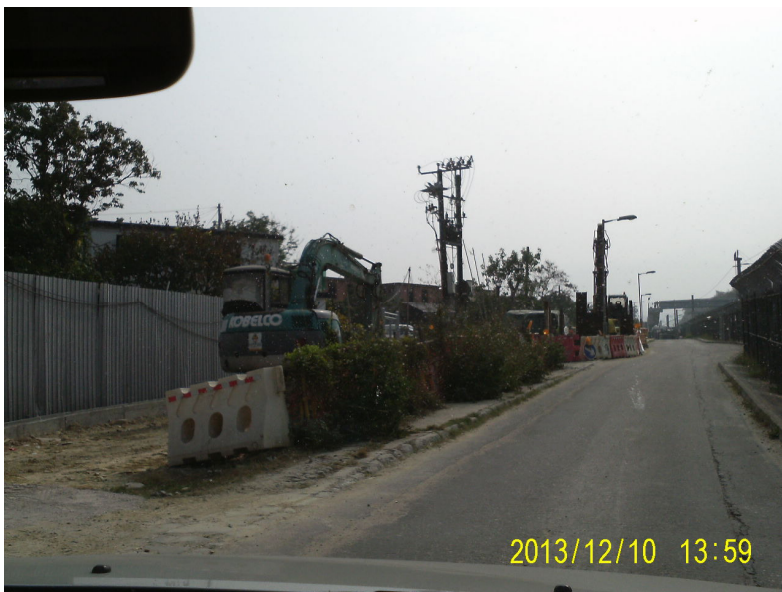
Construction works observed within close proximity of SR77 (Date: 10 December 2013)

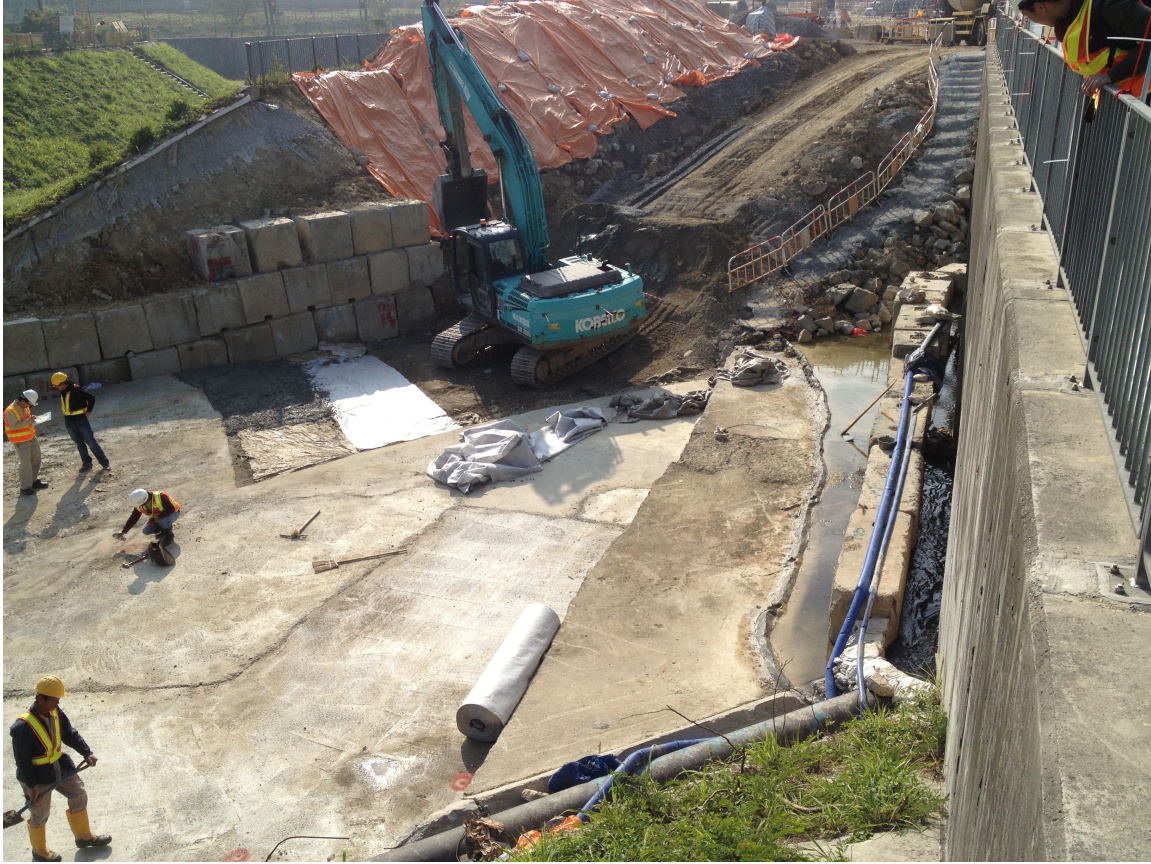
Water leakage has been remedied. No more river water enters the construction site. (Date: 23 December 2013)

Date	18 December 2013
Time	12:55
Monitoring Location	I5
Parameter	Suspended Solids
Action / Limit Levels	Action Level: 42.6 mg/L or 120% of upstream control station's SS of the same day (i.e. 17.4mg/L) Limit Level: 46.8 mg/L or 130% of upstream control station's SS of the same day (i.e. 18.8mg/L)
Measured Level	28mg/L (Limit level being exceeded – 130% of C3a)
Possible reason for the exceedance	The ET weekly visit was conducted on 18 December which identified the leakage of diverted river water through the concrete blocks at Box Culvert ID4 into the works site then downstream into the river with silt-laden site runoff.
Action taken / to be taken	Contractor has been advised to fill up the leakage and strengthen it to avoid leakage again. The ET weekly visit conducted on 23 December 2013 confirmed that the leakage of the diverted river water has been remedied. (Refer to the attached photo) The water quality monitoring conducted on 20 December 2013 showed the Suspended Solids level at I5 has dropped to below Action Limit. No further action(s) would be required.

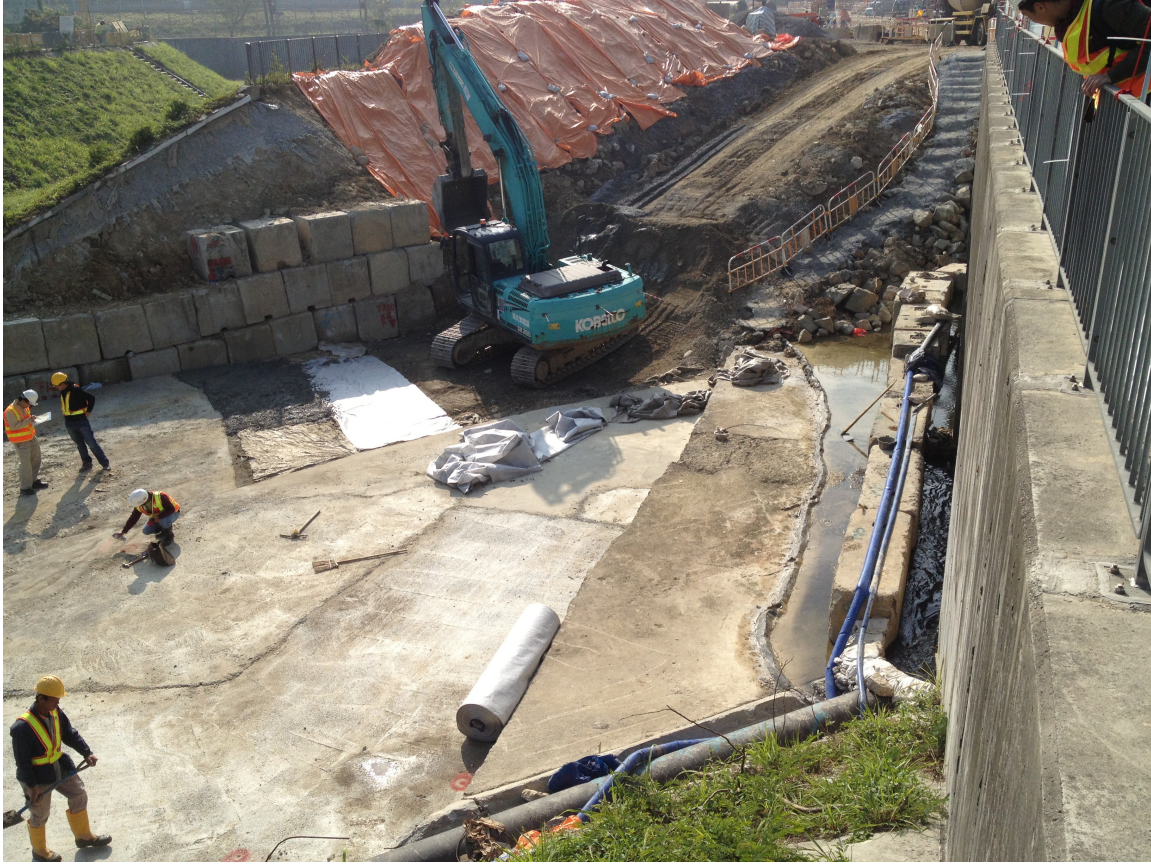
Water leakage has been remedied. No more river water enters the construction site. (Date: 23 December 2013)

Date	18 December 2013
Time	12:55
Monitoring Location	I5
Parameter	Turbidity
Action / Limit Levels	81.9 NTU or 120% of upstream control station's Tby of the same day (i.e. 25.2NTU) 91.9 NTU or 130% of upstream control station's Tby of the same day (i.e. 27.3NTU)
Measured Level	48.7NTU (Limit level being exceeded – 130% of C3a)
Possible reason for the exceedance	The ET weekly visit was conducted on 18 December which identified the leakage of diverted river water through the concrete blocks at Box Culvert ID4 into the works site then downstream into the river with silt-laden site runoff.
Action taken / to be taken	Contractor has been advised to fill up the leakage and strengthen it to avoid leakage again. The ET weekly visit conducted on 23 December 2013 confirmed that the leakage of the diverted river water has been remedied. (Refer to the attached photo) The water quality monitoring conducted on 20 December 2013 showed the Turbidity level at I5 has dropped to below Action Limit. No further action(s) would be required.

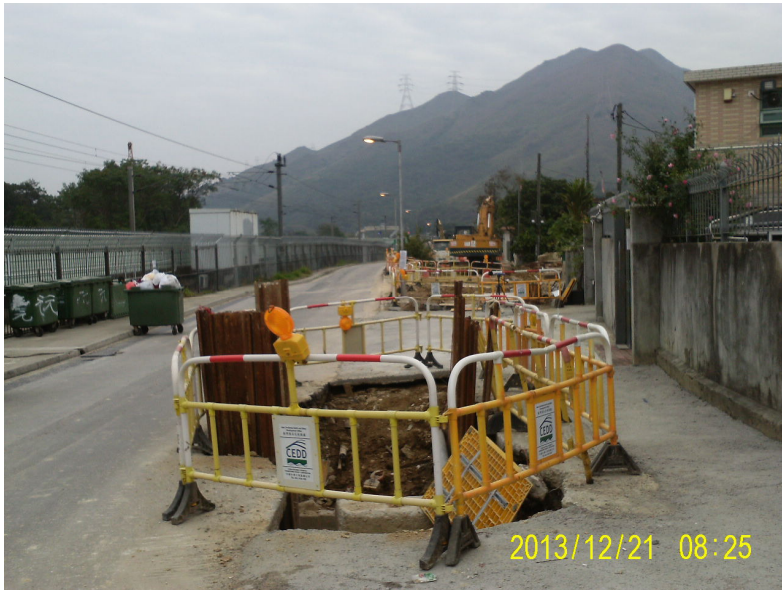
Construction works observed within close proximity of SR77 (Date: 21 December 2013)

Action taken / to be taken	<p>As the exceedance was non-project related, no further investigation and specific remedial measure(s) would be recommended for the Entrusted Works.</p> <p>Nevertheless, the following mitigation measures had been implemented on-site for dust suppression:</p> <ol style="list-style-type: none"> 1. Exposed slopes near the river were covered with impervious sheets; 2. Any open stockpile of construction materials were covered with impervious sheet; 3. Sufficient watering was applied along the haul road.
Remarks	-

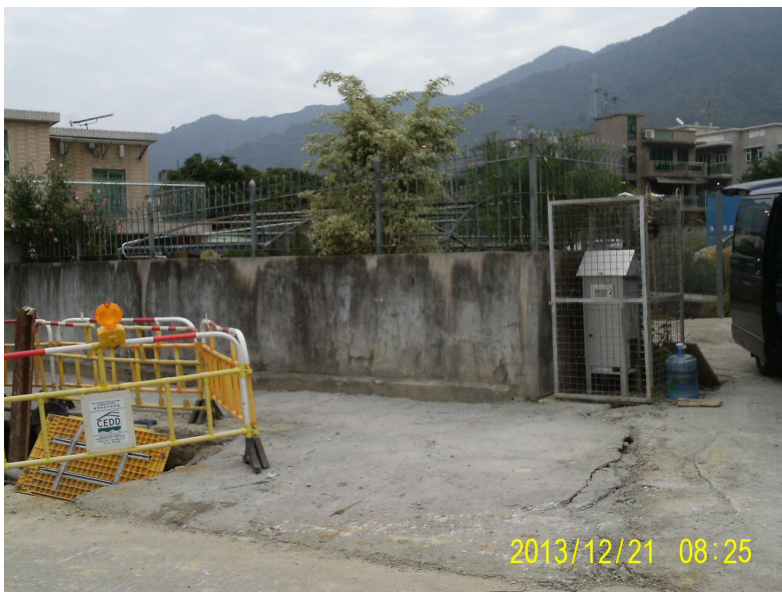
Construction works observed within close proximity of SR77 (Date: 21 December 2013)

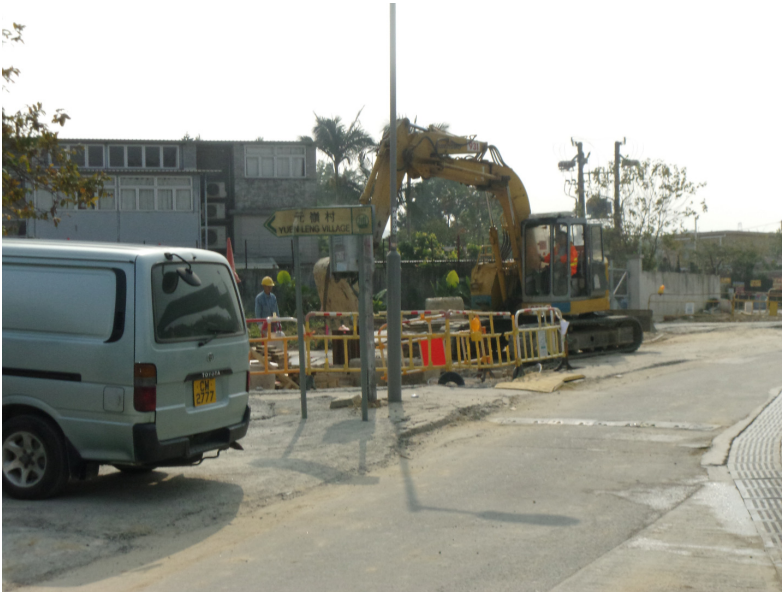
Construction works observed within close proximity of SR77 (Date: 27 December 2013)

Action taken / to be taken	<p>As the exceedance was non-project related, no further investigation and specific remedial measure(s) would be recommended for the Entrusted Works.</p> <p>Nevertheless, the following mitigation measures had been implemented on-site for dust suppression:</p> <ol style="list-style-type: none"> 1. Exposed slopes near the river were covered with impervious sheets; 2. Any open stockpile of construction materials were covered with impervious sheet; 3. Sufficient watering was applied along the haul road.
Remarks	-

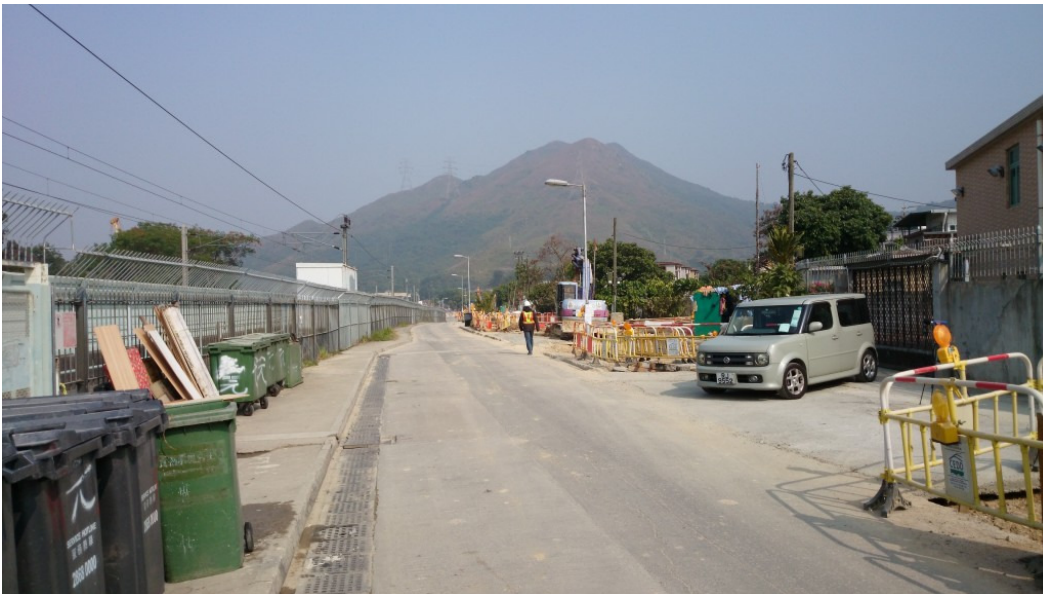
Construction works observed within close proximity of SR77 (Date: 27 December 2013)

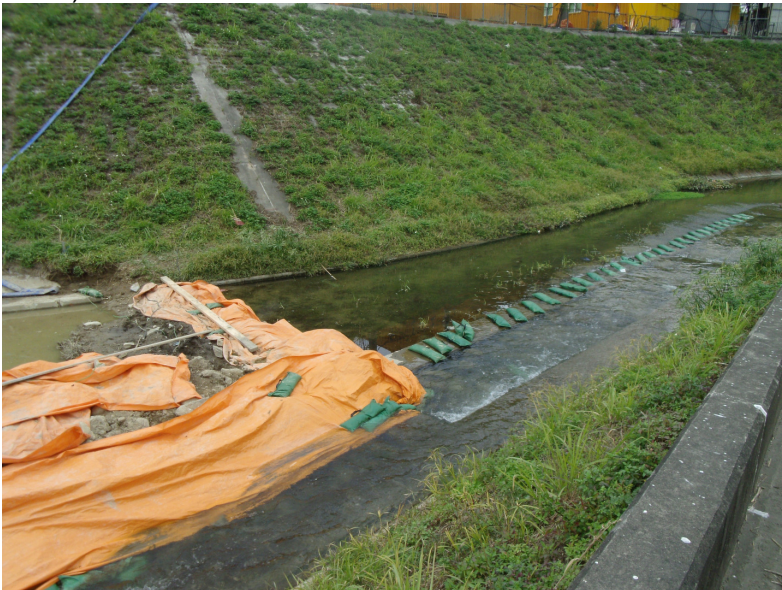
The bund is being created to protect the river from site runoff. (Date: 3 January 2014)

Action taken / to be taken	<p>The following mitigation measures were implemented by the Contractor accordingly:</p> <p>The Constructor has built a river diversion structure at the river channel to protect the river from potential site runoff from future construction works, and the construction of the bund has been completed (refer to attached photos).</p> <p>The Contractor has been reminded to pay attention to the accidental site runoff, including constructing additional protection structure to minimize the risk of site runoff.</p> <p>The water quality monitoring conducted on 30 December 2013 showed the Turbidity level at I5 has dropped to below Action Limit.</p> <p>No further action(s) is required.</p>
Remarks	-
