Highways Department

**Agreement No. HMW
5/2009 (EP) Traffic
Improvements to Tuen
Mun Road Town Centre
Section**

Monthly Environmental
Monitoring and Audit
Report - November 2012

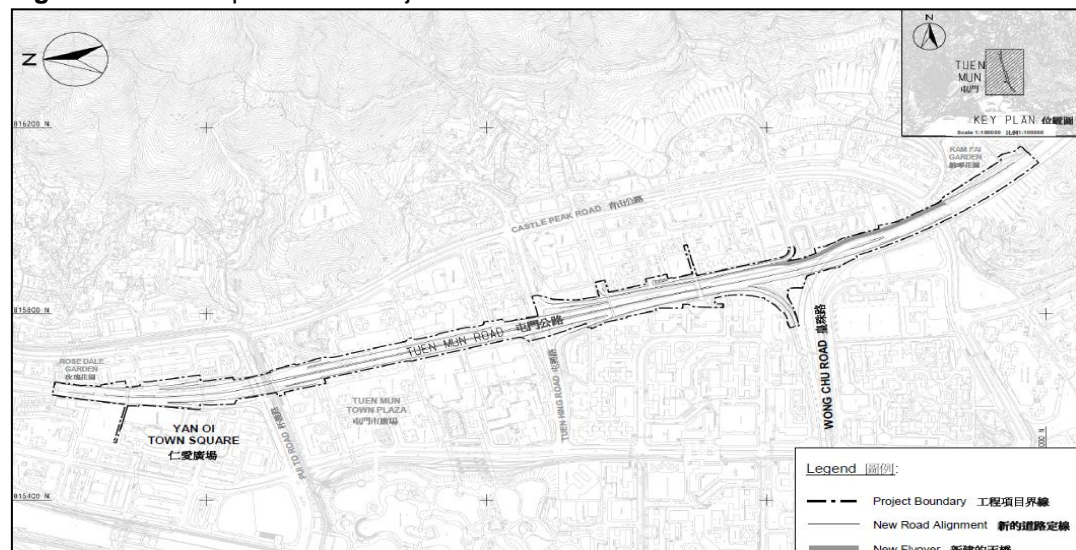
Figure 1.1 Site plan of the Project

Locations	Major Works Undertaken
All area	Footbridge construction and demolition, noise barrier construction; piling works, underground utilities and drainage diversion, Erection of noise barrier/ enclosure steelworks

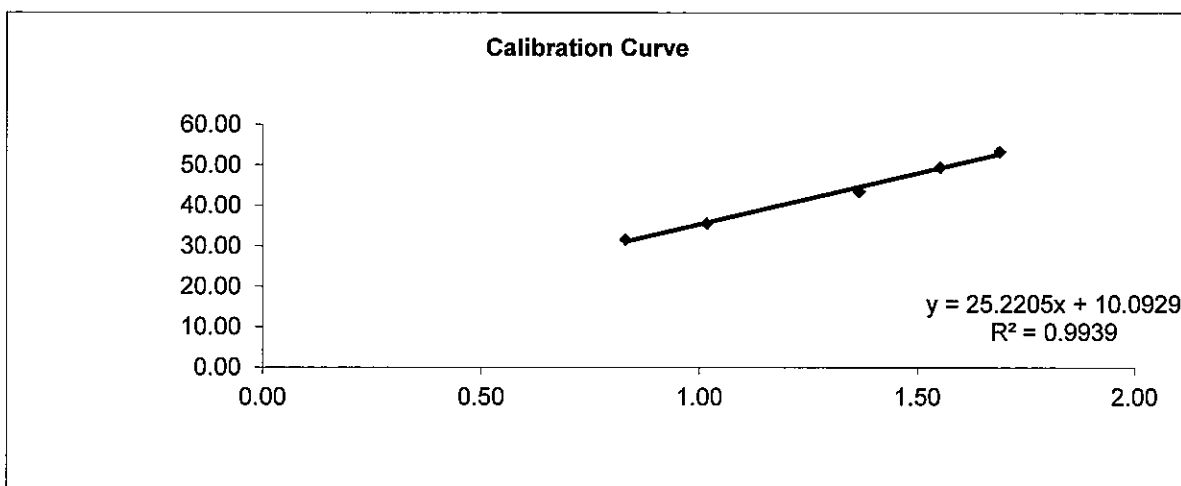
Calibration date	17-Sep-12	Barometric pressure	753 mm Hg
Next Calibration date	16-Nov-12	Temperature (°C)	30 °C
Sampler location	AW Boon Haw Secondary School	Temperature (K)	303 K
Sampler model	TE-5170	P _{std}	760 mm Hg
Sampler serial number	521	T _{std}	298 K
Calibrator model		GMW-2535	
Calibrator serial number		1378	
Slope of the standard curve, m _s		1.99405	
Intercept of the standard curve, b _s		-0.00397

Resistance Plate No.	Manometer Reading (inch H ₂ O)	Flow Recorder Reading (CFM)	Calculated Q _{std} (m ³ /min)	Continuous Flow Recorder Reading IC (CFM)
5	2.80	32.00	0.83	31.59
7	4.20	36.00	1.02	35.54
10	7.60	44.00	1.37	43.43
13	9.80	50.00	1.55	49.36
18	11.60	54.00	1.69	53.31

Linear Regression
 Sampler slope (m) : **25.2205**
 Sampler intercept (b) : **10.0929**
 Correlation coefficient (R²) : **0.9939**

Correlation coefficient is greater than 0.9900 and the calibration result is accepted.

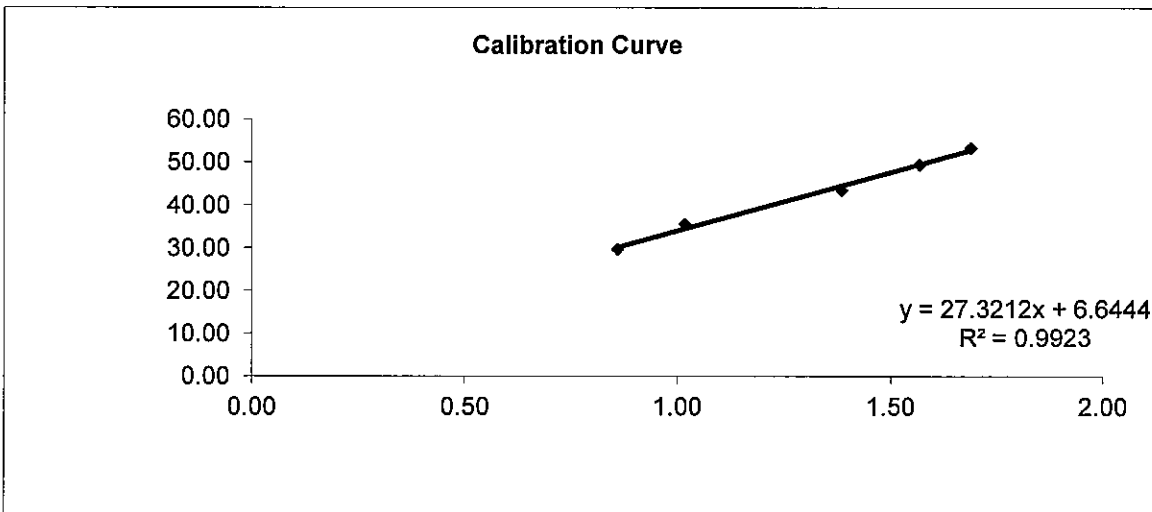
Calibration date	17-Sep-12	Barometric pressure	753 mm Hg
Next Calibration date	16-Nov-12	Temperature (°C)	30 °C
Sampler location	Wu Siu Kui Primary School	Temperature (K)	303 K
Sampler model	TE-5170	P _{std}	760 mm Hg
Sampler serial number	505	T _{std}	298 K
Calibrator model	GMW-2535		
Calibrator serial number	1378		
Slope of the standard curve, m _s	1.99405		
Intercept of the standard curve, b _s	-0.00397

Resistance Plate No.	Manometer Reading (inch H ₂ O)	Flow Recorder Reading (CFM)	Calculated Q _{std} (m ³ /min)	Continuous Flow Recorder Reading IC (CFM)
5	3.00	30.00	0.86	29.61
7	4.20	36.00	1.02	35.54
10	7.80	44.00	1.38	43.43
13	10.00	50.00	1.57	49.36
18	11.60	54.00	1.69	53.31

Linear Regression
 Sampler slope (m) : **27.3212**
 Sampler intercept (b) : **6.6444**
 Correlation coefficient (R²) : **0.9923**

Correlation coefficient is greater than 0.9900 and the calibration result is accepted.

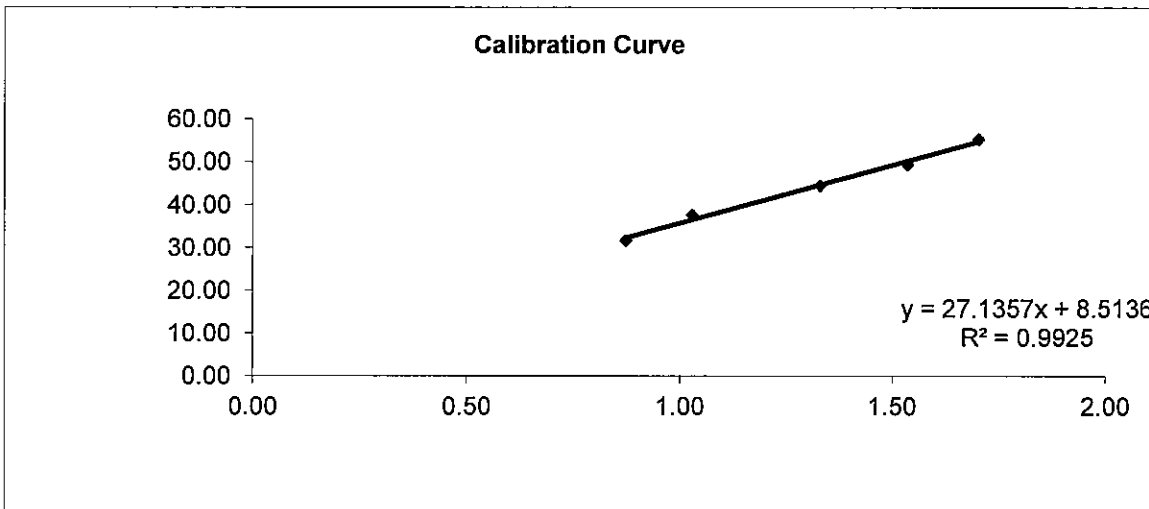
Calibration date	17-Sep-12	Barometric pressure	753 mm Hg
Next Calibration date	16-Nov-12	Temperature (°C)	30 °C
Sampler location	Tai Tung Pui Social Service	Temperature (K)	303 K
Sampler model	TE-5170	P _{std}	760 mm Hg
Sampler serial number	522	T _{std}	298 K
Calibrator model		GMW-2535	
Calibrator serial number		1378	
Slope of the standard curve, m _s		1.99405	
Intercept of the standard curve, b _s		-0.00397

Resistance Plate No.	Manometer Reading (inch H ₂ O)	Flow Recorder Reading (CFM)	Calculated Q _{std} (m ³ /min)	Continuous Flow Recorder Reading IC (CFM)
5	3.10	32.00	0.87	31.59
7	4.30	38.00	1.03	37.51
10	7.20	45.00	1.33	44.42
13	9.60	50.00	1.54	49.36
18	11.80	56.00	1.70	55.28

Linear Regression
 Sampler slope (m) : **27.1357**
 Sampler intercept (b) : **8.5136**
 Correlation coefficient (R²) : **0.9925**

Correlation coefficient is greater than 0.9900 and the calibration result is accepted.

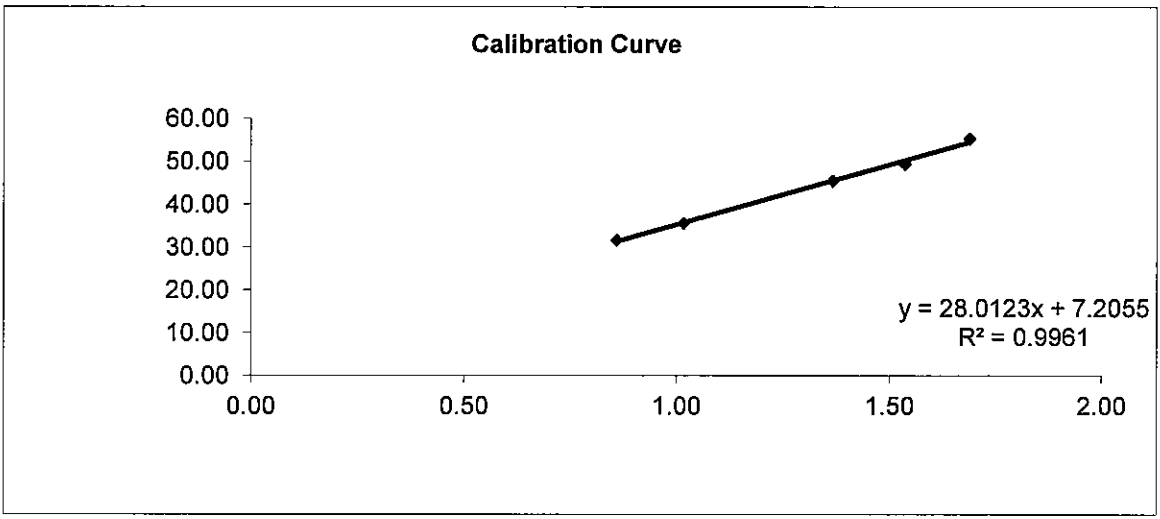
Calibration date	17-Sep-12	Barometric pressure	753 mm Hg
Next Calibration date	16-Nov-12	Temperature (°C)	30 °C
Sampler location	Choi Cheung Kok Secondary	Temperature (K)	303 K
Sampler model	Thermo Anderson	P _{std}	760 mm Hg
Sampler serial number	1278	T _{std}	298 K
Calibrator model	GMW-2535		
Calibrator serial number	1378		
Slope of the standard curve, m _s	1.99405		
Intercept of the standard curve, b _s	-0.00397

Resistance Plate No.	Manometer Reading (inch H ₂ O)	Flow Recorder Reading (CFM)	Calculated Q _{std} (m ³ /min)	Continuous Flow Recorder Reading IC (CFM)
5	3.00	32.00	0.86	31.59
7	4.20	36.00	1.02	35.54
10	7.60	46.00	1.37	45.41
13	9.60	50.00	1.54	49.36
18	11.60	56.00	1.69	55.28

Linear Regression
 Sampler slope (m) : **28.0123**
 Sampler intercept (b) : **7.2055**
 Correlation coefficient (R²) : **0.9961**

Correlation coefficient is greater than 0.9900 and the calibration result is accepted.

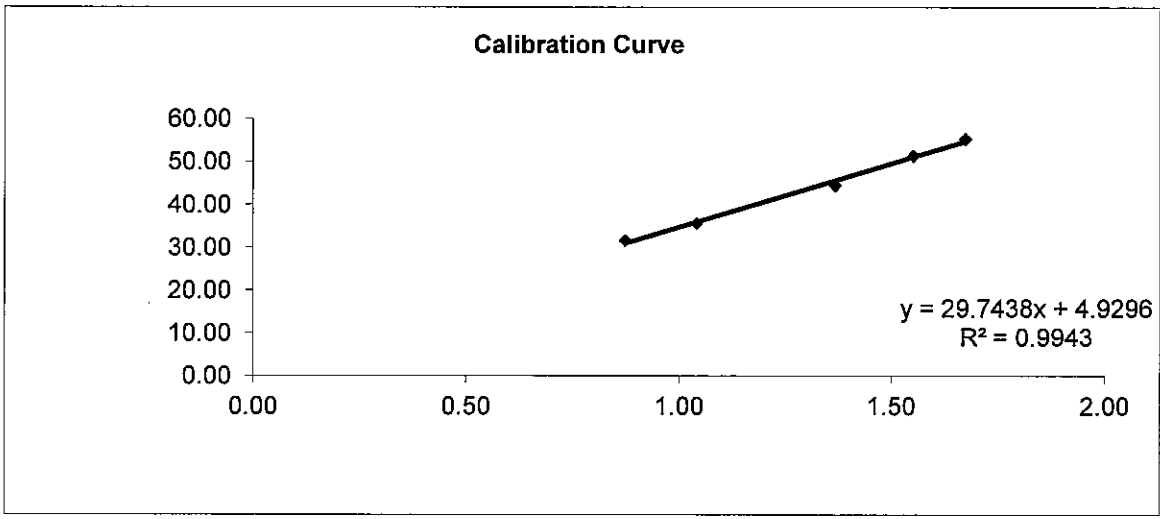
Calibration date	17-Sep-12	Barometric pressure	753 mm Hg
Next Calibration date	16-Nov-12	Temperature (°C)	30 °C
Sampler location	Tuen Mun Town Hall	Temperature (K)	303 K
Sampler model	TE-5170	P _{std}	760 mm Hg
Sampler serial number	516	T _{std}	298 K
Calibrator model	GMW-2535		
Calibrator serial number	1378		
Slope of the standard curve, m _s	1.99405		
Intercept of the standard curve, b _s	-0.00397

Resistance Plate No.	Manometer Reading (inch H ₂ O)	Flow Recorder Reading (CFM)	Calculated Q _{std} (m ³ /min)	Continuous Flow Recorder Reading IC (CFM)
5	3.10	32.00	0.87	31.59
7	4.40	36.00	1.04	35.54
10	7.60	45.00	1.37	44.42
13	9.80	52.00	1.55	51.33
18	11.40	56.00	1.67	55.28

Linear Regression
 Sampler slope (m) : **29.7438**
 Sampler intercept (b) : **4.9296**
 Correlation coefficient (R²) : **0.9943**

Correlation coefficient is greater than 0.9900 and the calibration result is accepted.

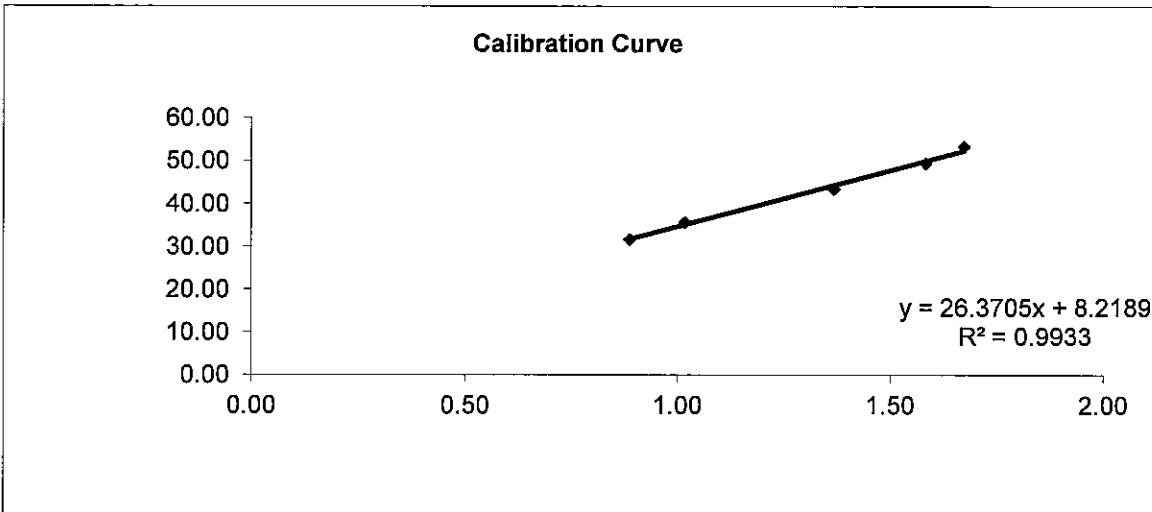
Calibration date	17-Sep-12	Barometric pressure	753 mm Hg
Next Calibration date	16-Nov-12	Temperature (°C)	30 °C
Sampler location	Yan Oi Tong	Temperature (K)	303 K
Sampler model	TE-5170	P _{std}	760 mm Hg
Sampler serial number	510	T _{std}	298 K
Calibrator model	GMW-2535		
Calibrator serial number	1378		
Slope of the standard curve, m _s	1.99405		
Intercept of the standard curve, b _s	-0.00397

Resistance Plate No.	Manometer Reading (inch H ₂ O)	Flow Recorder Reading (CFM)	Calculated Q _{std} (m ³ /min)	Continuous Flow Recorder Reading IC (CFM)
5	3.20	32.00	0.89	31.59
7	4.20	36.00	1.02	35.54
10	7.60	44.00	1.37	43.43
13	10.20	50.00	1.58	49.36
18	11.40	54.00	1.67	53.31

Linear Regression
 Sampler slope (m) : **26.3705**
 Sampler intercept (b) : **8.2189**
 Correlation coefficient (R²) : **0.9933**

Correlation coefficient is greater than 0.9900 and the calibration result is accepted.

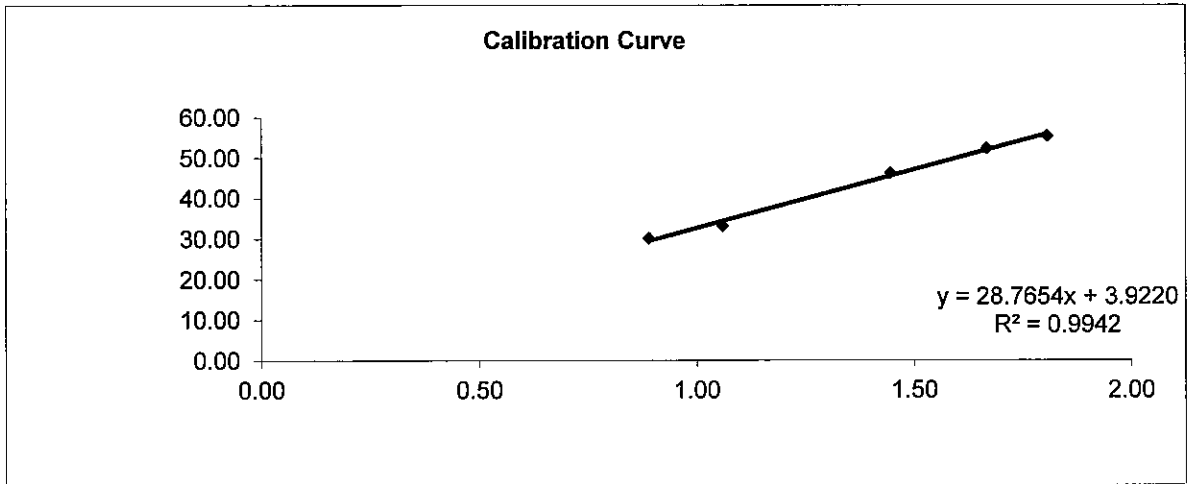
Calibrator model	GMW-2535
Calibrator serial number	1378
Slope of the standard curve, m_s	1.99405
Intercept of the standard curve, b_s	-0.00397

Resistance Plate No.	Manometer Reading (inch H ₂ O)	Flow Recorder Reading (CFM)	Calculated Q _{std} (m ³ /min)	Continuous Flow Recorder Reading IC (CFM)
5	3.10	30.00	0.89	30.15
7	4.40	33.00	1.06	33.17
10	8.20	46.00	1.45	46.23
13	10.90	52.00	1.67	52.26
18	12.80	55.00	1.81	55.28

Linear Regression
 Sampler slope (m) : **28.7654**
 Sampler intercept (b) : **3.9220**
 Correlation coefficient (R²) : **0.9942**

Correlation coefficient is greater than 0.9900 and the calibration result is accepted.

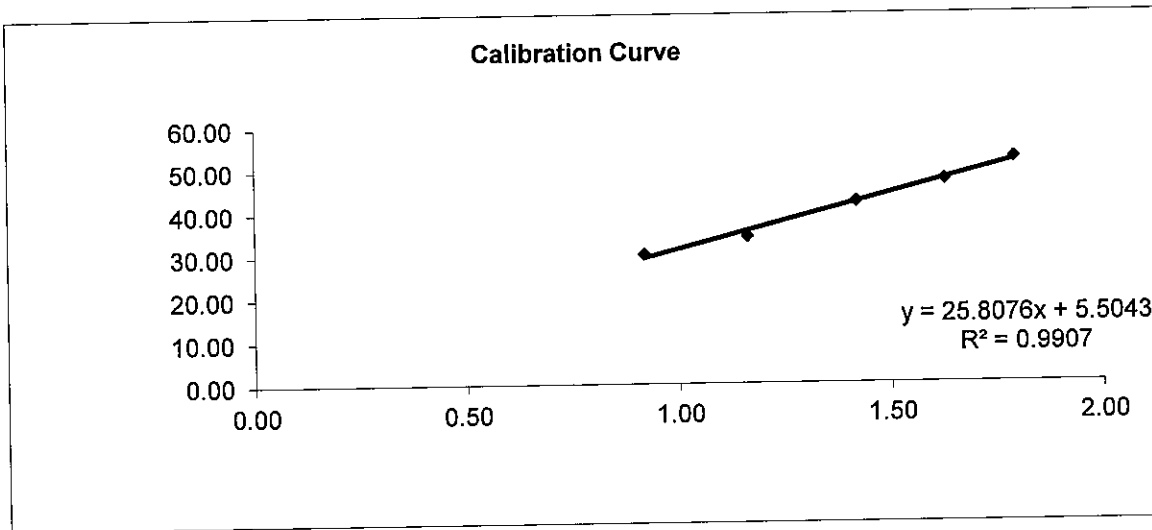
Calibration date	16-Nov-12	Barometric pressure	760 mm Hg
Next Calibration date	15-Jan-13	Temperature (°C)	22 °C
Sampler location	Tai Tung Pui Social Service	Temperature (K)	295 K
Sampler model	TE-5170	P _{std}	760 mm Hg
Sampler serial number	522	T _{std}	298 K
Calibrator model		GMW-2535	
Calibrator serial number		1378	
Slope of the standard curve, m _s		1.99405	
Intercept of the standard curve, b _s		-0.00397

Resistance Plate No.	Manometer Reading (inch H ₂ O)	Flow Recorder Reading (CFM)	Calculated Q _{std} (m ³ /min)	Continuous Flow Recorder Reading IC (CFM)
5	3.30	30.00	0.92	30.15
7	5.30	34.00	1.16	34.17
10	7.90	42.00	1.42	42.21
13	10.40	47.00	1.63	47.24
18	12.60	52.00	1.79	52.26

Linear Regression

Sampler slope (m) : **25.8076**
 Sampler intercept (b) : **5.5043**
 Correlation coefficient (R²) : **0.9907**

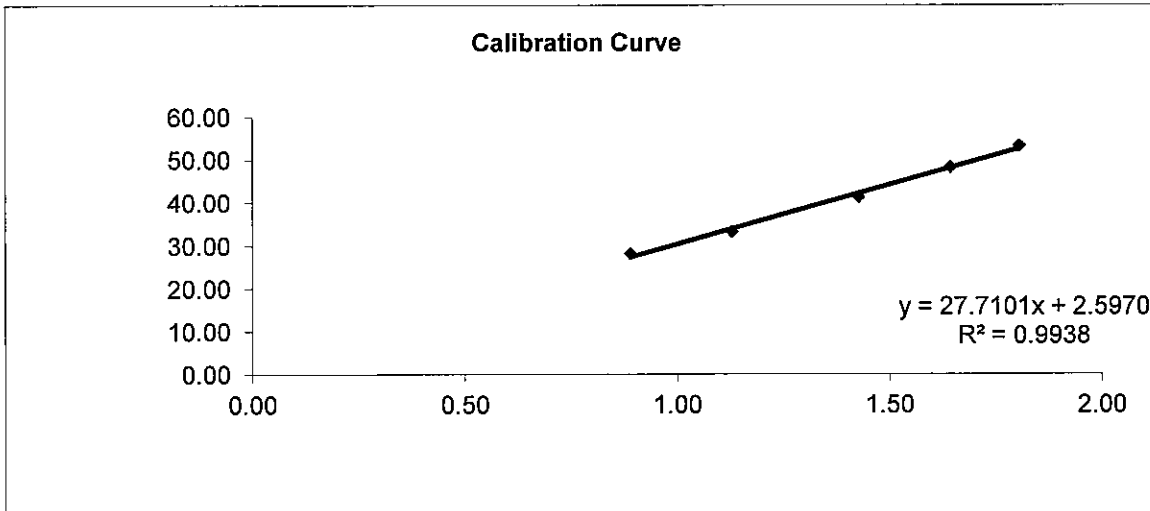
Calibrator model	GMW-2535
Calibrator serial number	1378
Slope of the standard curve, m _s	1.99405
Intercept of the standard curve, b _s	-0.00397

Resistance Plate No.	Manometer Reading (inch H ₂ O)	Flow Recorder Reading (CFM)	Calculated Q _{std} (m ³ /min)	Continuous Flow Recorder Reading IC (CFM)
5	3.10	28.00	0.89	28.14
7	5.00	33.00	1.13	33.17
10	8.00	41.00	1.43	41.21
13	10.60	48.00	1.64	48.24
18	12.80	53.00	1.81	53.27

Linear Regression
 Sampler slope (m) : 27.7101
 Sampler intercept (b) : 2.5970
 Correlation coefficient (R²) : 0.9938

Correlation coefficient is greater than 0.9900 and the calibration result is accepted.

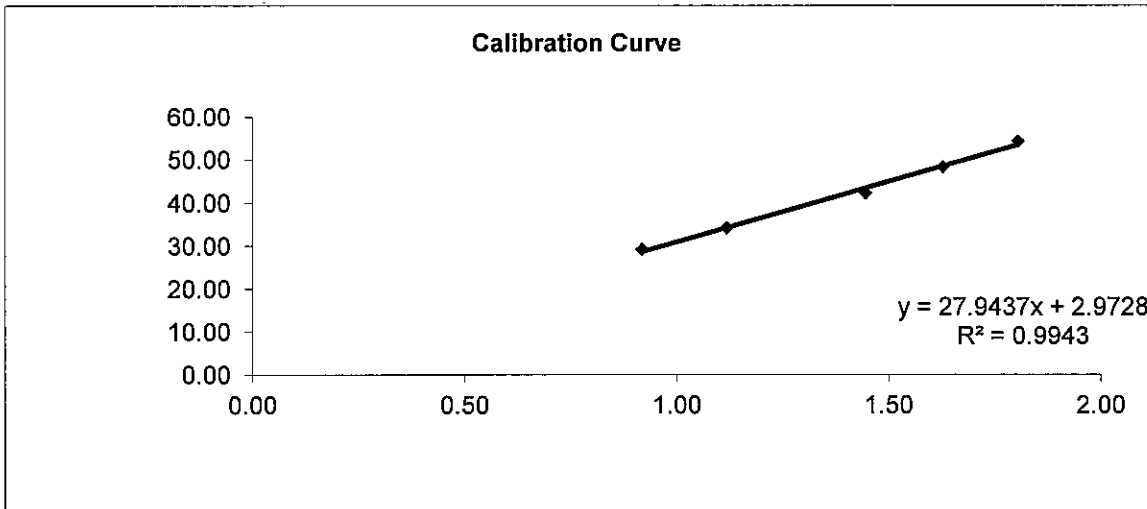
Calibration date	16-Nov-12	Barometric pressure	760 mm Hg
Next Calibration date	15-Jan-13	Temperature (°C)	22 °C
Sampler location	Choi Cheung Kok Secondary	Temperature (K)	295 K
Sampler model	Thermo Anderson	P _{std}	760 mm Hg
Sampler serial number	1278	T _{std}	298 K
Calibrator model		GMW-2535	
Calibrator serial number		1378	
Slope of the standard curve, m _s		1.99405	
Intercept of the standard curve, b _s		-0.00397

Resistance Plate No.	Manometer Reading (inch H ₂ O)	Flow Recorder Reading (CFM)	Calculated Q _{std} (m ³ /min)	Continuous Flow Recorder Reading IC (CFM)
5	3.30	29.00	0.92	29.15
7	4.90	34.00	1.12	34.17
10	8.20	42.00	1.45	42.21
13	10.40	48.00	1.63	48.24
18	12.80	54.00	1.81	54.27

Linear Regression
 Sampler slope (m) : 27.9437
 Sampler intercept (b) : 2.9728
 Correlation coefficient (R²) : 0.9943

Correlation coefficient is greater than 0.9900 and the calibration result is accepted.

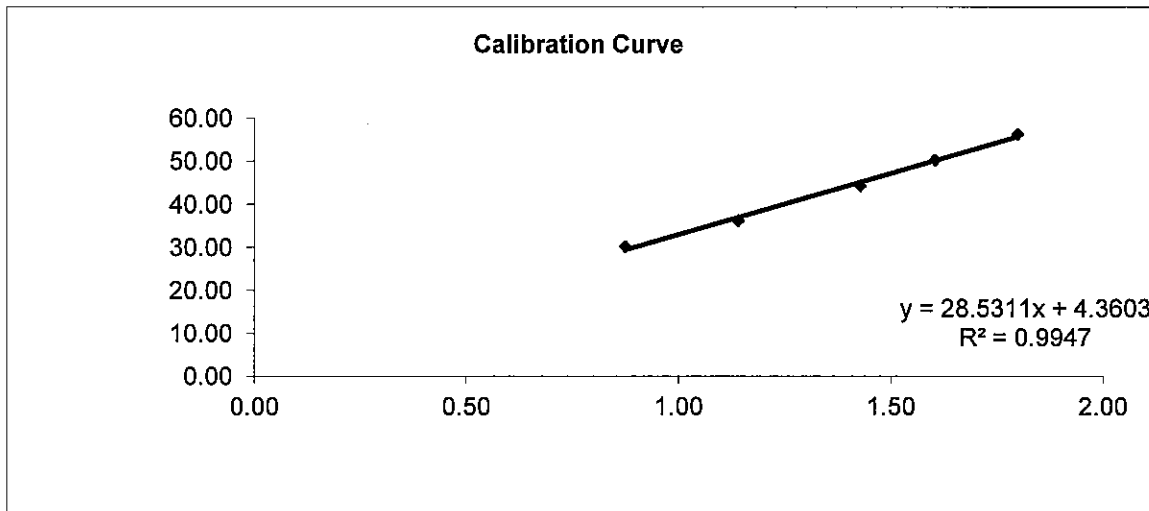
Calibration date	16-Nov-12	Barometric pressure	760 mm Hg
Next Calibration date	15-Jan-13	Temperature (°C)	22 °C
Sampler location	Tuen Mun Town Hall	Temperature (K)	295 K
Sampler model	TE-5170	P _{std}	760 mm Hg
Sampler serial number	516	T _{std}	298 K
Calibrator model	GMW-2535		
Calibrator serial number	1378		
Slope of the standard curve, m _s	1.99405		
Intercept of the standard curve, b _s	-0.00397

Resistance Plate No.	Manometer Reading (inch H ₂ O)	Flow Recorder Reading (CFM)	Calculated Q _{std} (m ³ /min)	Continuous Flow Recorder Reading IC (CFM)
5	3.00	30.00	0.88	30.15
7	5.10	36.00	1.14	36.18
10	8.00	44.00	1.43	44.22
13	10.10	50.00	1.60	50.25
18	12.70	56.00	1.80	56.28

Linear Regression
 Sampler slope (m) : 28.5311
 Sampler intercept (b) : 4.3603
 Correlation coefficient (R²) : 0.9947

Correlation coefficient is greater than 0.9900 and the calibration result is accepted.

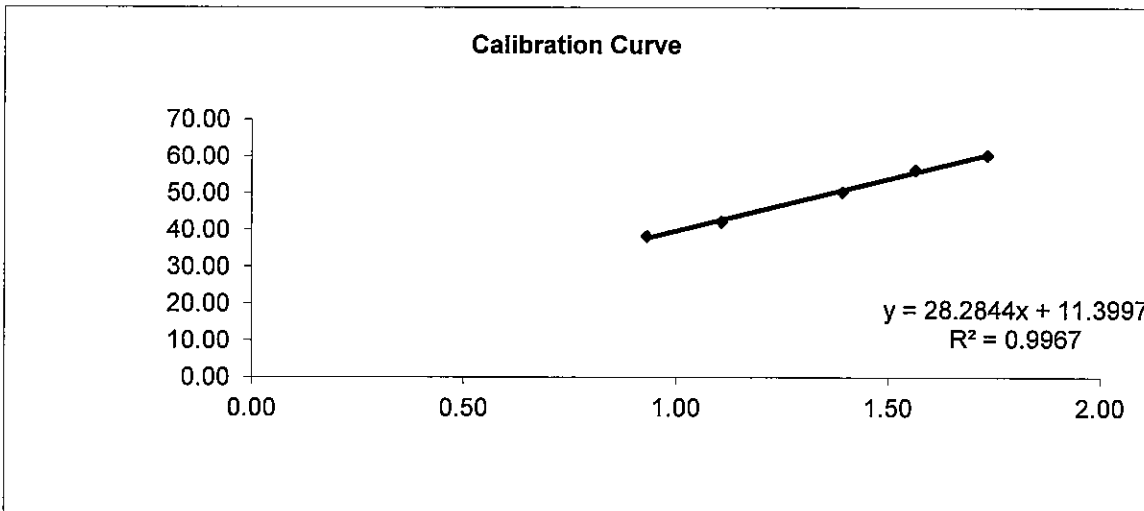
Calibrator model	GMW-2535
Calibrator serial number	1378
Slope of the standard curve, m _s	1.99405
Intercept of the standard curve, b _s	-0.00397

Resistance Plate No.	Manometer Reading (inch H ₂ O)	Flow Recorder Reading (CFM)	Calculated Q _{std} (m ³ /min)	Continuous Flow Recorder Reading IC (CFM)
5	3.40	38.00	0.93	38.19
7	4.80	42.00	1.11	42.21
10	7.60	50.00	1.39	50.25
13	9.60	56.00	1.56	56.28
18	11.80	60.00	1.73	60.30

Linear Regression
 Sampler slope (m) : 28.2844
 Sampler intercept (b) : 11.3997
 Correlation coefficient (R²) : 0.9967

Correlation coefficient is greater than 0.9900 and the calibration result is accepted.
