Highways Department

**Agreement No. HMW
5/2009 (EP) Traffic
Improvements to Tuen
Mun Road Town Centre
Section**

Monthly Environmental
Monitoring and Audit
Report - November 2012

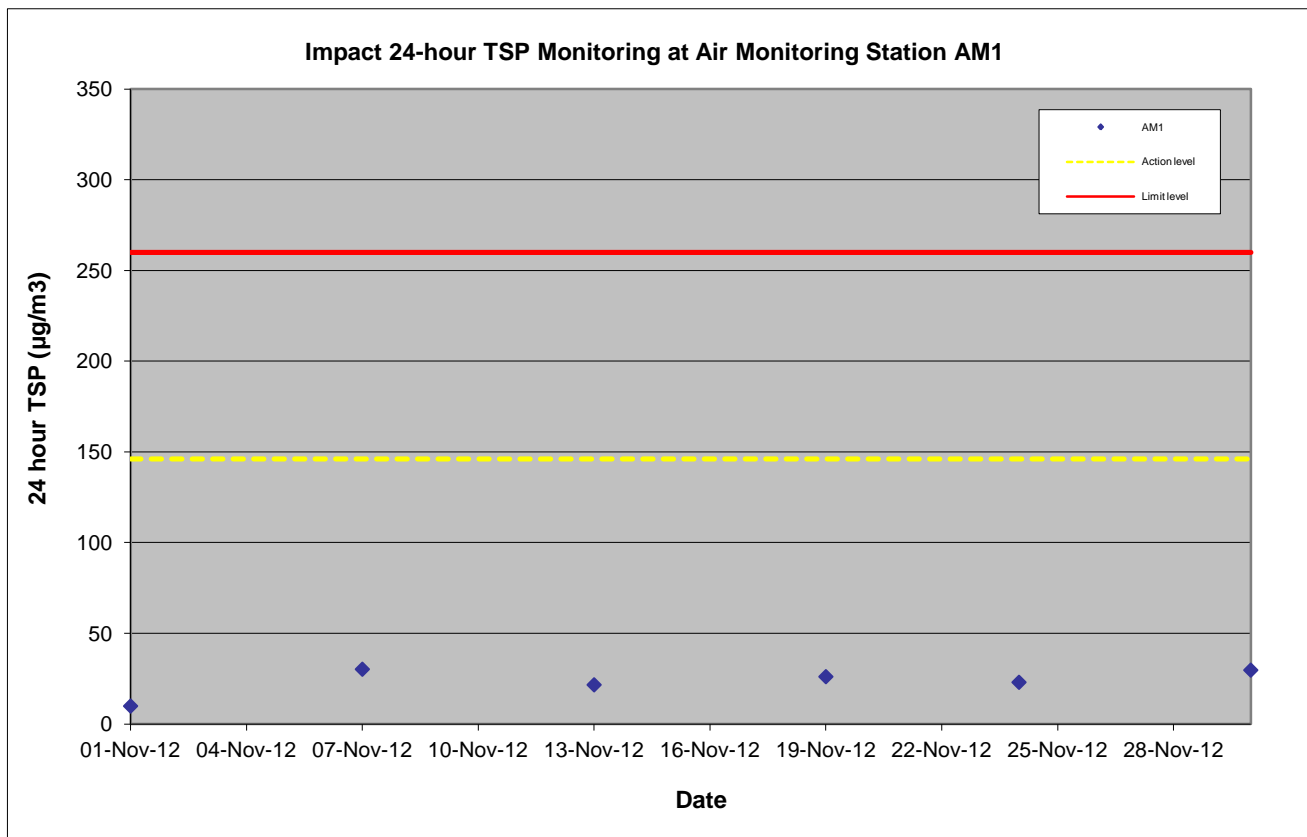
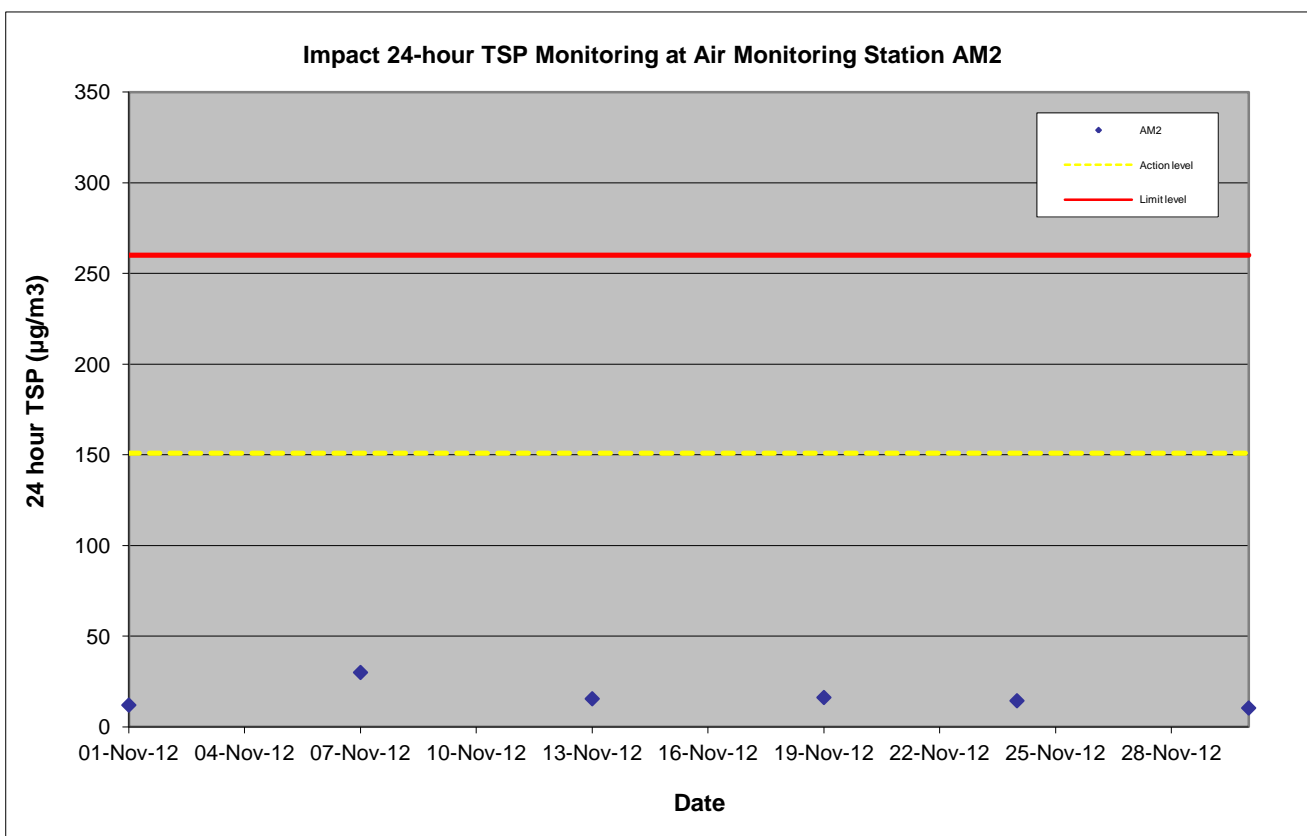
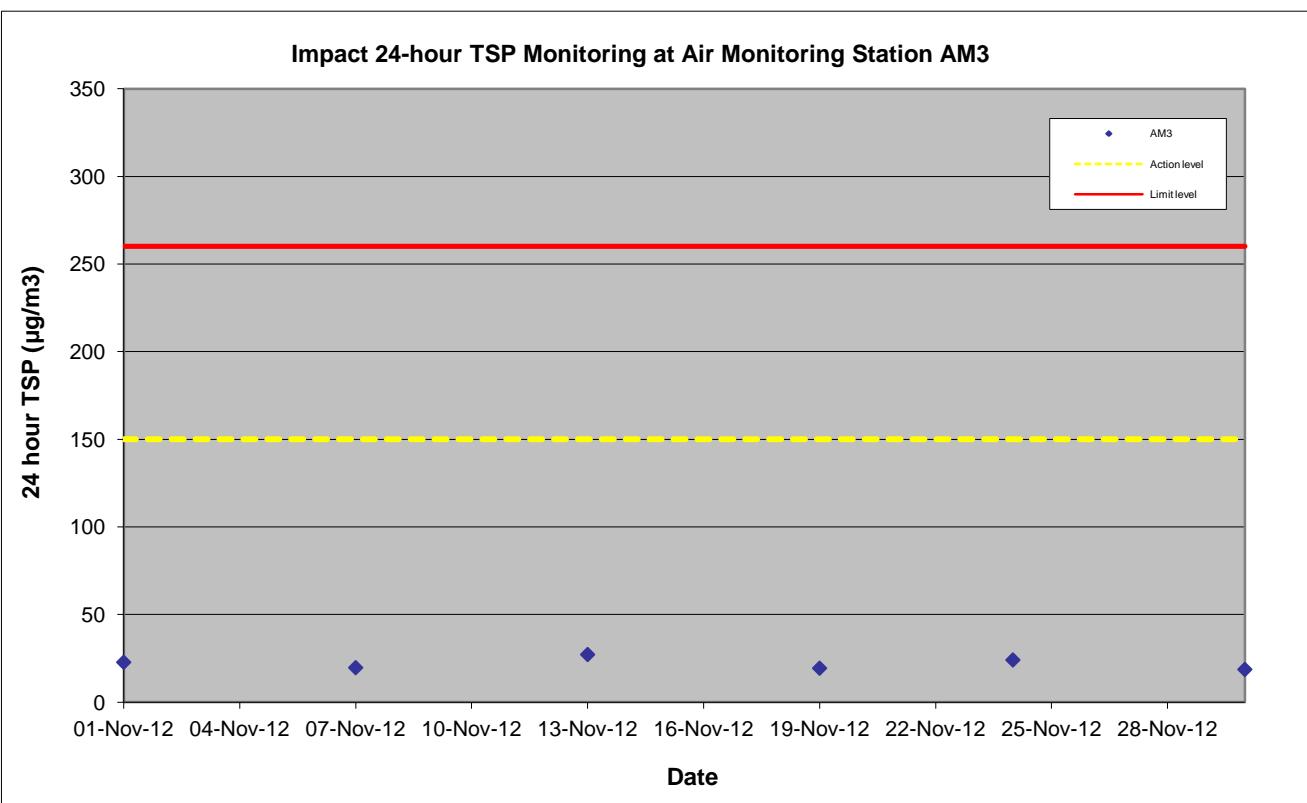
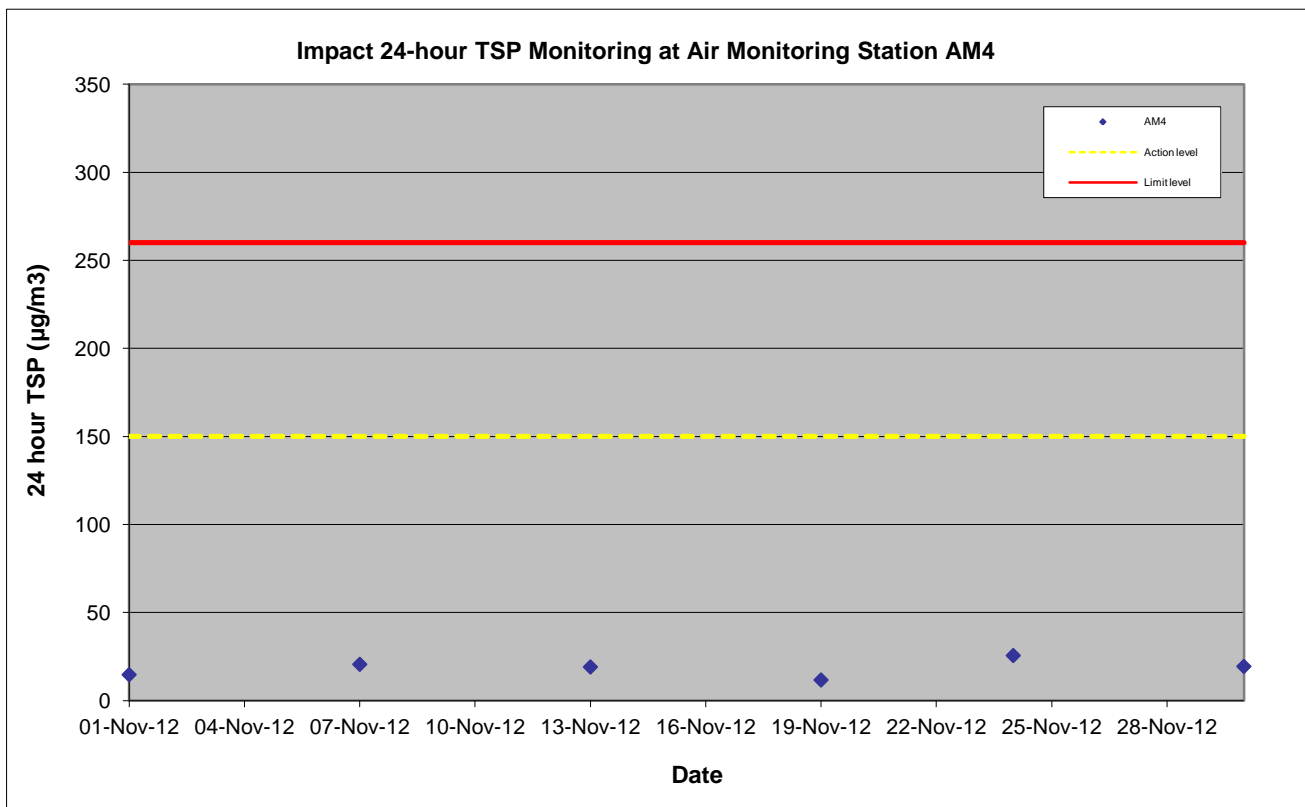
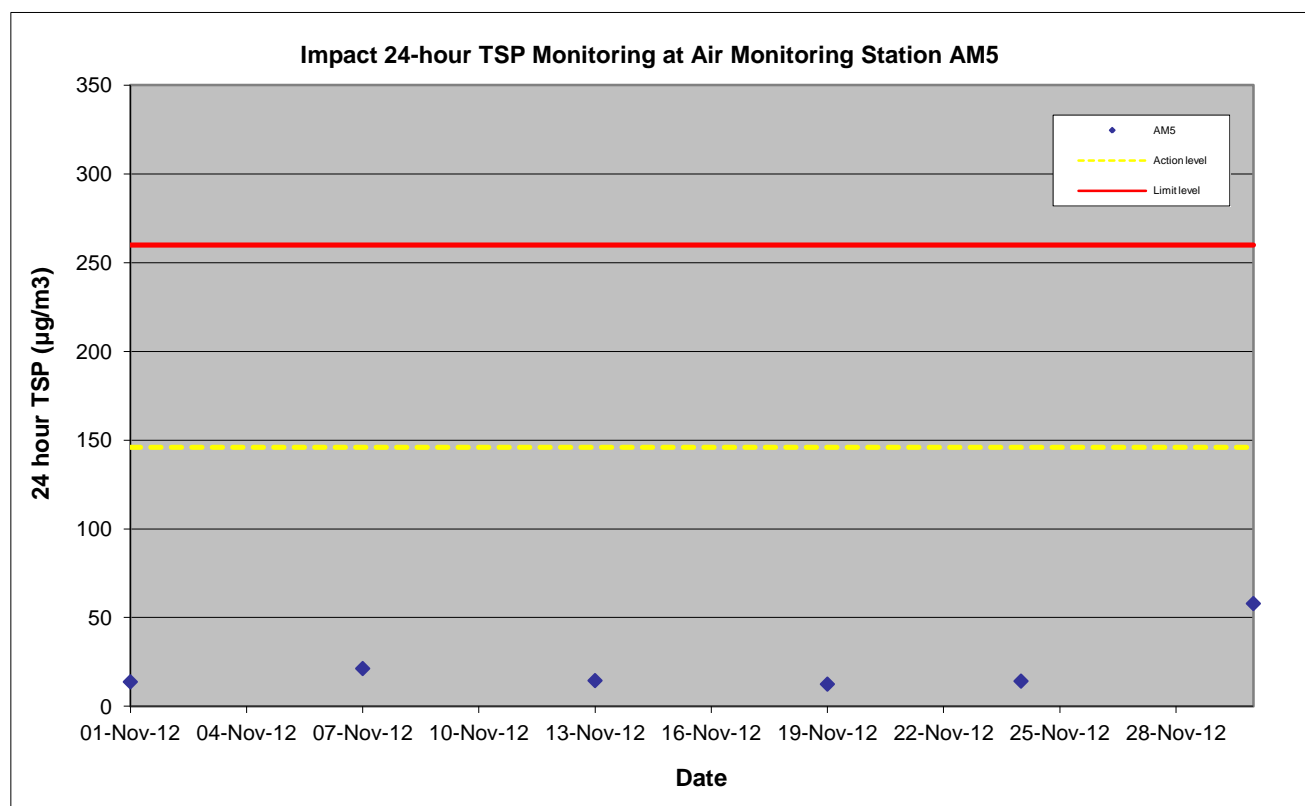
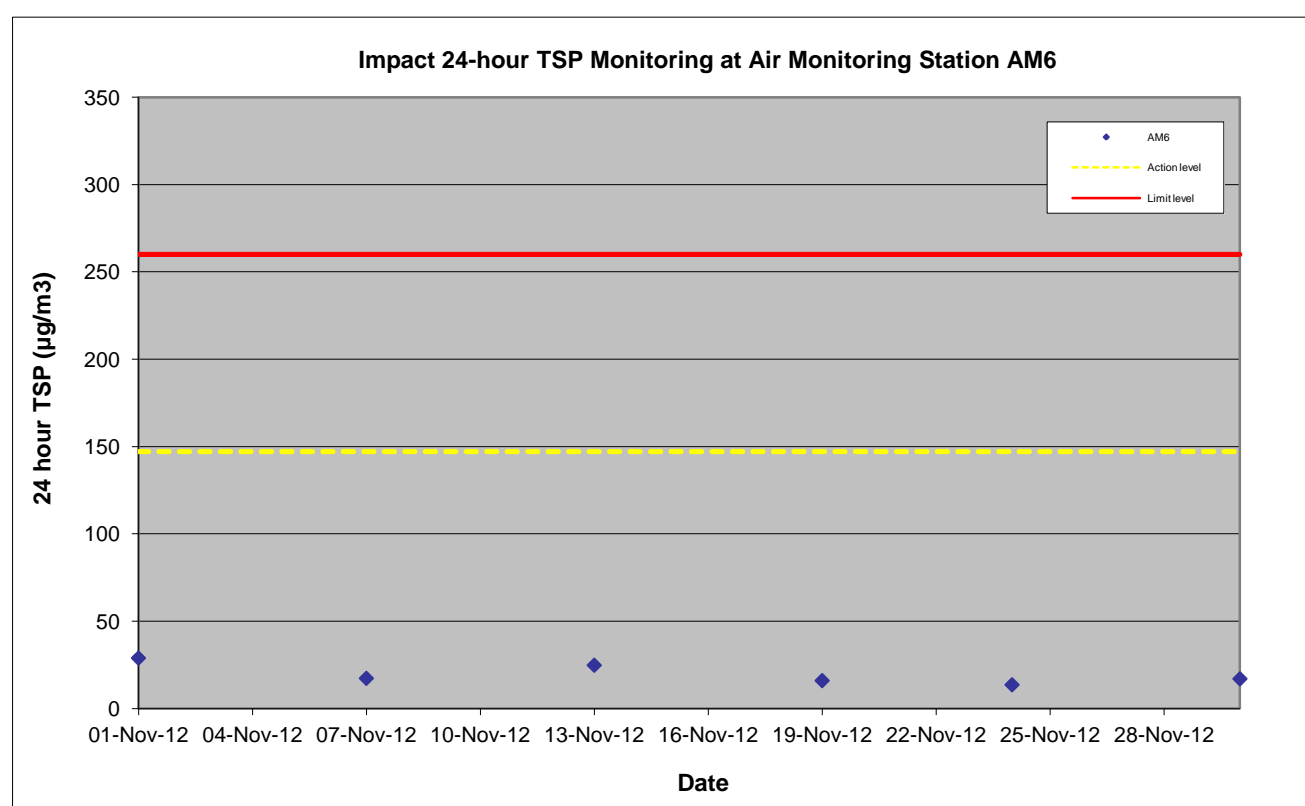
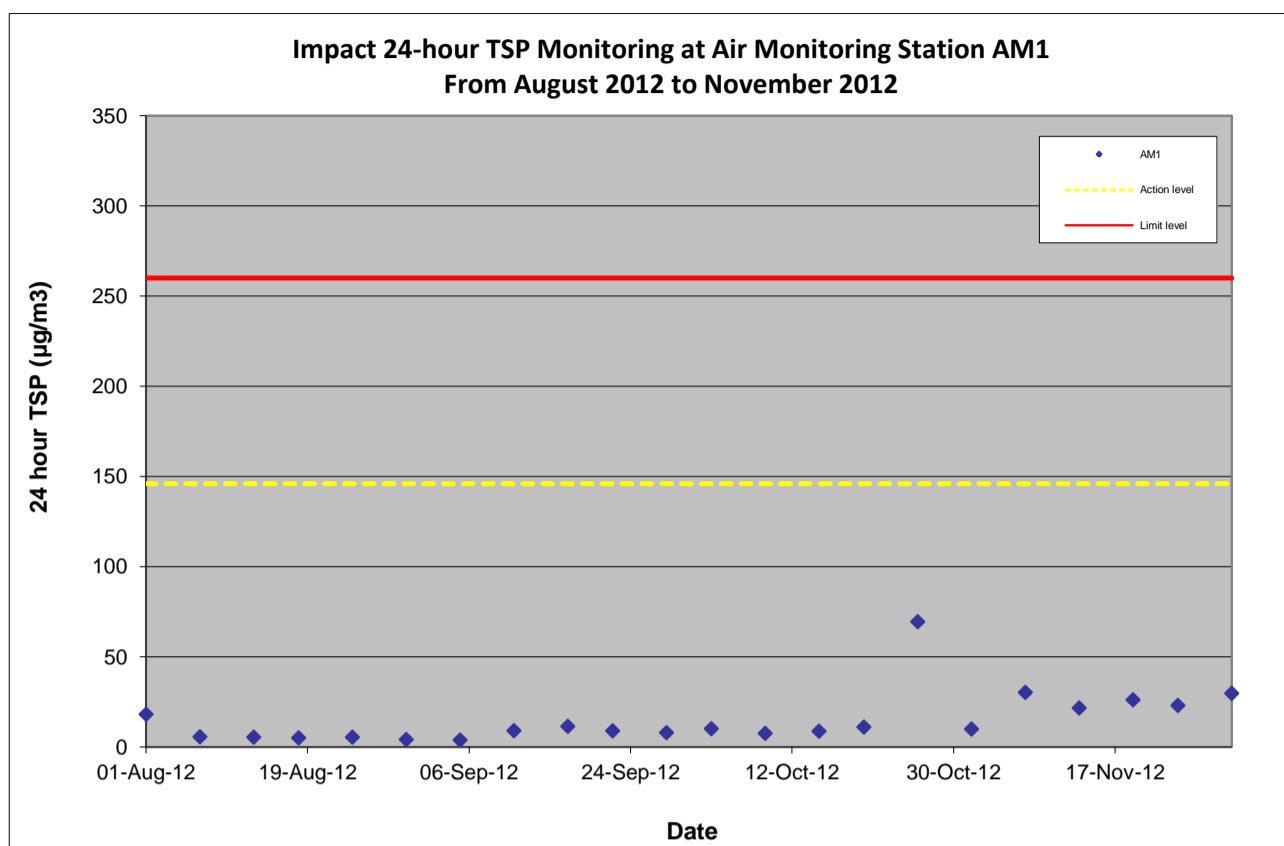
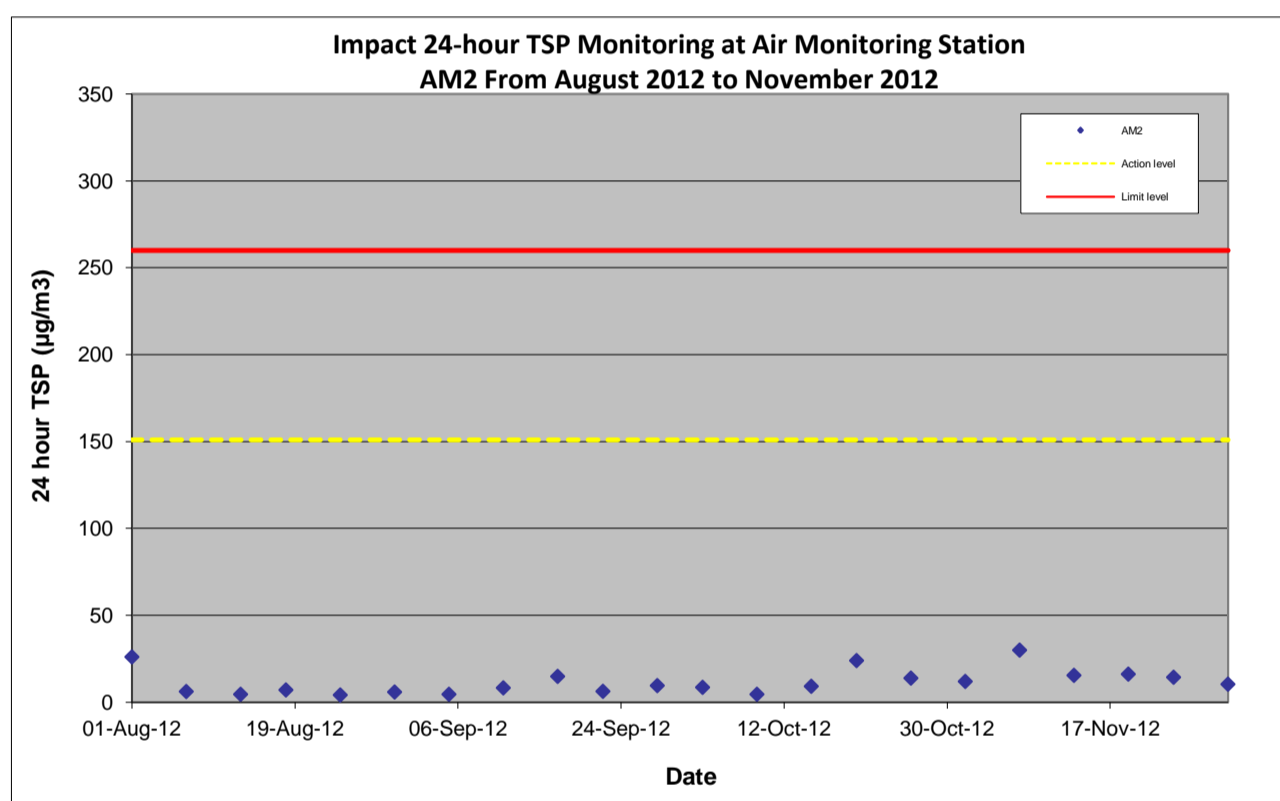
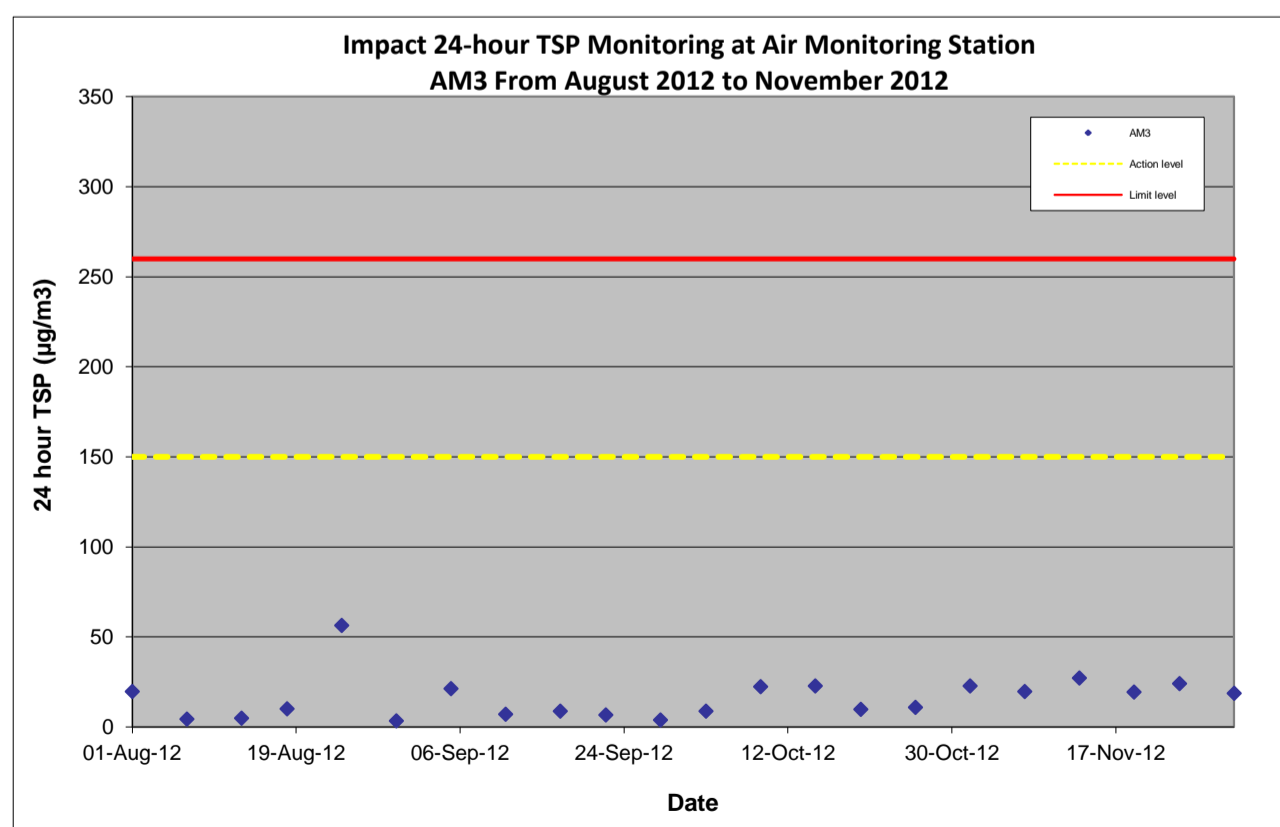
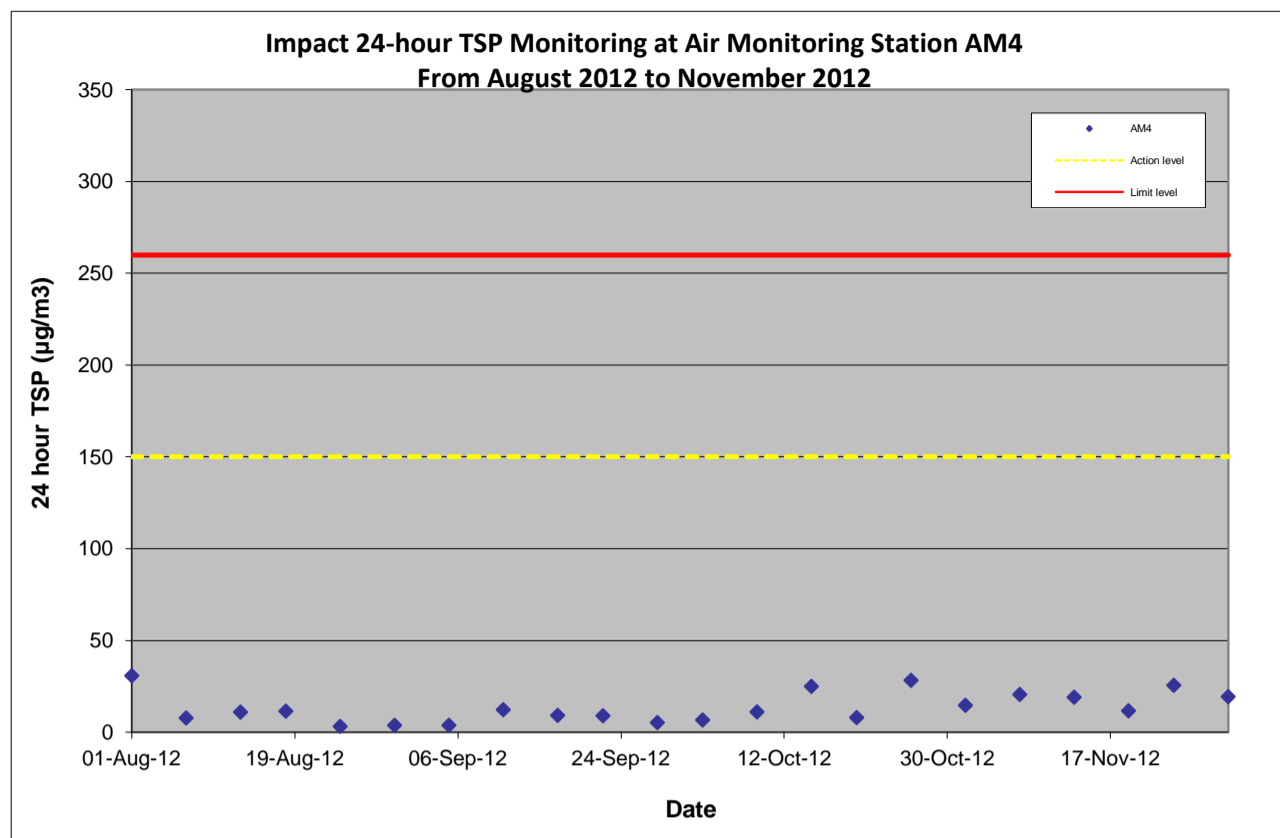
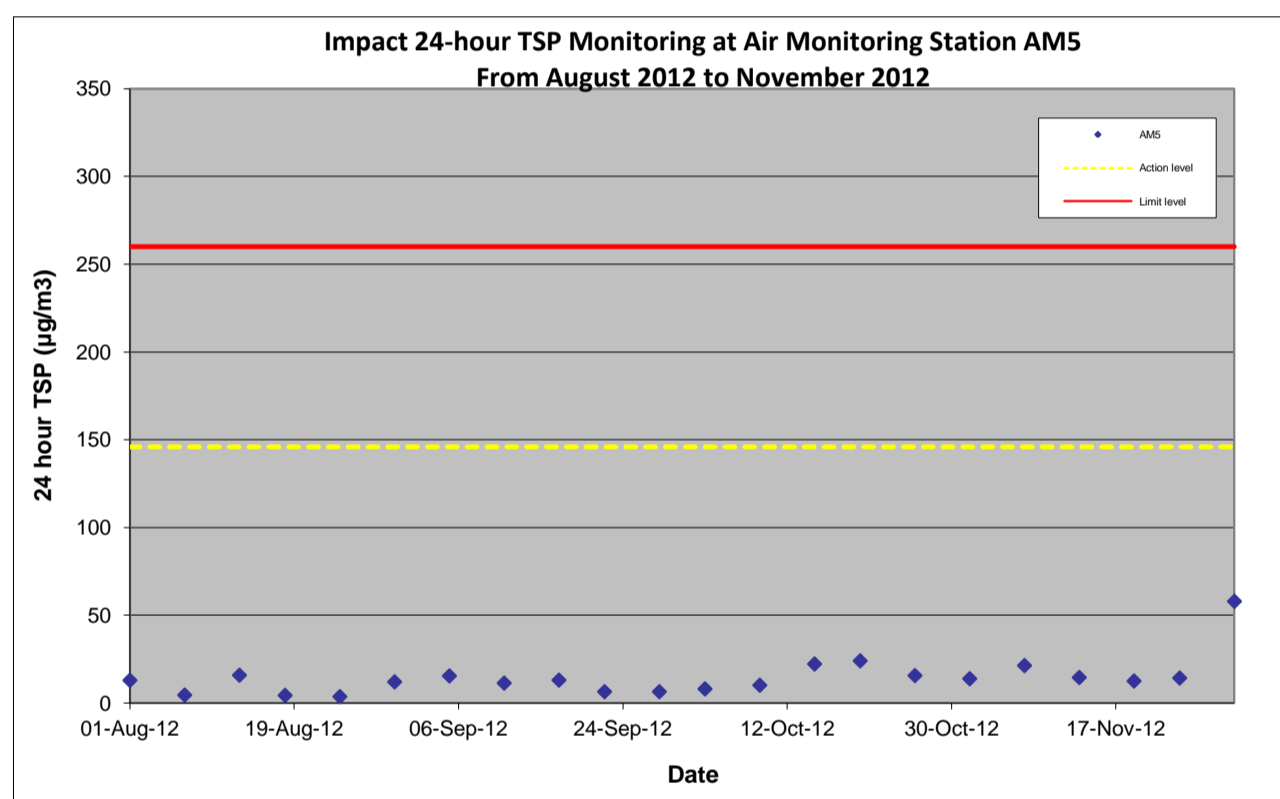
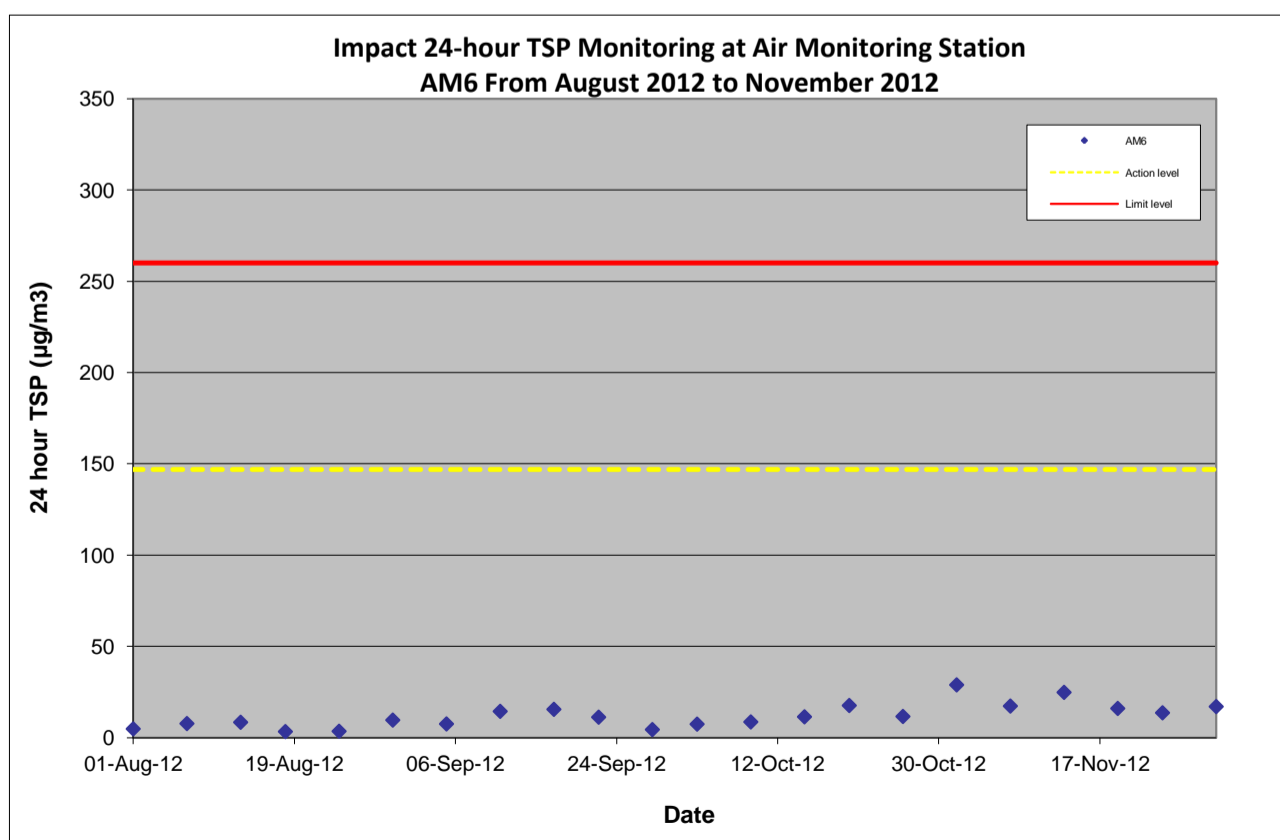
Average (ug/m ³)	19.6
Max (ug/m ³)	28.9
Min (ug/m ³)	13.6

Action Level (ug/m ³)	147
Limit Level (ug/m ³)	260
