Highways Department

**Agreement No. HMW
5/2009 (EP) Traffic
Improvements to Tuen
Mun Road Town Centre
Section**

Monthly Environmental
Monitoring and Audit
Report - November 2012

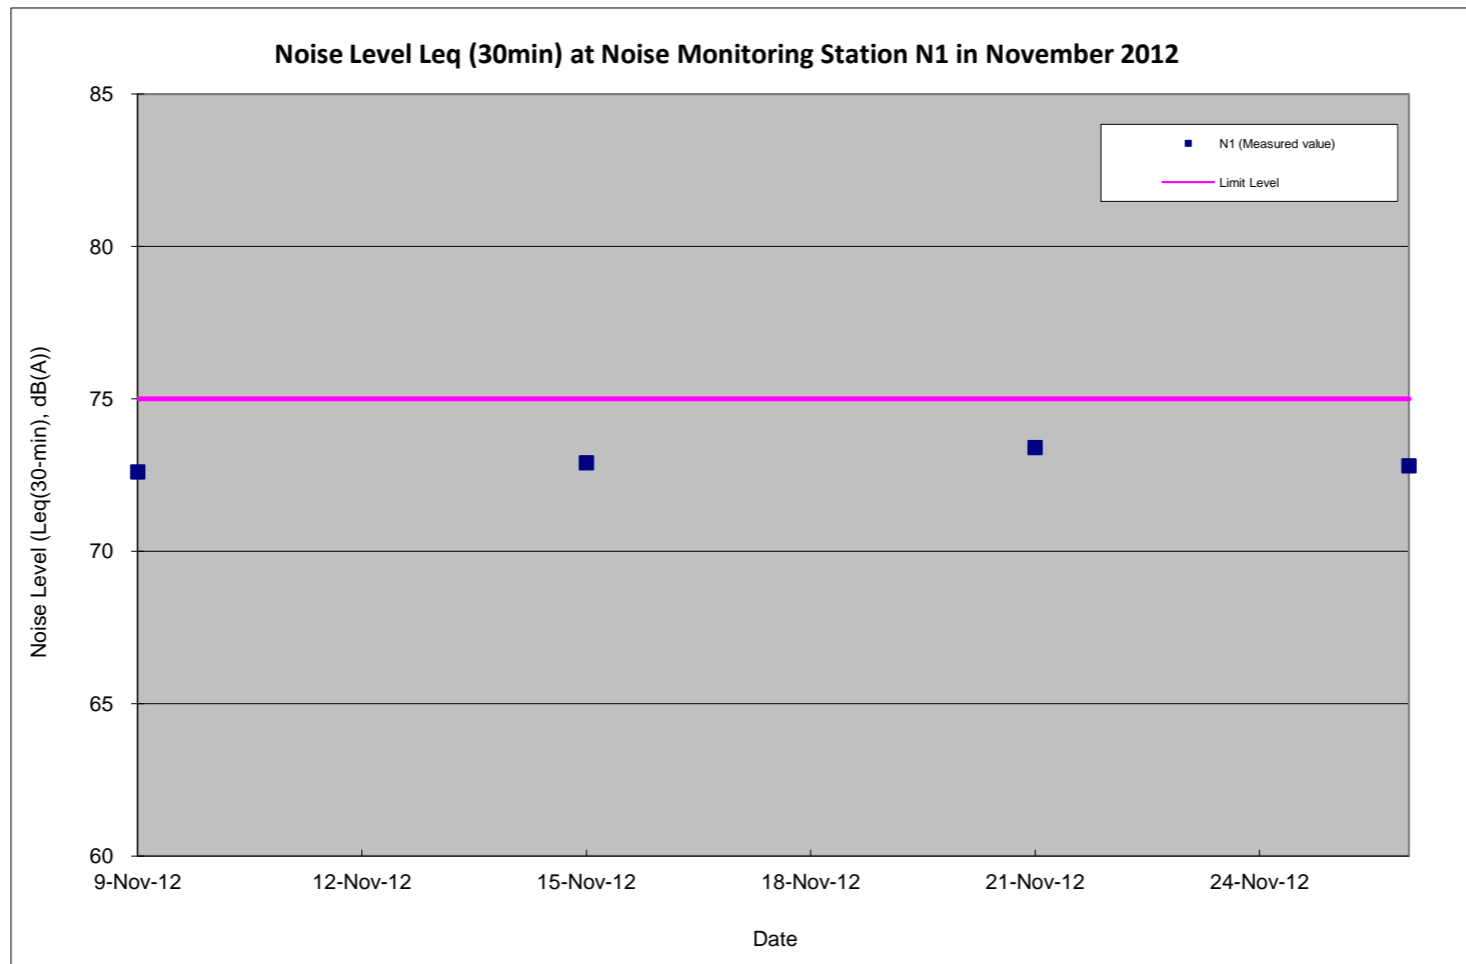
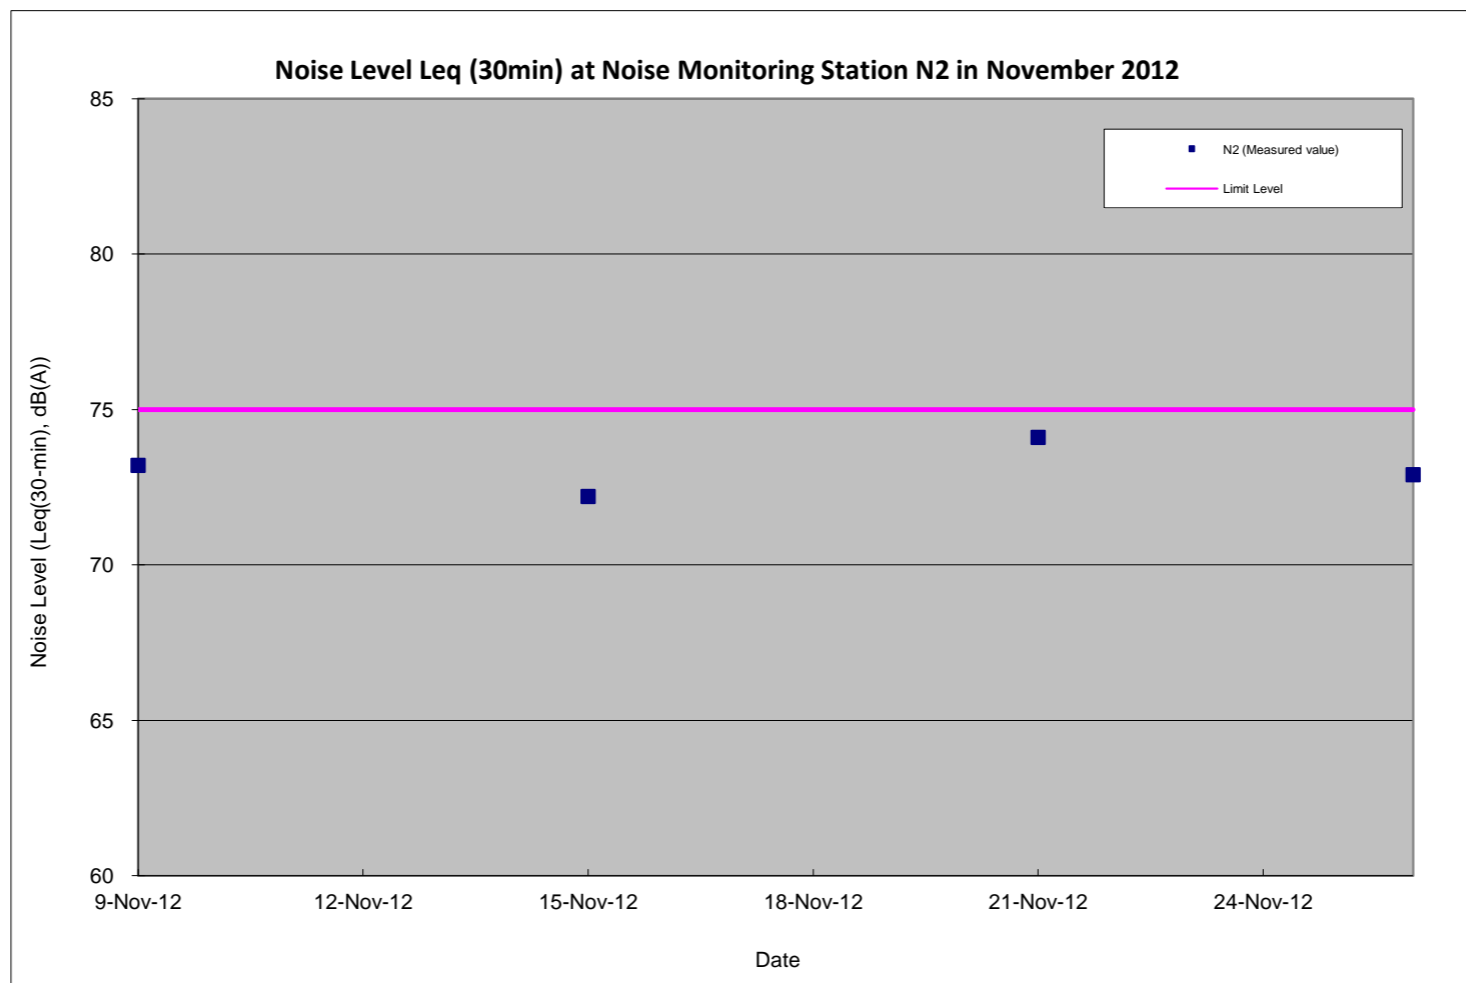
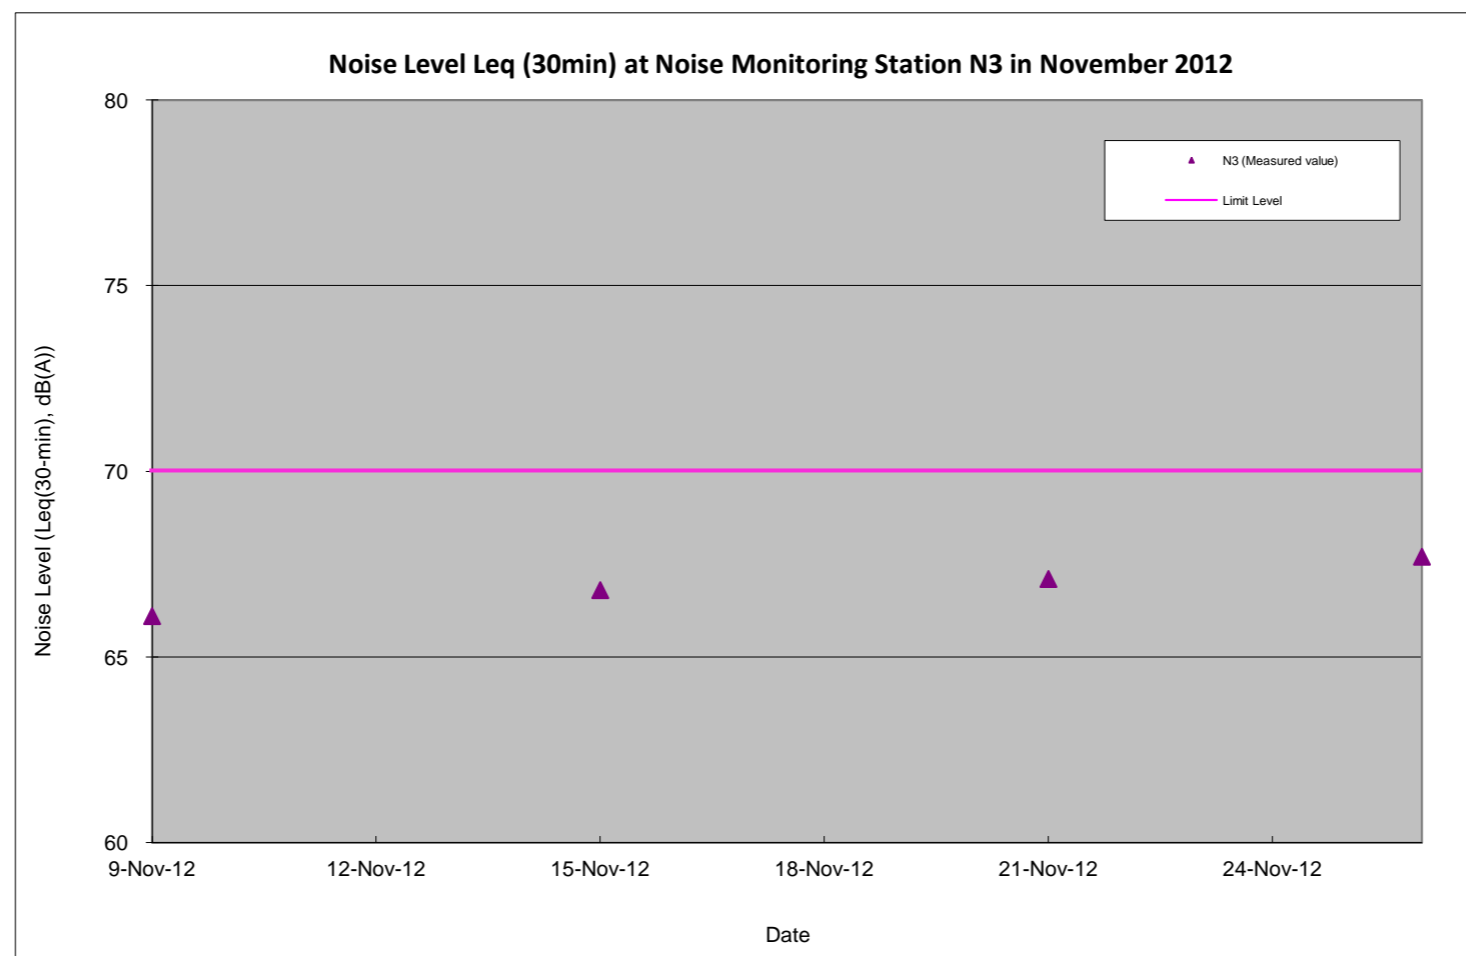
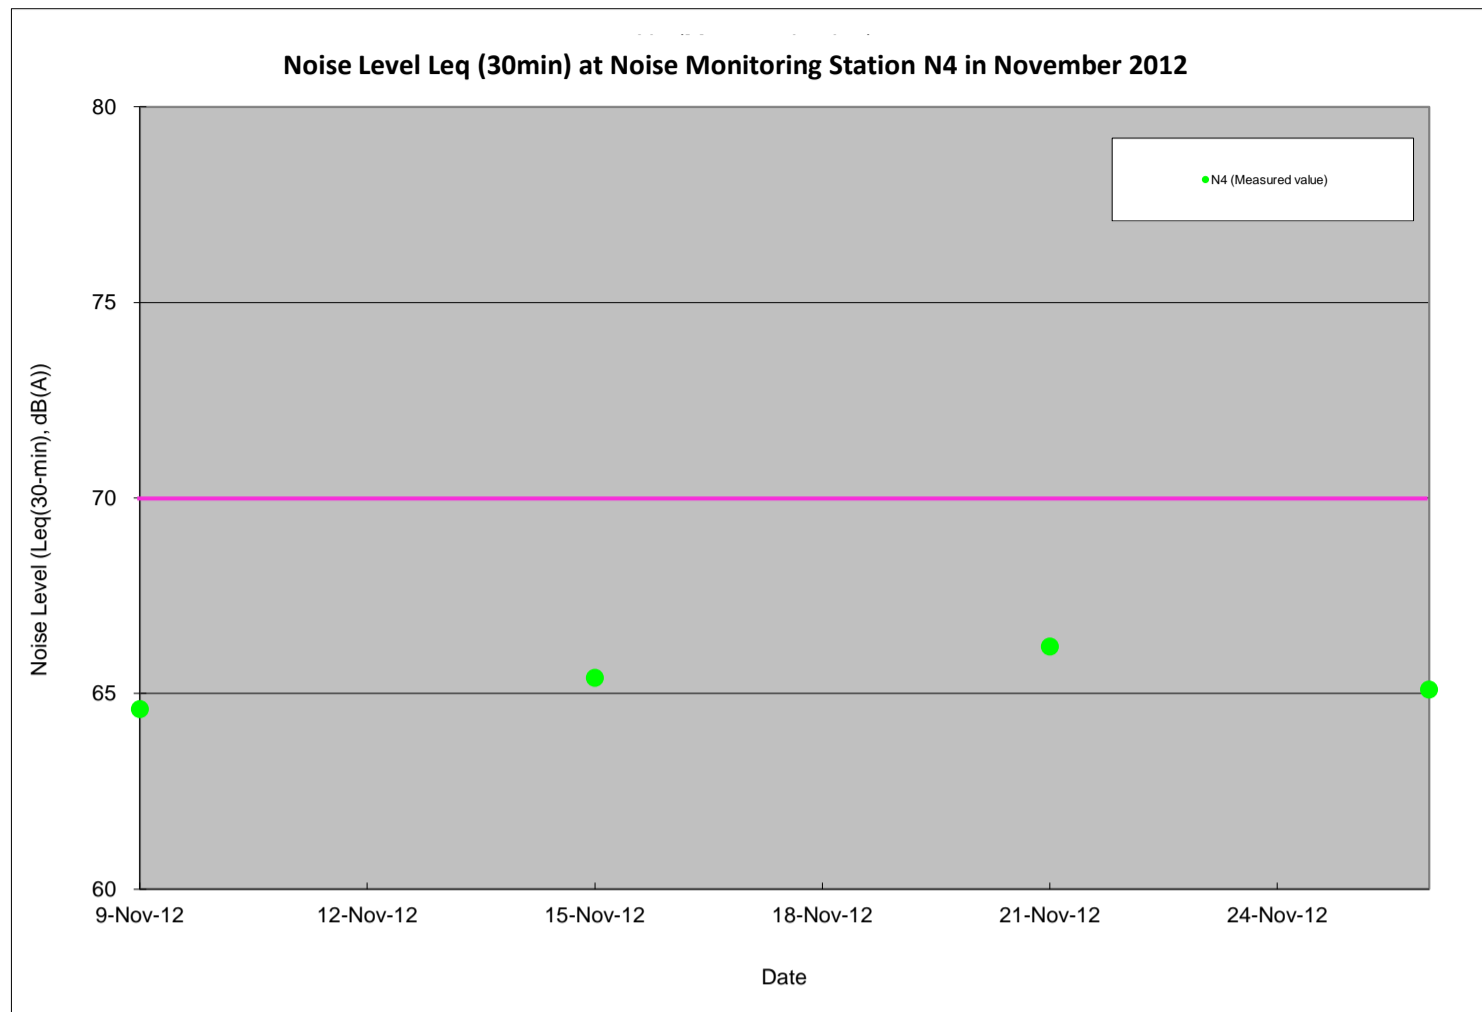
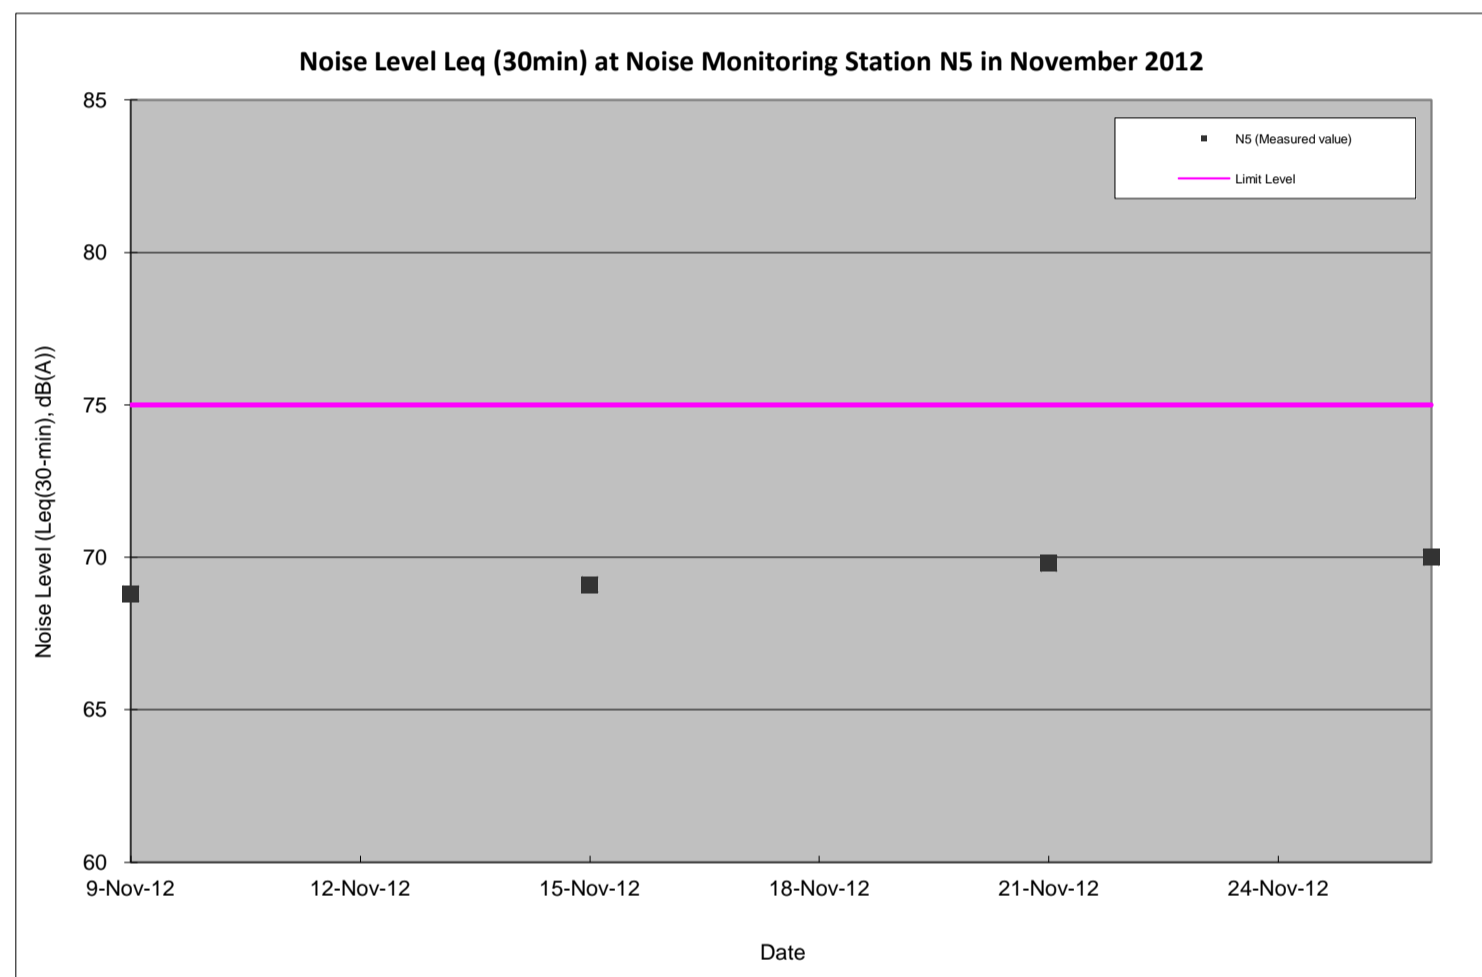
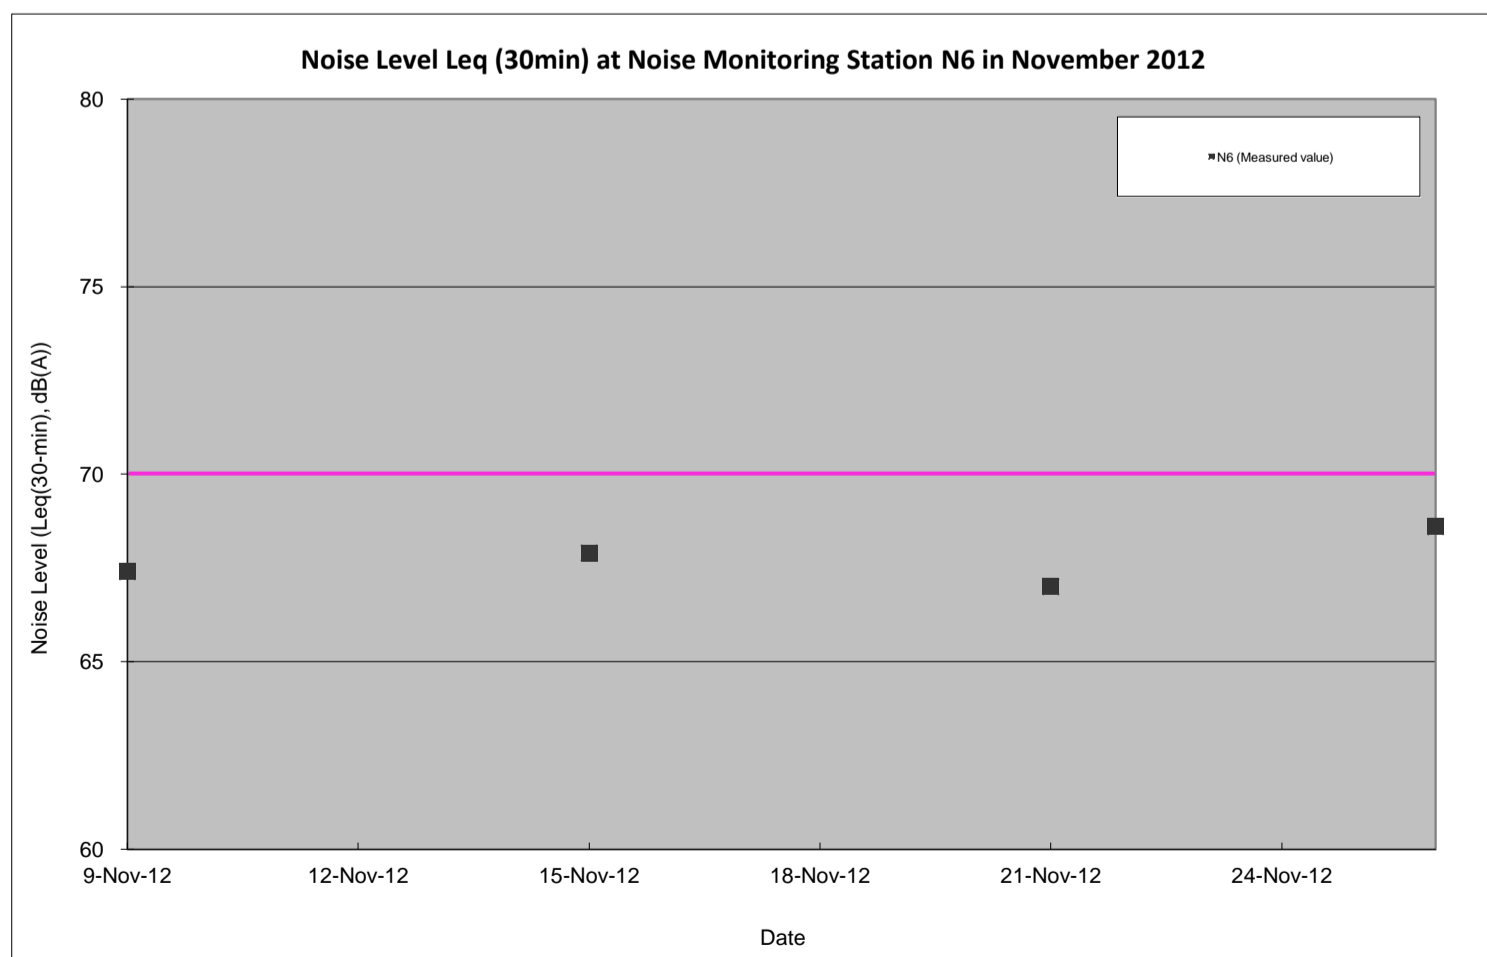
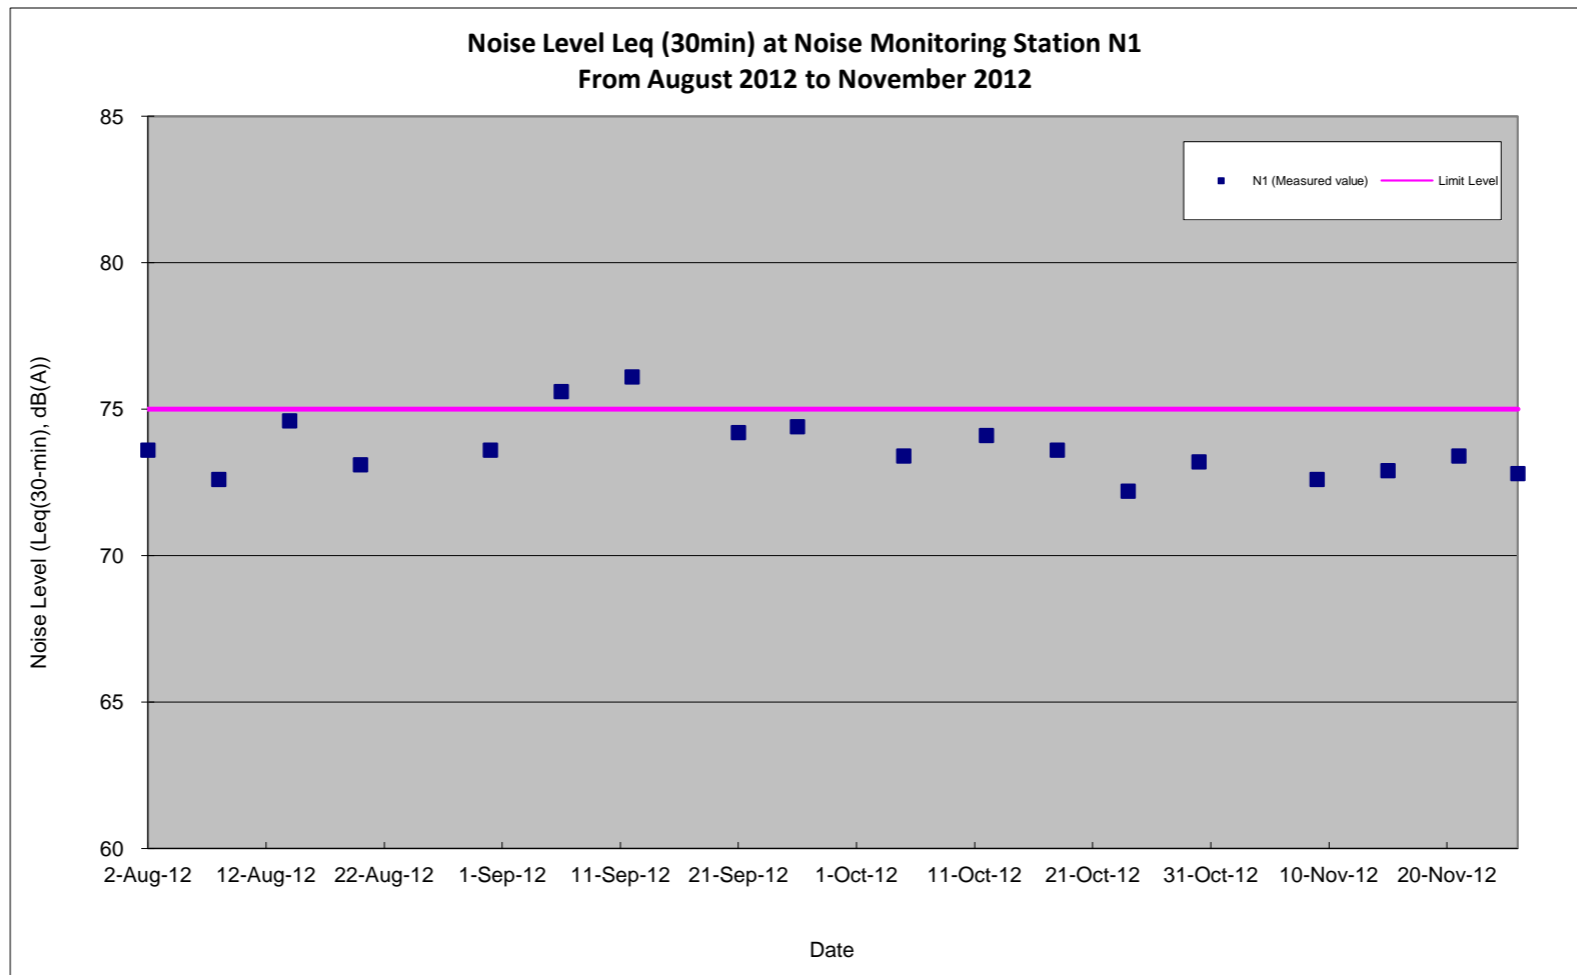
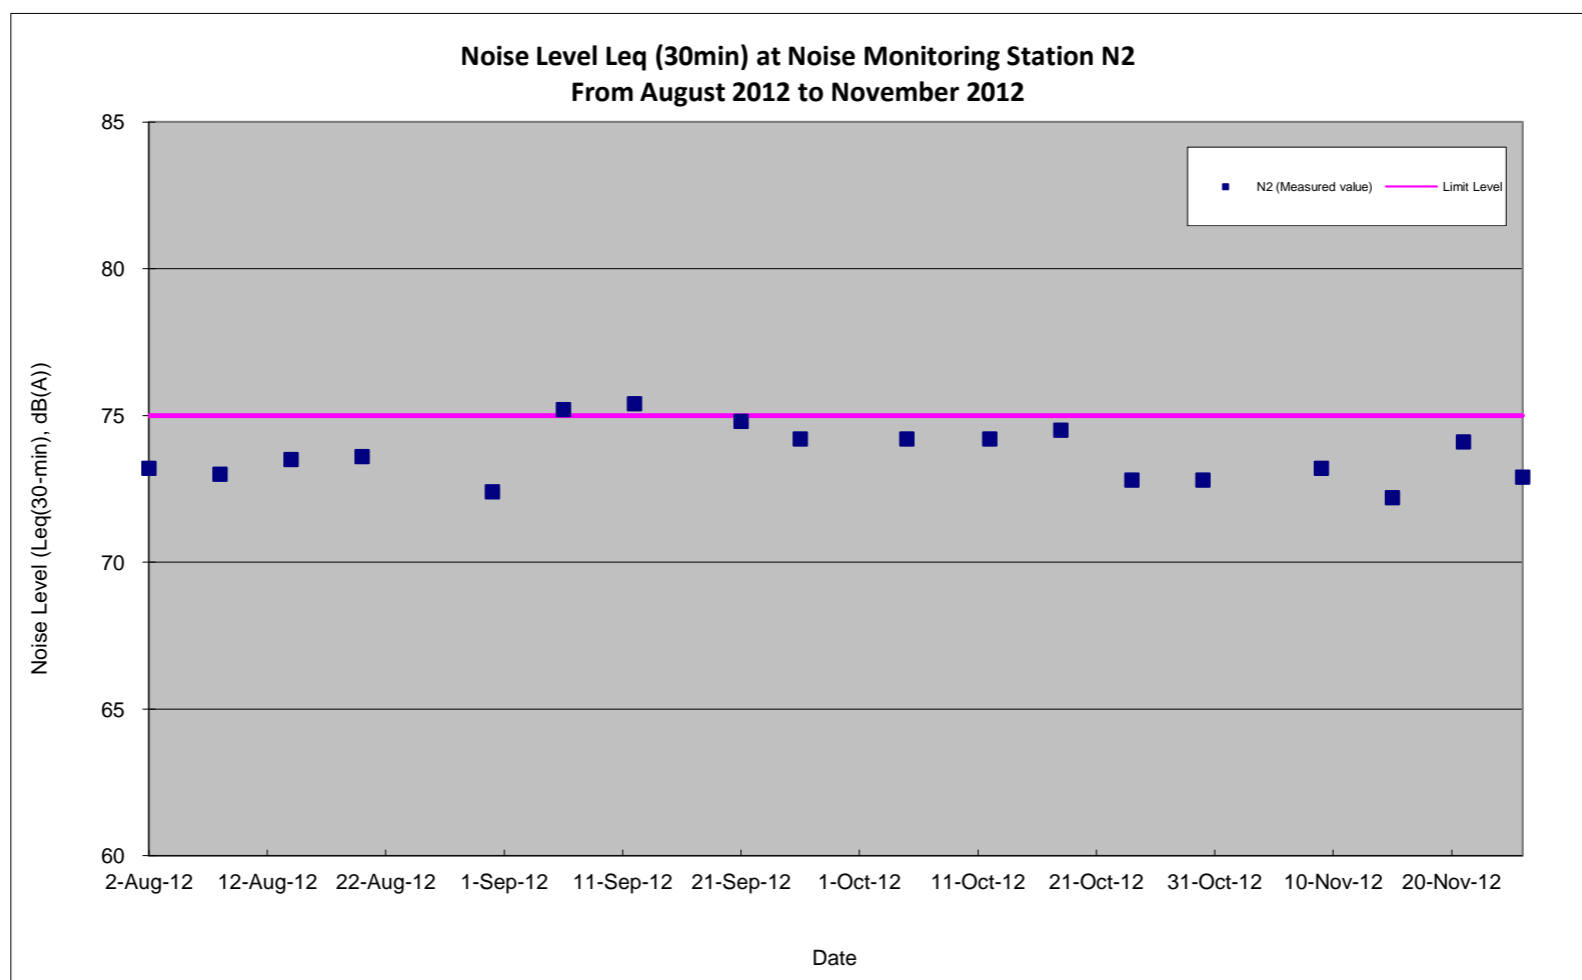
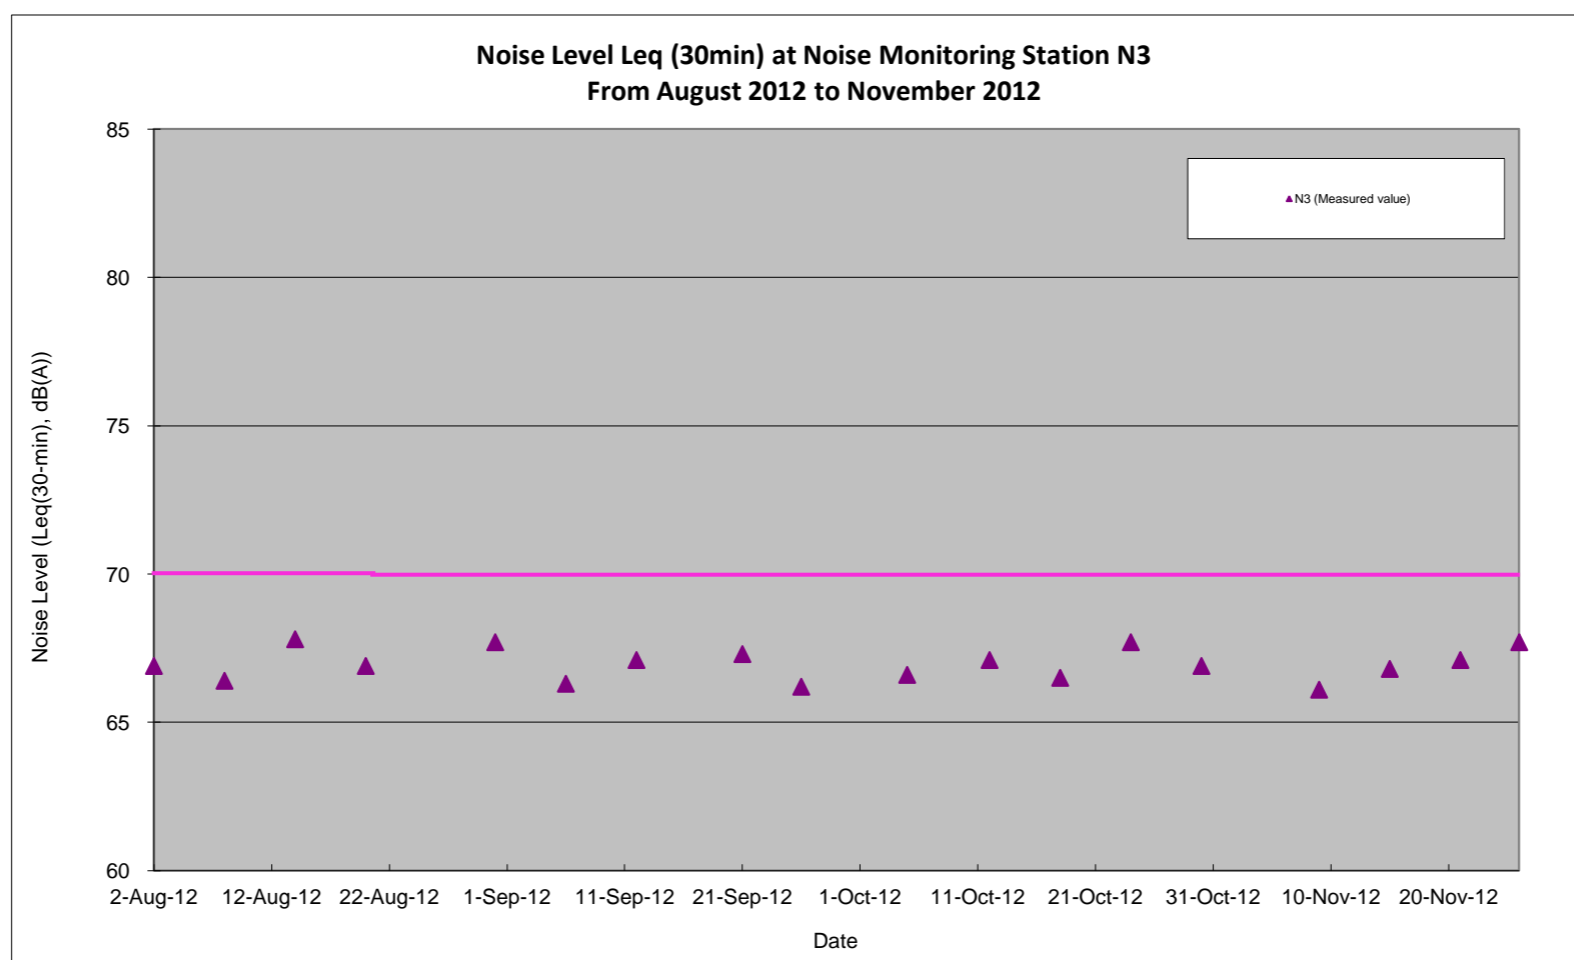
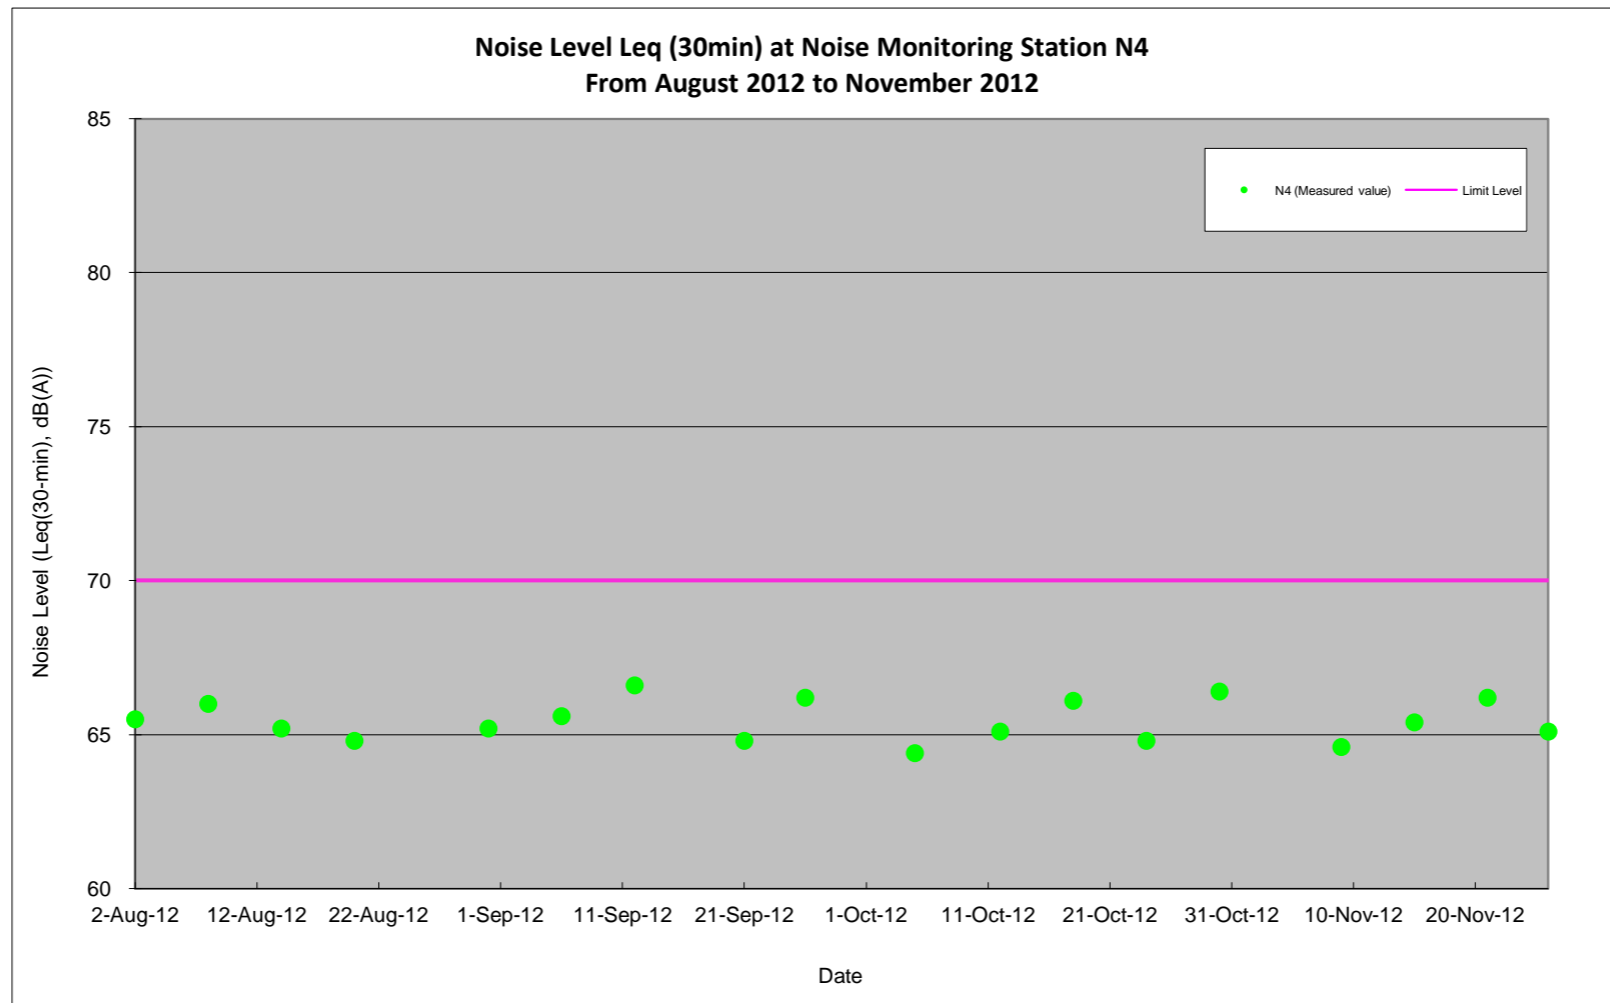
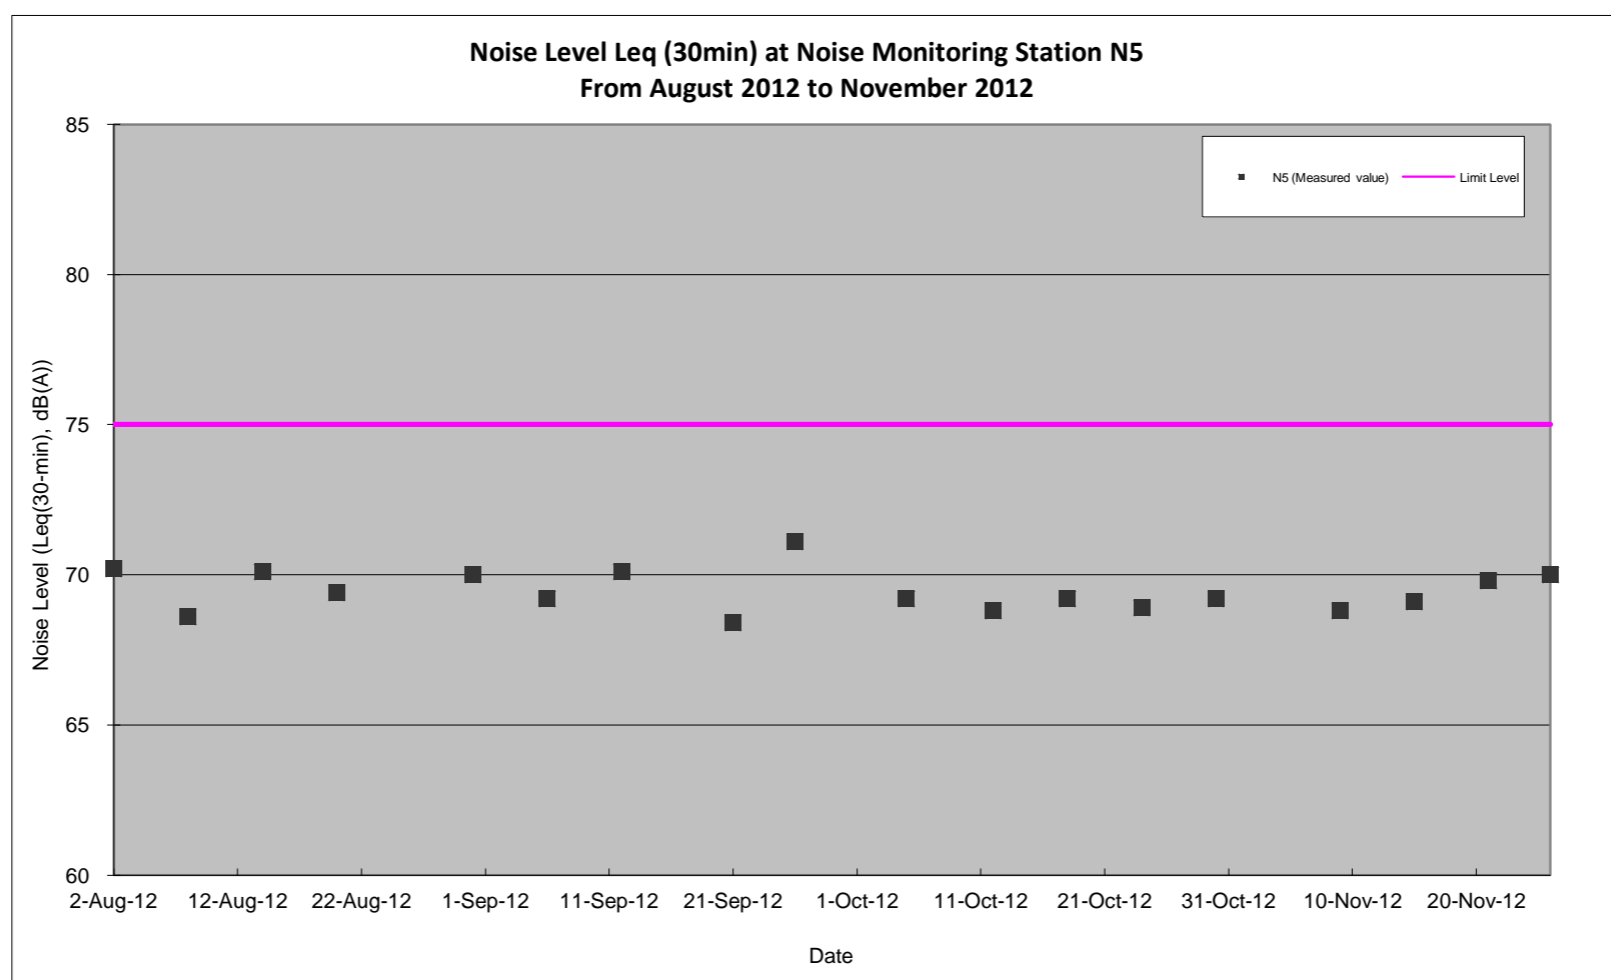
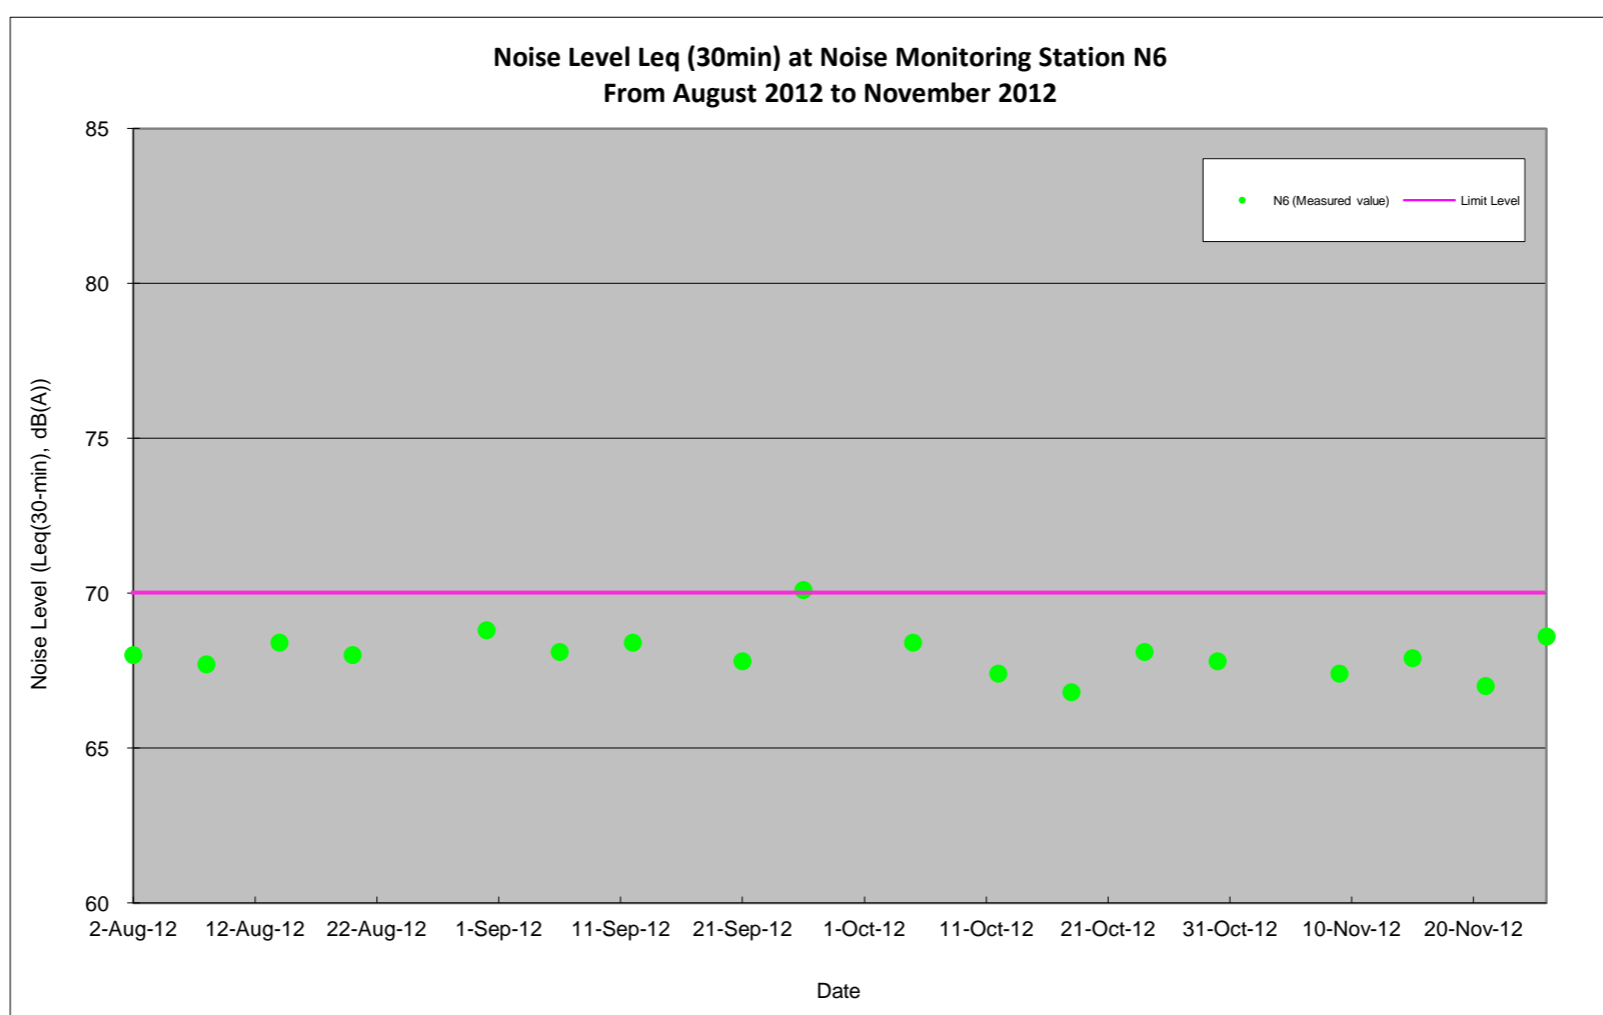
ID	Premise	Time	Measured Noise Level, dB(A)				Baseline Noise Level, dB(A)	Construction Noise Level, dB(A)
			L _{Aeq} 30min	Limit	L ₁₀ 5min	L ₉₀ 5min	L _{Aeq} 30min	L _{Aeq} 30min
N1	Kam Fai Garden	9:50-10:20	73	75	75	71	76	Measured ≤ Baseline
N2	Tai Tung Pui Social Service Building	10:35-11:05	73	75	75	71	78	Measured ≤ Baseline
N3	Yuen Yuen Primary School	11:15-11:45	68	70	69	66	69	Measured ≤ Baseline
N4	Wu Siu Kui Primary School	08:30-09:00	65	70	67	64	67	Measured ≤ Baseline
N5	Tuen King Building	13:00-13:30	70	75	72	67	70	Measured ≤ Baseline
N6	Choi Cheung kok Secondary School	13:50-14:20	69	70	70	66	69	Measured ≤ Baseline

Note: (#): Construction Noise Level = Measured Noise Level - Baseline Noise Level
