Highways Department

**Agreement No. HMW
5/2009 (EP) Traffic
Improvements to Tuen
Mun Road Town Centre
Section**

Monthly Environmental
Monitoring and Audit
Report - June 2013

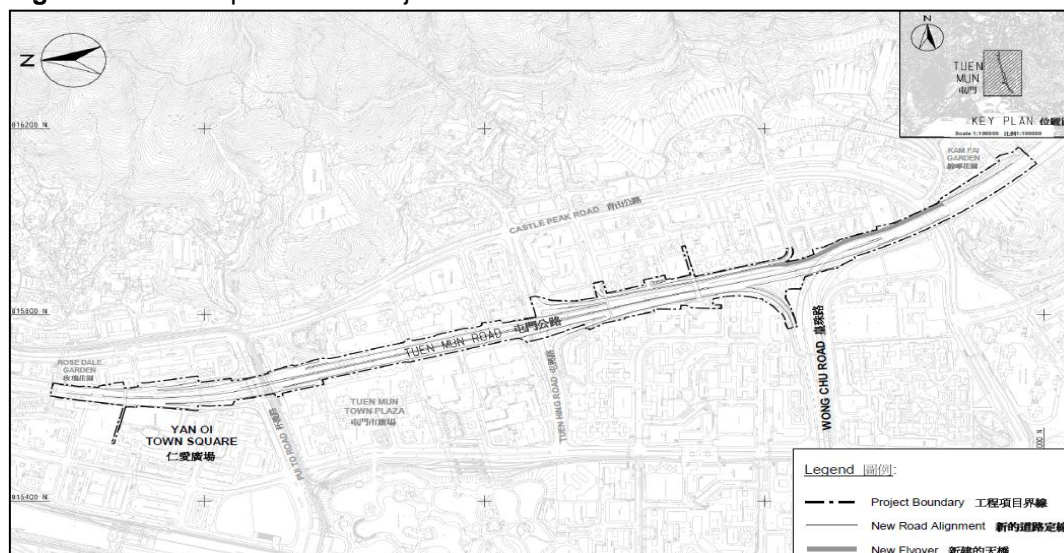
Figure 1.1 Site plan of the Project

Locations	Major Works Undertaken
All area	Footbridge construction, noise barrier construction, underground utilities and drainage diversion, Erection of noise barrier/ enclosure steelworks

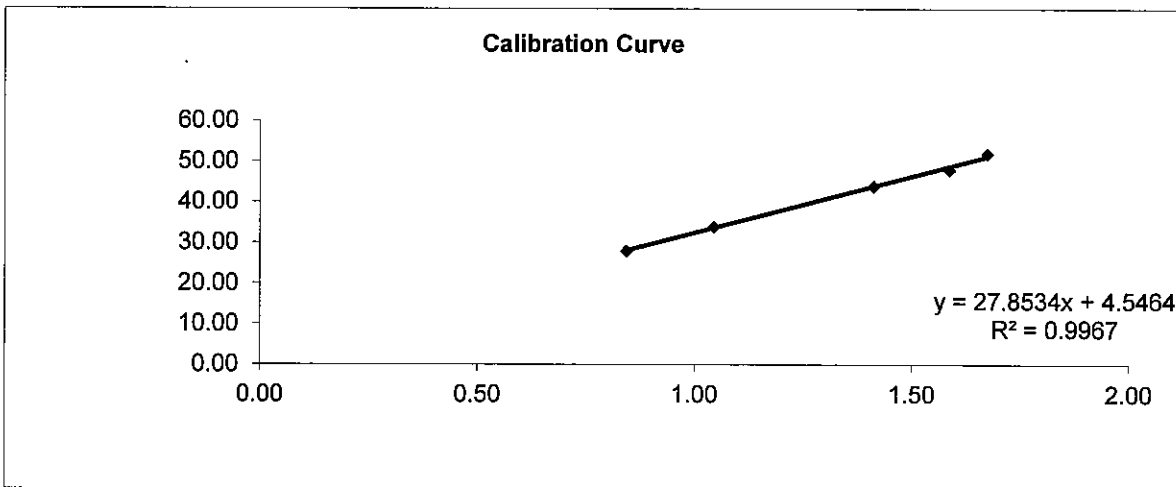
Resistance Plate No.	Manometer Reading (inch H ₂ O)	Flow Recorder Reading (CFM)	Calculated Q _{std} (m ³ /min)	Continuous Flow Recorder Reading IC (CFM)
5	3.00	28.00	0.84	27.93
7	4.60	34.00	1.04	33.91
10	8.40	44.00	1.41	43.88
13	10.60	48.00	1.59	47.87
18	11.80	52.00	1.67	51.86

Linear Regression
 Sampler slope (m) : 27.8534
 Sampler intercept (b) : 4.5464
 Correlation coefficient (R²) : 0.9967

Correlation coefficient is greater than 0.9900 and the calibration result is accepted.

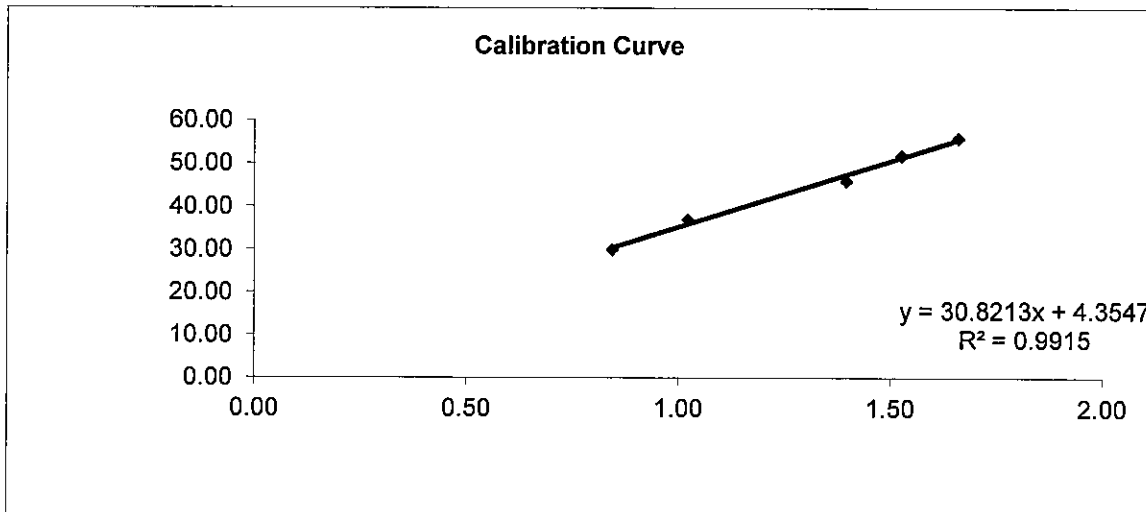
Resistance Plate No.	Manometer Reading (inch H ₂ O)	Flow Recorder Reading (CFM)	Calculated Q _{std} (m ³ /min)	Continuous Flow Recorder Reading IC (CFM)
5	3.00	30.00	0.84	29.92
7	4.40	37.00	1.02	36.90
10	8.20	46.00	1.40	45.88
13	9.80	52.00	1.53	51.86
18	11.60	56.00	1.66	55.85

Sampler slope (m) :	30.8213
Sampler intercept (b) :	4.3547
Correlation coefficient (R ²) :	0.9915

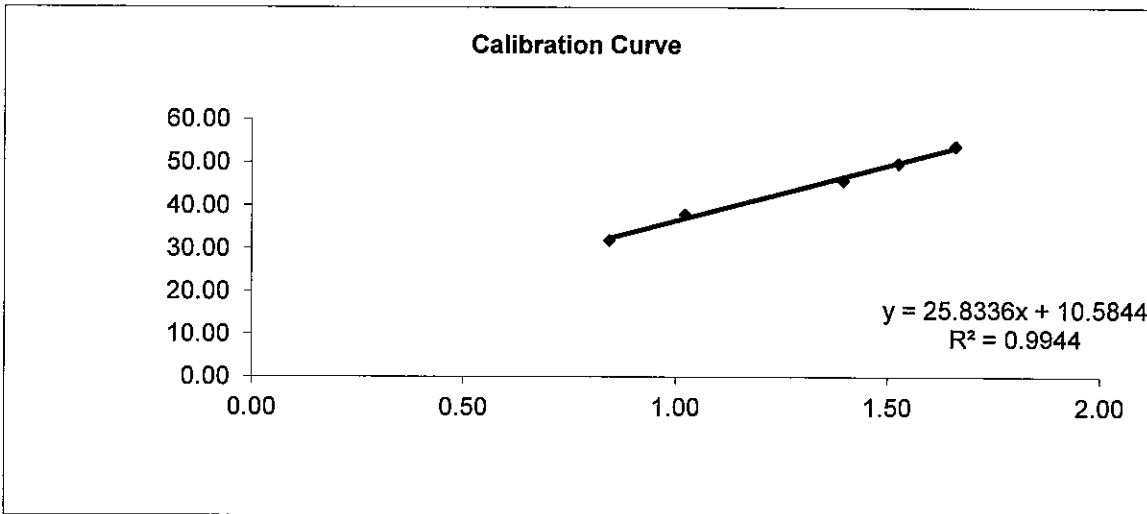
Resistance Plate No.	Manometer Reading (inch H ₂ O)	Flow Recorder Reading (CFM)	Calculated Q _{std} (m ³ /min)	Continuous Flow Recorder Reading IC (CFM)
5	3.00	32.00	0.84	31.92
7	4.40	38.00	1.02	37.90
10	8.20	46.00	1.40	45.88
13	9.80	50.00	1.53	49.87
18	11.60	54.00	1.66	53.86

Sampler slope (m) :	25.8336
Sampler intercept (b) :	10.5844
Correlation coefficient (R ²) :	0.9944

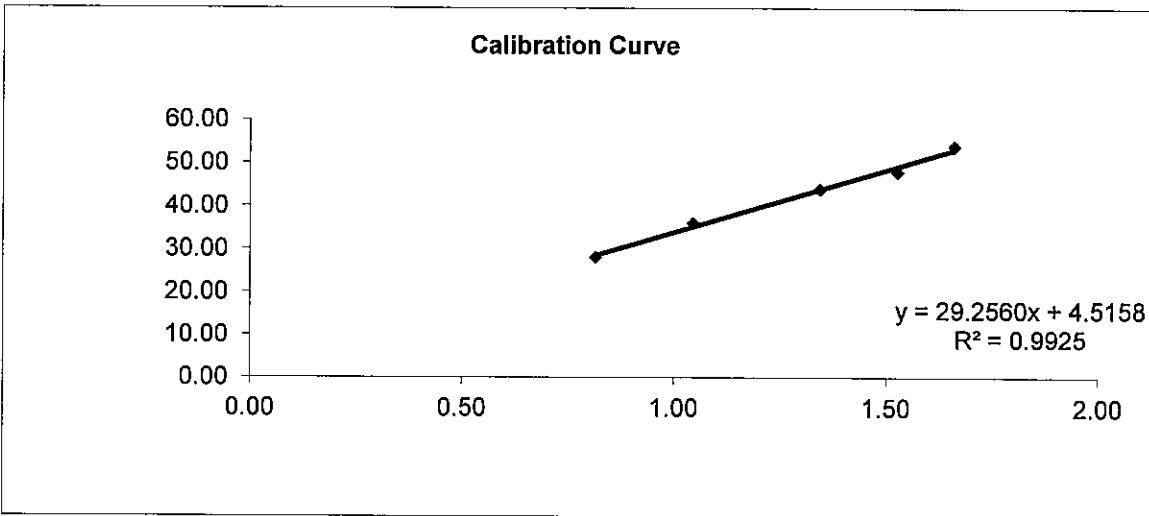
Resistance Plate No.	Manometer Reading (inch H ₂ O)	Flow Recorder Reading (CFM)	Calculated Q _{std} (m ³ /min)	Continuous Flow Recorder Reading IC (CFM)
5	2.80	28.00	0.81	27.93
7	4.60	36.00	1.04	35.91
10	7.60	44.00	1.34	43.88
13	9.80	48.00	1.53	47.87
18	11.60	54.00	1.66	53.86

Linear Regression
 Sampler slope (m) : **29.2560**
 Sampler intercept (b) : **4.5158**
 Correlation coefficient (R²) : **0.9925**

Correlation coefficient is greater than 0.9900 and the calibration result is accepted.

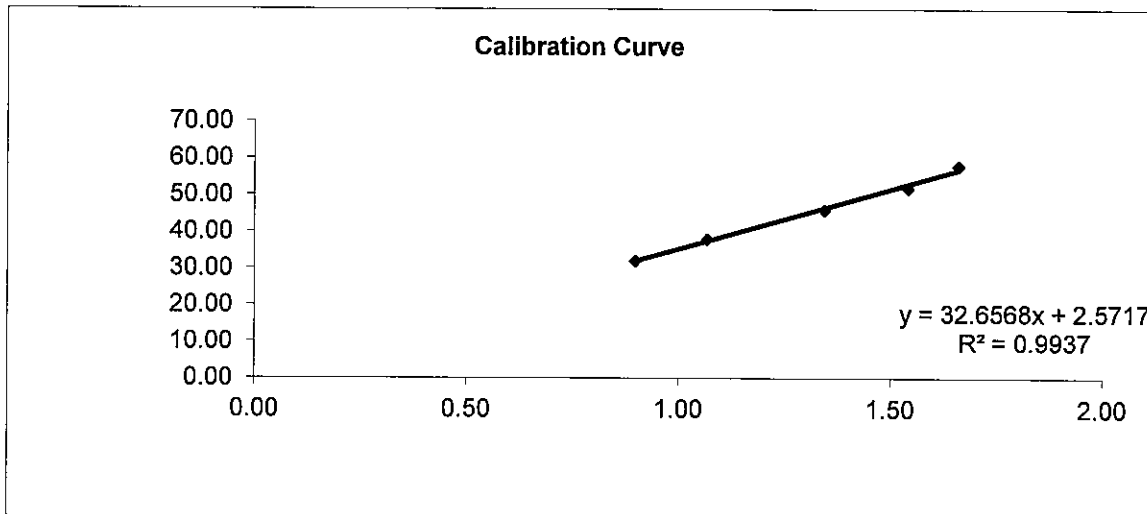
Resistance Plate No.	Manometer Reading (inch H ₂ O)	Flow Recorder Reading (CFM)	Calculated Q _{std} (m ³ /min)	Continuous Flow Recorder Reading IC (CFM)
5	3.40	32.00	0.90	31.92
7	4.80	38.00	1.07	37.90
10	7.60	46.00	1.34	45.88
13	10.00	52.00	1.54	51.86
18	11.60	58.00	1.66	57.85

Sampler slope (m) :	32.6568
Sampler intercept (b) :	2.5717
Correlation coefficient (R ²) :	0.9937

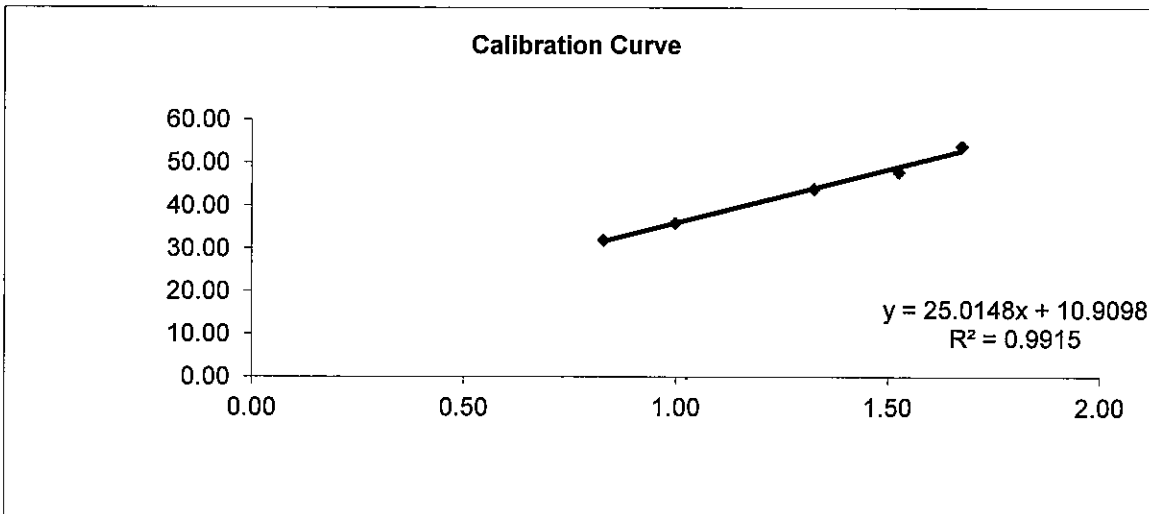
Resistance Plate No.	Manometer Reading (inch H ₂ O)	Flow Recorder Reading (CFM)	Calculated Q _{std} (m ³ /min)	Continuous Flow Recorder Reading IC (CFM)
5	2.90	32.00	0.83	31.92
7	4.20	36.00	1.00	35.91
10	7.40	44.00	1.33	43.88
13	9.80	48.00	1.53	47.87
18	11.80	54.00	1.67	53.86

Linear Regression
 Sampler slope (m) : **25.0148**
 Sampler intercept (b) : **10.9098**
 Correlation coefficient (R²) : **0.9915**

Correlation coefficient is greater than 0.9900 and the calibration result is accepted.
