Contract No. EP/SP/58/08
Sludge Treatment Facilities
Environmental Monitoring and Audit Report
For
October 2012

MaterialLab Ref No.: 100440EN121192

Date : 05 November 2012

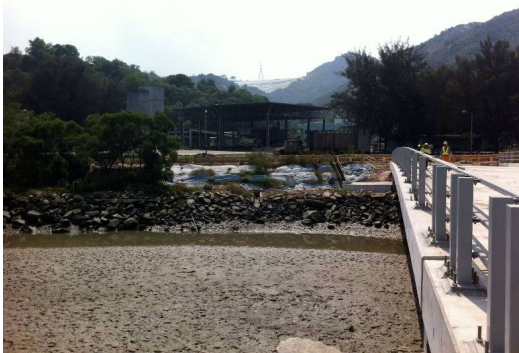
<p>3. Photographic Record of the Original Transplant Trees Location</p>

<p>The new tree plantings will be proposed on the either side of the bridge at portion 6 to fulfil the EIA requirement.</p>	
<p>4. Photographic Record of the Compensatory Tree Locations</p>

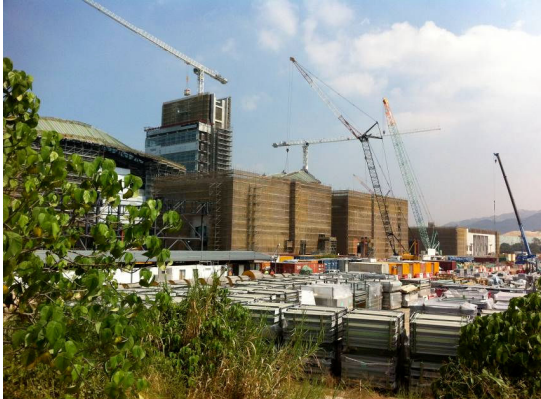
<p>More compensatory trees will be added for the dead transplant trees, which should be reflected in the tree felling resubmission. Final locations of the compensatory planting to be verified on site by the contractor. These shall be reflected in the revised compensatory proposal as well.</p>	
<p>5. Photographic Record of the Night-Time Working</p>

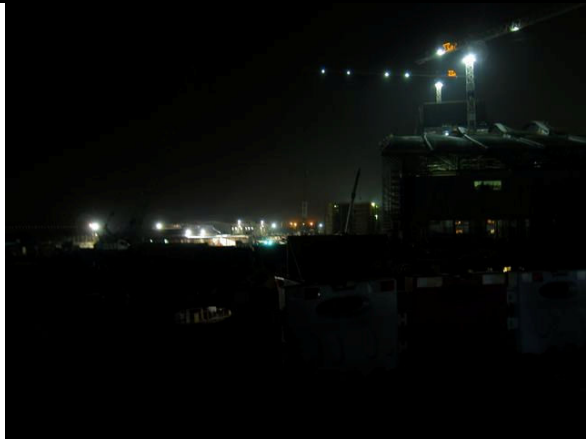
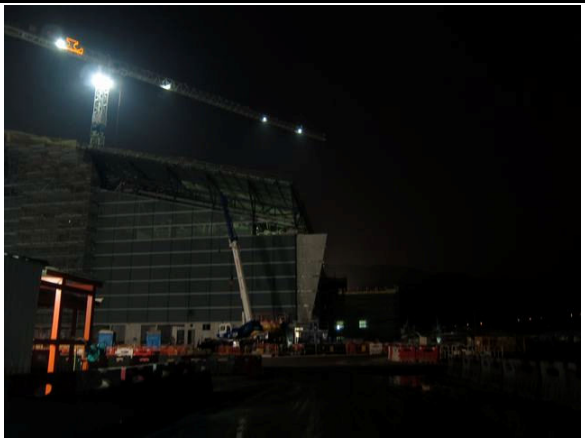
<p>The lighting during night-time working is confined within the working area within the site boundary. Periphery area and the sensitive receivers are not affected by the lighting during night-time working.</p>	<p>The lighting during night-time working is confined within the working area within the site boundary. Periphery area and the sensitive receivers are not affected by the lighting during night-time working.</p>
