Ref No.: 100440EN121501

Contract No. EP/SP/58/08
Sludge Treatment Facilities
Environmental Monitoring and Audit Report
For
November 2012

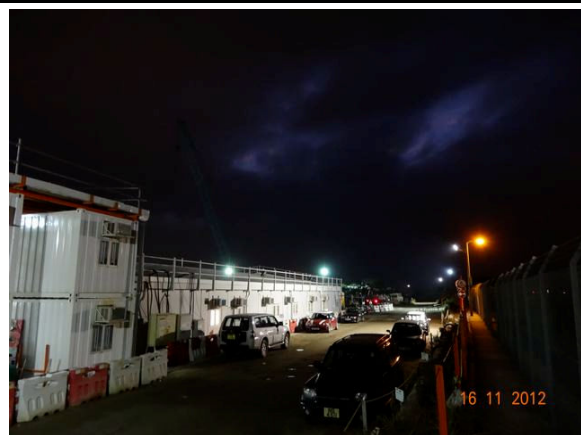
5. Photographic Record of the Night-Time Working

The lighting during night-time working is confined within the working area within the site boundary. Periphery area and the sensitive receivers are not affected by the lighting during night-time working.

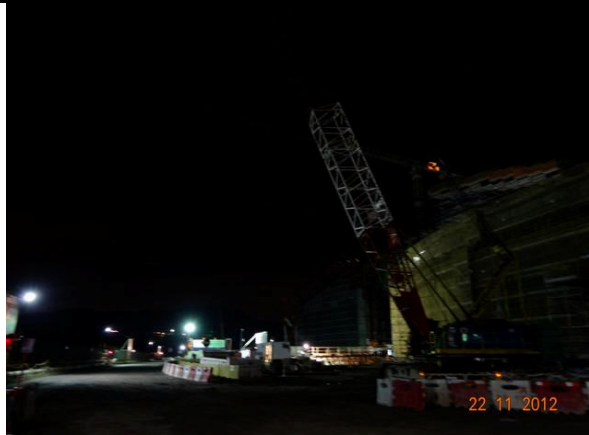
The lighting during night-time working is confined within the working area within the site boundary. Periphery area and the sensitive receivers are not affected by the lighting during night-time working.

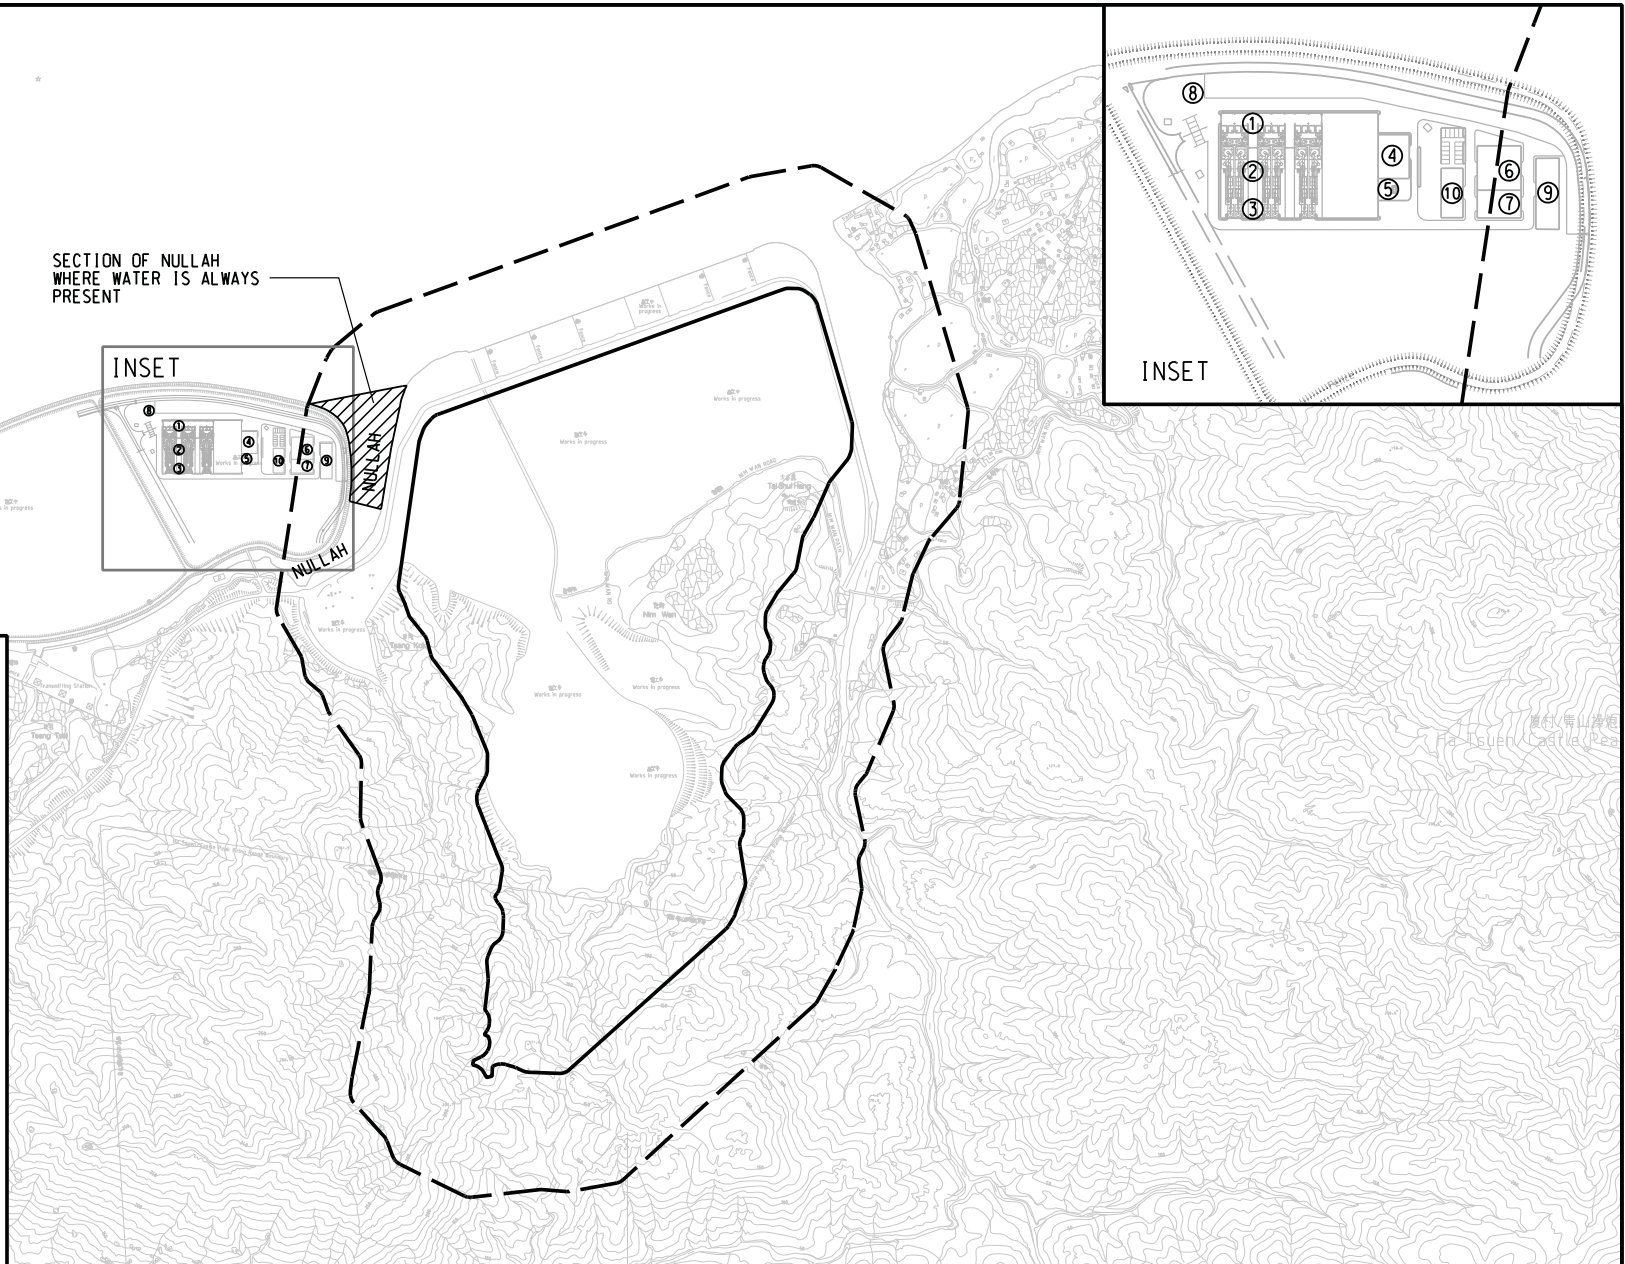
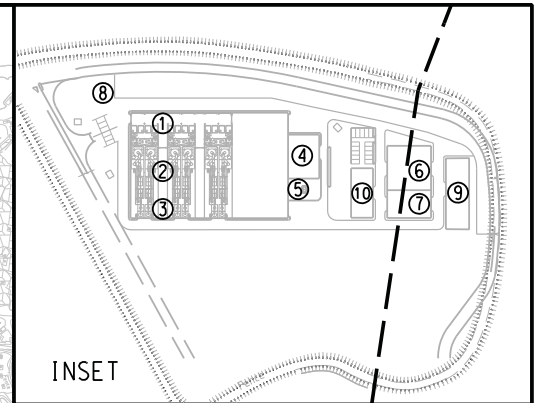
Figure 3.1
Site Layout Plan

- ① DELIVERY BAY
- ② INCINERATORS AND AIR CONTROL EQUIPMENT
- ③ FUEL GAS RESIDUE SILOS, ASH SILOS & LOADING AREA
- ④ CHEMICAL / FUEL STORAGE AND FEEDING
- ⑤ STACK
- ⑥ ADMINISTRATION BUILDING & LABORATORY
- ⑦ MAINTENANCE WORKSHOP
- ⑧ UTILITY YARD
- ⑨ DESALINATION PLANT, SEAWATER PUMPING STATION & STORAGE TANK
- ⑩ SEWAGE TREATMENT WORKS

The Contractor, VW-VES (HK) Limited, has been awarded a contract by the Environmental Protection Department of the Government of the Hong Kong Special Administrative Region for the Sludge Treatment Facilities. The location of the site is shown in Figure 3.1.
