ROAD WORKS at WEST KOWLOON

(No. EP-366/2009/A)

Environmental Monitoring and Audit Report No. 76

(October 2017)

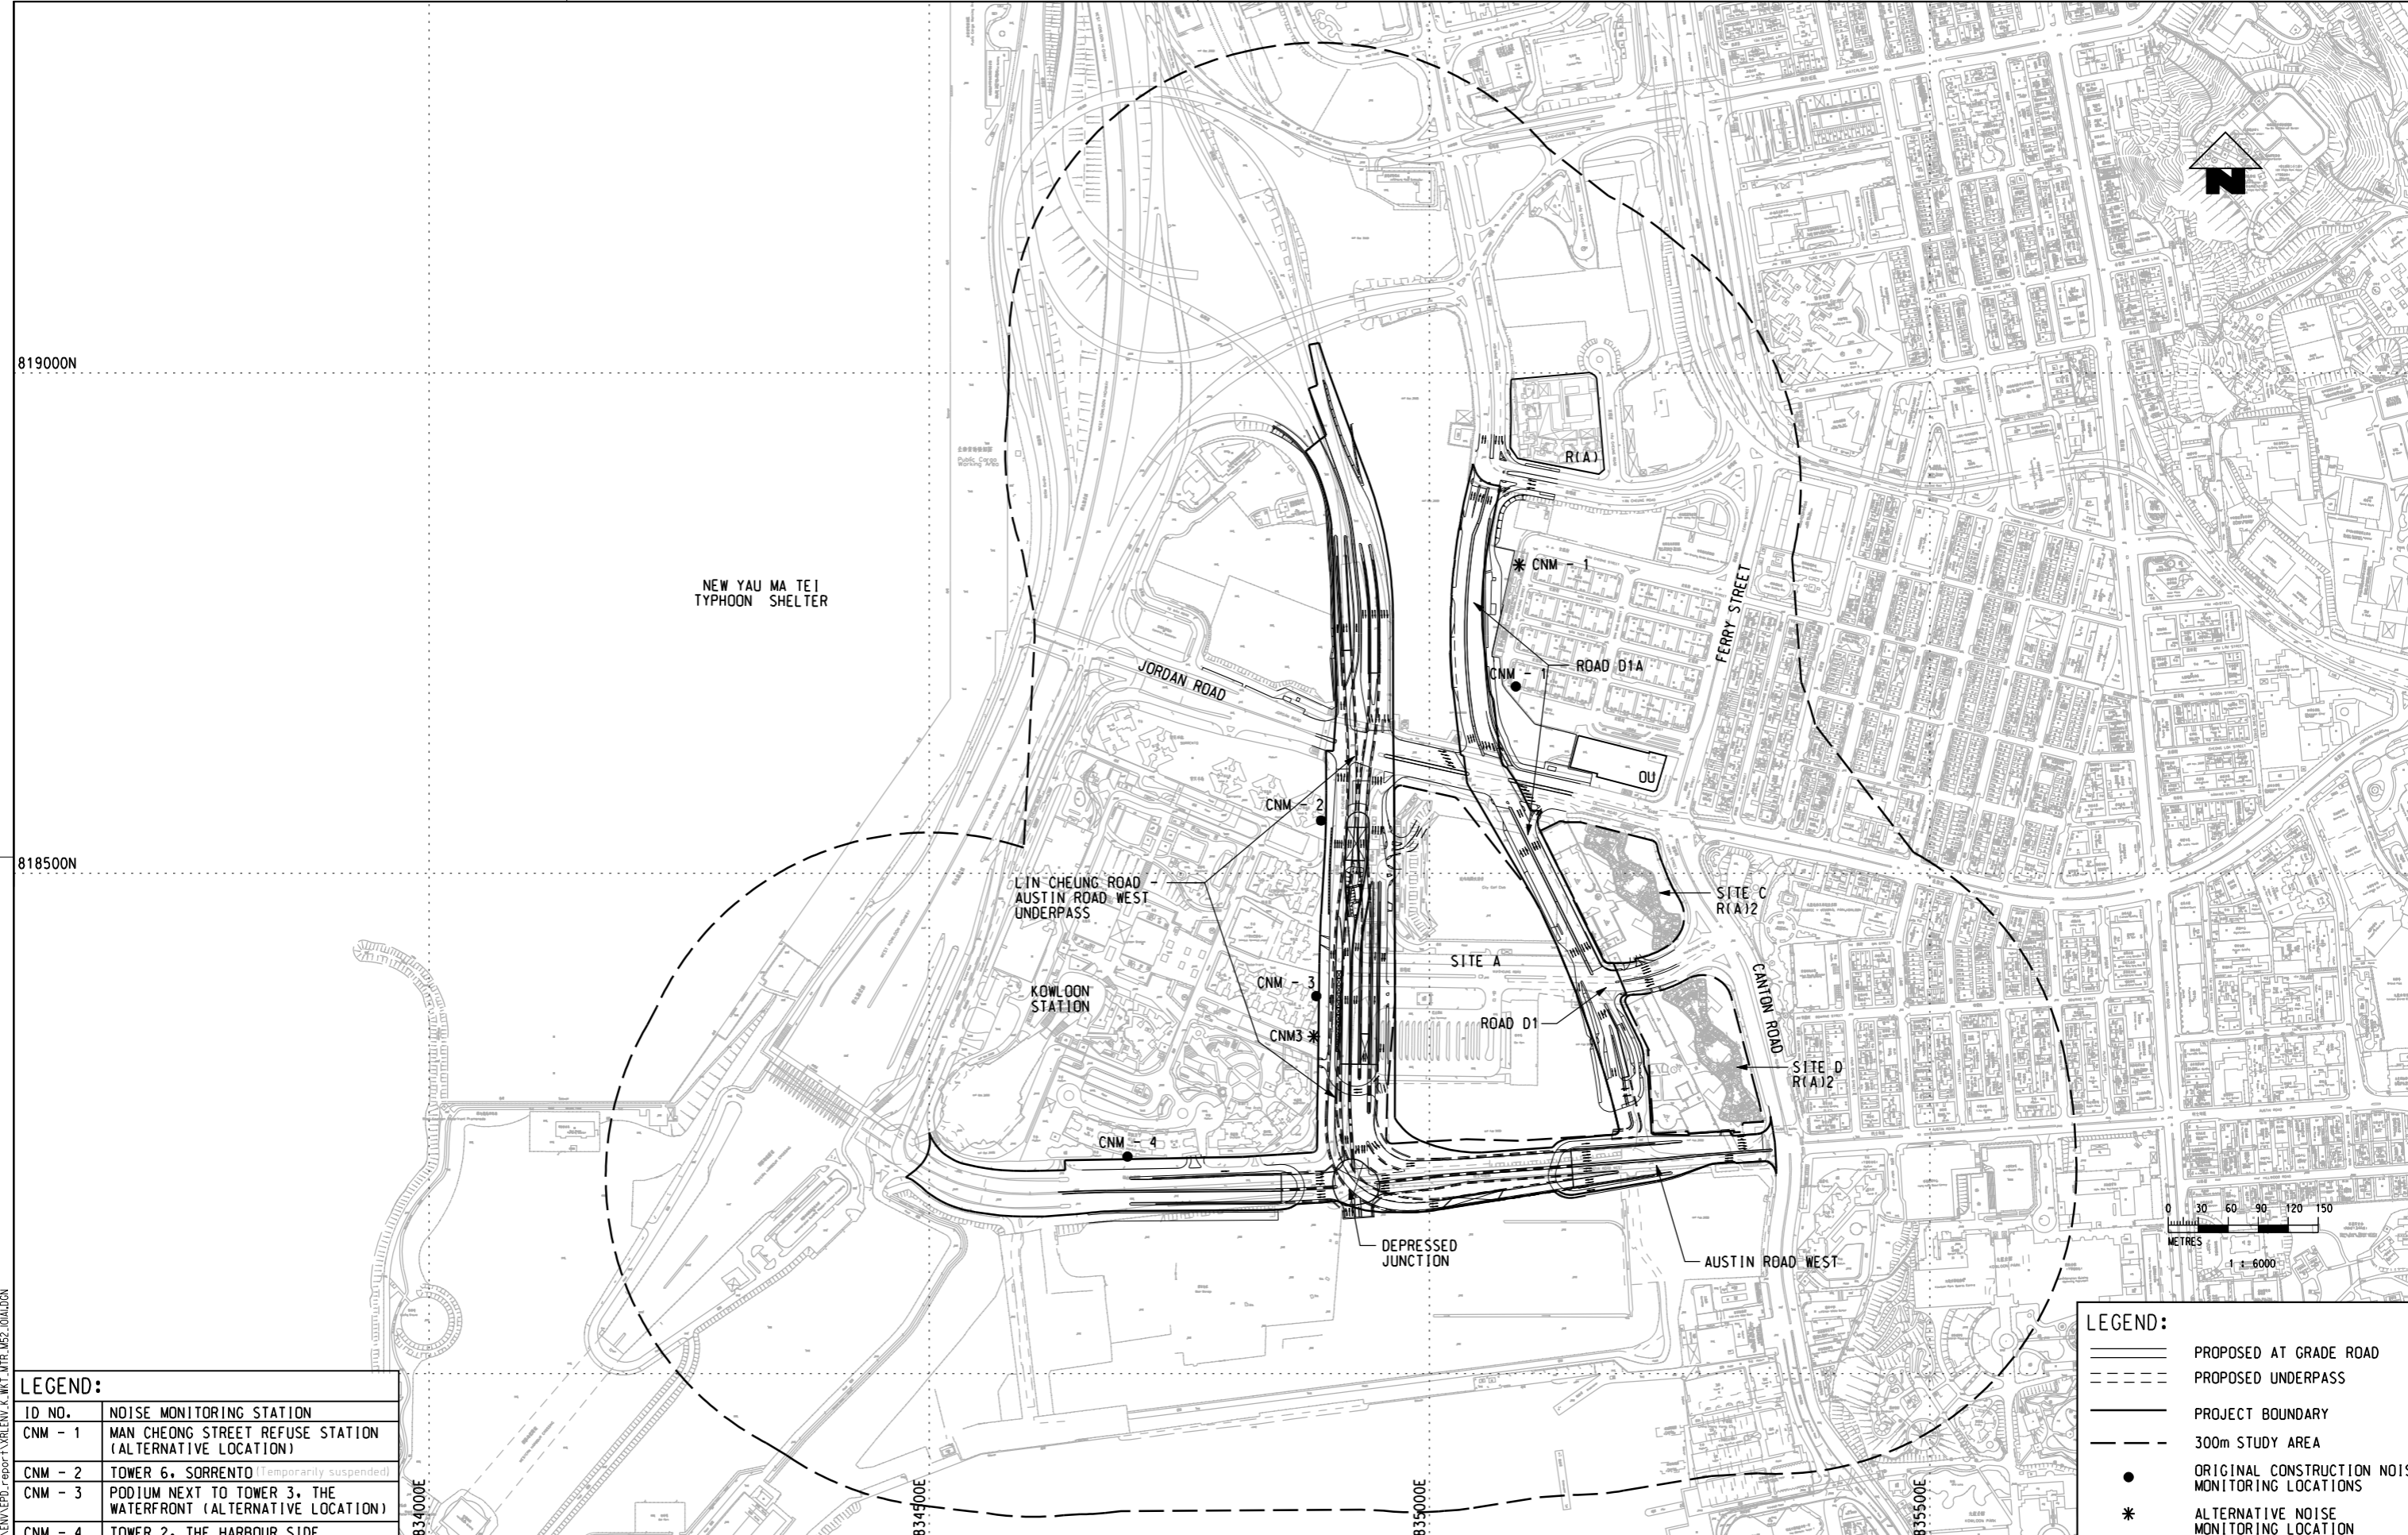
| ID NO. | NOISE MONITORING STATION |
