# ROADWORKS AT WEST KOWLOON

Final Environmental Monitoring and Audit Report  
(Revision 01)

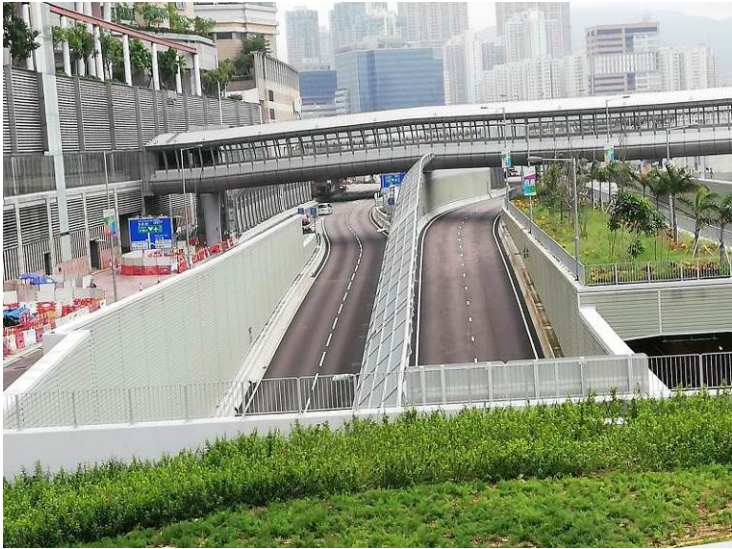
EIA/EP Ref.	Photo Records
<p>3.34 and Figure C8017/C/XRL/ENS/M52/013</p>	<p>Example photo showing the low noise road surfacing which extended further at least 30m into the underpass at each opening</p>

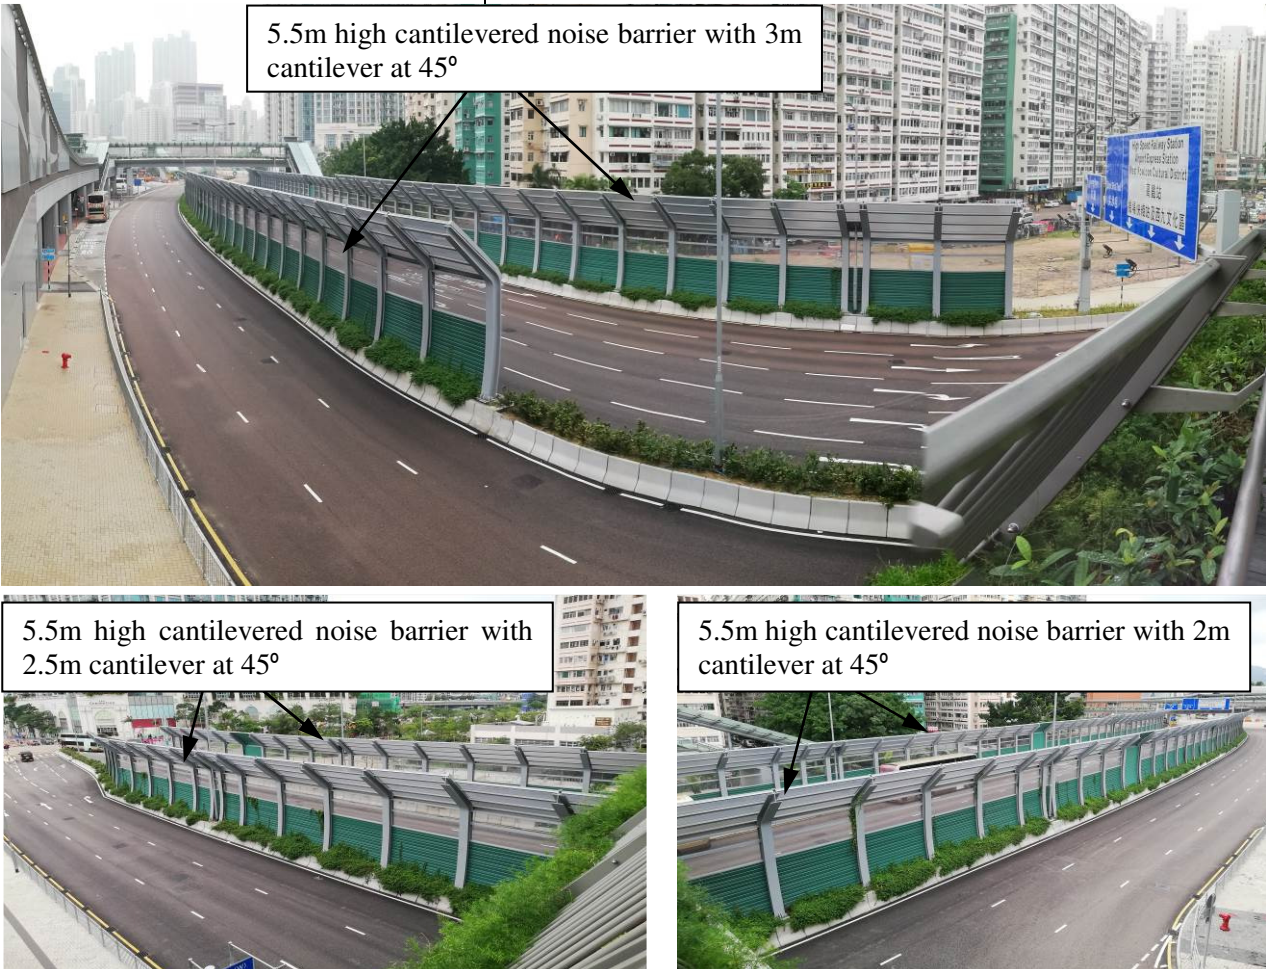
<p>3.33, Table 3.2 and Figure C8017/C/XRL/ENS/M52/004 of a submission in 2018 under EP condition 2.6</p>	<p>The locations of the cantilevered noise barriers in Road D1A(N).</p>

<p>5.5m high cantilevered noise barrier with 3m cantilever at 45°</p> <p>5.5m high cantilevered noise barrier with 2.5m cantilever at 45°</p> <p>5.5m high cantilevered noise barrier with 2m cantilever at 45°</p>

3.33, Table 3.2 and Figure C8017/C/XRL/ENS/M52/004 of a submission in 2018 under EP condition 2.6 <sup>[2]</sup>	<ul style="list-style-type: none"> <li>about 80m long of 5.5m high cantilevered noise barrier with 3m cantilever inclined at 45° along the southbound carriageway of Road D1A to the north of Jordan Road.</li> <li>about 55m long of 5.5m high cantilevered noise barrier with 2.5m cantilever inclined at 45° along the central divider of Road D1A to the north of Jordan Road.</li> <li>about 90m long of 5.5m high cantilevered noise barrier with 2m cantilever inclined at 45° along the central divider of Road D1A to the north of Jordan Road.</li> <li>about 60m long of 5.5m high cantilevered noise barrier with 3m cantilever inclined at 45° along the central divider of Road D1A to the north of Jordan Road.</li> <li>about 205m long footbridge (FB14) spanning Lin Cheung Road and Road D1A to the north of Jordan Road.</li> </ul>	To reduce the traffic noise impact.	MTR until maintenance or management agency is assigned. Maintenance responsibilities will be assigned to HyD	Before commencement of road operation	<ul style="list-style-type: none"> <li>Completed.</li> <li>Completed.</li> <li>Completed.</li> <li>Completed.</li> <li>Completed</li> </ul>	<p>Cantilevered noise barriers were installed along central divider of Road D1A(N) in accordance with the EIA and the application for VEP-368/2012. Refer to <b>Appendix I</b> for photos.</p> <p>FB14 was constructed in accordance with the EIA and the application for VEP-368/2012. Refer to <b>Appendix I</b> for photos.</p>

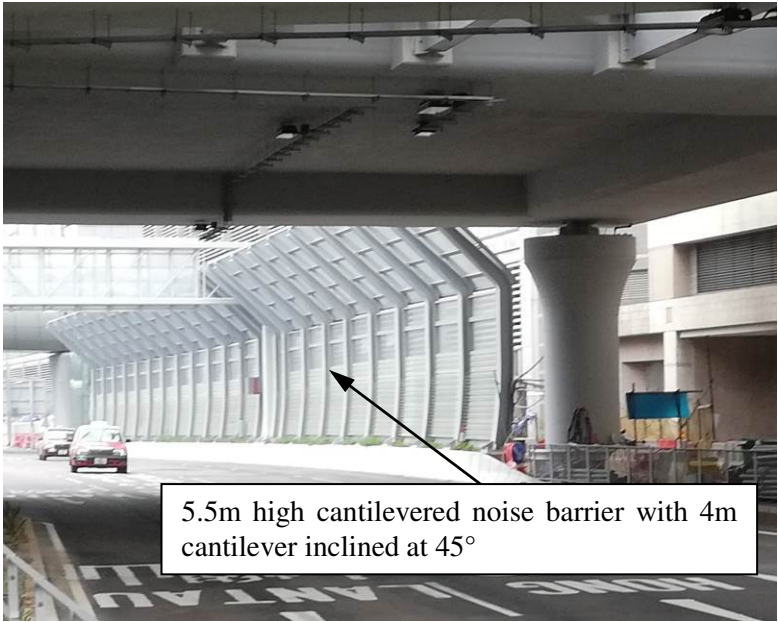
EIA/EP Ref.	Photo Records
<p>Table 3.2 and Figure C8017/C/XRL/ENS/M52/005 of a submission in 2018 under EP condition 2.6</p>	<p>The location of cantilevered noise barrier along N/B carriageway of Lin Cheung Road to south of Jordan Road.</p>

<p>5.5m high cantilevered noise barrier with 4m cantilever inclined at 45°</p>
<p>Table 3.2 and Figure C8017/C/XRL/ENS/M52/005 of a submission in 2018 under EP condition 2.6</p>	<p>The location of vertical barrier on the top of retaining wall at +7.5 mPD along N/B carriageway of Lin Cheung Road to south of Jordan Road.</p>

Table 3.2 and Figure C8017/C/XRL/ENS/M52/005 of a submission in 2018 under EP condition 2.6 <sup>[2]</sup>	<ul style="list-style-type: none"> <li>about 60m long of noise screening structure in the form of either landscape deck or semi-enclosure covering the main carriageway (northbound and southbound) of Lin Cheung Road to the south of Jordan Road.</li> <li>about 95m long of 5.5m high cantilevered noise barrier with 4m cantilever inclined at 45° along the northbound carriageway of Lin Cheung Road to the south of Jordan Road.</li> <li>about 80m long of 3m high vertical barrier on the top of retaining wall at +7.5 mPD along the northbound carriageway of Lin Cheung Road to the south of Jordan Road.</li> </ul>	To reduce the traffic noise impact.	MTR until maintenance or management agency is assigned. Maintenance responsibilities will be assigned to HyD	Before commencement of road operation	<ul style="list-style-type: none"> <li>Completed.</li> <li>Completed.</li> <li>Completed.</li> </ul>	<p>Landscape deck/semi-enclosure was installed over the main carriage (N/B and S/B) of Lin Cheung Road to south of Jordan Road. Refer to <b>Appendix I</b> for photo.</p> <p>Cantilevered noise barrier was installed along N/B carriageway of Lin Cheung Road to south of Jordan Road in accordance with the EIA and the application for VEP-368/2012. Refer to <b>Appendix I</b> for photo.</p> <p>Vertical barrier was installed at N/B carriageway of Lin Cheung Road to south of Jordan Road in accordance with the EIA and the application for VEP-368/2012. Refer to <b>Appendix I</b> for photo.</p>

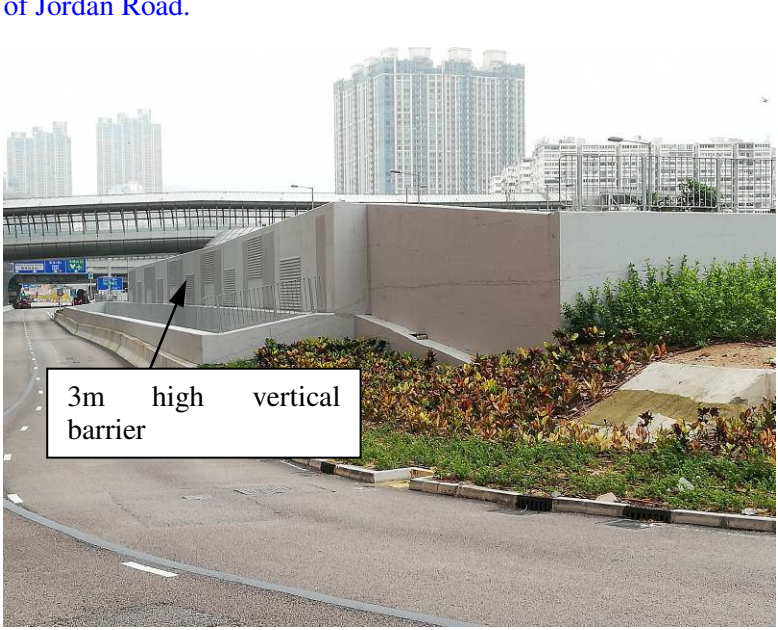
<p>3m high vertical barrier</p>

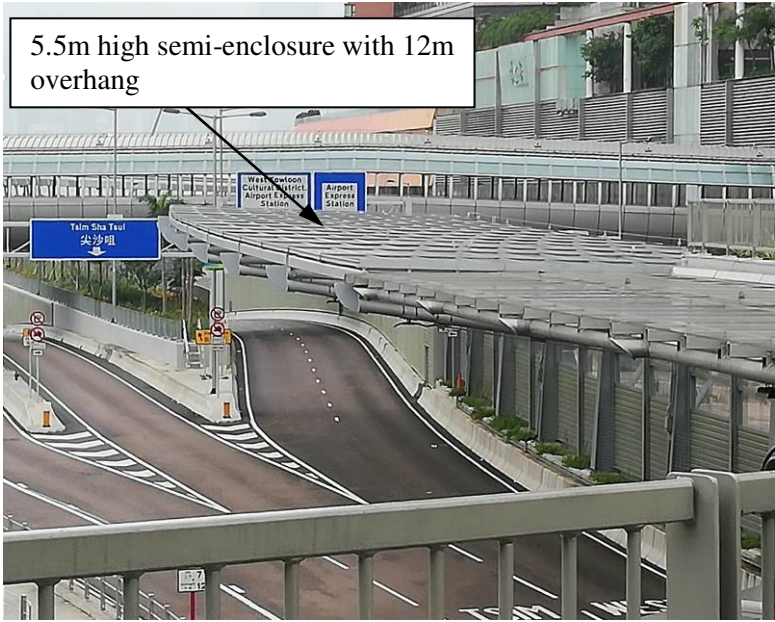
EIA/EP Ref.	Photo Records
<p>Table 3.2 and Figure C8017/C/XRL/ENS/M52/005 of a submission in 2018 under EP condition 2.6</p>	<p>The location of semi-enclosure with overhang along S/B carriageway of Lin Cheung Road to south of Jordan Road.</p>

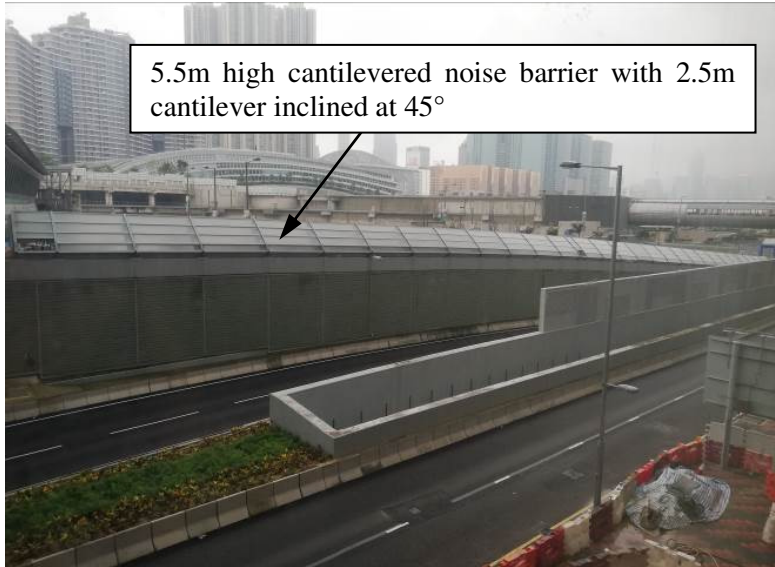
<p>Table 3.2 and Figure C8017/C/XRL/ENS/M52/005 of a submission in 2018 under EP condition 2.6</p>	<p>The location of cantilevered noise barrier along S/B carriageway of Lin Cheung Road to south of Jordan Road.</p>

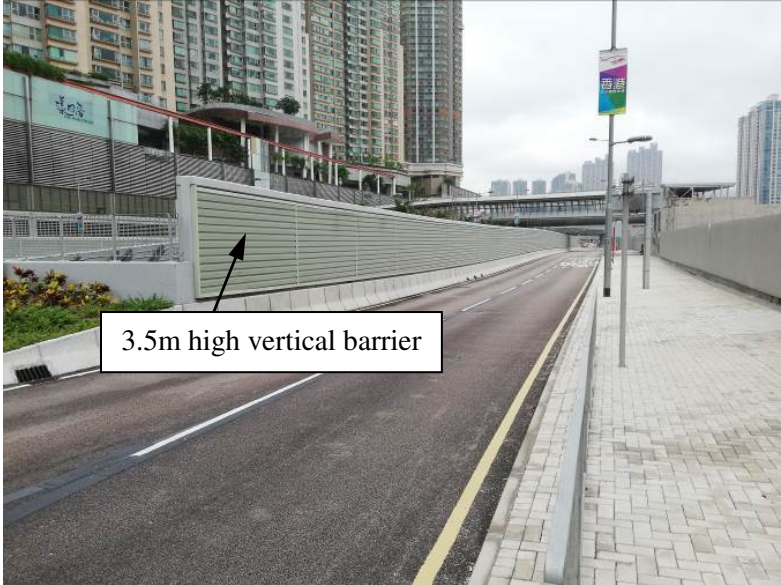
EIA/EP Ref.	Photo Records
<p>Table 3.2 and Figure C8017/C/XRL/ENS/M52/005 of a submission in 2018 under EP condition 2.6</p>	<p>The location of vertical barrier along S/B carriageway of Lin Cheung Road to south of Jordan Road.</p>

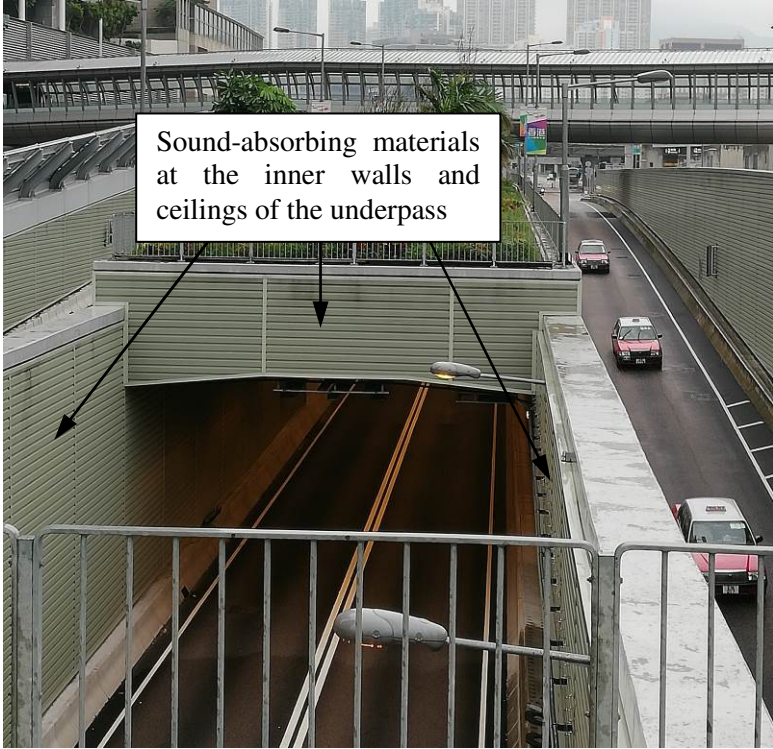
EIA/EP Ref.	Photo Records
3.38	<p>Sample photo showing the sound-absorbing materials installed at the inner walls and ceilings of the underpass extended at least 30m into the underpass at each portal and opening being treated. (arrow)</p>

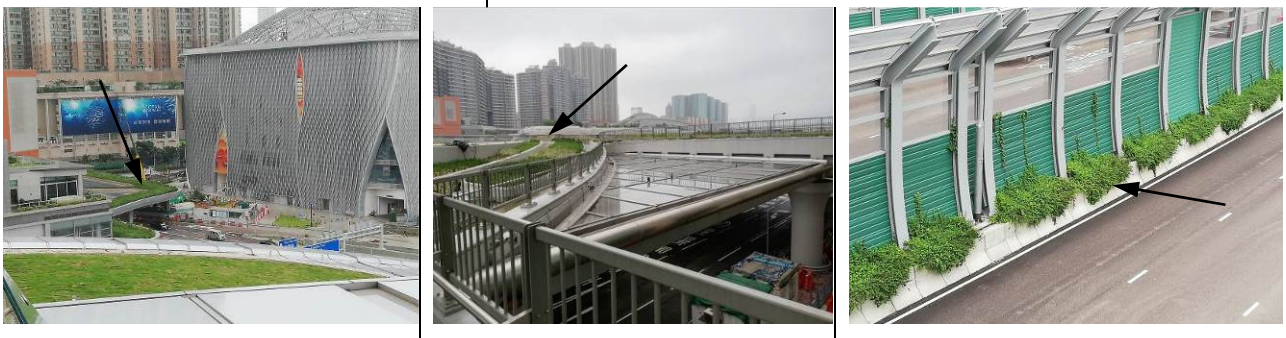
Table 4.2	<p>Sample photos showing aesthetically pleasing design as regard to the form, material and finishes should be incorporated to landscape deck, noise barriers/enclosures, engineering structures and associated infrastructure facilities. (arrow)</p>

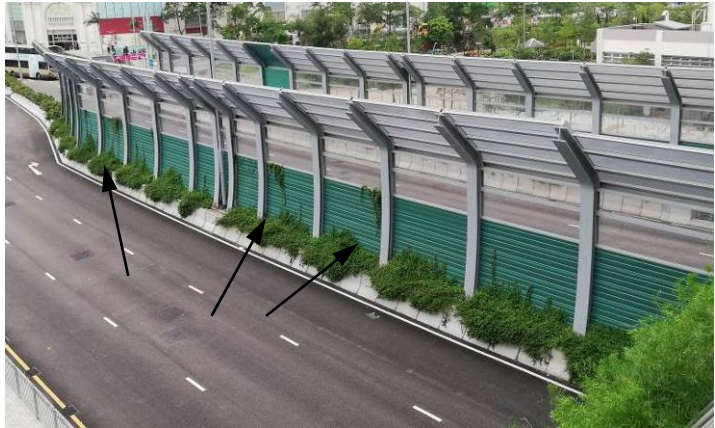
EIA/EP Ref.	Photo Records
Table 4.2	<p data-bbox="651 248 1433 315">Sample photo showing the climbers on wire mesh to soften the noise barriers. (arrow)</p>

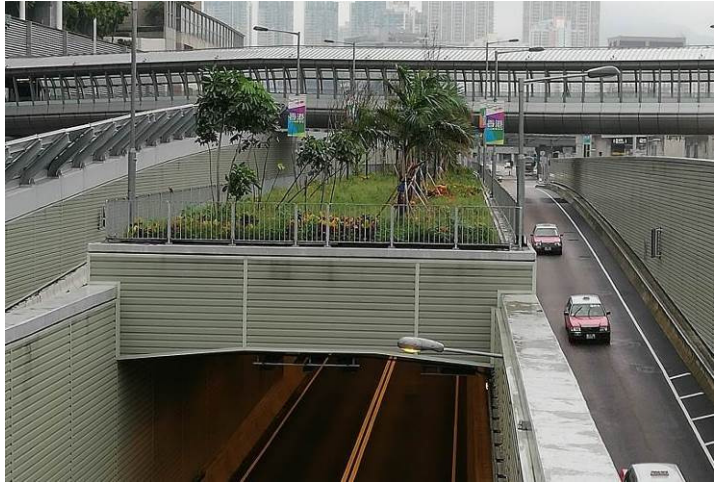
Table 4.2	<p data-bbox="651 797 1433 864">Sample photo showing the buffer tree and shrub planting to screen proposed noise barriers and enclosures</p>

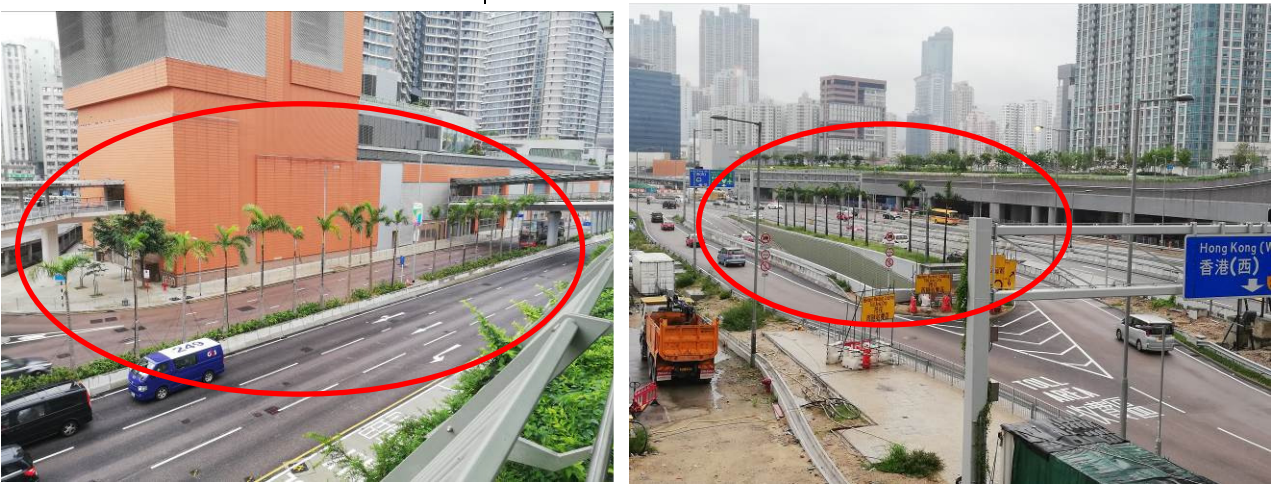
Table 4.2	<p data-bbox="651 1402 1433 1503">Sample photos showing the structures and ornamental tree, shrub planting along roadside amenity areas and central divider to enhance the landscape and visual quality. (circle)</p>

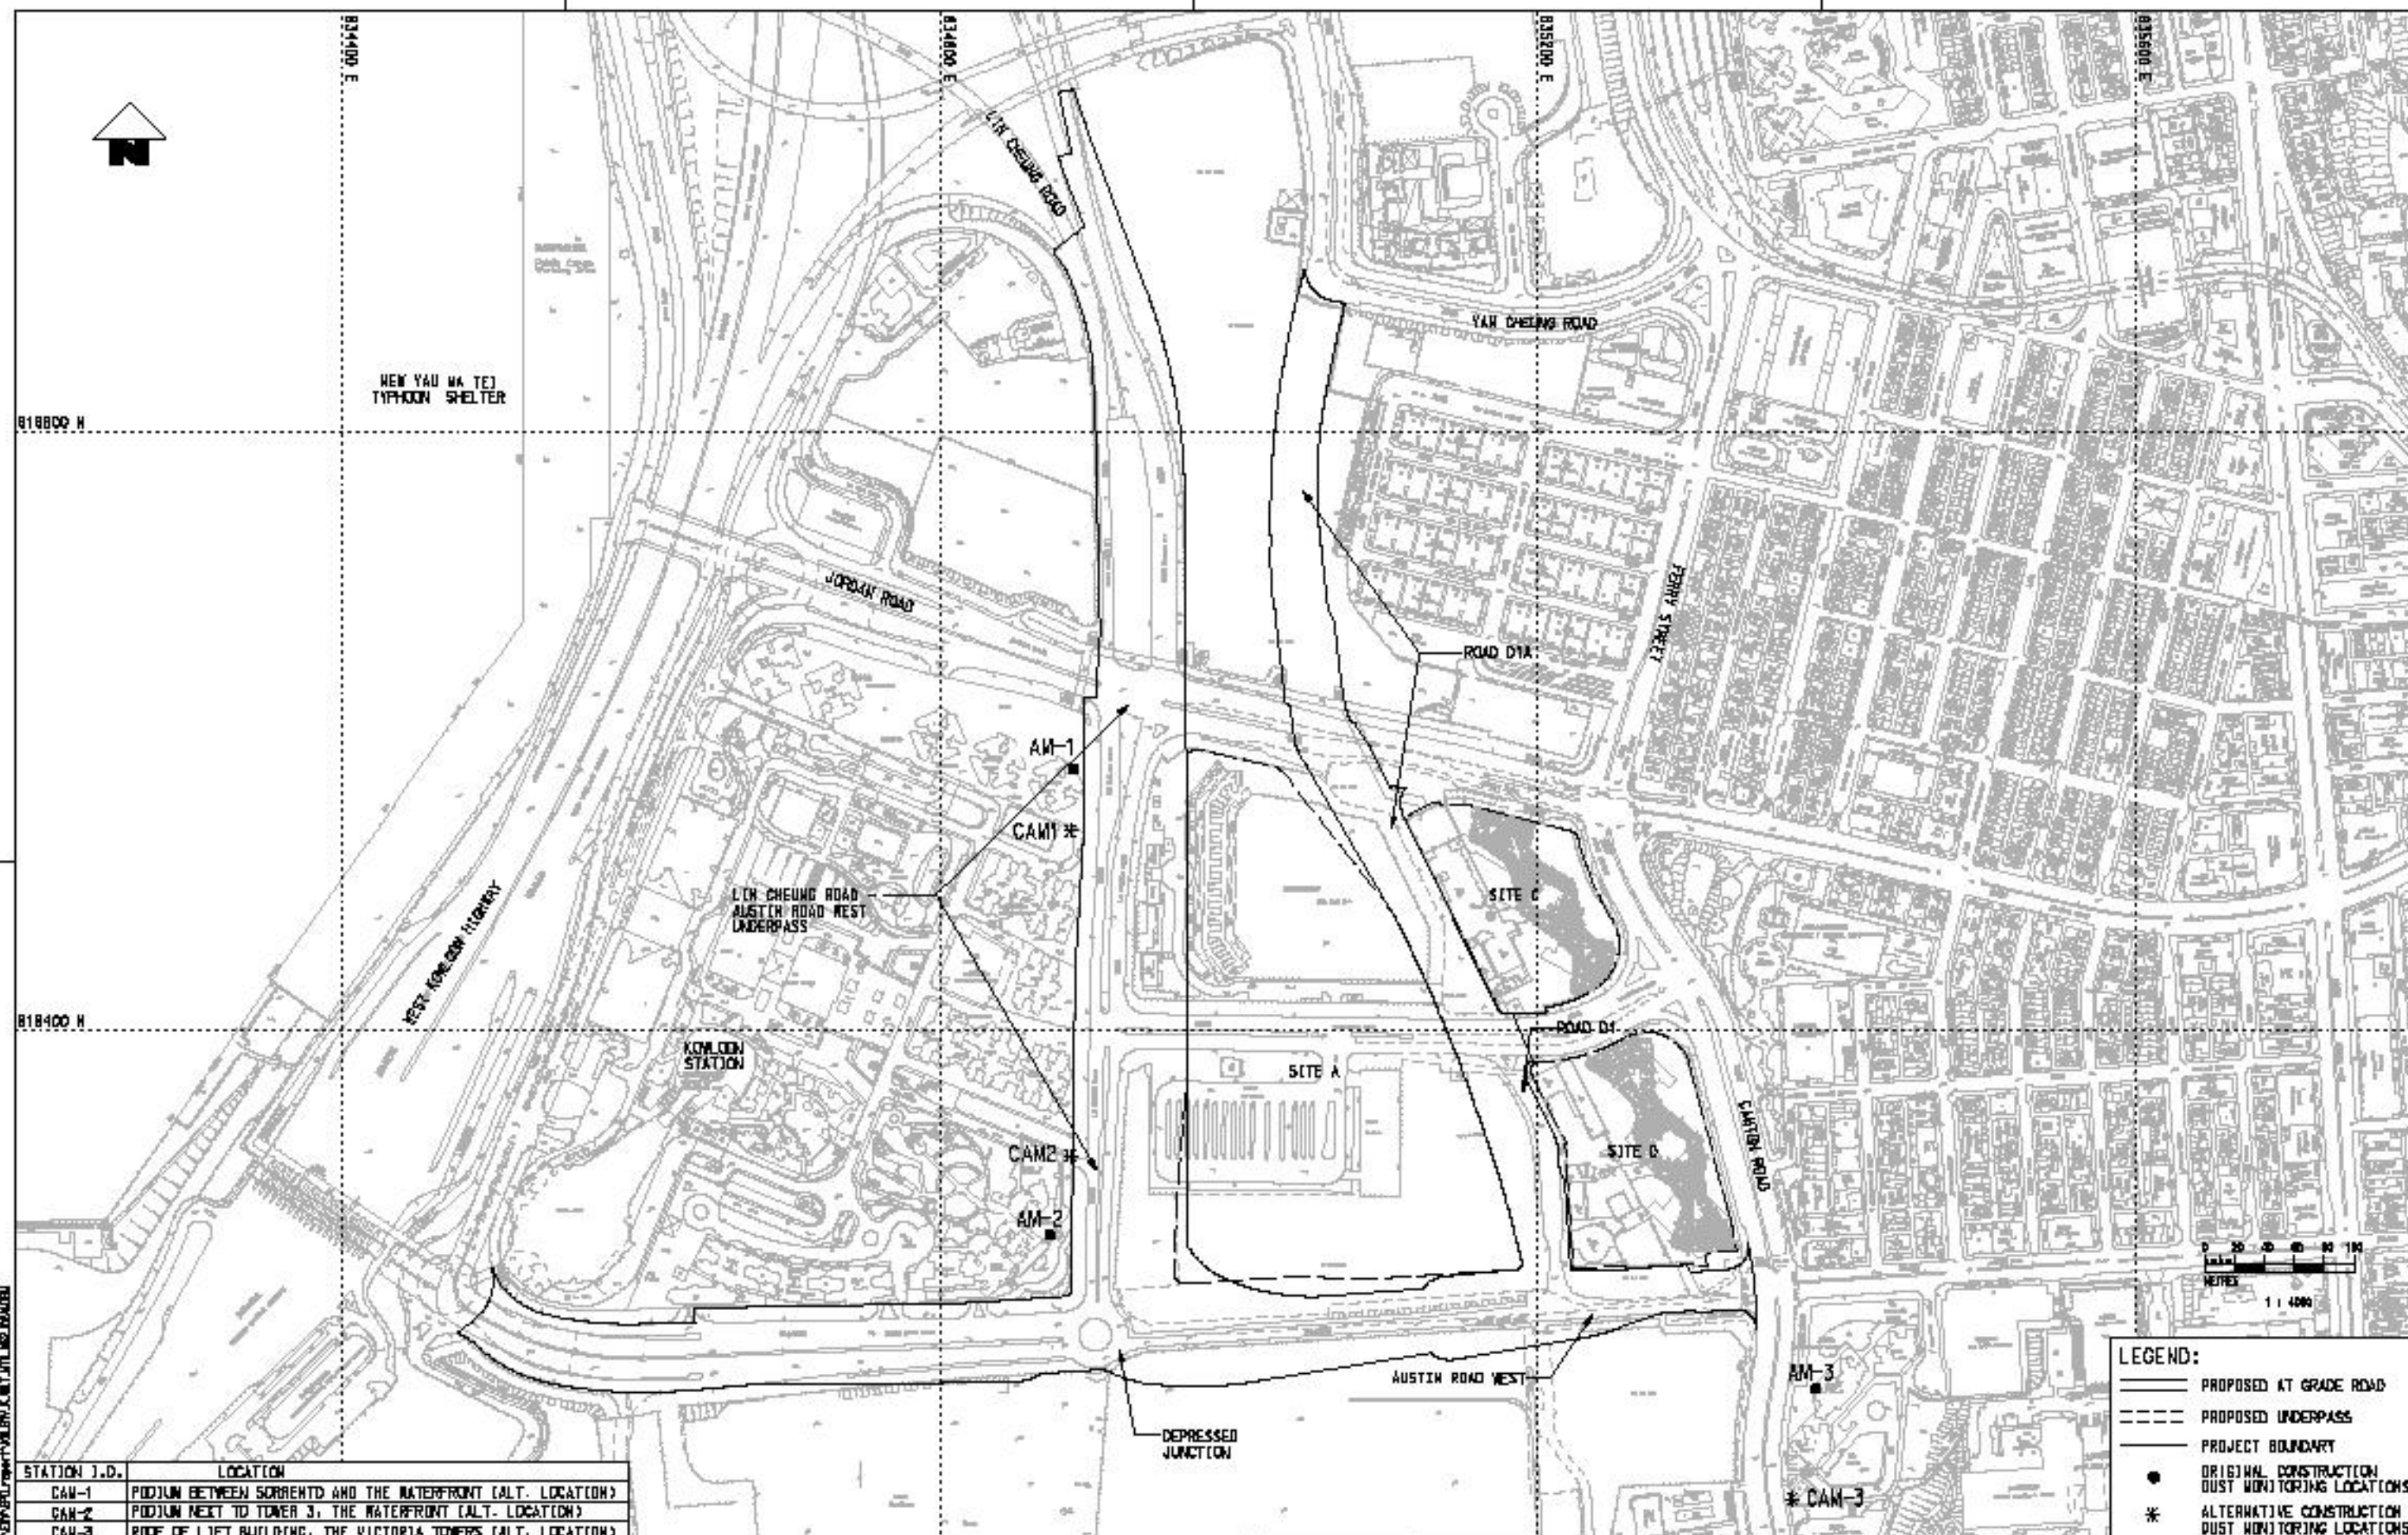
Appendix D  
Monitoring Locations

- PROPOSED AT GRADE ROAD
- PROPOSED UNDERPASS
- PROJECT BOUNDARY
- ORIGINAL CONSTRUCTION DUST MONITORING LOCATIONS
- ALTERNATIVE CONSTRUCTION DUST MONITORING LOCATIONS

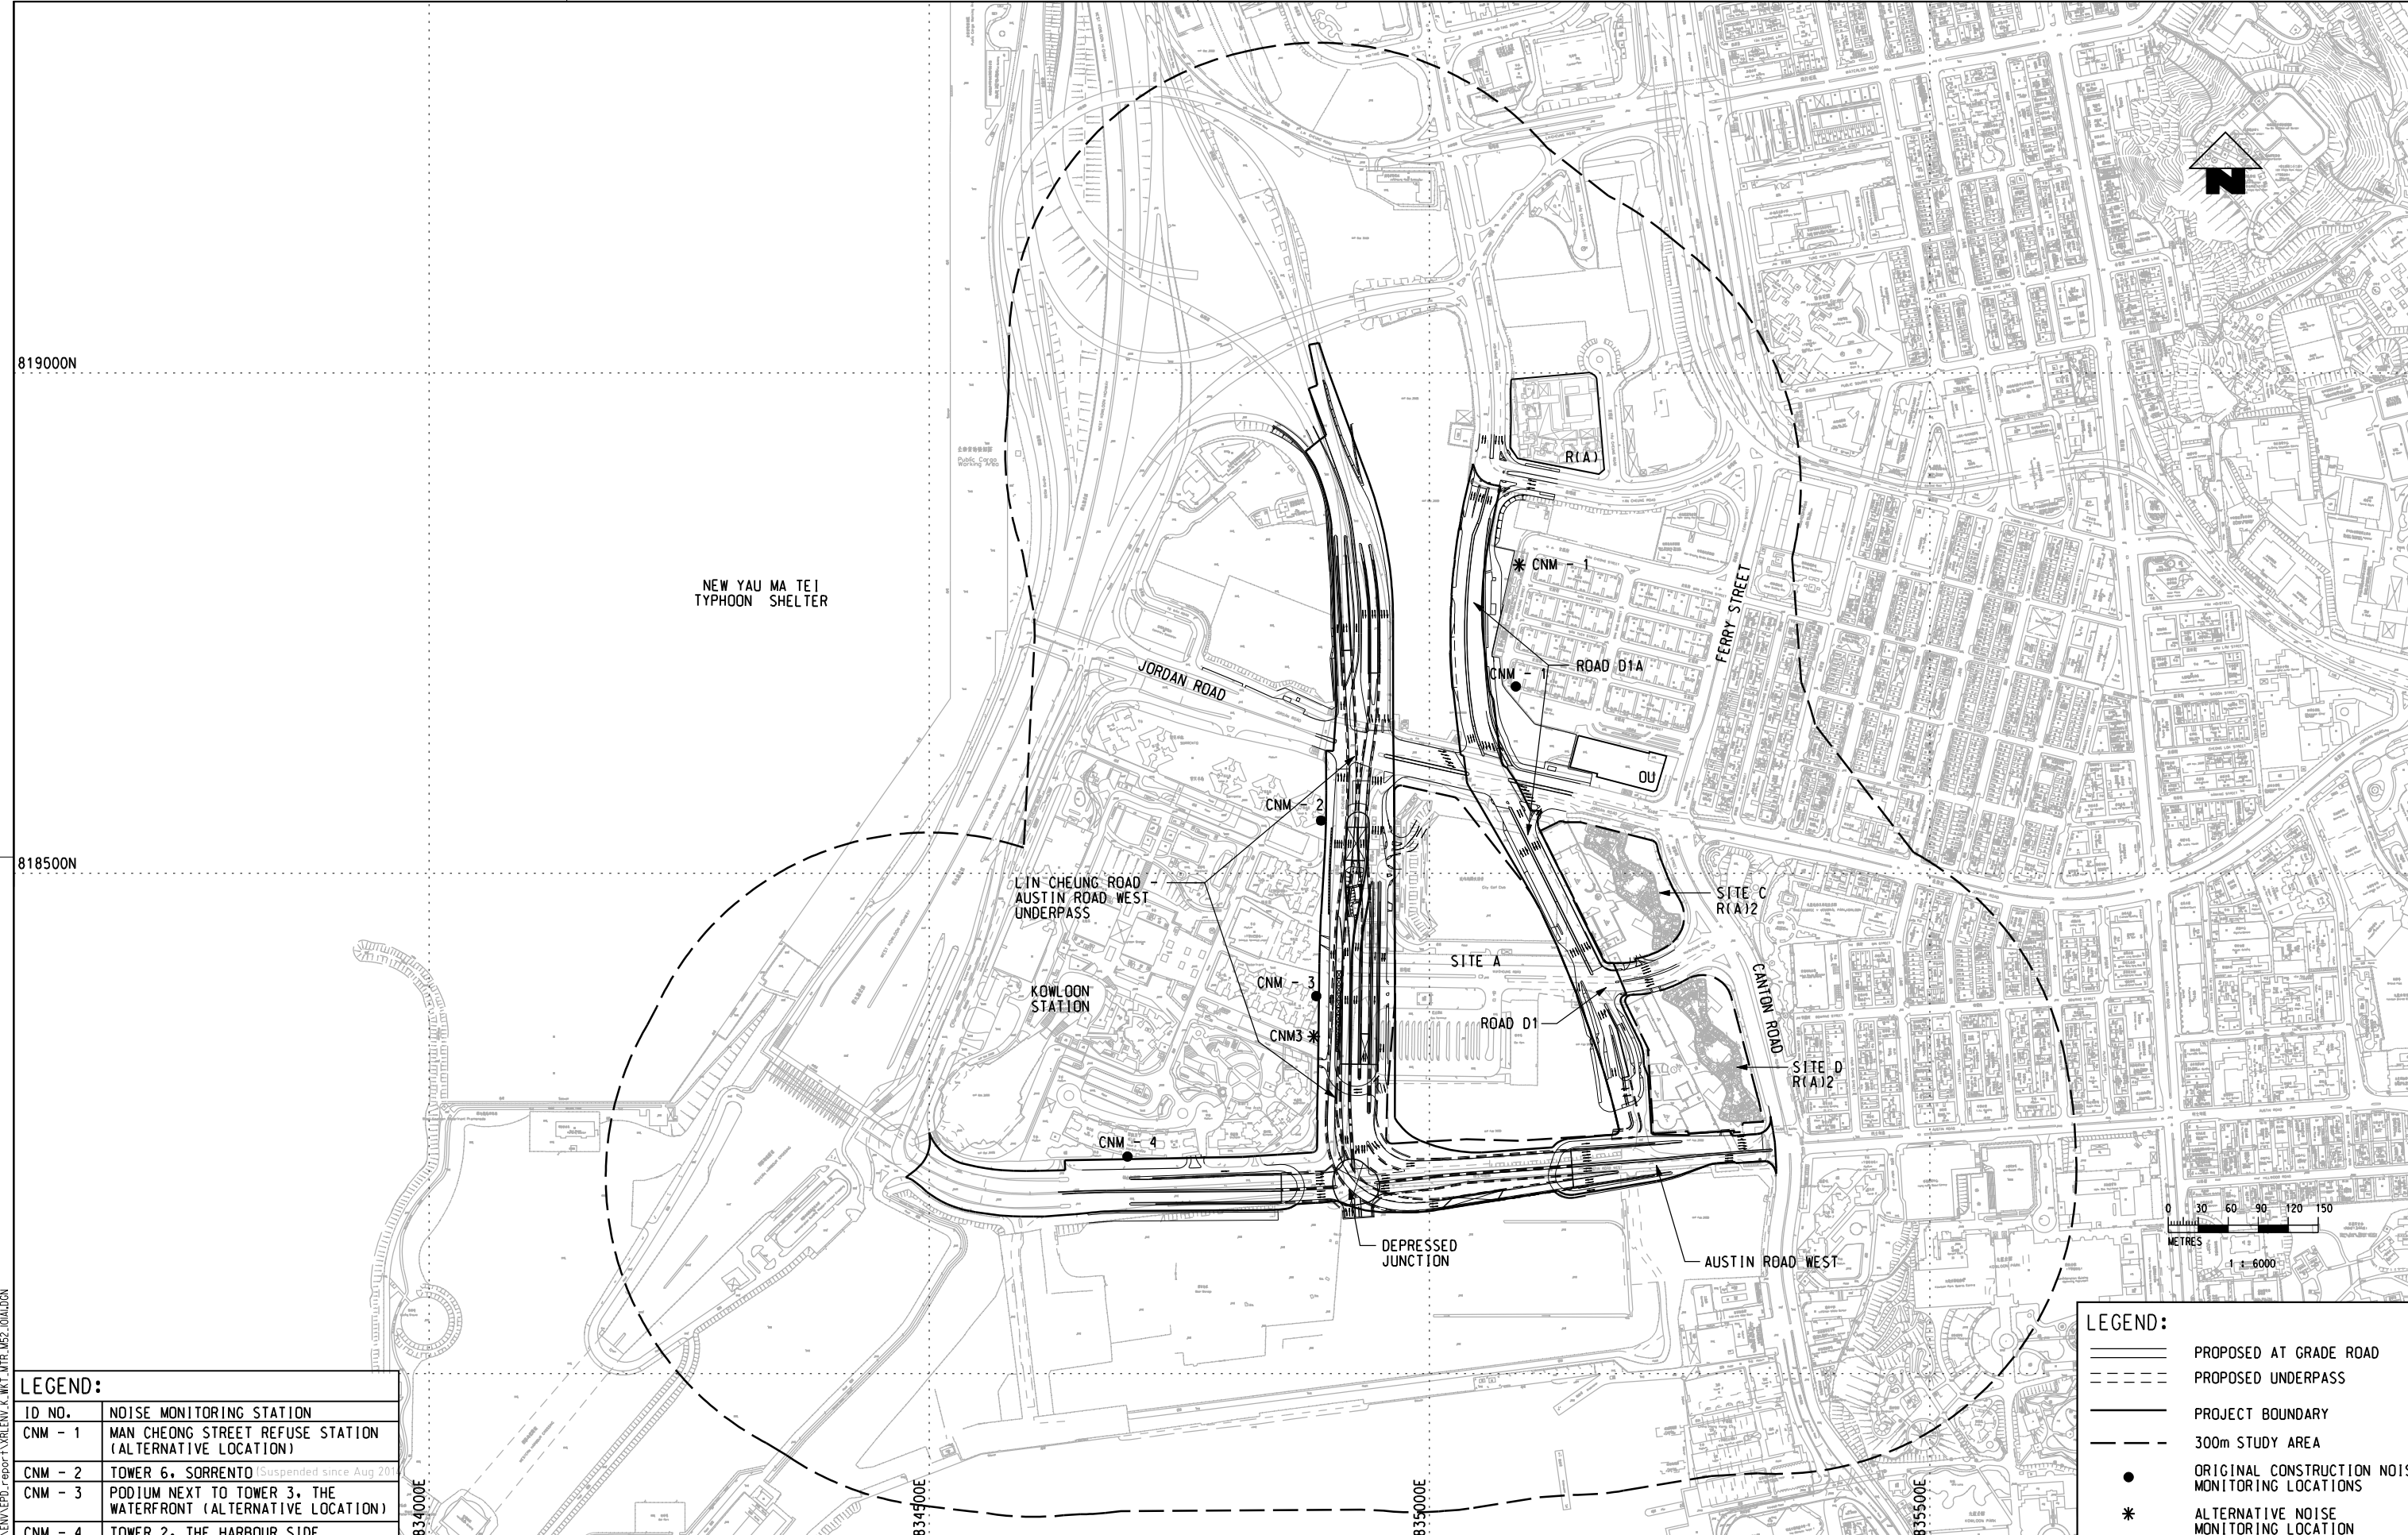
ID NO.	NOISE MONITORING STATION
CNM - 1	MAN CHEONG STREET REFUSE STATION (ALTERNATIVE LOCATION)
CNM - 2	TOWER 6, SORRENTO (Suspended since Aug 2011)
CNM - 3	PODIUM NEXT TO TOWER 3, THE WATERFRONT (ALTERNATIVE LOCATION)
CNM - 4	TOWER 2, THE HARBOUR SIDE

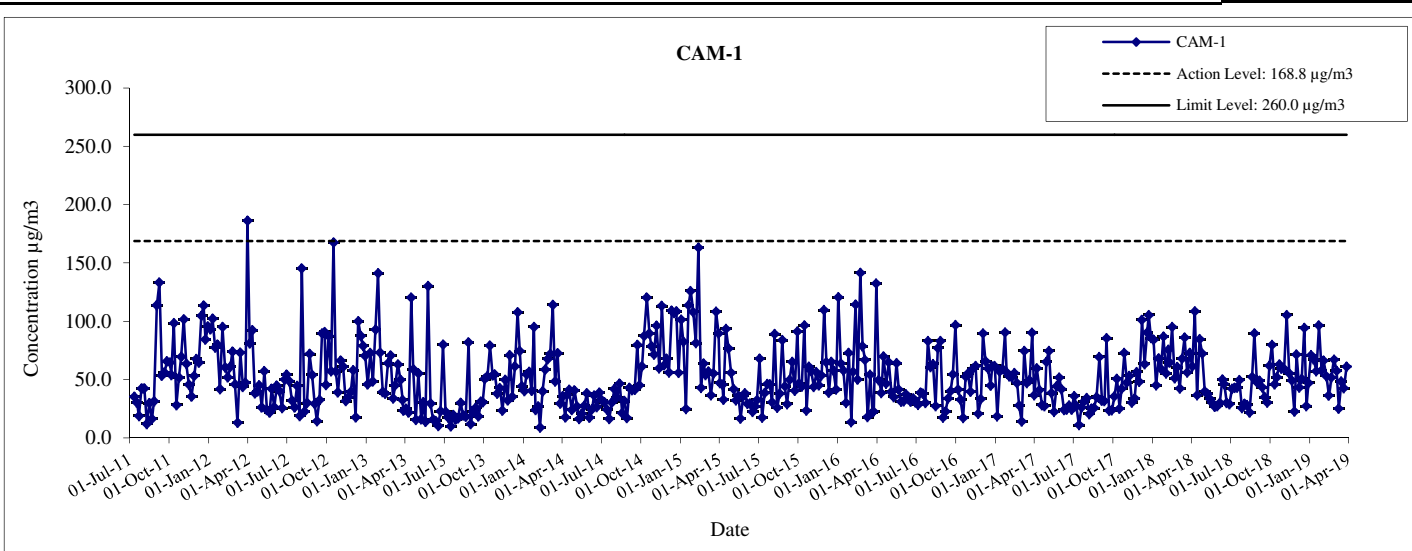
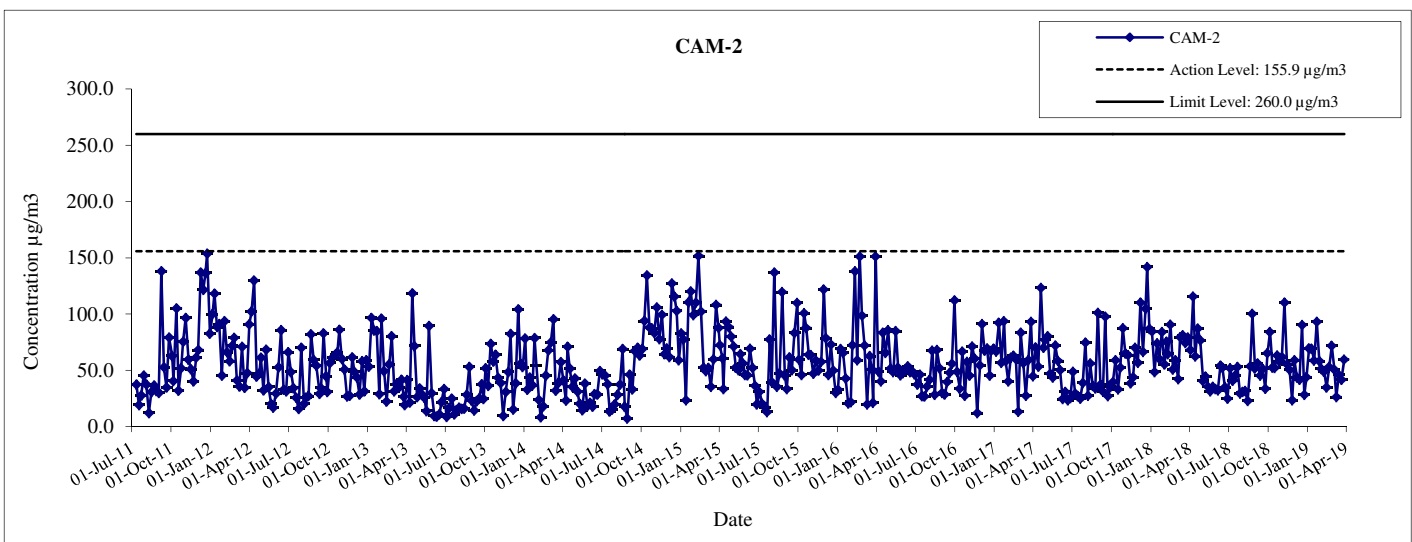
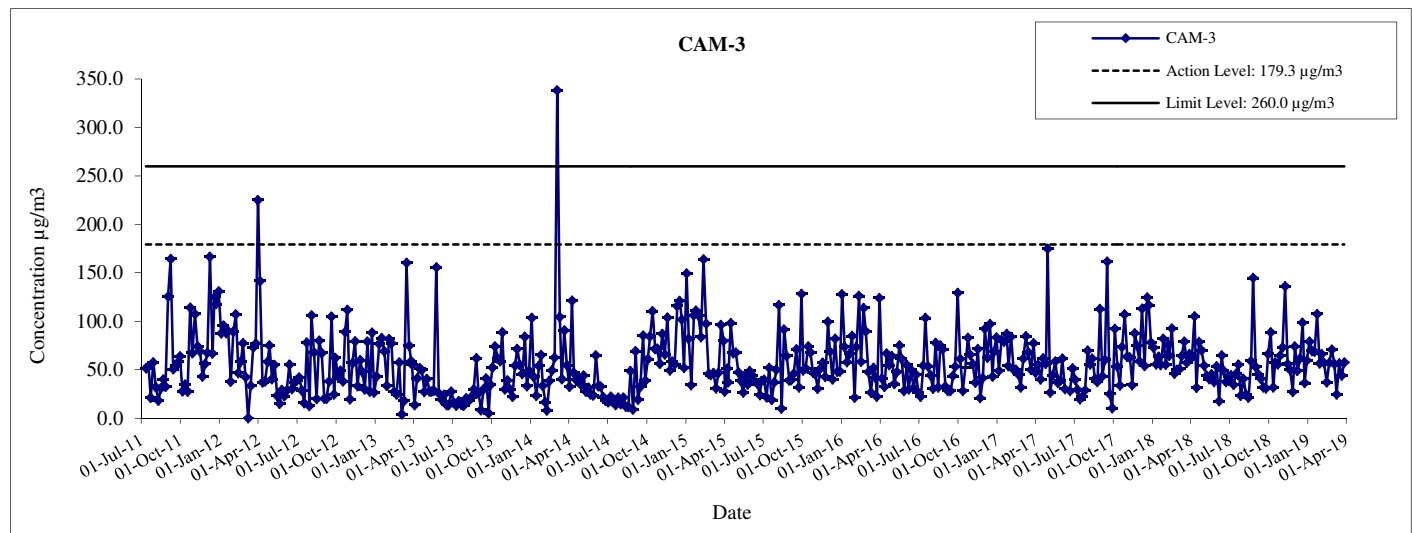
# Graphical Plots of Impact Monitoring Results (Air Quality)

- Major Construction Activities:
- a. Sheet Piling and Excavation (July 2011 - Aug 2012)
  - b. Utilities diversion and re-construction (Aug 2012 - Dec 2015)
  - c. Road diversion and underpass construction (Feb 2013 - Dec 2017)
  - d. Surface laying and Road markings (Oct 2017 - Dec 2018)
  - e. Reinstatement and Rectification (Jan 2019 - Mar 2019)

Impact monitoring for air quality and air-borne noise were conducted in accordance with the EM&A Manual in the reporting period. 7 nos. of 24-hour TSP Action Levels and 1 no. of 24-hour TSP Limit Levels exceedances were recorded in the reporting period. However, most of them were found non-Project related after the investigations and excavation and breaking might be the potential cause of exceedances according to the findings from investigations for the rest of records, relevant actions have been taken by the Contractors to minimize the dust nuisance in accordance with the recommendations in EIA and EM&A Manual. As a result, this could conclude that the construction activities did not have a noticeable adverse effect on the general air quality.

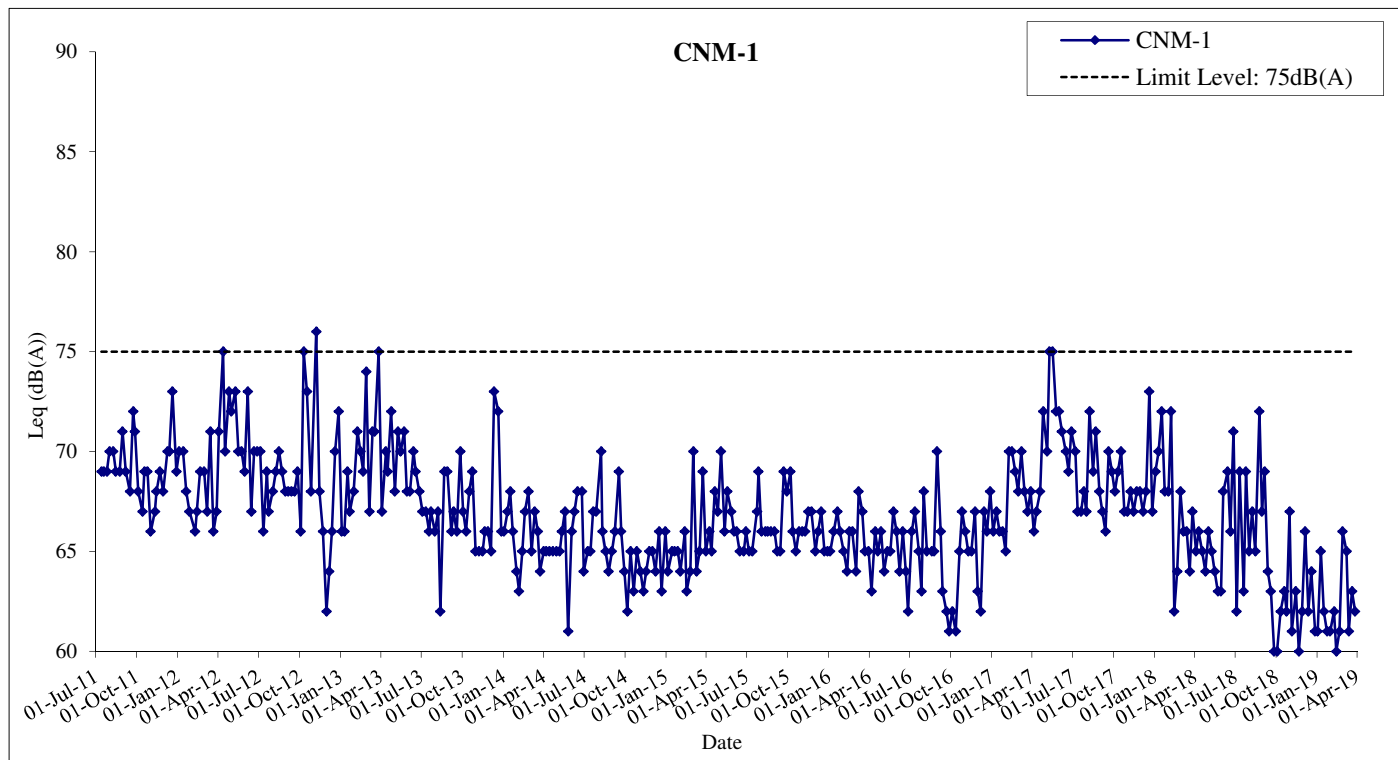
### Graphical Plots of Impact Monitoring Results (Construction Noise)

- Major Construction Activities:
- a. Sheet Piling and Excavation (July 2011 - Aug 2012)
  - b. Utilities diversion and re-construction (Aug 2012 - Dec 2015)
  - c. Road diversion and underpass construction (Feb 2013 - Dec 2017)
  - d. Surface laying and Road markings (Oct 2017 - Aug 2018)
  - e. Reinstatement and Rectification (Jan 2019 - Mar 2019)

15 nos. of exceedance of air-borne noise Action Levels and 99 nos. of exceedance of air-borne Limit Levels were recorded in the reporting period. Operation of heavy powered mechanical plants for foundation works might be the possible cause of exceedances; relevant actions have been taken by the Contractors to control the noise impact in accordance with the recommendations in EIA and EM&A manual
