ROAD WORKS at WEST KOWLOON

(No. EP-366/2009/A)

Final Environmental Monitoring and Audit Report  
(Revision 02)

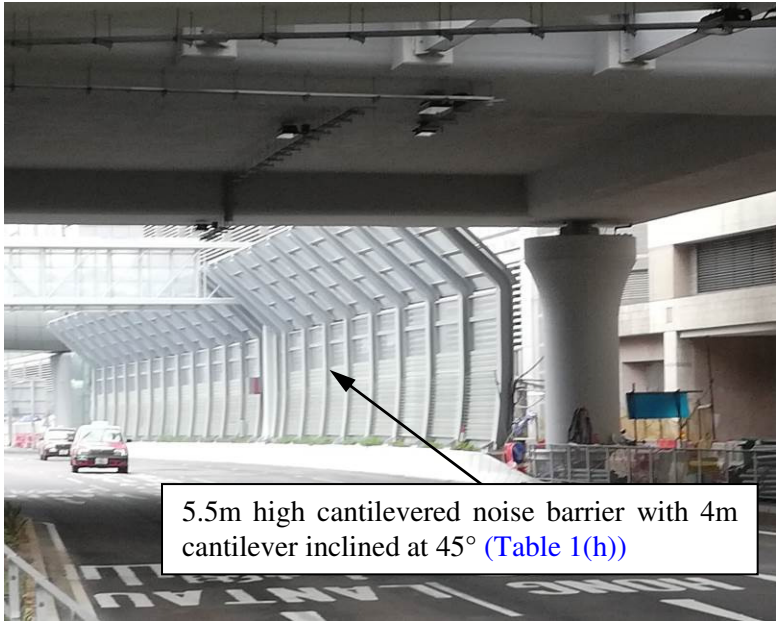
No.	EIA <sup>[1]</sup> /RR <sup>[2]</sup> /EP <sup>[3]</sup> Ref.	Photo Records
07	Table 3.2 <sup>[2]</sup> and Table 1 <sup>[3]</sup> and Figure C8017/C/XRL/ENS/M52/005 of a submission in 2018 under EP condition 2.6	<p>The location of cantilevered noise barrier along N/B carriageway of Lin Cheung Road to south of Jordan Road.</p>

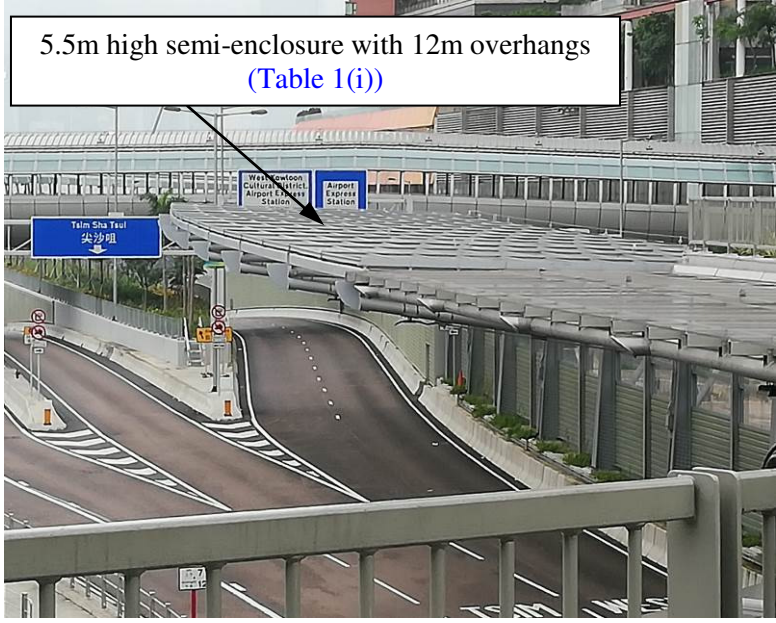
08	Table 3.2 <sup>[2]</sup> and Table 1 <sup>[3]</sup> and Figure C8017/C/XRL/ENS/M52/005 of a submission in 2018 under EP condition 2.6	<p>The location of semi-enclosure with overhang along S/B carriageway of Lin Cheung Road to south of Jordan Road.</p>

Table 3.2 <sup>[2]</sup> and Table 1 <sup>[3]</sup> and Figure C8017/C/XRL/ENS/M52/005 of a submission in 2018 under EP condition 2.6	<p>(g) about 60m long of landscape deck or semi-enclosure covering the main carriageway (northbound and southbound) of Lin Cheung Road to the south of Jordan Road.</p> <p>(h) about 95m long of 5.5m high cantilevered noise barrier with 4m cantilever inclined at 45° along the northbound carriageway of Lin Cheung Road to the south of Jordan Road.</p> <p>(i) about 55m long of 5.5m high semi-enclosure with 12m overhang along the southbound carriageway of Lin Cheung Road to the south of Jordan Road.</p>	To reduce the traffic noise impact.	MTR until maintenance or management agency is assigned. Maintenance responsibilities will be assigned to HyD	Before commencement of road operation	<ul style="list-style-type: none"> <li>Completed.</li> <li>Completed.</li> <li>Completed.</li> </ul>	<p>Landscape deck/semi-enclosure was installed over the main carriage (N/B and S/B) of Lin Cheung Road to south of Jordan Road in accordance with the RR. Refer to <b>Appendix I - No. 06</b> of Photo Record.</p> <p>Cantilevered noise barrier was installed along N/B carriageway of Lin Cheung Road to south of Jordan Road in accordance with the RR. Refer to <b>Appendix I - No. 07</b> of Photo Record.</p> <p>Semi-enclosure with 12m overhang was installed along S/B carriageway of Lin Cheung Road to south of Jordan Road in accordance with the RR. Refer to <b>Appendix I - No. 08</b> of Photo Record.</p>

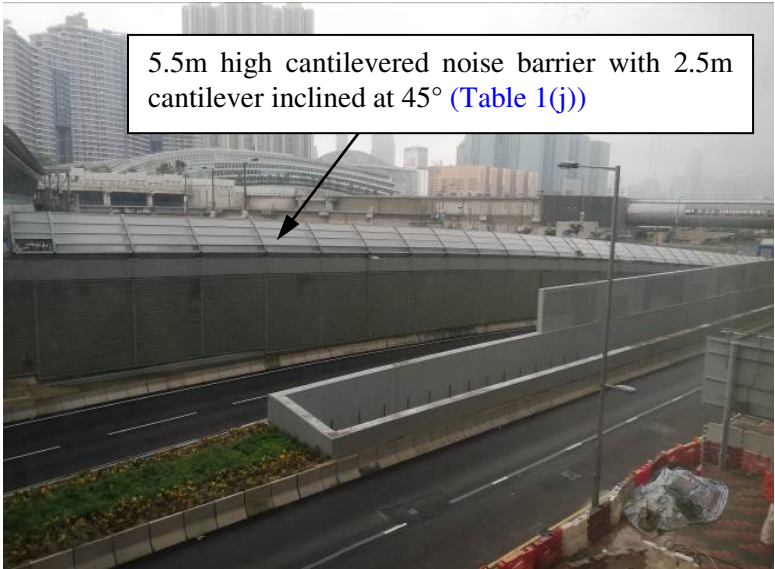
No.	EIA <sup>[1]</sup> /RR <sup>[2]</sup> /EP <sup>[3]</sup> Ref.	Photo Records
09	Table 3.2 <sup>[2]</sup> and Table 1 <sup>[3]</sup> and Figure C8017/C/XRL/ENS/M52/005 of a submission in 2018 under EP condition 2.6	<p>The location of cantilevered noise barrier along S/B carriageway of Lin Cheung Road to south of Jordan Road.</p>

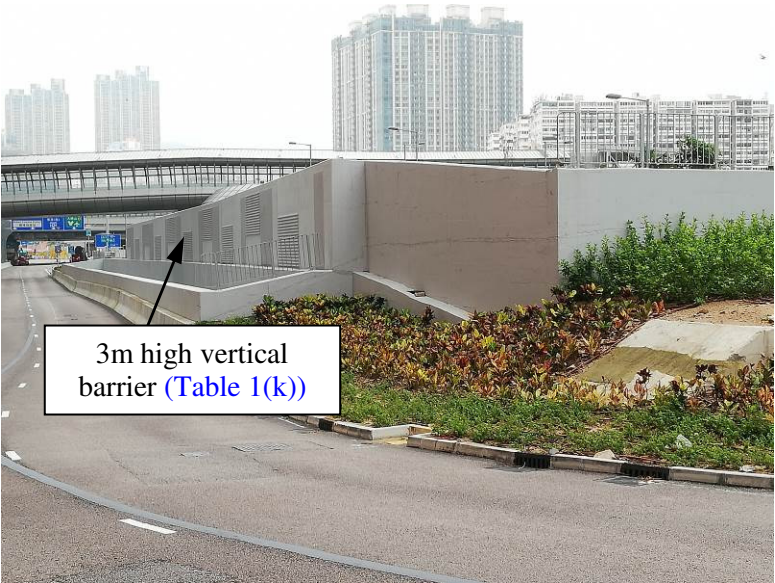
10	Table 3.2 <sup>[2]</sup> and Table 1 <sup>[3]</sup> and Figure C8017/C/XRL/ENS/M52/005 of a submission in 2018 under EP condition 2.6	<p>The location of vertical barrier on the top of retaining wall at +7.5 mPD along N/B carriageway of Lin Cheung Road to south of Jordan Road.</p>

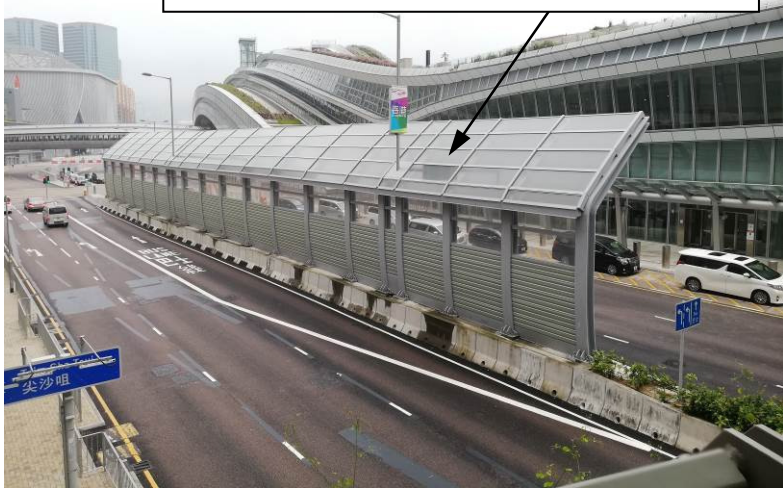
12	3.3, Table 3.2 <sup>[2]</sup> and Table 2 <sup>[3]</sup> and Figure C8017/C/XRL/ENS/M52/005 of a submission in 2018 under EP condition 2.6	<p>The location of cantilevered noise barrier along the central divider of Road D1A(S) to south of Jordan Road</p>

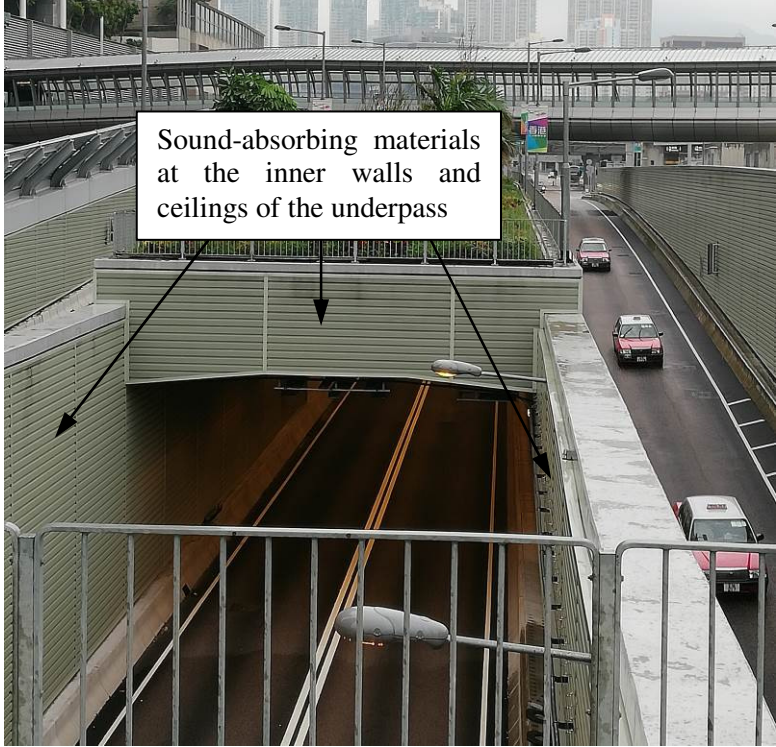
No.	EIA <sup>[1]</sup> /RR <sup>[2]</sup> /EP <sup>[3]</sup> Ref.	Photo Records
15	3.38 <sup>[2]</sup>	<p>Sample photo showing the sound-absorbing materials installed at the inner walls and ceilings of the underpass extended at least 30m into the underpass at each portal and opening being treated. (arrow)</p>

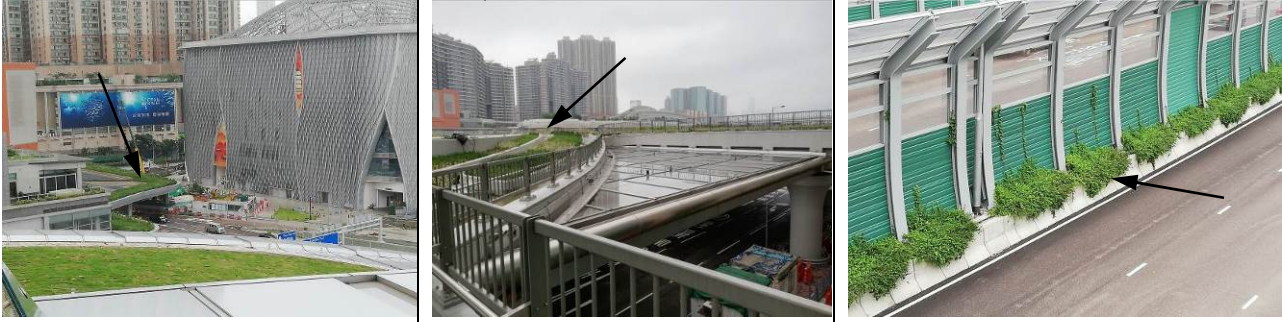
16	Table 4.2 <sup>[2]</sup>	<p>Sample photos showing aesthetically pleasing design as regard to the form, material and finishes should be incorporated to landscape deck, noise barriers/enclosures, engineering structures and associated infrastructure facilities. (arrow)</p>

5.50 <sup>[1]</sup>	<ul style="list-style-type: none"> <li>• A surface water drainage system will be provided to collect road runoff.</li> <li>• The road drainage should be directed through silt traps in the gully inlets to remove silt and grit before entering the public storm water drainage system; and</li> <li>• The silt traps should be regularly cleaned and maintained in good working condition.</li> </ul>		MTR until maintenance or management agency is assigned. Maintenance responsibilities will be assigned to HyD	During design and operation	• Implemented	
<b>Landscape and Visual Management</b>						
Table 4.2 <sup>[2]</sup>	<ul style="list-style-type: none"> <li>• Aesthetically pleasing design as regard to the form, material and finishes should be incorporated to landscape deck, noise barriers/enclosures, engineering structures and associated infrastructure facilities</li> </ul>	To minimize landscape and visual impacts during operational phase	MTR until maintenance or management agency is assigned. Maintenance responsibilities will be assigned to HyD	Before commencement of road operation	• Completed.	Aesthetically pleasing design has been incorporated to the noise mitigation measures and associated infrastructure facilities in accordance with the RR. Refer to <b>Appendix I - No.16</b> for sample photo.

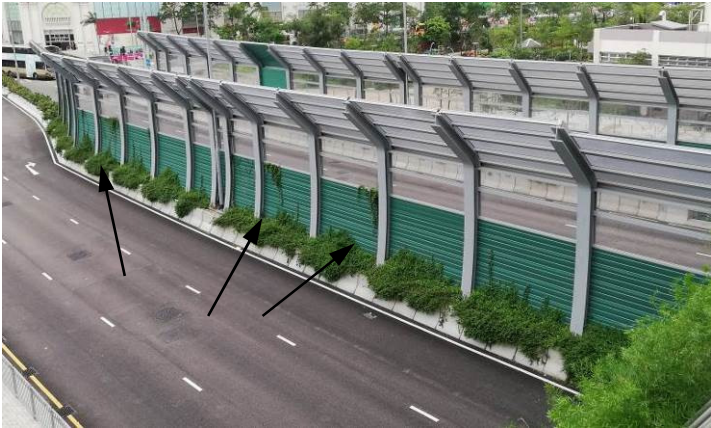
No.	EIA <sup>[1]</sup> /RR <sup>[2]</sup> /EP <sup>[3]</sup> Ref.	Photo Records
17	Table 4.2 <sup>[2]</sup>	<p>Sample photo showing the climbers on wire mesh to soften the noise barriers. (arrow)</p>

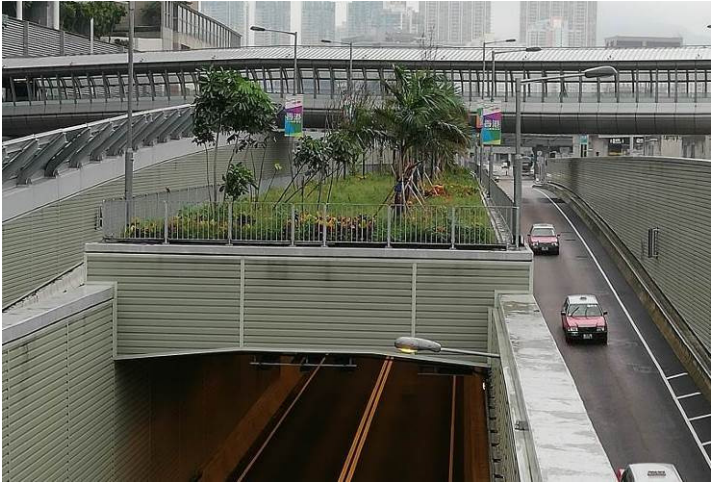
18	Table 4.2 <sup>[2]</sup>	<p>Sample photo showing the buffer tree and shrub planting to screen proposed noise barriers and enclosures</p>

EIA <sup>[1]</sup> / RR <sup>[2]</sup> / EP <sup>[3]</sup> Ref #	Environmental Protection Measures / Mitigation Measures	Objectives of the Recommended Measures & Main Concern to Address	Who to implement the measures?	When to implement the measures?	Implementation Status	Remarks
Table 4.2 <sup>[2]</sup>	<ul style="list-style-type: none"> <li>Buffer Tree and Shrub Planting to screen proposed noise barriers and enclosures.</li> </ul>	To minimize landscape and visual impacts during operational phase	MTR until maintenance or management agency is assigned. Maintenance responsibilities will be assigned in accordance with ETW TC(W) No. 2/2004 on "Maintenance of Vegetation and Hard Landscape Features" upon completion of the detailed design for the Project	Before commencement of road operation	<ul style="list-style-type: none"> <li>Completed.</li> </ul>	Buffer Tree and Shrub have been planted to screen proposed noise barriers and enclosures in accordance with the RR. Refer to <b>Appendix I - No.18</b> for sample photo.

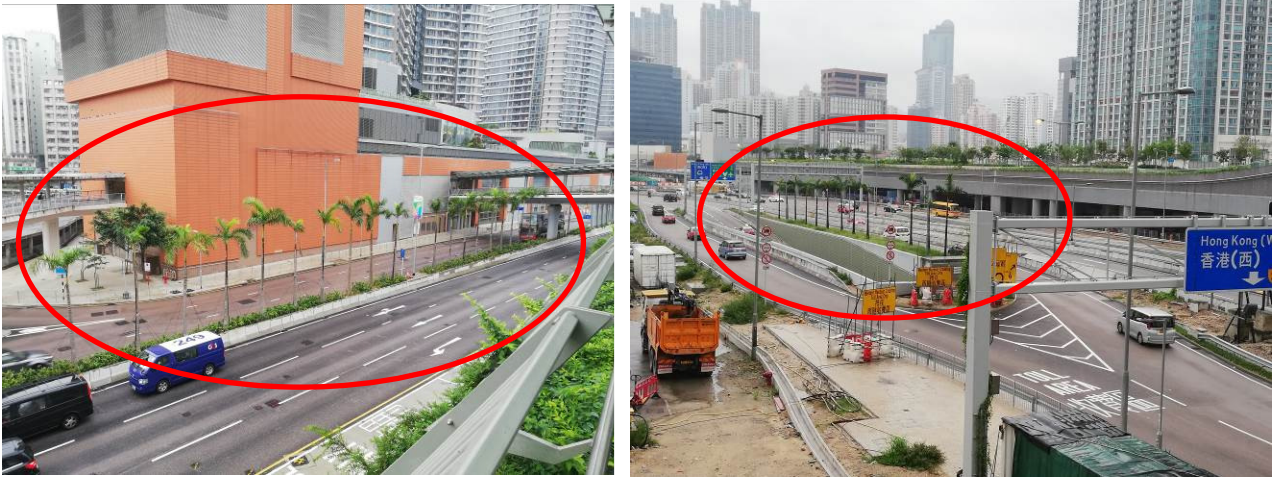
19	Table 4.2 <sup>[2]</sup>	<p>Sample photos showing the structures and ornamental tree, shrub planting along roadside amenity areas and central divider to enhance the landscape and visual quality. (circle)</p>

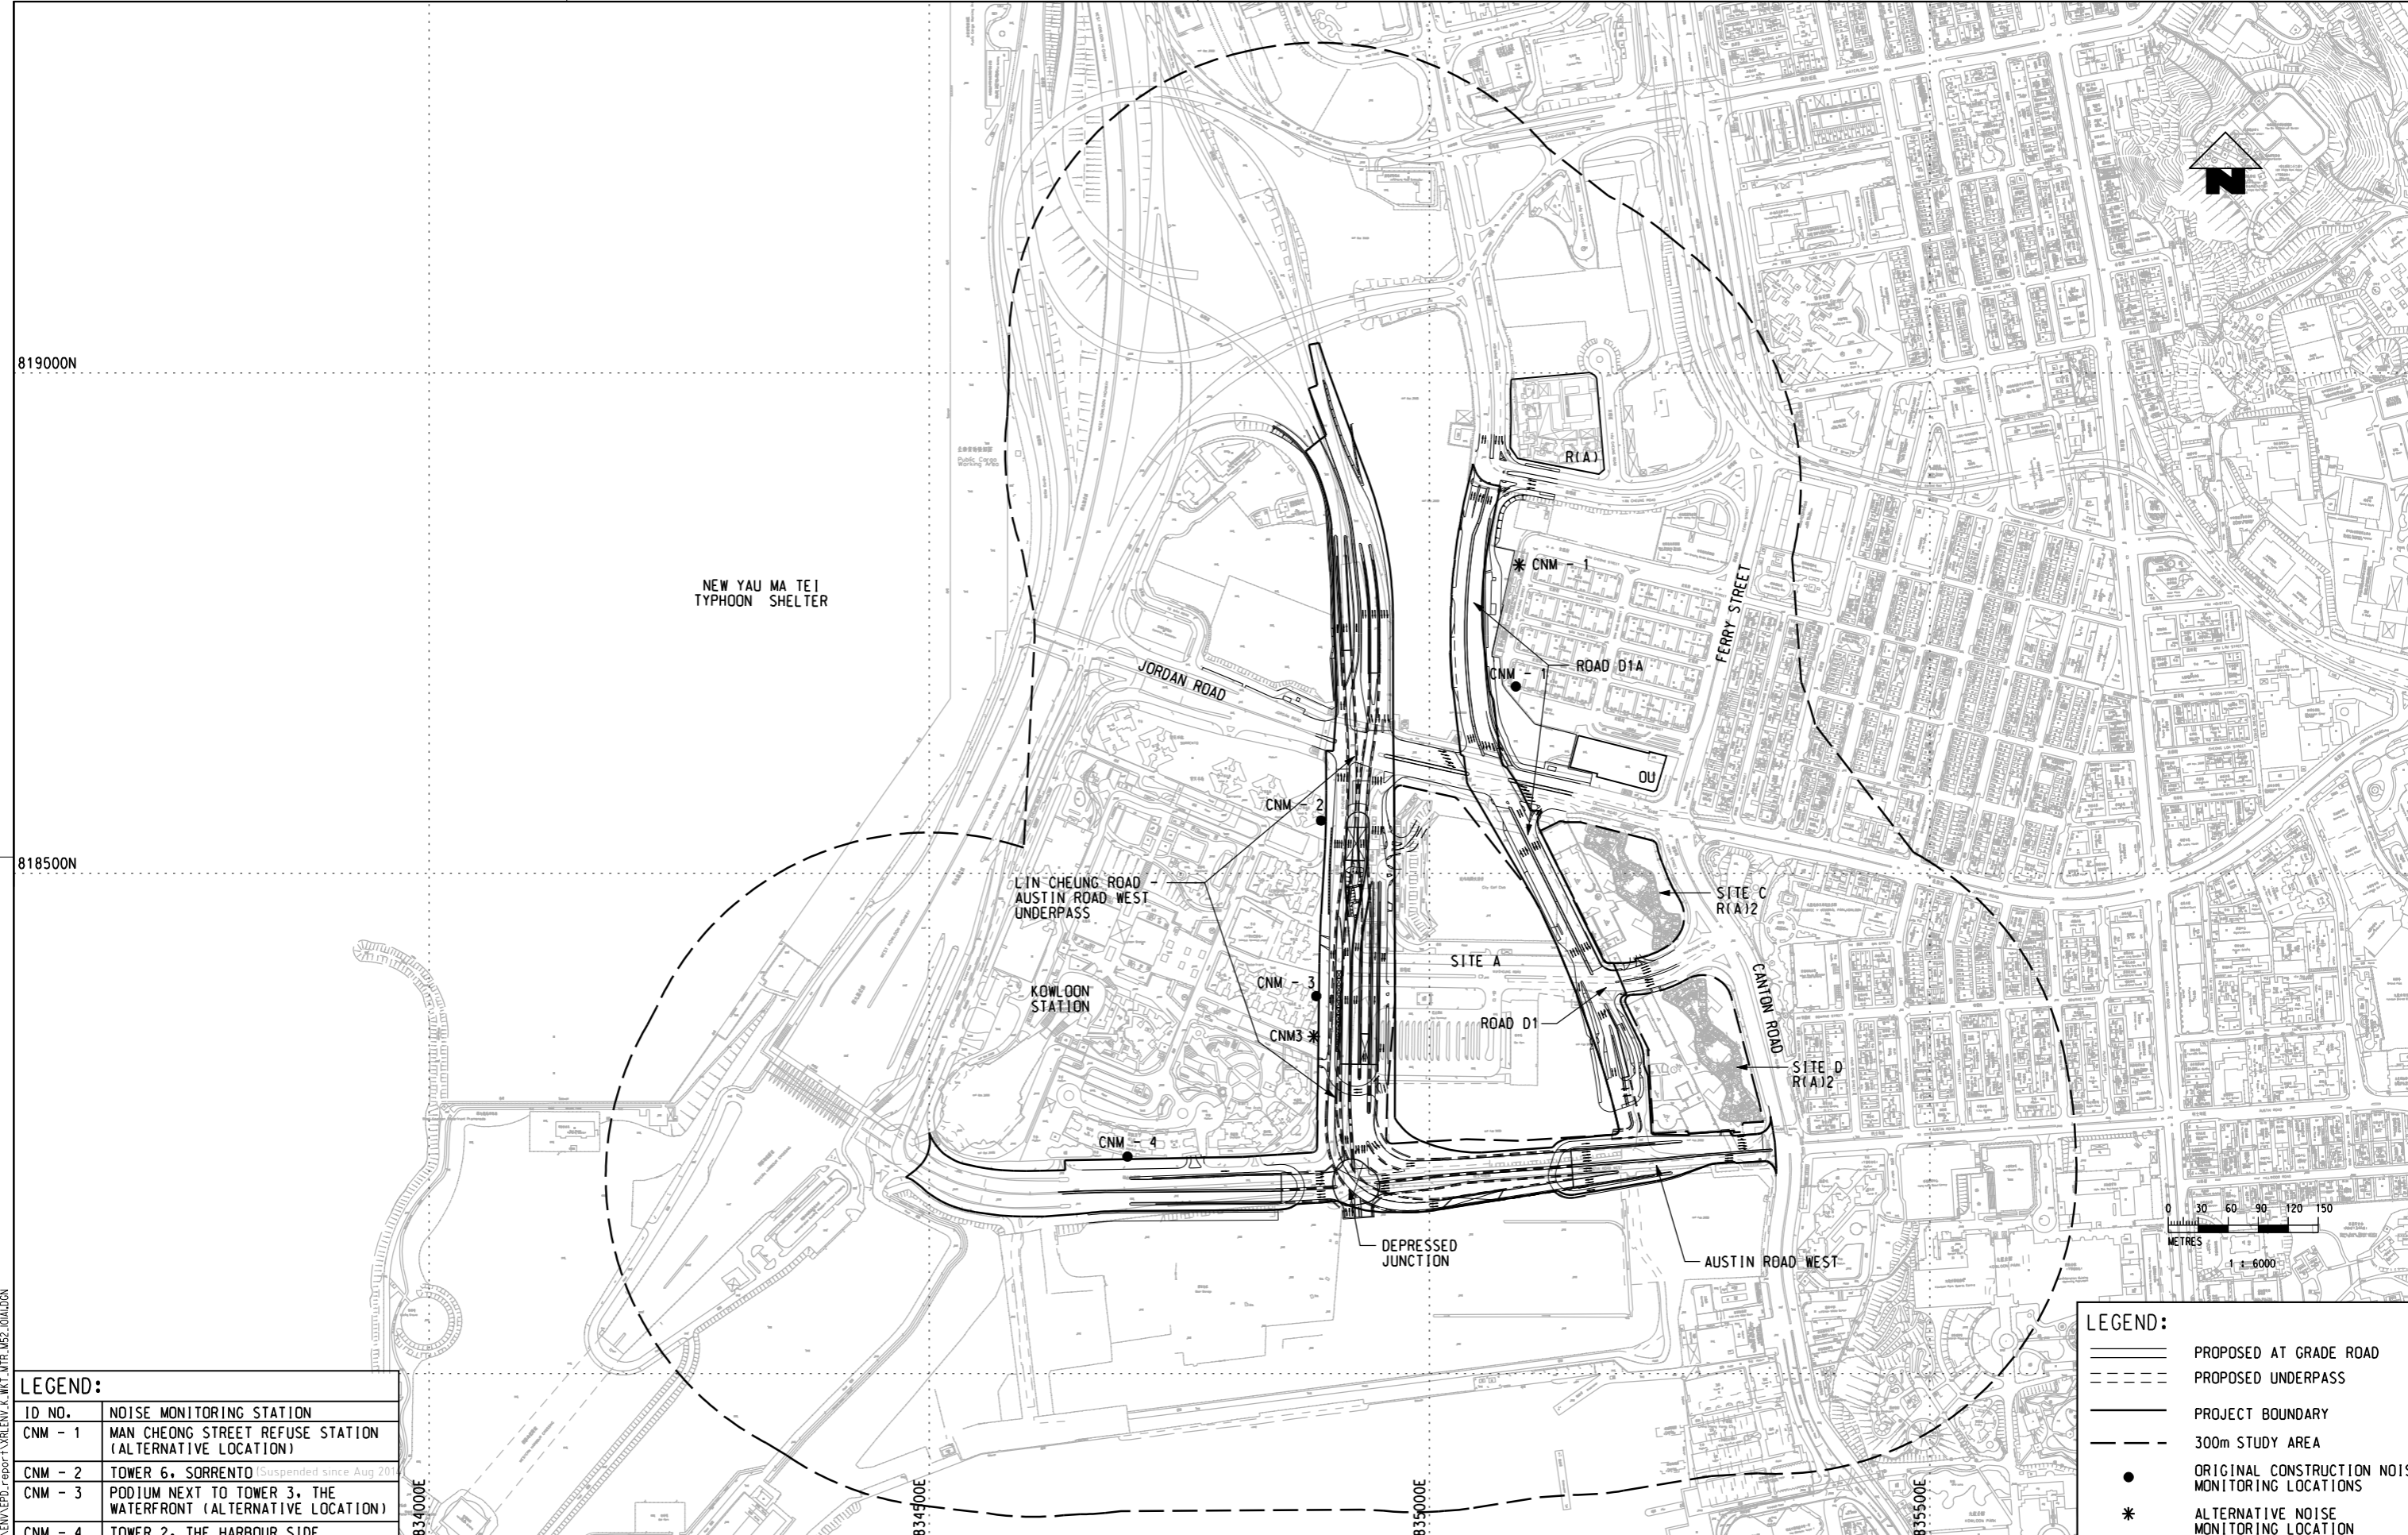
ID NO.	NOISE MONITORING STATION
CNM - 1	MAN CHEONG STREET REFUSE STATION (ALTERNATIVE LOCATION)
CNM - 2	TOWER 6, SORRENTO (Suspended since Aug 2011)
CNM - 3	PODIUM NEXT TO TOWER 3, THE WATERFRONT (ALTERNATIVE LOCATION)
CNM - 4	TOWER 2, THE HARBOUR SIDE

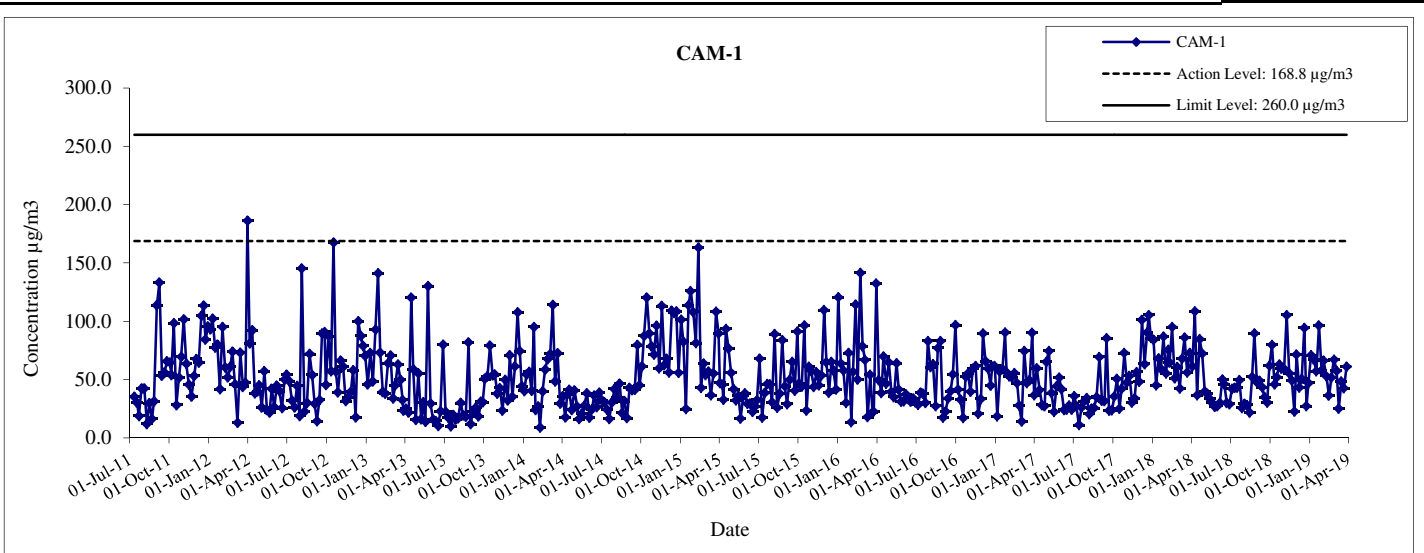
# Graphical Plots of Impact Monitoring Results (Air Quality)

- Major Construction Activities:
- a. Sheet Piling and Excavation (July 2011 - Aug 2012)
  - b. Utilities diversion and re-construction (Aug 2012 - Dec 2015)
  - c. Road diversion and underpass construction (Feb 2013 - Dec 2017)
  - d. Surface laying and Road markings (Oct 2017 - Dec 2018)
  - e. Reinstatement and Rectification (Jan 2019 - Mar 2019)

Weather Conditions: Typical fine and occasionally raining during the monitoring periods

Impact monitoring for air quality and air-borne noise were conducted in accordance with the EM&A Manual in the reporting period. 7 nos. of 24-hour TSP Action Levels and 1 no. of 24-hour TSP Limit Levels exceedances were recorded in the reporting period. However, most of them were found non-Project related after the investigations and excavation and breaking might be the potential cause of exceedances according to the findings from investigations for the rest of records, relevant actions have been taken by the Contractors to minimize the dust nuisance in accordance with the recommendations in EIA and EM&A Manual. As a result, this could conclude that the construction activities did not have a noticeable adverse effect on the general air quality.

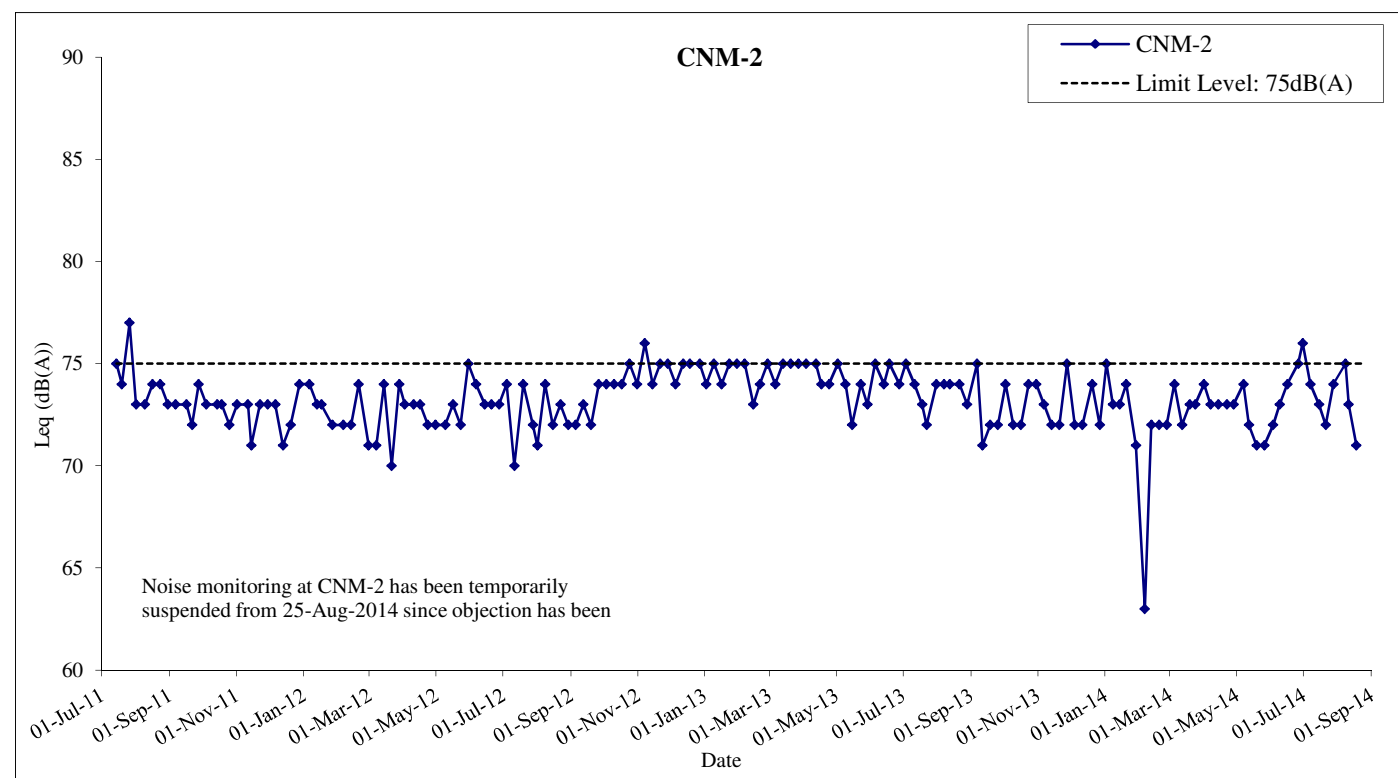
### Graphical Plots of Impact Monitoring Results (Construction Noise)

- Major Construction Activities:
- a. Sheet Piling and Excavation (July 2011 - Aug 2012)
  - b. Utilities diversion and re-construction (Aug 2012 - Dec 2015)
  - c. Road diversion and underpass construction (Feb 2013 - Dec 2017)
  - d. Surface laying and Road markings (Oct 2017 - Aug 2018)
  - e. Reinstatement and Rectification (Jan 2019 - Mar 2019)

Weather Conditions: Typical fine and occasionally raining during the monitoring periods

15 nos. of exceedance of air-borne noise Action Levels and 99 nos. of exceedance of air-borne Limit Levels were recorded in the reporting period. Operation of heavy powered mechanical plants for foundation works might be the possible cause of exceedances; relevant actions have been taken by the Contractors to control the noise impact in accordance with the recommendations in EIA and EM&A manual
