Contract No. DC/2009/23

HATS Stage 2A - Upgrading of **Preliminary Treatment Works at** North Point, Wan Chai East and Central

Monthly Environmental Monitoring and Audit Report January 2013

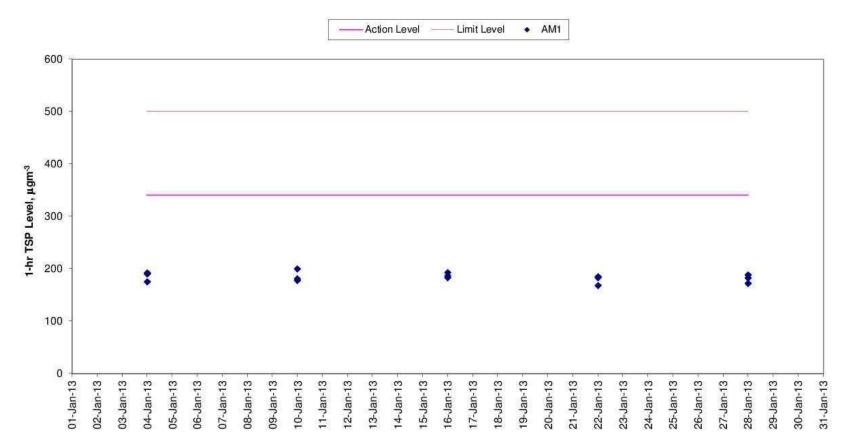
1-hr TSP Levels AM1 (Chan's Creative School)

5. All 1-hour TSP monitoring was conducted as scheduled in the reporting month. No Action/Limit Level exceedance was recorded.

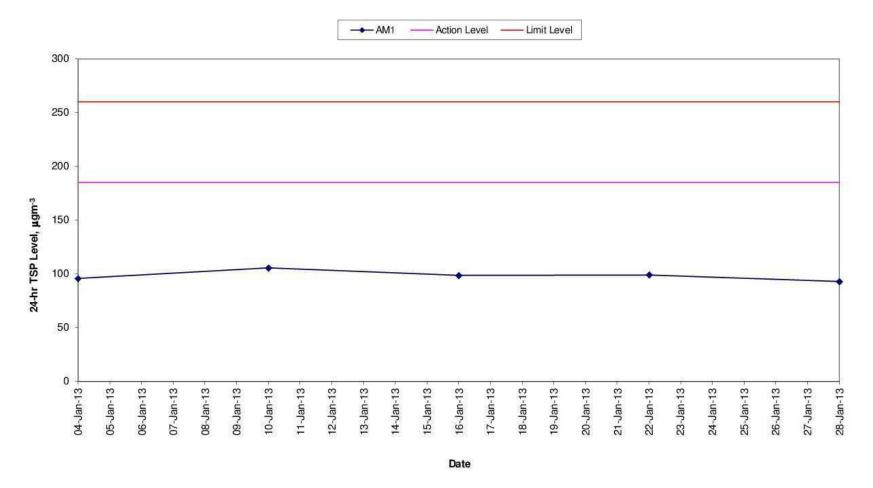
24-hr TSP Levels AM1 (Chan's Creative School)

6. All 24-hour TSP monitoring was conducted as scheduled in the reporting month. No Action/Limit Level exceedance was recorded.
