Shatin to Central Link – Tai Wai to Hung Hom Section and Mong Kok East to Hung Hom Section

Monthly EM&A Report No. 5

[Period from 1 to 31 January 2013]

Shatin to Central Link - Tai Wai to Hung Hom Section and Mong Kok East to Hung Hom Section

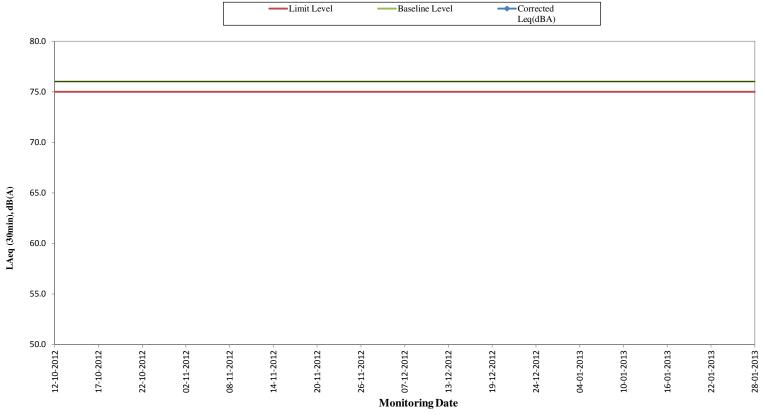
Regular Noise Monitoring Results at NMS-CA-6 (No. 16-23 Nam Kok Road) (LAeq, 30min) for the Past 4 Months

- For the corrected noise level without showing the in this graph, the measured noise level is below baseline level.
