FUGRO TECHNICAL SERVICES LIMITED

Contract No. EP/SP/58/08
Sludge Treatment Facilities
Environmental Monitoring and Audit Report
For
February 2013

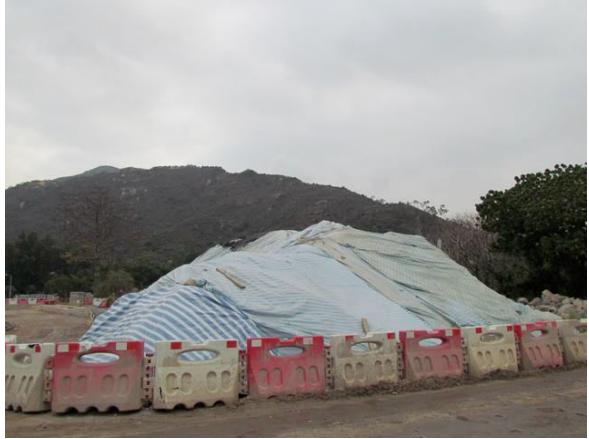
1. Photographic Record of the PFA Treatment	2. Photographic Record of Protection to the Fell / Retained Trees

<p>The PFA excavated has been dehydrated under sunlight, and will be buried back to its original position inside the site boundary. Capping of the PFA is established to prevent spreading in air.</p>	<p>T758 is confirmed to be retained on site. Proper tree protection should be applied to protect T758. Amendment to the tree felling application will be submitted.</p>

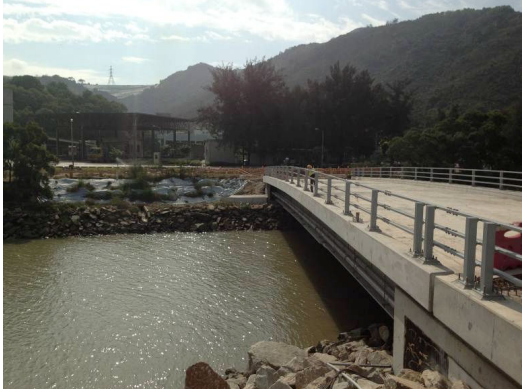
<p>3. Photographic Record of the Original Transplant Trees Location</p>

<p>The new tree plantings will be proposed on the either side of the bridge at portion 6 to fulfil the EIA requirement.</p>	
<p>4. Photographic Record of the Compensatory Tree Locations</p>

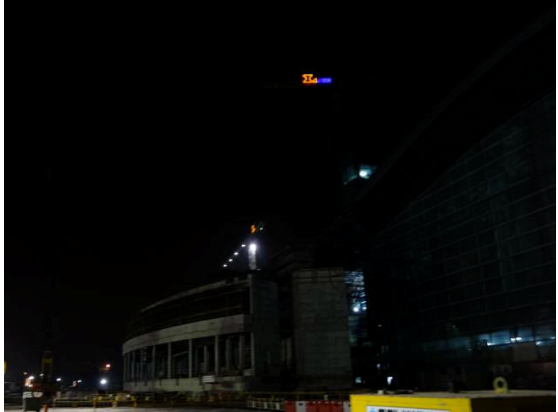
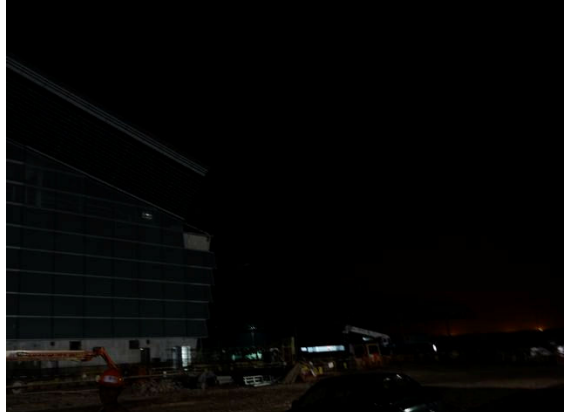
<p>The lighting during night-time working is confined within the working area within the site boundary. Periphery area and the sensitive receivers are not affected by the lighting during night-time working.</p>	<p>The lighting during night-time working is confined within the working area within the site boundary. Periphery area and the sensitive receivers are not affected by the lighting during night-time working.</p>
