Contract No. EP/SP/58/08
Sludge Treatment Facilities
Environmental Monitoring and Audit Report
For
December 2013

HONG KONG SLUDGE TREATMENT FACILITY Project Overview

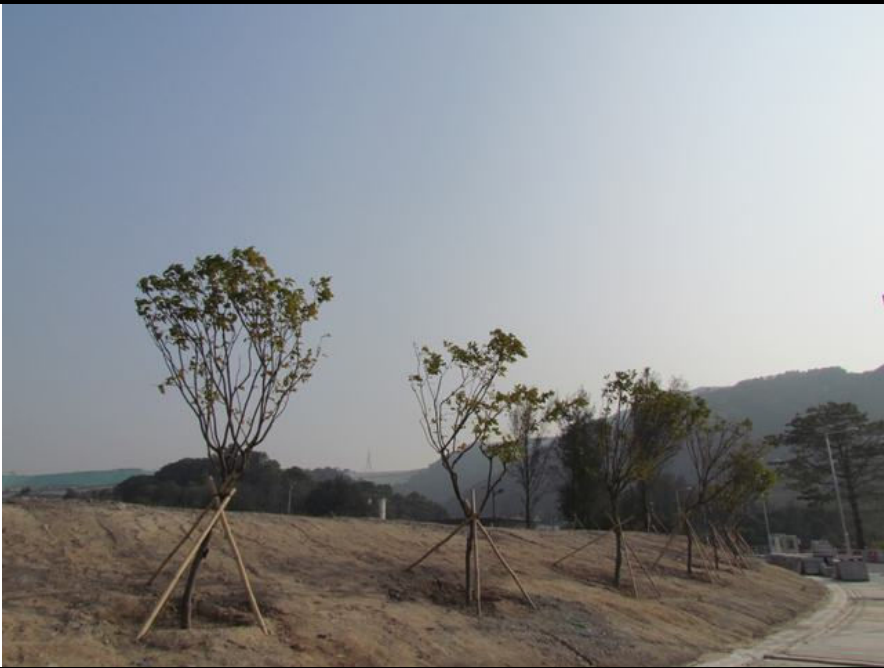
<p>4. Photographic Record of the Compensatory Tree Locations</p>

CM3	Design / Construction Planning	Trees unavoidably affected by the works should be transplanted where practical.	Total 13 nos. of transplant trees have been transplanted back to the site.	Conditions of the transplanted trees under close monitoring.
CM4	Design / Construction Planning	Compensatory tree planting should be provided to compensate for felled trees.	First batch of compensatory trees has completed. Trees sizes, girth, species tailored with the submitted compensatory tree plan.	First batch of compensatory trees has finished. Site photos refer to Table 4.5.

<p>First batch of compensatory trees has finished.</p>	
<p>5. Photographic Record of the Night-Time Working</p>

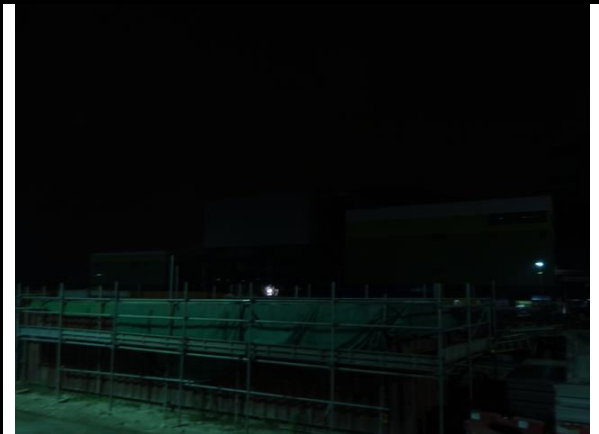
<p>The lighting during night-time working is confined within the working area within the site boundary. Periphery area and the sensitive receivers are not affected by the lighting during night-time working.</p>	<p>The lighting during night-time working is confined within the working area within the site boundary. Periphery area and the sensitive receivers are not affected by the lighting during night-time working.</p>
