Contract No. EP/SP/58/08
Sludge Treatment Facilities
Environmental Monitoring and Audit Report
For
October 2014

John K. M. Ho
(Environmental Team Leader)

11 November 2014

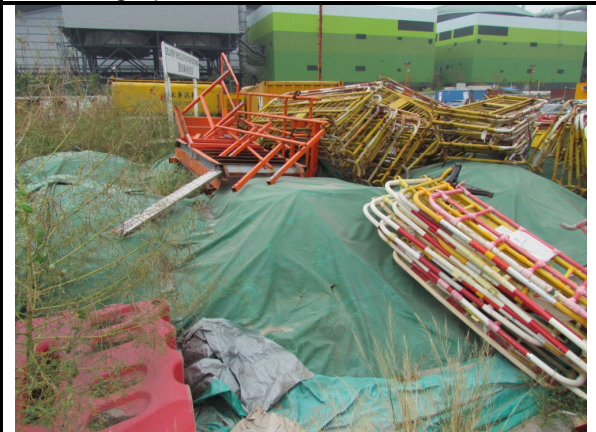
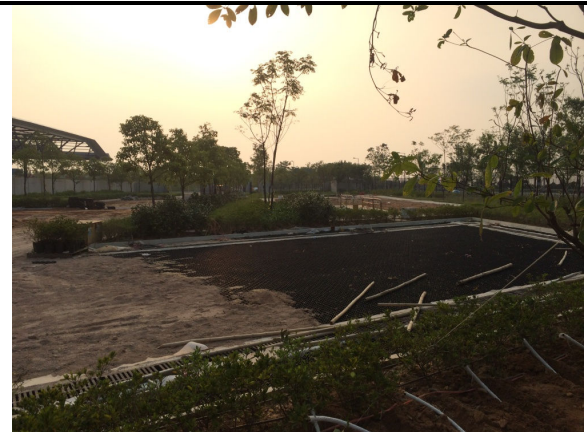
1. Photographic Record of the PFA Treatment

<p>Capping of the PFA is established to prevent spreading in air.</p>	<p>Suitable topsoil has been imported to the site for softscape planting.</p>

Topsoil found within the project site is PFA. Suitable topsoil already imported for planting. All PFA excavated during the tree felling works has been retained in the site confinement. The PFA has been under dehydration and concealed properly to prevent spreading in the air. Backfill of PFA to its original location inside site area is under progress.

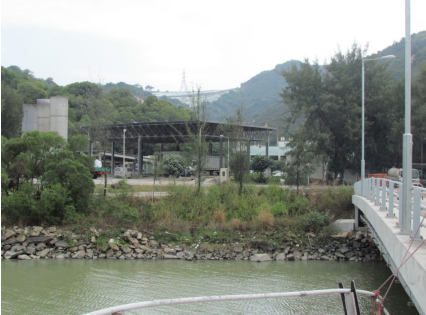
<p>2. Photographic Record of Protection to the Fell / Retained Trees</p>	<p>4. Photographic Record of the Compensatory Tree Locations</p>

<p>T758 is confirmed to be retained on site. Proper tree protection should be applied to protect T758.</p>	<p>Second batch of compensatory trees has finished.</p>
<p>3. Photographic Record of the Original Transplant Trees Location</p>	<p>5. Photographic Record of the Night-Time Working</p>

<p>Total 13 nos. of transplant trees have been transplanted back to the site in August and September 2013. There have 2 transplant trees found dead in March. Status of the other transplant trees is under close monitoring.</p>	<p>The lighting during night-time working is confined within the working area within the site boundary. Periphery area and the sensitive receivers are not affected by the lighting during night-time working.</p>

The Tree felling work approved under the Phase 1 and 2 tree felling application has been completed. Proper procedures of tree felling have been observed. The tree felling works should not cause damages to the existing trees on site. T758 has been confirmed to be retained on site. Proper tree protection should be set up for T758.

- CM3** – Trees unavoidably affected by the works should be transplanted where practical. Total 13 nos. of transplant trees have been transplanted back to the site in August and September 2013. There have 2 more transplant trees found dead in the March. Compensatory trees will be proposed in the revised compensatory planting proposal in compensation for the loss of the 2 trees. Status of the other transplant trees is under close monitoring.
