TEST REPORT

CONTRACT NO. CV/2009/02
HANDLING OF SURPLUS PUBLIC FILL
TUEN MUN AREA 38 FILL BANK
MONTHLY EM&A REPORT NO.46
(SEPTEMBER 2013)

Report No.: ENA31833

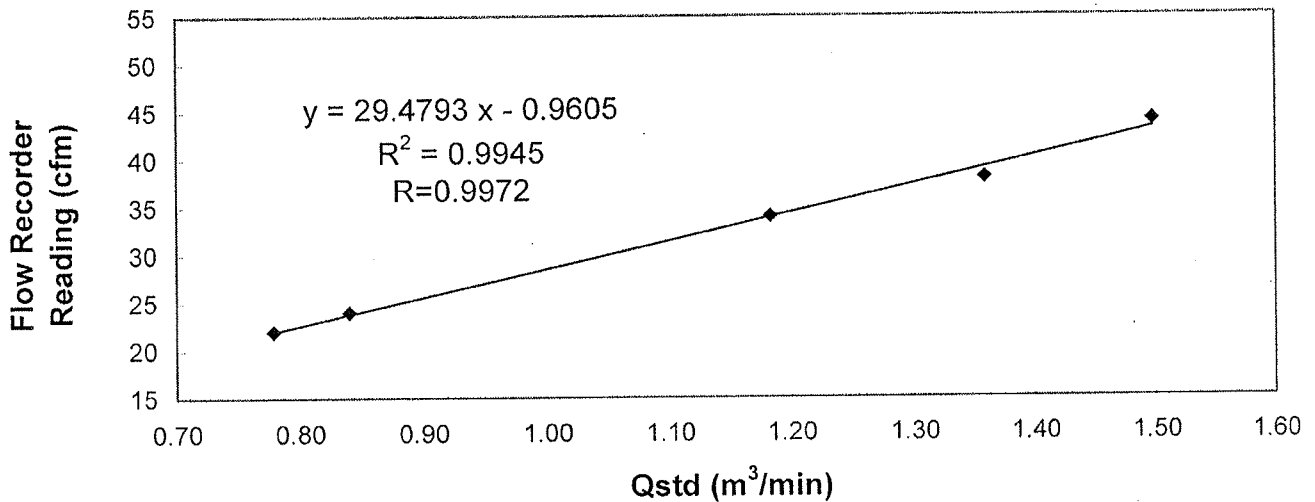
Sampler 9795 Calibration Curve
Site: Tuen Mun (A1)

Flow recorder reading (cfm)	44	38	34	24	22
Qstd (Actual flow rate, m ³ /min)	1.50	1.36	1.18	0.84	0.78
Pressure :	757.56 mm Hg		Temp. :	300 K

Acceptance Criteria : Correlation coefficient (r) of the calibration curve greater than 0.990 after a 5-point calibration

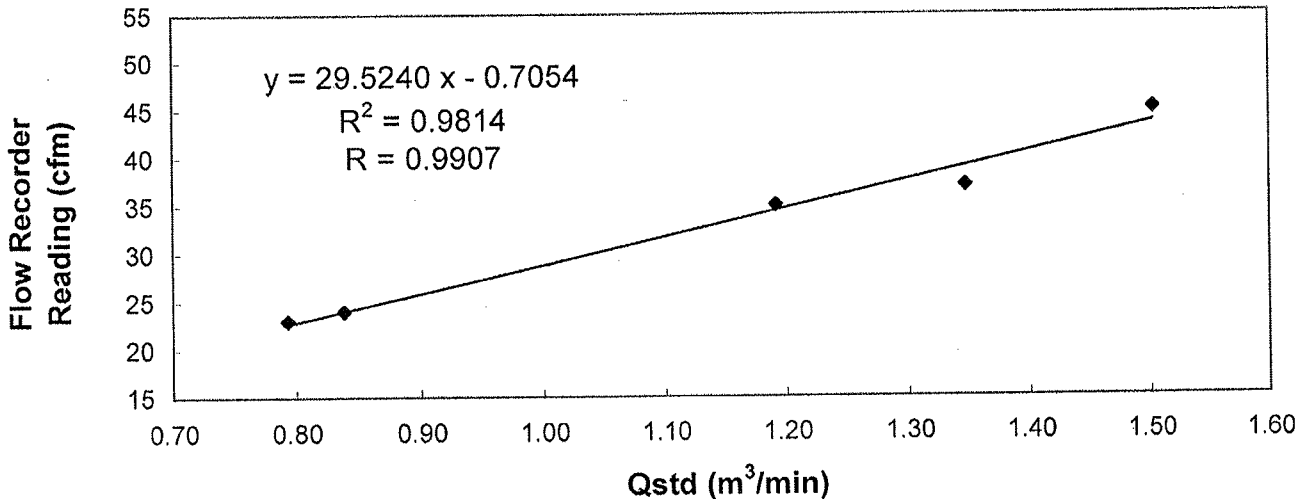
**Sampler 9795 Calibration Curve
Site: Tuen Mun (A1)**

Results	Flow recorder reading (cfm)	45	37	35	24	23
	Qstd (Actual flow rate, m ³ /min)	1.50	1.35	1.19	0.84	0.79
	Pressure :	757.56 mm Hg		Temp. :	301 K

Acceptance Criteria : Correlation coefficient (r) of the calibration curve greater than 0.990 after a 5-point calibration

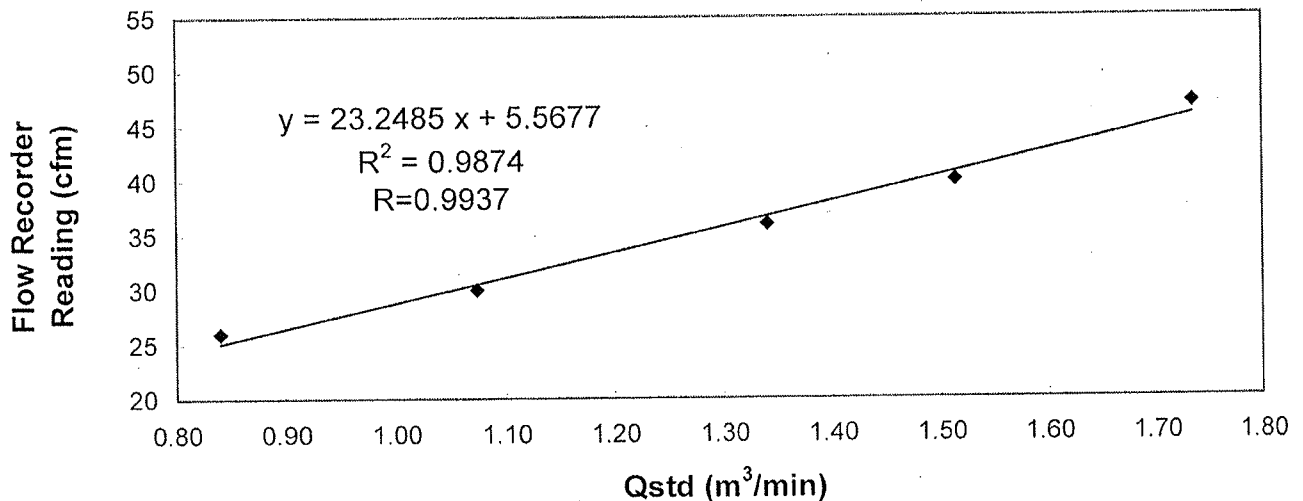
Sampler 9864 Calibration Curve
Site: Tuen Mun (A2)

Results	Flow recorder reading (cfm)	47	40	36	30	26
	Qstd (Actual flow rate, m ³ /min)	1.73	1.51	1.34	1.07	0.84
	Pressure : 757.56 mm Hg	Temp. : 300 K

Acceptance Criteria : Correlation coefficient (r) of the calibration curve greater than 0.990 after a 5-point calibration

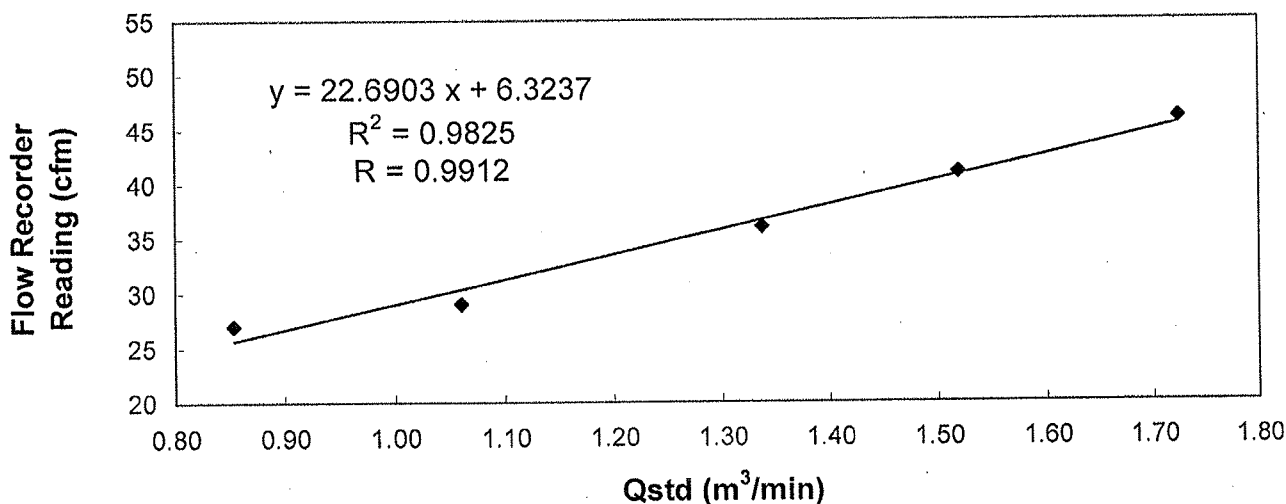
Sampler 9864 Calibration Curve
Site: Tuen Mun (A2)

Flow recorder reading (cfm)	46	41	36	29	27
Qstd (Actual flow rate, m ³ /min)	1.72	1.52	1.34	1.06	0.85
Pressure :	757.56 mm Hg		Temp. :	301 K

Acceptance Criteria : Correlation coefficient (r) of the calibration curve greater than 0.990 after a 5-point calibration

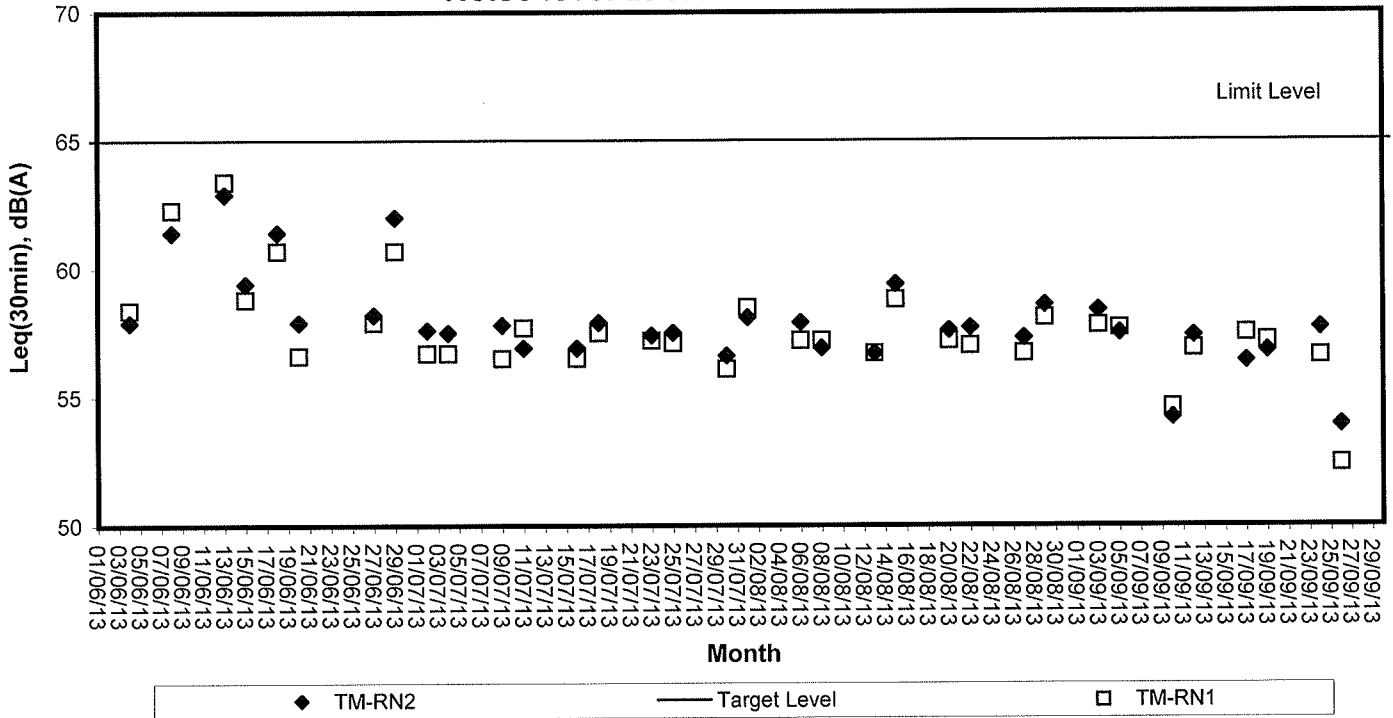
Noise level at TM-RN1 and TM-RN2

Date	Start Sampling Time (hh:mm)	Noise Level dB (A)			Wind Speed (m/s)	Weather Condition
		L _{eq} (30min)	L ₁₀	L ₉₀		
03/09/13	10:11	57.8	58.9	51.2	0.4	Cloudy
05/09/13	09:25	57.7	58.6	54.2	0.3	Drizzle
10/09/13	08:05	54.6	56.9	48.4	0.1	Fine
12/09/13	14:05	56.9	58.0	52.8	0.4	Fine
17/09/13	16:47	57.5	58.3	49.9	0.3	Fine
19/09/13	14:40	57.2	59.0	55.8	0.6	Fine
24/09/13	09:40	56.6	57.8	53.4	0.3	Cloudy
26/09/13	13:00	52.4	56.1	46.9	0.3	Fine

Date	Start Sampling Time (hh:mm)	Noise Level dB (A)			Wind Speed (m/s)	Weather Condition
		L _{eq} (30min)	L ₁₀	L ₉₀		
03/09/13	10:09	58.4	59.1	51.3	0.3	Cloudy
05/09/13	09:30	57.5	58.9	53.8	0.3	Drizzle
10/09/13	08:10	54.2	56.6	48.1	0.1	Fine
12/09/13	14:10	57.4	59.0	52.5	0.4	Fine
17/09/13	16:15	56.4	57.9	49.5	0.4	Fine
19/09/13	14:45	56.8	58.6	55.9	0.7	Fine
24/09/13	14:45	57.7	59.0	54.1	0.2	Cloudy
26/09/13	13:35	53.9	56.8	47.2	0.3	Fine

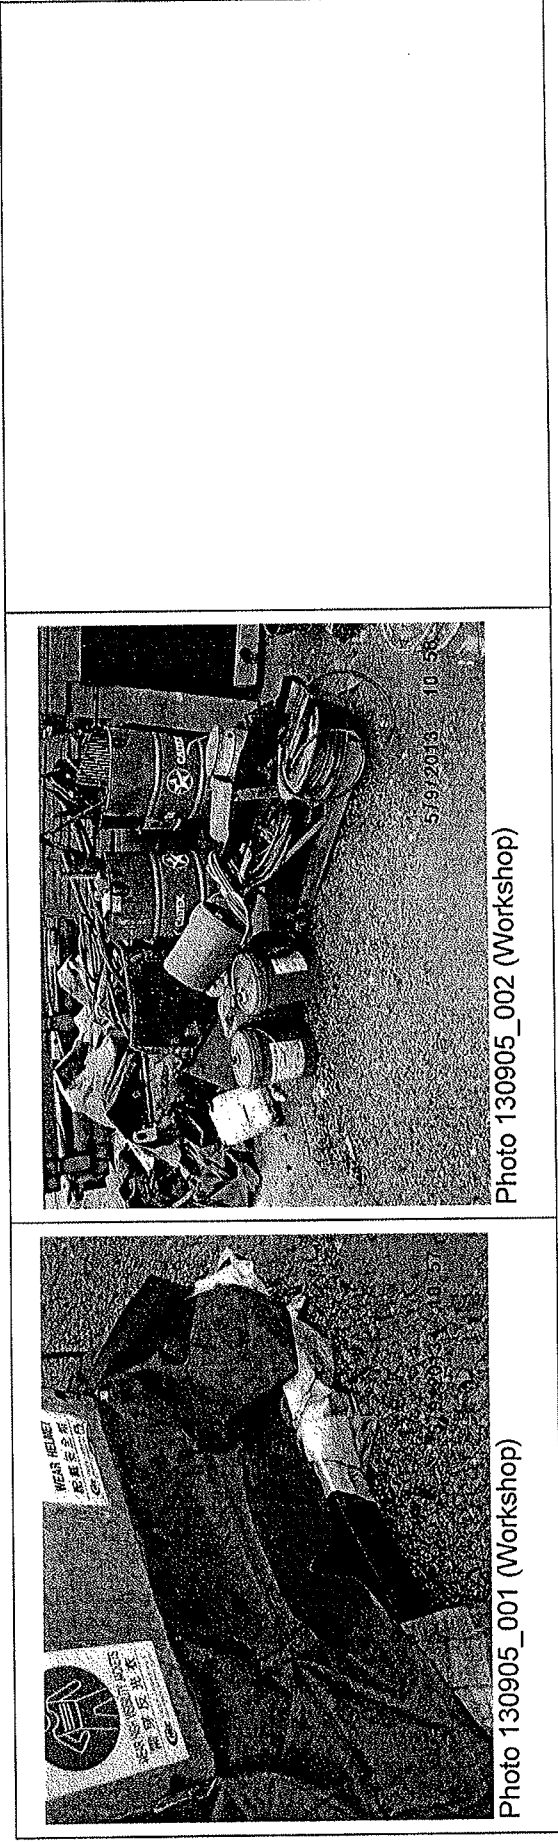
Photo 130905_002 (Workshop)

Date	Key Findings	Action(s) Taken recommended by ET	Action(s) Taken by the Contractor during the site audit	Rectification Status by ET
05 September 2013	Stagnant water was noted inside a drip tray of a generator at workshop. (New item)	To drain the stagnant water out or apply pesticide to avoid mosquito breeding.	---	Follow-up
	20L oil drums were noted discarded near workshop. (New item)	To store the oil drums in an appropriate storage area.	---	Follow-up
12 September 2013	Stagnant water was noted inside a drip tray of a generator at workshop. (Previous item)	To drain the stagnant water out or apply pesticide to avoid mosquito breeding.	---	Follow-up
	20L oil drums were noted discarded near workshop. (Previous item)	To store the oil drums in an appropriate storage area.	20L oil drums discarded near workshop were collected.	Closed
	Mud and silt were noted accumulated inside the main drainage channel. (New item)	To clear the accumulated mud and silt.	---	Follow-up
