TEST REPORT

**CONTRACT NO. CV/2009/02
HANDLING OF SURPLUS PUBLIC FILL
TUEN MUN AREA 38 FILL BANK
MONTHLY EM&A REPORT NO.48
(NOVEMBER 2013)**

Report No.: ENA32169

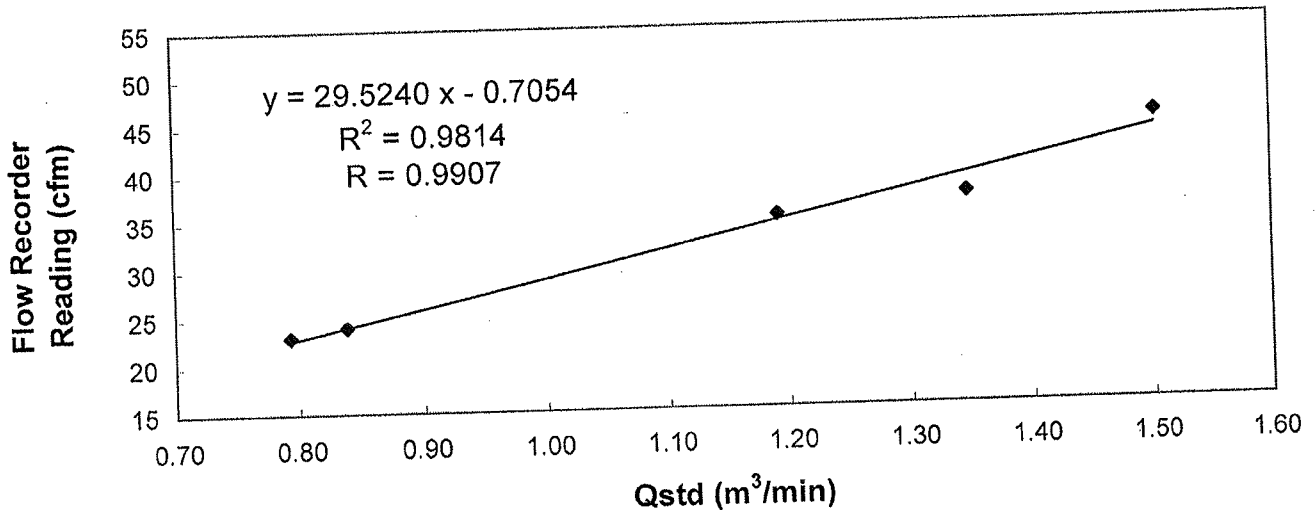
Results	Flow recorder reading (cfm)	45	37	35	24	23
	Qstd (Actual flow rate, m ³ /min)	1.50	1.35	1.19	0.84	0.79
	Pressure :	757.56 mm Hg		Temp. :	301 K

**Sampler 9795 Calibration Curve
Site: Tuen Mun (A1)**

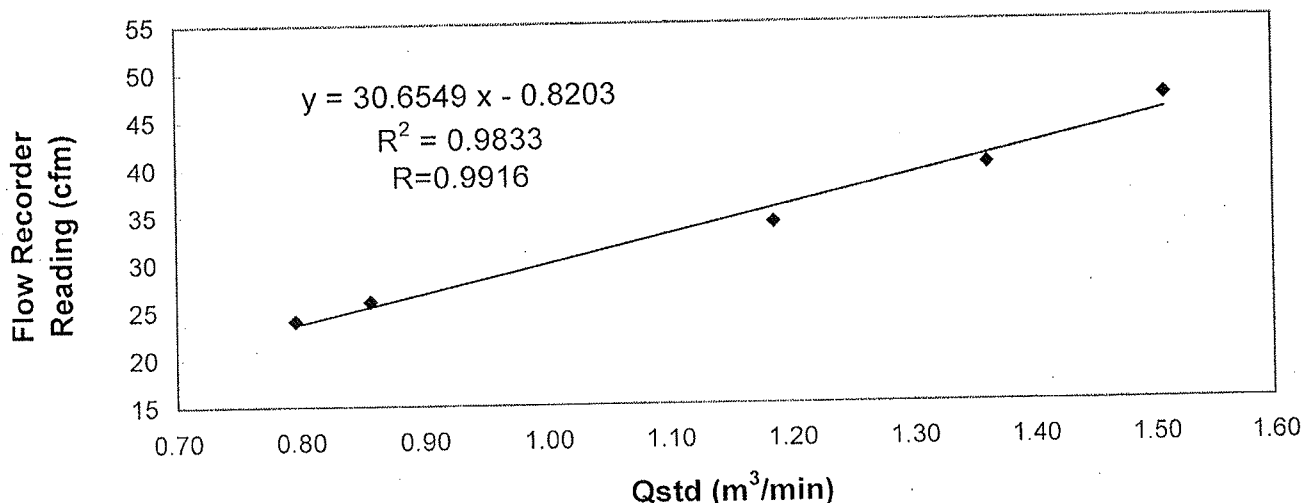
Results	Flow recorder reading (cfm)	47	40	34	26	24
	Qstd (Actual flow rate, m ³ /min)	1.51	1.36	1.19	0.86	0.80
	Pressure : 759.06 mm Hg	Temp. : 299 K

**Sampler 9795 Calibration Curve
Site: Tuen Mun (A1)**

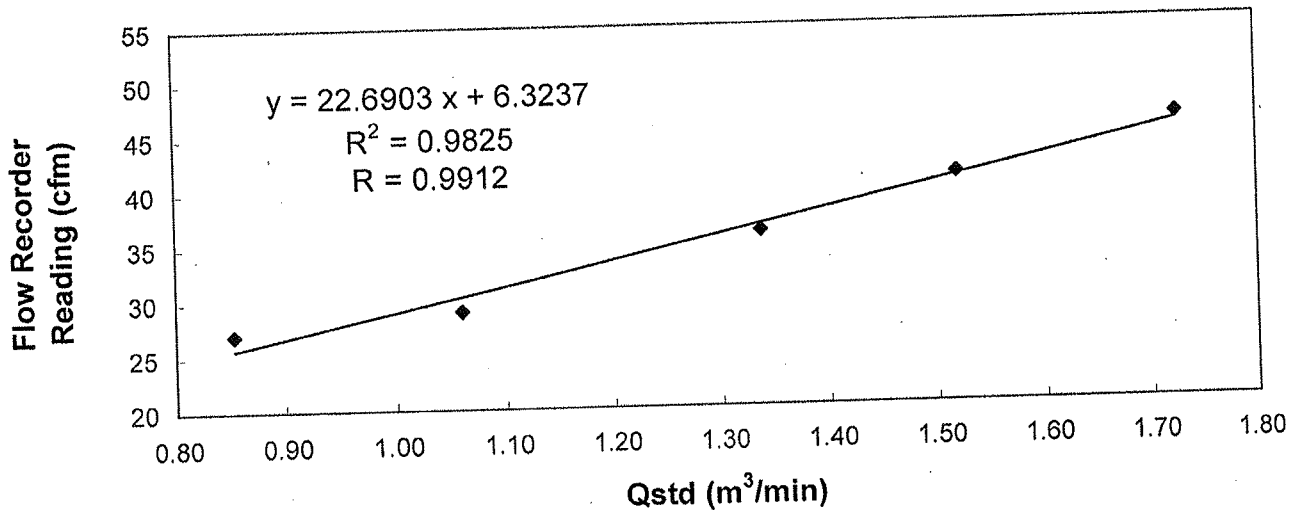
Results	Flow recorder reading (cfm)	46	41	36	29	27
	Qstd (Actual flow rate, m ³ /min)	1.72	1.52	1.34	1.06	0.85
	Pressure :	757.56 mm Hg			Temp. :	301 K

**Sampler 9864 Calibration Curve
Site: Tuen Mun (A2)**

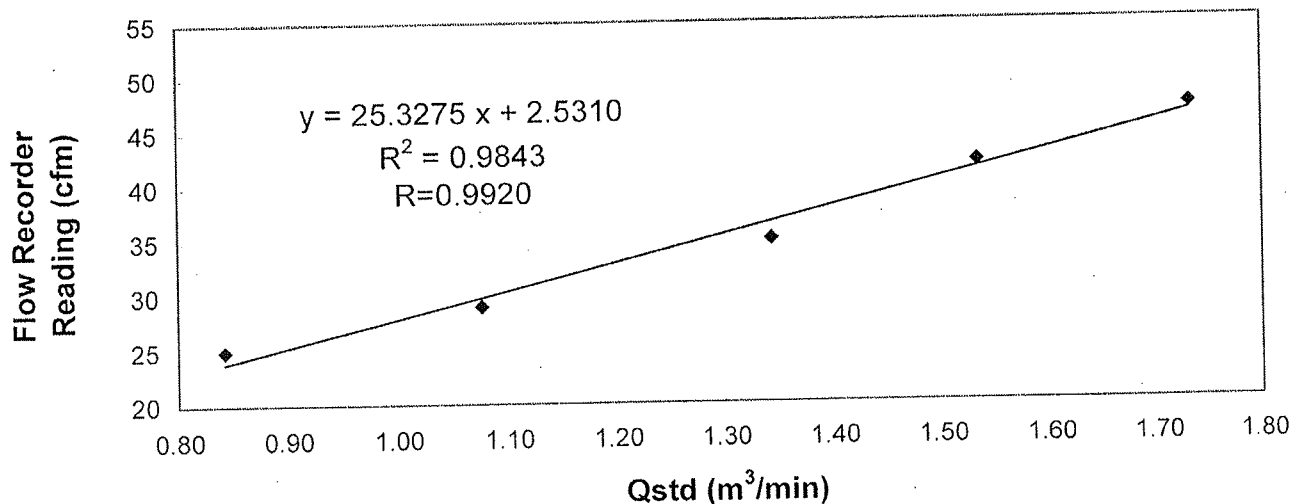
Results	Flow recorder reading (cfm)	47	42	35	29	25
	Qstd (Actual flow rate, m ³ /min)	1.73	1.53	1.34	1.08	0.84
	Pressure : 759.06 mm Hg	Temp. : 299 K

Sampler 9864 Calibration Curve
Site: Tuen Mun (A2)

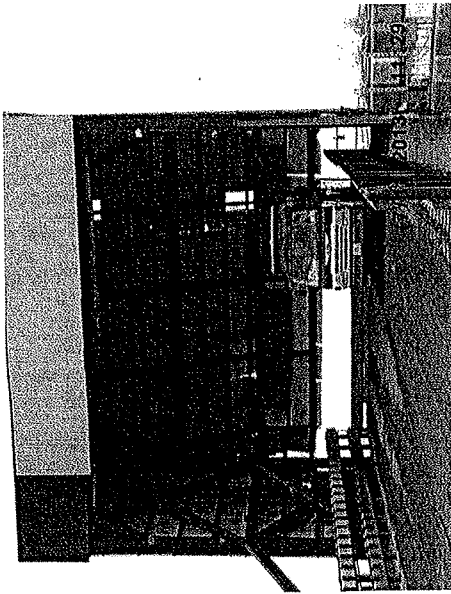
Photo 131107_001 (Tipping Hall No.2)

Date	Key Findings	Action(s) Taken recommended by ET	Action(s) Taken by the Contractor during the site audit	Rectification Status by ET
07 November 2013	The enclosure of tipping hall No.2 was noted damaged. (Previous item)	To repair the damaged part of the tipping hall properly.	---	Follow-up
	Skirt curtain for a generator at work shop was dirty. (Previous item)	To replace the skirt curtain properly.	Skirt curtain for a generator at work shop was replaced.	Closed
14 November 2013	The enclosure of tipping hall No.2 was noted damaged. (Previous item)	To repair the damaged part of the tipping hall properly.	---	Follow-up
	Water leakage was observed from a generator at dry soil deposition area. (New item)	To repair the trip tray of the generator in order to avoid water leakage.	---	Follow-up
	Rubbish was noted discarded near tipping hall No.2. (New item)	To collect and dispose the rubbish properly.	---	Follow-up

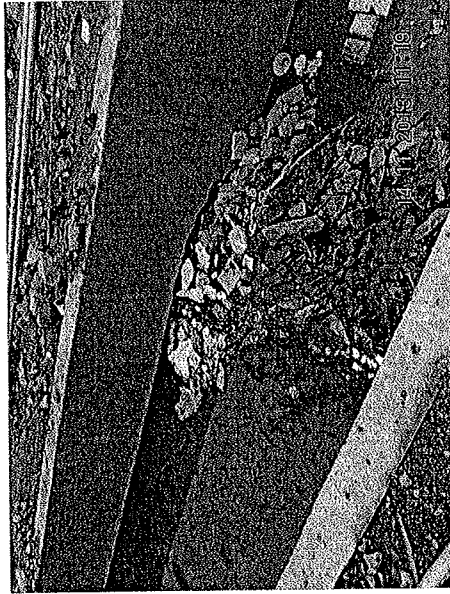
Photo 131114_004 (Main drainage channel)

Rubbish was noted accumulated inside the main drainage channel. (New item)	To collect and dispose the rubbish properly.	---	Follow-up
21 November 2013	The enclosure of tipping hall No.2 was noted damaged. (Previous item)	To repair the damaged part of the tipping hall properly.	---	Follow-up
	Water leakage was observed from a generator at dry soil deposition area. (Previous item)	To repair the trip tray of the generator in order to avoid water leakage.	No water leakage was observed from a generator at dry soil deposition area.	Closed
	Rubbish was noted discarded near tipping hall No.2. (Previous item)	To collect and dispose the rubbish properly.	Rubbish discarded near tipping hall No.2 was collected.	Closed
	Rubbish was noted accumulated inside the main drainage channel. (Previous item)	To collect and dispose the rubbish properly.	Rubbish accumulated inside the main drainage channel was cleared.	Closed

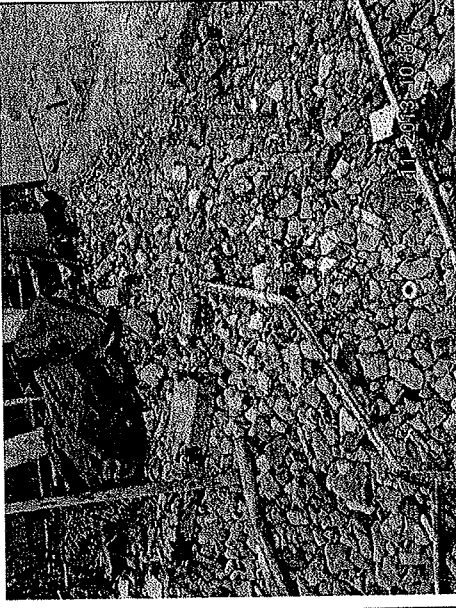
<p>Photo 131121_005 (Dry soil deposition area)</p>

Rubbish was noted discarded near a generator at dry soil deposition area. (New item)	To collect and dispose of the rubbish properly.	---	Follow-up
25 November 2013	The enclosure of tipping hall No.2 was noted damaged. (Previous item)	To repair the damaged part of the tipping hall properly.	---	Follow-up
	Rubbish was noted discarded near a generator at dry soil deposition area. (Previous item)	To collect and dispose of the rubbish properly.	Rubbish discarded near a generator at dry soil deposition area was cleared.	Closed
	Water leakage was noted from a drip tray for a generator at dry soil deposition area.	To repair the drain outlet of the drip tray to avoid water leakage.	---	Follow-up
	Standing water was noted inside a trip tray for a generator at work shop.	To drain the standing water or apply pesticide to avoid mosquito breeding.	---	Follow-up
	The skirt curtain for a generator at work shop was dirt.	To replace the dirt skirt curtain by clean one.	---	Follow-up
