China Harbour – China State Joint Venture

CONTRACT NO. CV/2009/02
HANDLING OF SURPLUS PUBLIC FILL
TUEN MUN AREA 38 FILL BANK
MONTHLY EM&A REPORT NO.49
(DECEMBER 2013)

Report No.: ENA40029

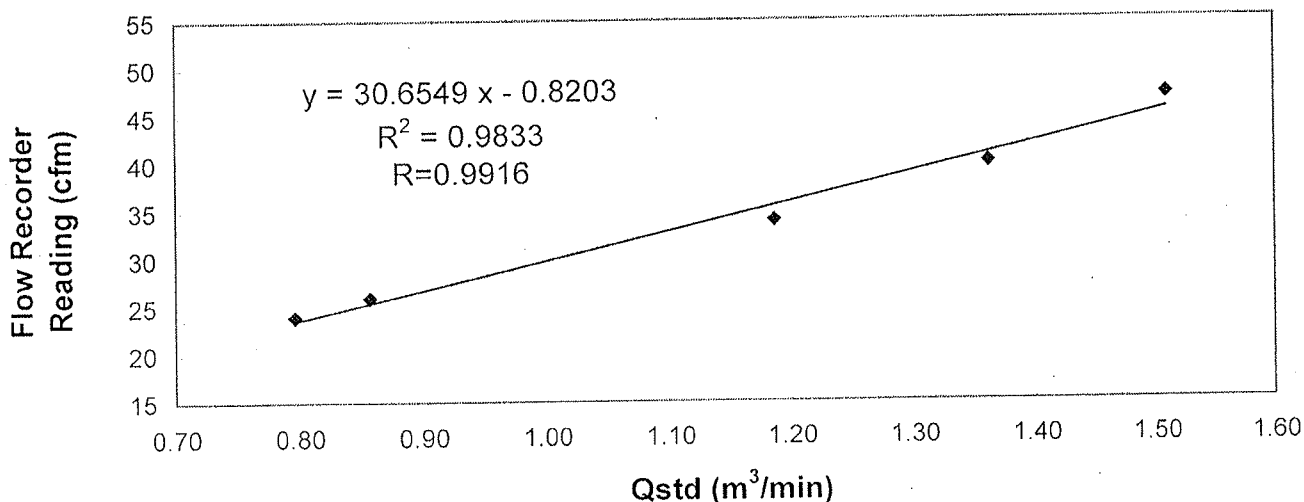
**Sampler 9795 Calibration Curve
Site: Tuen Mun (A1)**

Results	Flow recorder reading (cfm)	47	40	34	26	24
	Qstd (Actual flow rate, m ³ /min)	1.51	1.36	1.19	0.86	0.80
	Pressure : 759.06 mm Hg	Temp. : 299 K

Acceptance Criteria : Correlation coefficient (r) of the calibration curve greater than 0.990 after a 5-point calibration

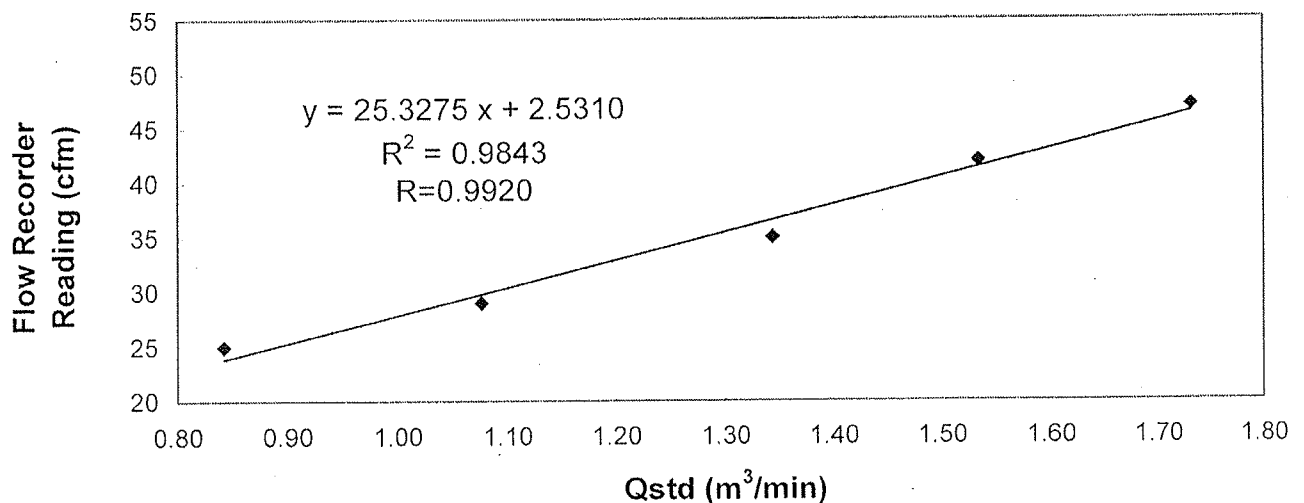
**Sampler 9864 Calibration Curve
Site: Tuen Mun (A2)**

Results	Flow recorder reading (cfm)	47	42	35	29	25
	Qstd (Actual flow rate, m ³ /min)	1.73	1.53	1.34	1.08	0.84
	Pressure : 759.06 mm Hg	Temp. : 299 K

Acceptance Criteria : Correlation coefficient (r) of the calibration curve greater than 0.990 after a 5-point calibration

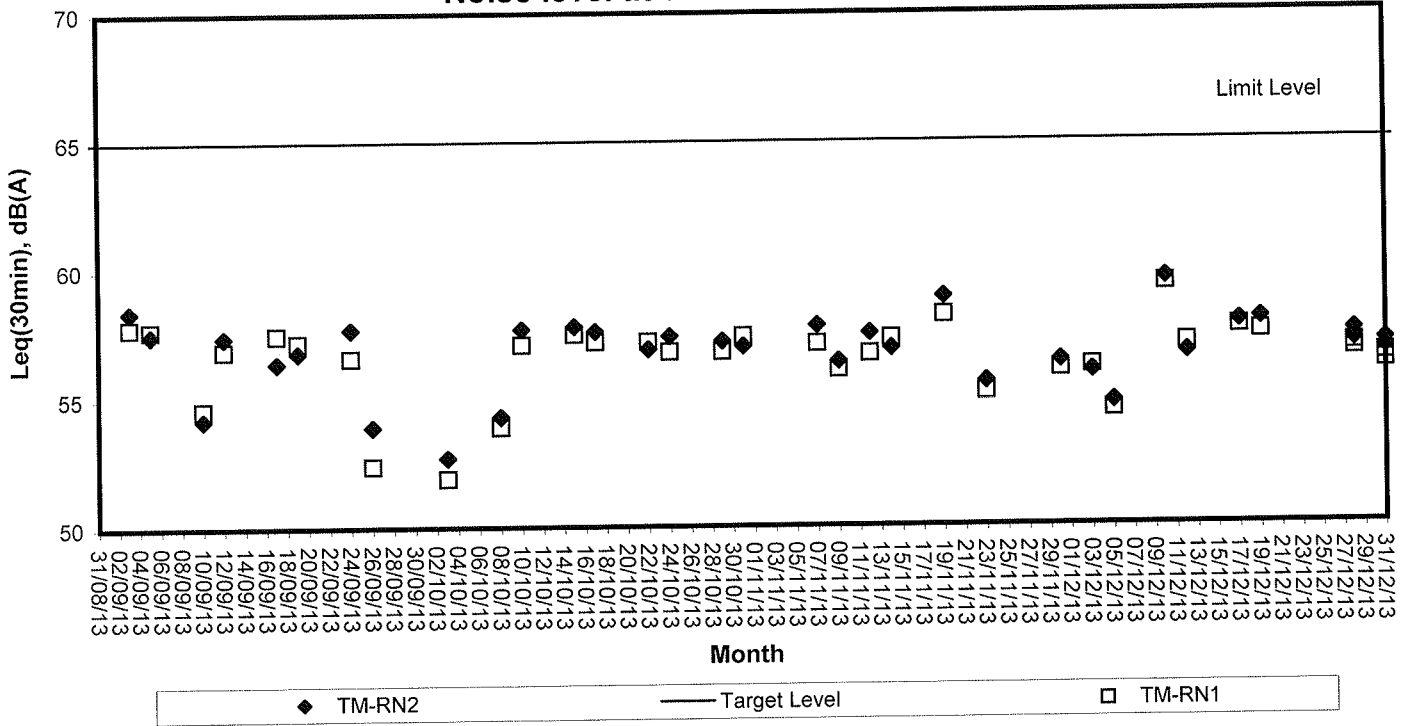
Noise level at TM-RN1 and TM-RN2

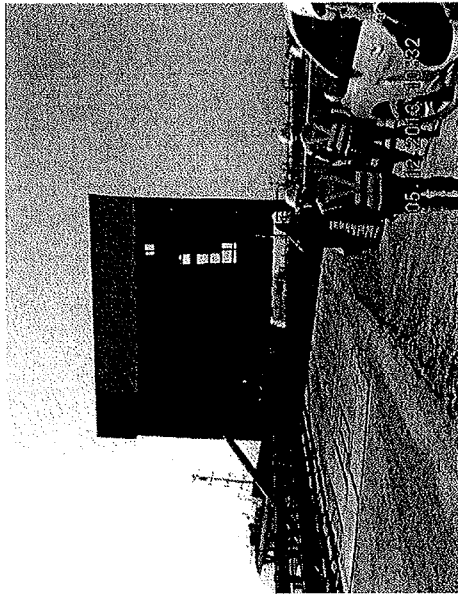
Date	Key Findings	Action(s) Taken recommended by ET	Action(s) Taken by the Contractor during the site audit	Rectification Status by ET
05 December 2013	The enclosure of tipping hall No.2 was noted damaged. (Previous item)	To repair the damaged part of the tipping hall properly.	---	Follow-up
	Water leakage was noted from a drip tray for a generator at dry soil deposition area. (Previous item)	To repair the drain outlet of the drip tray to avoid water leakage.	No water leakage was noted from a drip tray for a generator at dry soil deposition area.	Closed
	Standing water was noted inside a trip tray for a generator at work shop. (Previous item)	To drain the standing water or apply pesticide to avoid mosquito breeding.	No standing water was noted inside a trip tray for a generator at work shop.	Closed
	Rubbish was noted discarded inside the new drainage channel near workshop. (New item)	To collect and dispose of the rubbish properly.	---	Follow-up

Photo 131205_001 (Tipping Hall No.2)

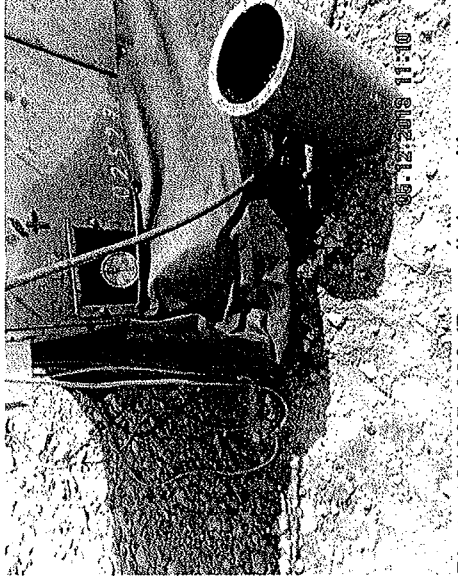
Photo 131205_002 (Dry soil deposition area) (Improved)

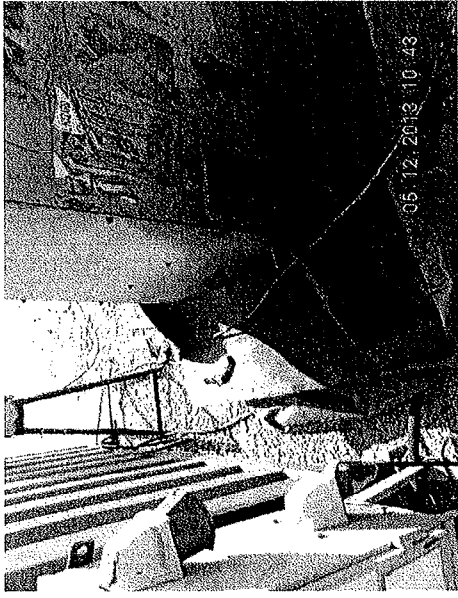
Photo 131205_003 (Work Shop) (Improved)

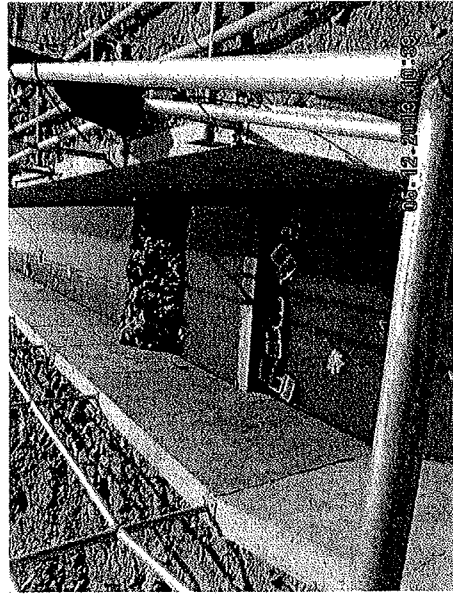
Item	Details of defective works or observations	Proposed Follow Up Action	Photo Ref.	Further Action Required (Yes/No)	Target Completion Date
1	Follow up action to item 3 on 17/10/13, item 2 on 24/10/13, item 1 on 31/10/13, item 1 on 07/11/13 and item 1 on 14/11/13 and item 1 on 21/11/13 and item 1 on 25/11/13, the enclosure of tipping hall No.2 was still noted damaged.	To repair the damaged part of the tipping hall properly.	131205_001	Yes	12/12/13
2	Follow up action to item 3 on 25/11/13, no water leakage was noted from a drip tray for a generator at dry soil deposition area.	---	131205_002	No	---
3	Follow up action to item 4 on 25/11/13, no standing water was noted inside a trip tray for a generator at work shop.	---	131205_003	No	---
4	Rubbish was noted discarded inside the new drainage channel near workshop.	To collect and dispose of the rubbish properly.	131205_004	Yes	12/12/13

Photo 131205_004 (New drainage channel near workshop)

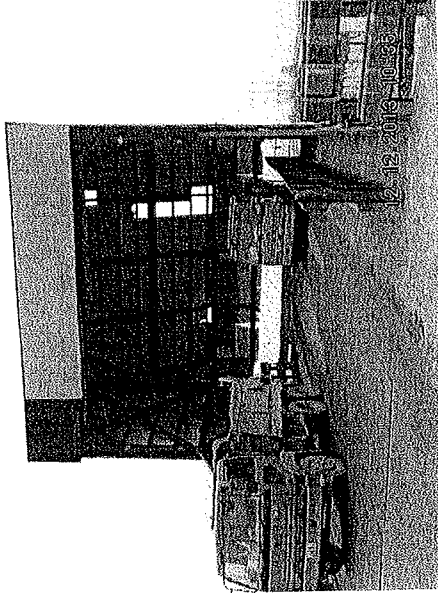
12 December 2013	The enclosure of tipping hall No.2 was noted damaged. (Previous item)	To repair the damaged part of the tipping hall properly.	---	Follow-up
	Rubbish was noted discarded inside the new drainage channel near workshop. (Previous item)	To collect and dispose of the rubbish properly.	---	Follow-up
	Idle tyres were noted discarded at water truck filling station. (New item)	To collect and store the tyres properly.	---	Follow-up
19 December 2013	The enclosure of tipping hall No.2 was noted damaged. (Previous item)	To repair the damaged part of the tipping hall properly.	---	Follow-up
	Rubbish was noted discarded inside the new drainage channel near workshop. (Previous item)	To collect and dispose of the rubbish properly.	Rubbish discarded inside the new drainage channel near workshop was collected.	Closed
	Idle tyres were noted discarded at water truck filling station. (Previous item)	To collect and store the tyres properly.	Idle tyres discarded at water truck filling station were cleared.	Closed

<p>Photo 131212_001 (Tipping Hall No.2)</p>

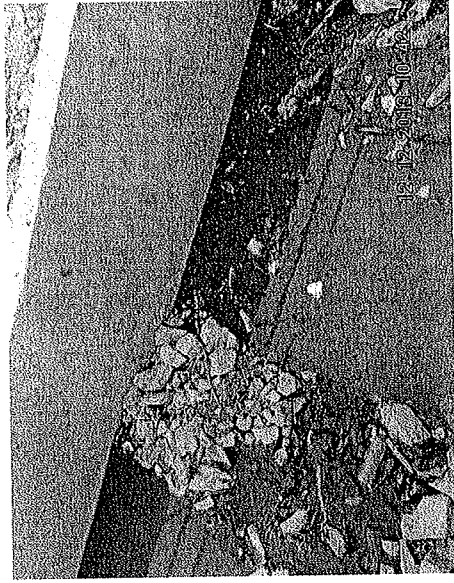
<p>Photo 131212_002 (New drainage channel near workshop)</p>

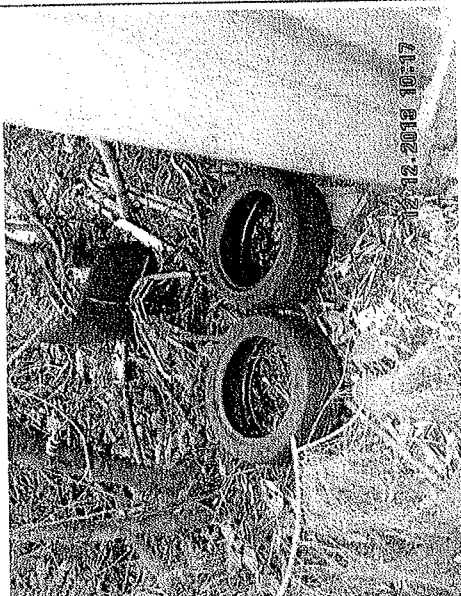
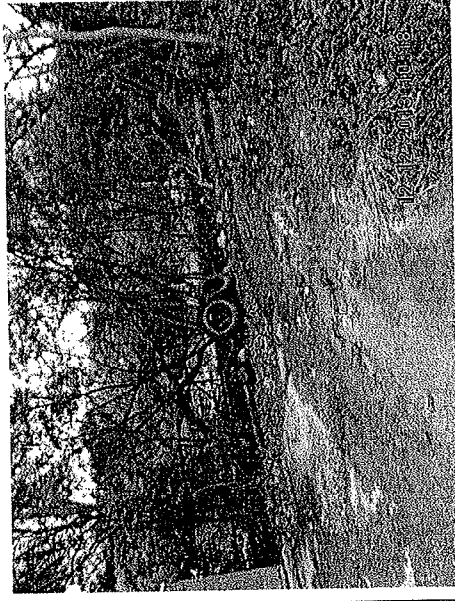
<p>Photo 131212_003 (Water truck filling station)</p>

<p>Photo 131212_004 (Water truck filling station)</p>

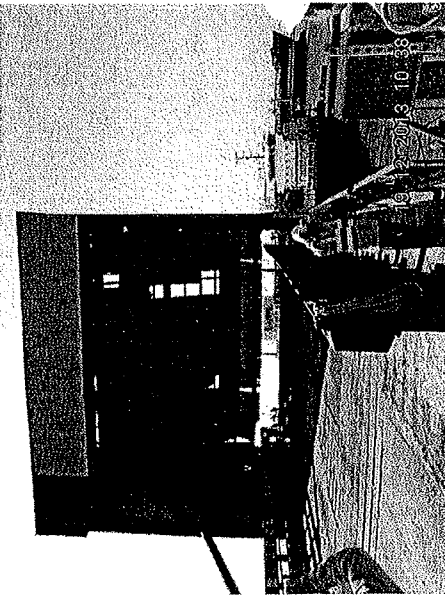
<p>Photo 131219_001 (Tipping Hall No.2)</p>

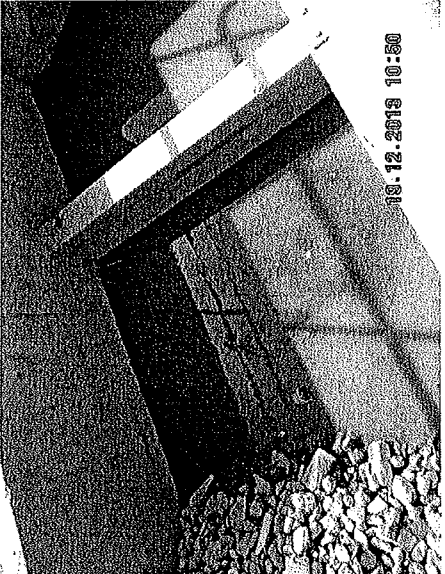
<p>Photo 131219_002 (New drainage channel near workshop) (Improved)</p>

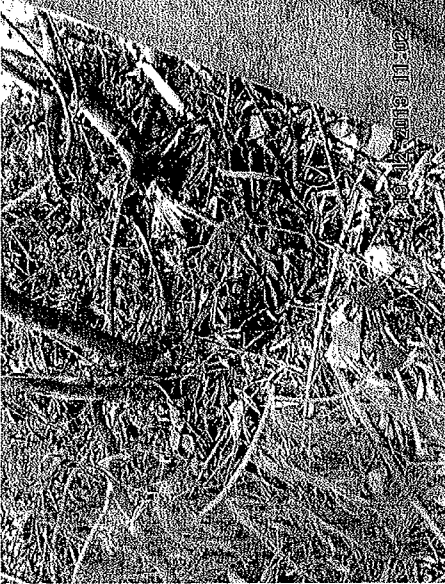
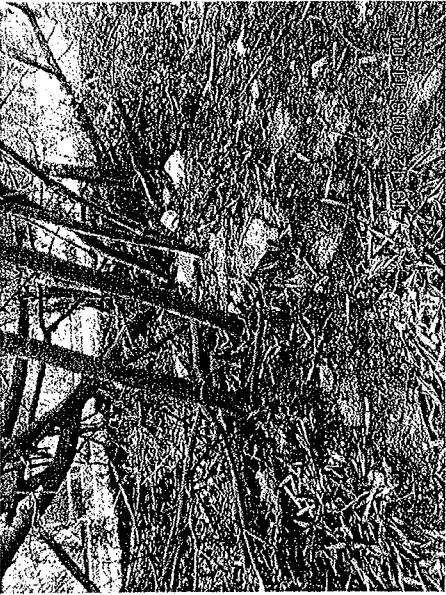
<p>Photo 131219_003 (Water truck filling station) (Improved)</p>

<p>Photo 131219_004 (Water truck filling station) (Improved)</p>

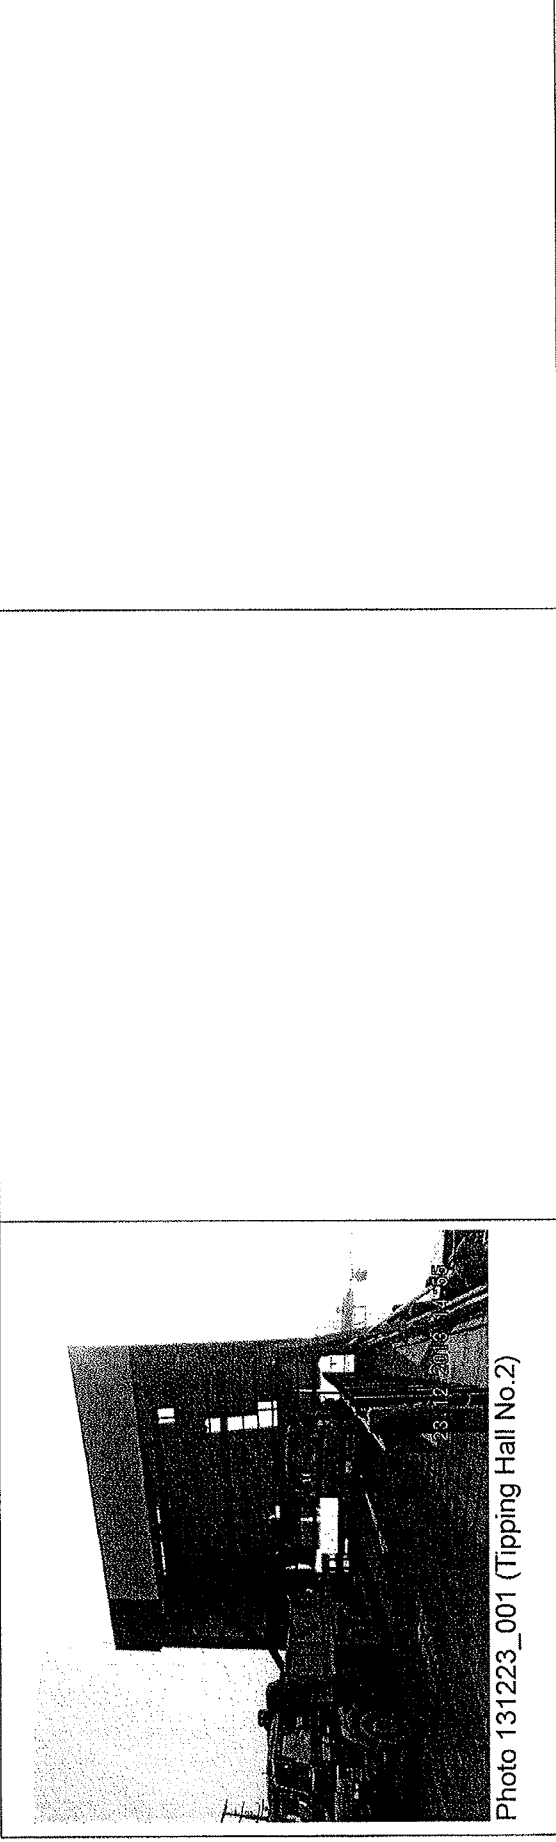
23 December 2013	The enclosure of tipping hall No.2 was noted damaged. (Previous item)	To repair the damaged part of the tipping hall properly.	---	Follow-up

Photo 131223_001 (Tipping Hall No.2)

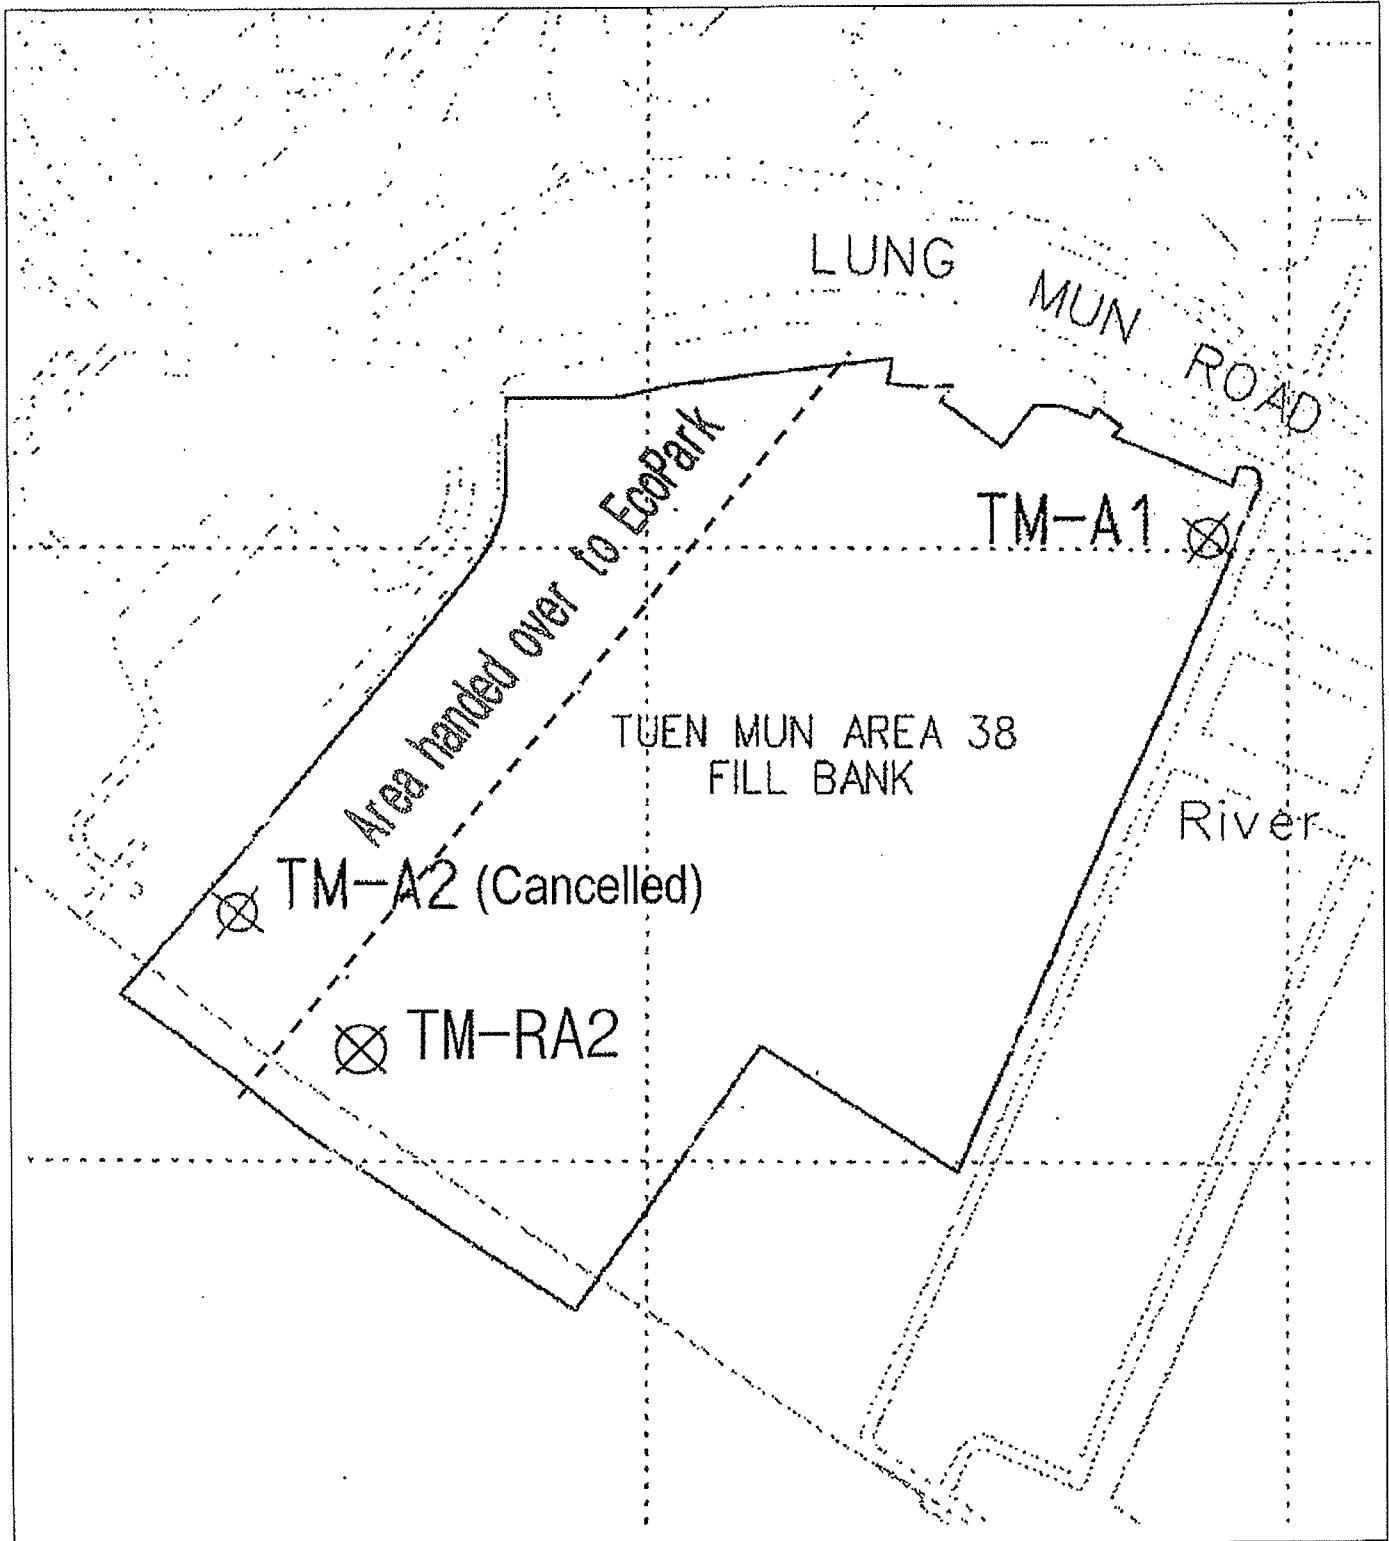
Figure 1
 Locations of Air Quality Monitoring Stations –
 Tuen Mun Area 38 Fill Bank

The locations of monitoring stations are shown in Figure 1.

Since the area for existing air monitoring station TM-A2 near Tipping Hall No.1 was handed over to EcoPark, air monitoring station TM-A2 was cancelled and the air monitoring was carried out at an alternative air monitoring station TM-RA2 (refer to Figure 1 attached) from 28 October 2008.

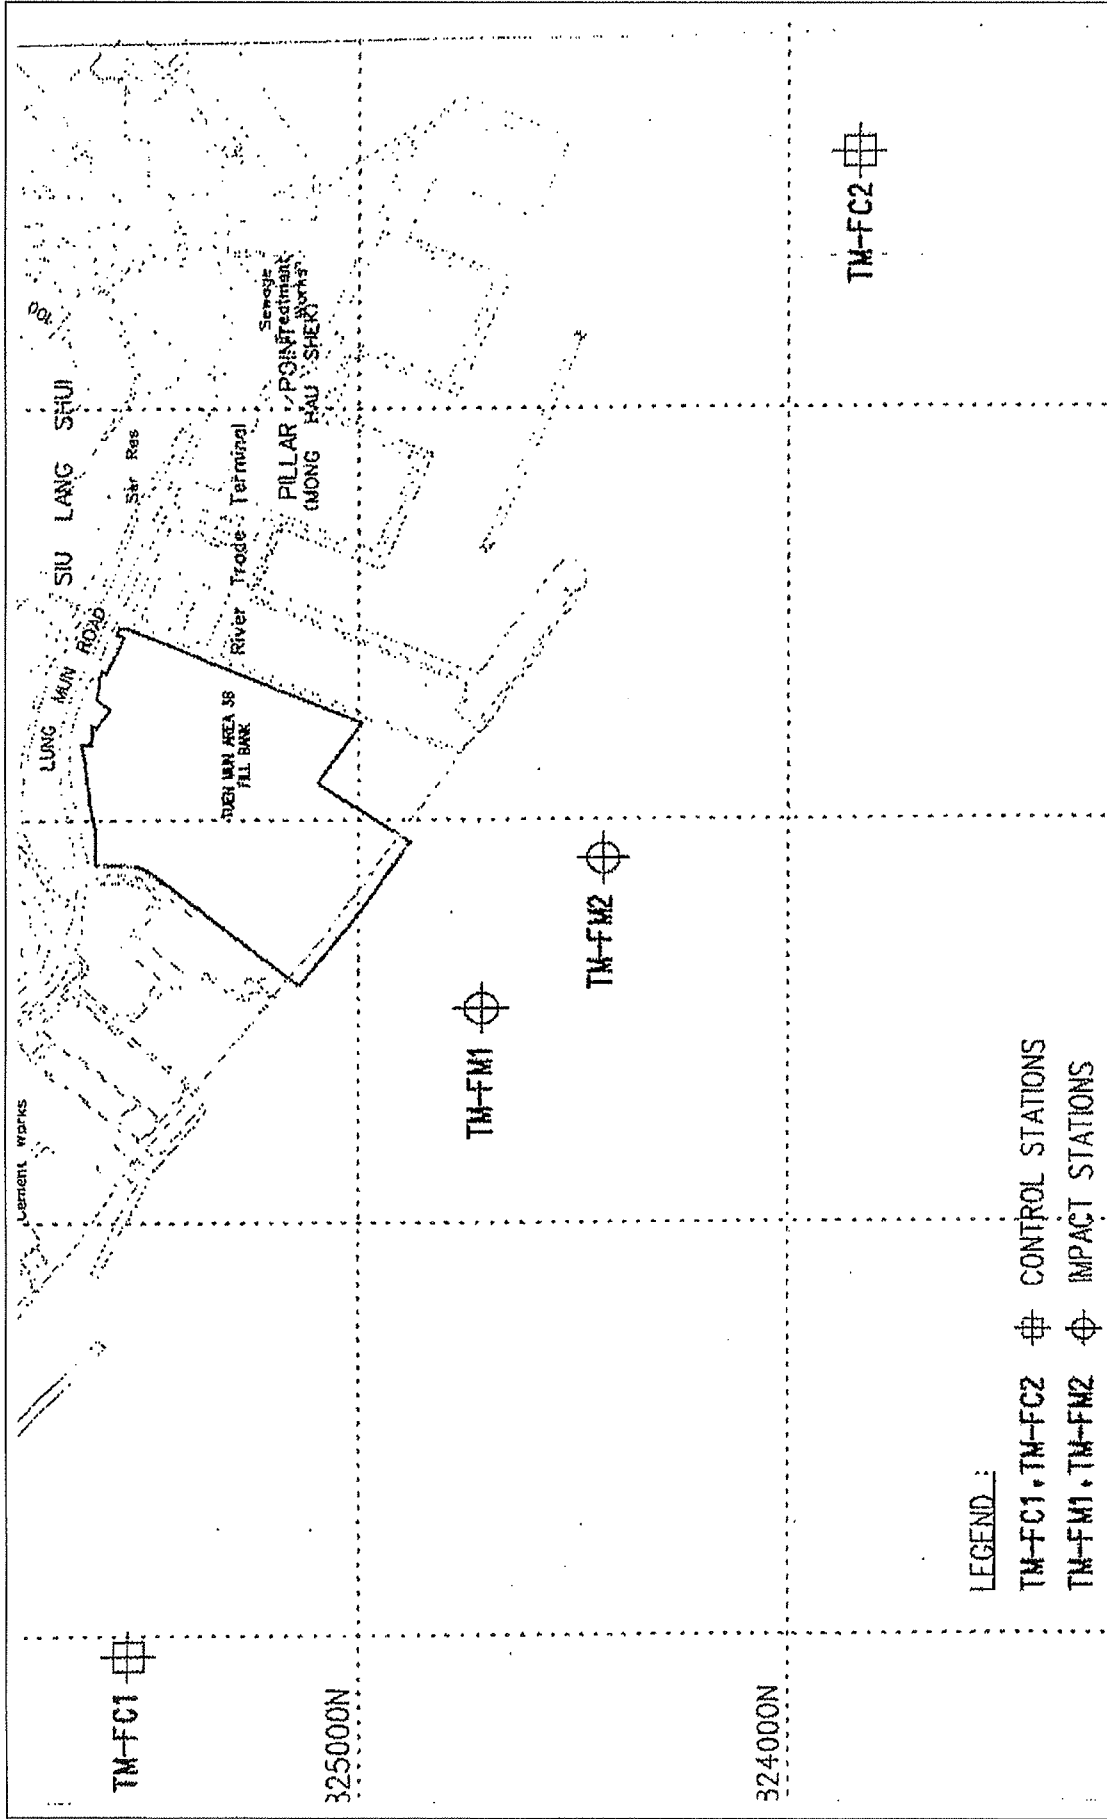
Figure 2
 Locations of Water Quality Monitoring Station –
 Tuen Mun Area 38 Fill Bank

As stipulated in the EM&A requirement, there were four monitoring stations undertaken during the impact monitoring. Figure 2 shows the locations of the marine water quality monitoring stations.

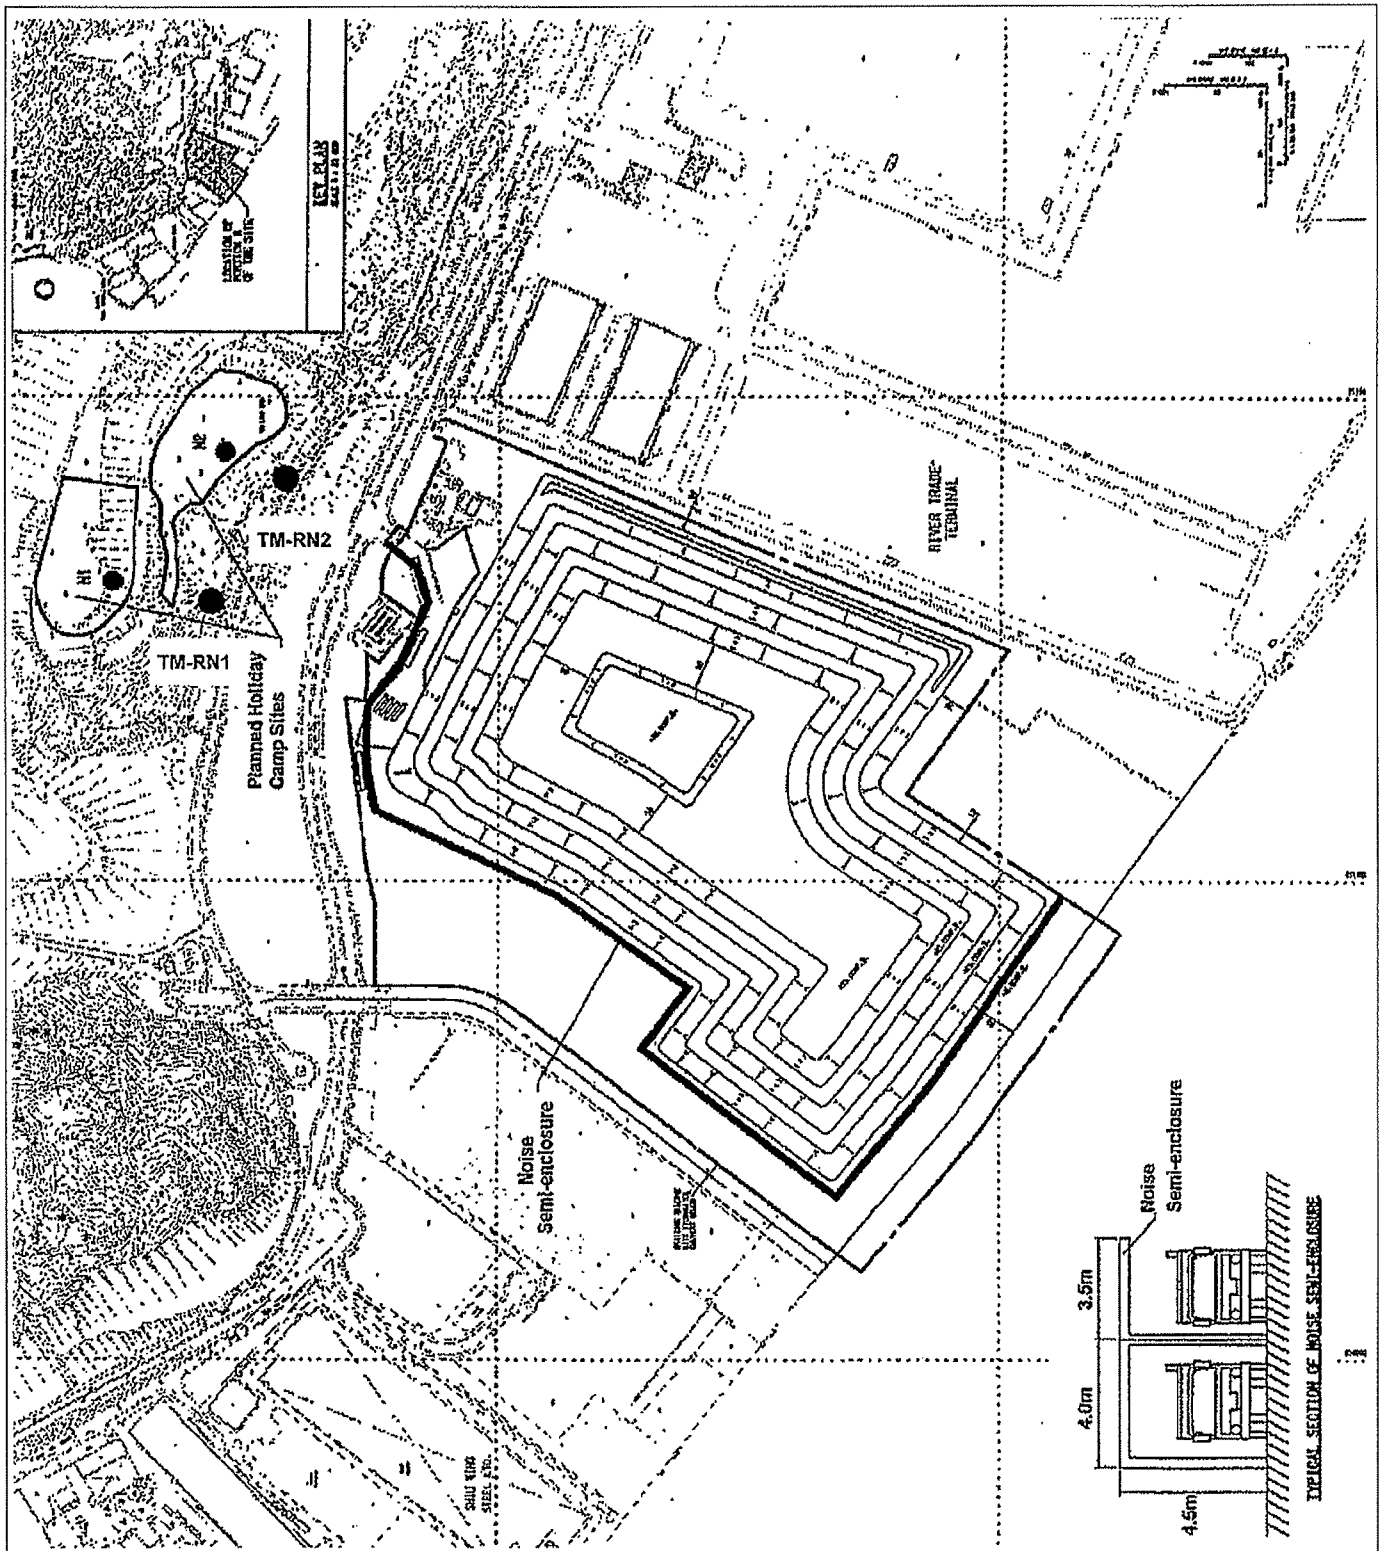
Figure 3
 Locations of Noise Quality Monitoring Stations –
 Tuen Mun Area 38 Fill Bank

The noise monitoring locations, TM-RN1 and TM-RN2 are shown in Figure 3. The noise measurement at TM-RN1 and TM-RN2 are façade measurement.

Since Lands Dept did not approve to carry out noise monitoring at their own area where the noise monitoring stations TM-N1 and TM-N2 located due to the security, noise monitoring carried out at two alternative noise monitoring stations TM-RN1 and TM-RN2 (refer to the Figure 3 attached) from 18 December 2007.
