CONTRACT NO. CV/2009/02
HANDLING OF SURPLUS PUBLIC FILL
TUEN MUN AREA 38 FILL BANK
MONTHLY EM&A REPORT NO.50
(01 TO 20 JANUARY 2014)

Issue Date: 18 February 2014

Report No.: ENA40187

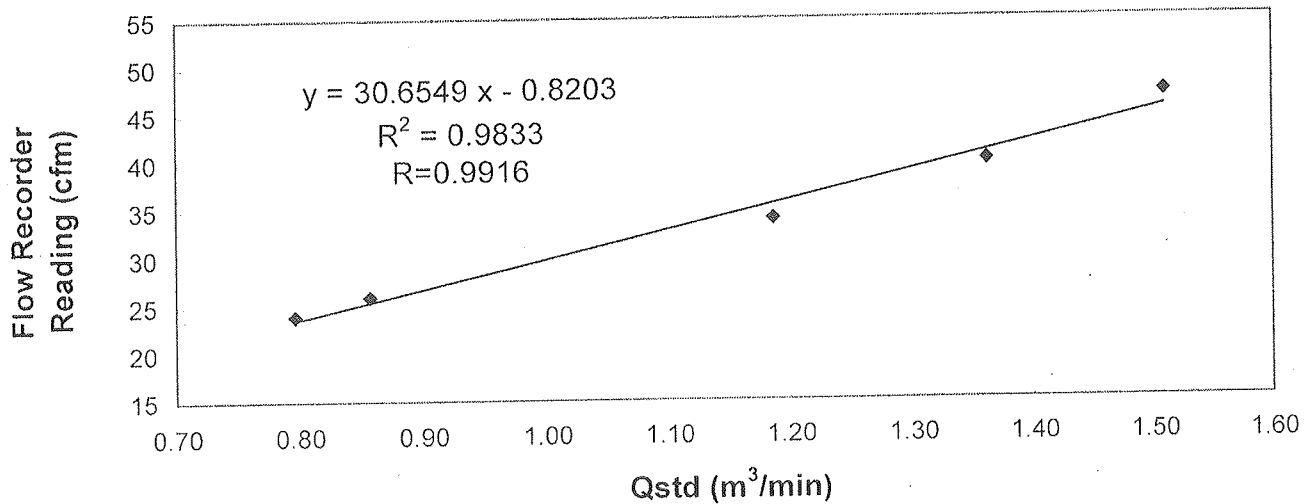
**Sampler 9795 Calibration Curve
Site: Tuen Mun (A1)**

Results :	Flow recorder reading (cfm)	47	40	34	26	24
	Qstd (Actual flow rate, m ³ /min)	1.51	1.36	1.19	0.86	0.80
	Pressure :	759.06 mm Hg			Temp. :	299 K

Acceptance Criteria : Correlation coefficient (r) of the calibration curve greater than 0.990 after a 5-point calibration

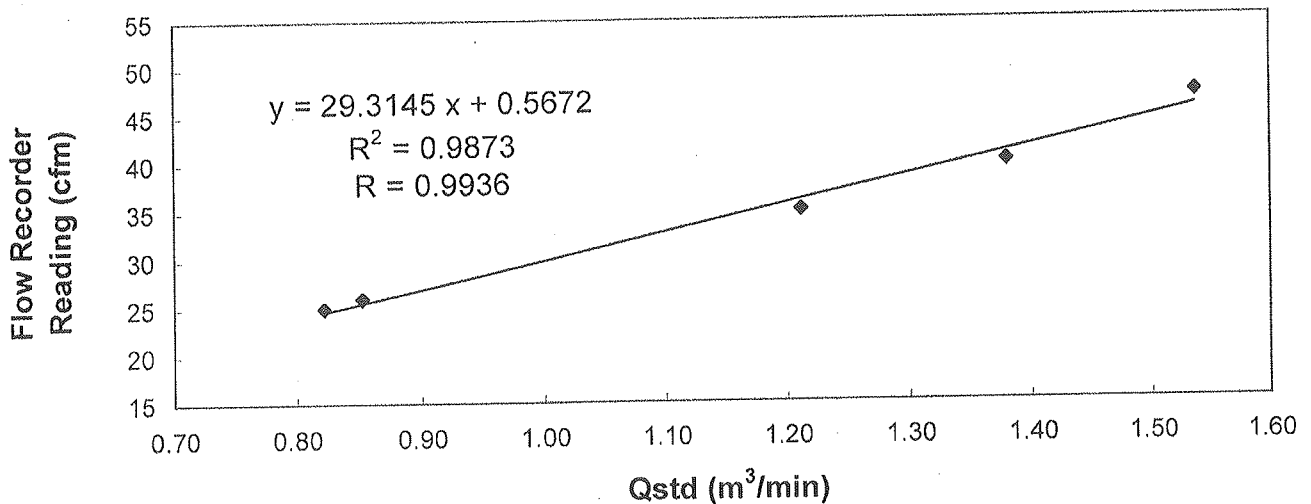
Sampler 9795 Calibration Curve
Site: Tuen Mun (A1)

Results	Flow recorder reading (cfm)	47	40	35	26	25
	Qstd (Actual flow rate, m ³ /min)	1.54	1.38	1.21	0.85	0.82
	Pressure : 760.56 mm Hg	Temp. : 292 K

Acceptance Criteria : Correlation coefficient (r) of the calibration curve greater than 0.990 after a 5-point calibration

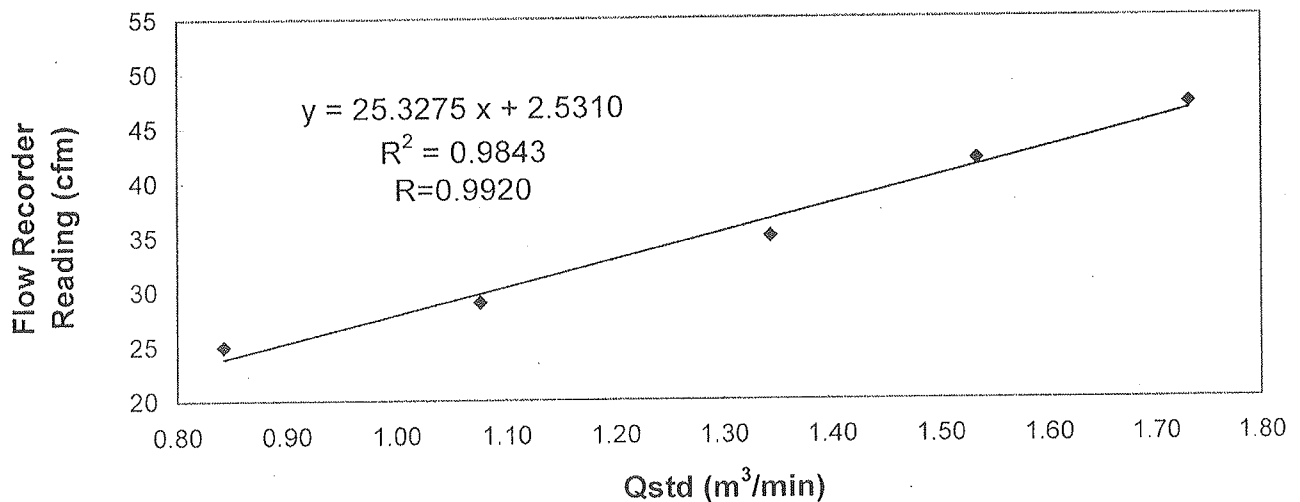
Sampler 9864 Calibration Curve
Site: Tuen Mun (A2)

Results	Flow recorder reading (cfm)	47	42	35	29	25
	Qstd (Actual flow rate, m ³ /min)	1.73	1.53	1.34	1.08	0.84
	Pressure : 759.06 mm Hg	Temp. : 299 K

Acceptance Criteria : Correlation coefficient (r) of the calibration curve greater than 0.990 after a 5-point calibration

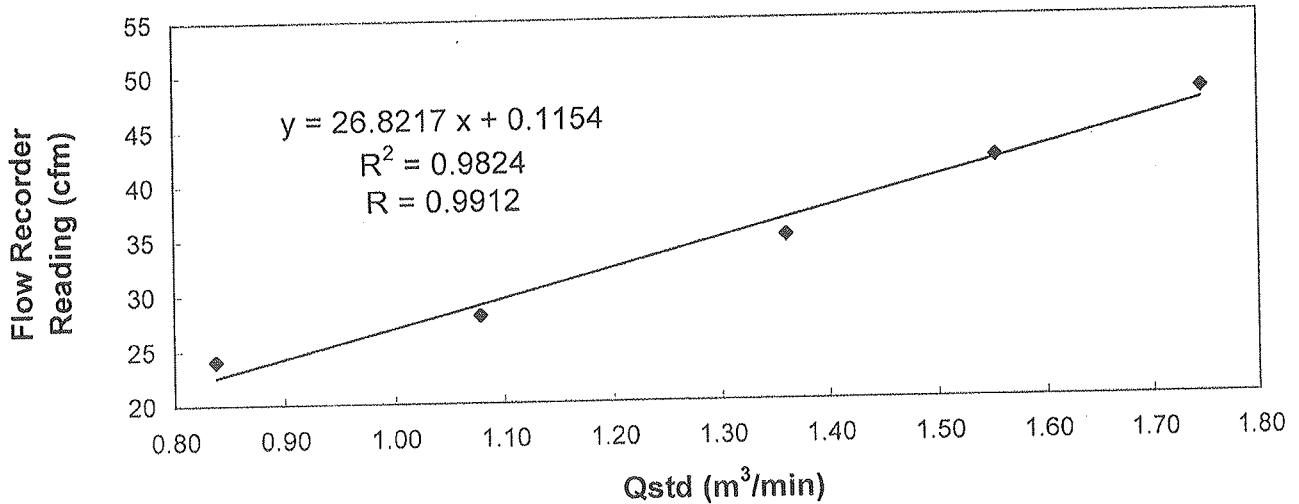
Sampler 9864 Calibration Curve
Site: Tuen Mun (A2)

Results	Flow recorder reading (cfm)	47	42	35	28	24
	Qstd (Actual flow rate, m ³ /min)	1.75	1.55	1.36	1.08	0.84
	Pressure :	760.56 mm Hg		Temp. :	292 K

Acceptance Criteria : Correlation coefficient (r) of the calibration curve greater than 0.990 after a 5-point calibration

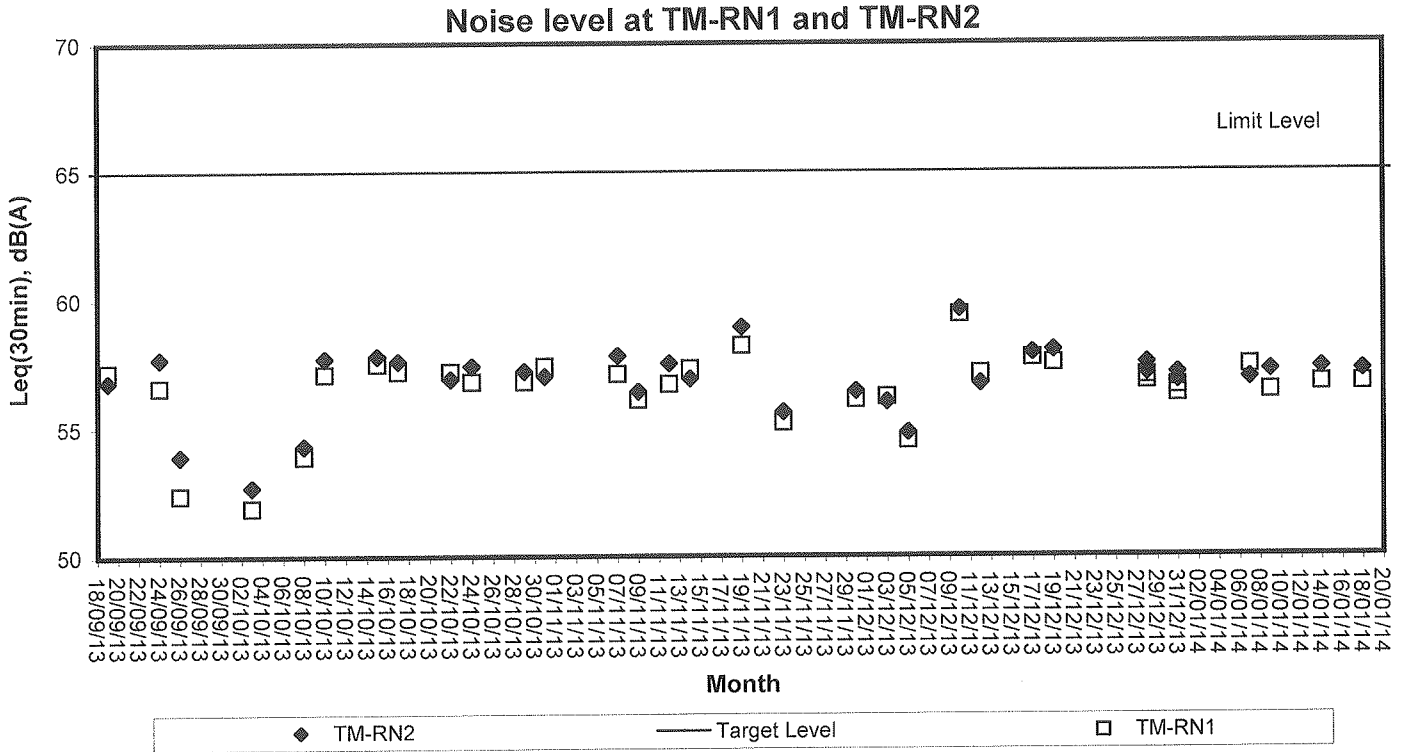
Noise Monitoring (Day-time)

Date	Start Sampling Time (hh:mm)	Noise Level dB (A)			Wind Speed (m/s)	Weather Condition
		L _{eq} (30min)	L ₁₀	L ₉₀		
07/01/14	16:40	57.4	59.0	54.2	0.3	Fine
09/01/14	09:50	56.4	57.9	53.5	0.3	Fine
14/01/14	16:40	56.7	58.2	53.3	0.4	Fine
18/01/14	15:25	56.7	58.0	52.7	0.4	Fine

Date	Start Sampling Time (hh:mm)	Noise Level dB (A)			Wind Speed (m/s)	Weather Condition
		L _{eq} (30min)	L ₁₀	L ₉₀		
07/01/14	16:45	56.9	58.8	54.4	0.4	Fine
09/01/14	09:15	57.2	58.4	54.1	0.4	Fine
14/01/14	17:15	57.3	58.8	52.9	0.4	Fine
18/01/14	14:50	57.2	59.0	53.0	0.4	Fine

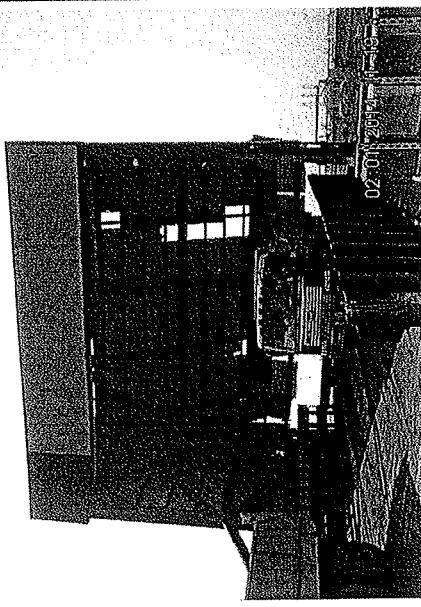
<p>Photo 140102_001 (Tipping Hall No.2)</p>

<i>Date</i>	<i>Key Findings</i>	<i>Action(s) Taken recommended by ET</i>	<i>Action(s) Taken by the Contractor during the site audit</i>	<i>Rectification Status by ET</i>
02 January 2014	The enclosure of tipping hall No.2 was noted damaged. (Previous item)	To repair the damaged part of the tipping hall properly.	---	Follow-up
	Mud and silt were found accumulated inside the main drainage channel near tipping hall No.3. (New item)	To clear the accumulated mud and silt to avoid any blockage.	---	Follow-up
	Mud and silt were found accumulated inside the main drainage channel near CREO. (New item)	To clear the accumulated mud and silt to avoid any blockage.	---	Follow-up
	Chemical drums outside the chemical waste storage area were found without drip tray. (New item)	To provide appropriate drip tray for all chemicals and chemical waste, and store them properly.	---	Follow-up

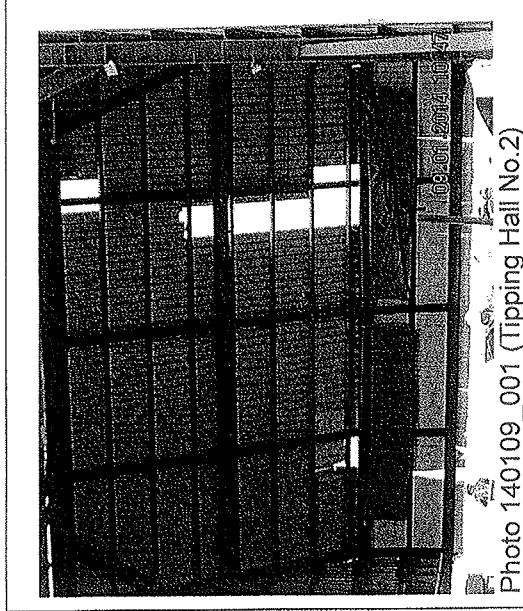
Photo 140109_001 (Tipping Hall No.2)

Date	Key Findings	Action(s) Taken recommended by ET	Action(s) Taken by the Contractor during the site audit	Rectification Status by ET
09 January 2014	The enclosure of tipping hall No.2 was noted damaged. (Previous item)	To repair the damaged part of the tipping hall properly.	---	Follow-up
	Mud and silt were found accumulated inside the main drainage channel near tipping hall No.3. (Previous item)	To clear the accumulated mud and silt to avoid any blockage.	---	Follow-up
	Mud and silt were found accumulated inside the main drainage channel near CREO. (Previous item)	To clear the accumulated mud and silt to avoid any blockage.	Mud and silt accumulated inside the drainage channel near CREO were cleared.	Closed
	Chemical drums outside the chemical waste storage area were found without drip tray. (Previous item)	To provide appropriate drip tray for all chemicals and chemical waste, and store them properly.	All chemical waste were stored inside the chemical waste storage area properly.	Closed

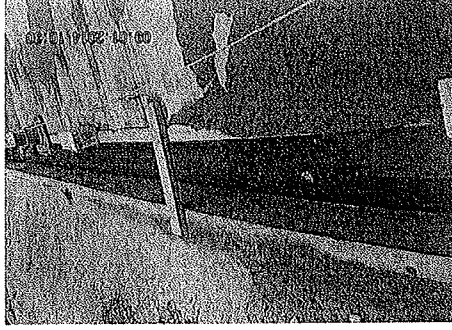
Photo 140109_003 (Drainage channel near CREO) (improved)

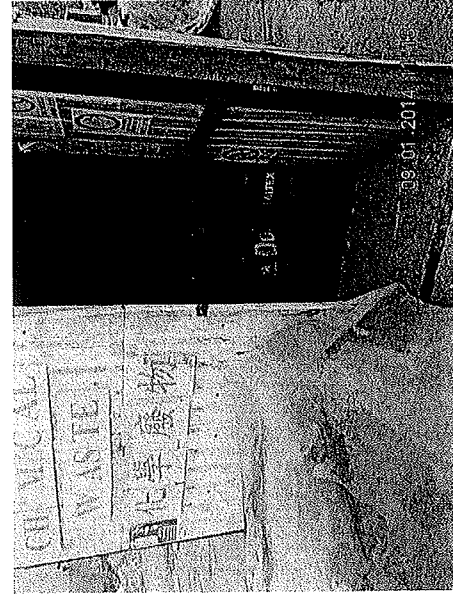
Photo 140109_004 (Chemical waste storage area) (Improved)

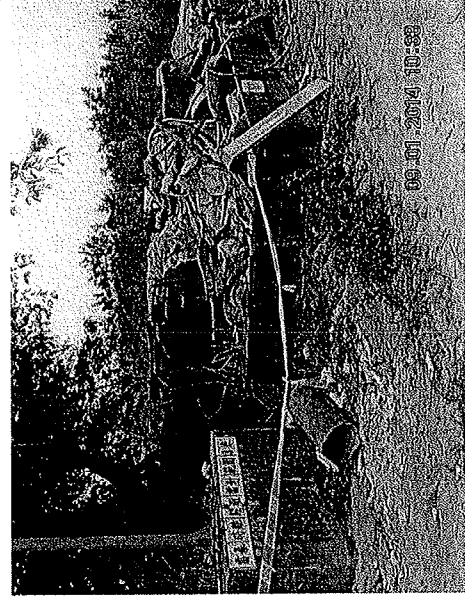
Photo 140109_005 (Near CREO)

The tray for C&D waste near CREO was full and without cover. (New item)	To cover the tray properly and dispose of C&D waste inside the tray as soon as possible.	---	Follow-up
	Oil leakage was noted from an excavator at workshop. (New item)	To clear the leaked oil and treat the contaminated materials as chemical waste.	---	Follow-up
17 January 2014	The enclosure of tipping hall No.2 was noted damaged. (Previous item)	To repair the damaged part of the tipping hall properly.	---	Follow-up
	Mud and silt were found accumulated inside the main drainage channel near tipping hall No.3. (Previous item)	To clear the accumulated mud and silt to avoid any blockage.	---	Follow-up
	The tray for C&D waste near CREO was full and without cover. (Previous item)	To cover the tray properly and dispose of C&D waste inside the tray as soon as possible.	Waste in side the tray for C&D waste near CREO was collected and covered properly.	Closed

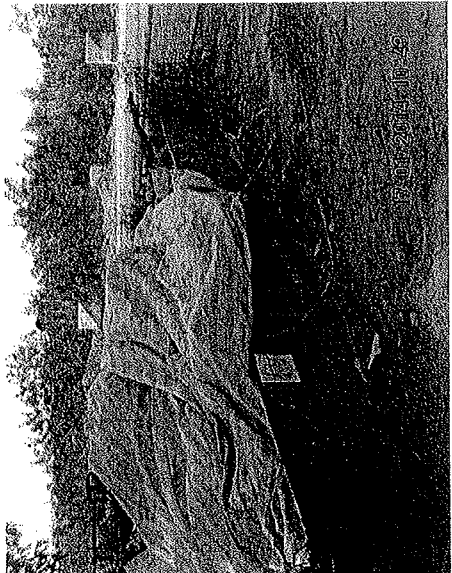
<p>Photo 140117_003 (Near CREO) (Improved)</p>

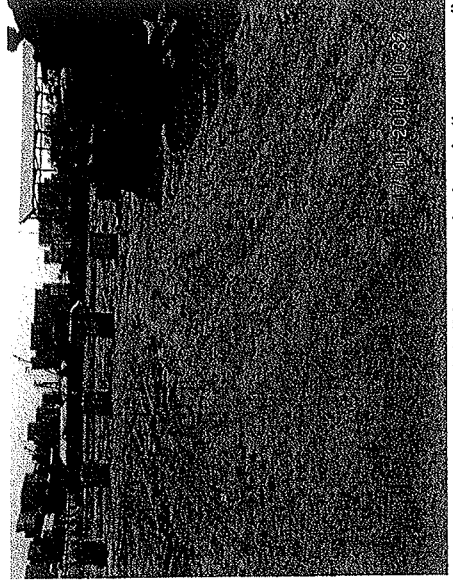
Oil leakage was noted from an excavator at workshop. (Previous item)	To clear the leaked oil and treat the contaminated materials as chemical waste.	Leaked oil I from an excavator at workshop was cleared.	Closed

<p>Photo 140117_004 (New workshop) (Improved)</p>
