**Contract No.: CV/2013/06
Handling of Surplus Public Fill
(2014-2016)**

**TUEN MUN AREA 38 FILL BANK
MONTHLY EM&A REPORT NO.6
(JUNE 2014)**

Report No.: ENA41152

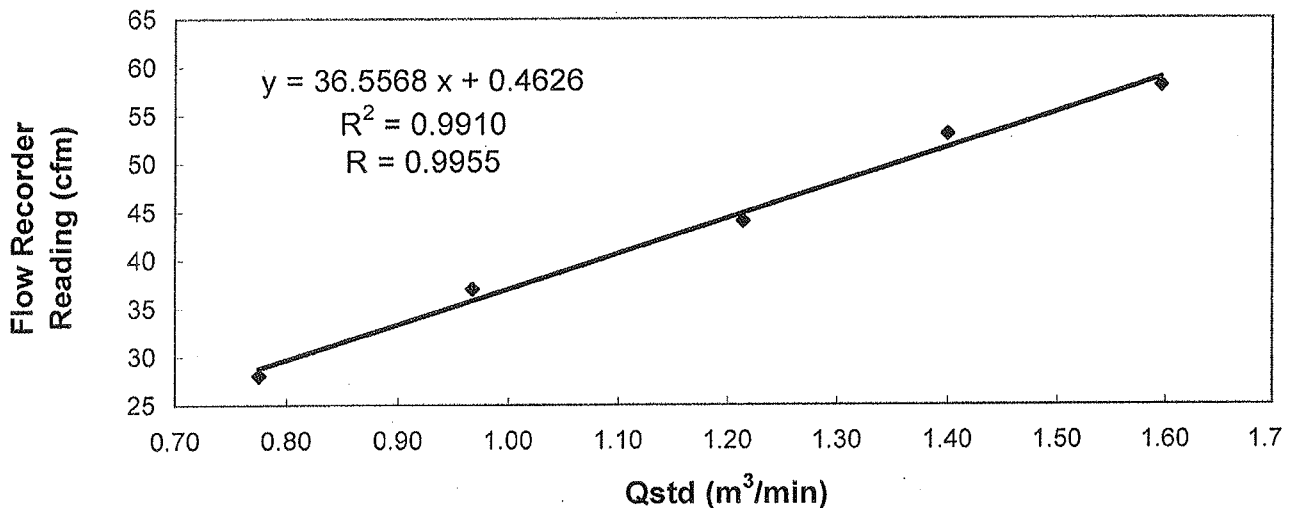
Sampler 10347 Calibration Curve
Site: Tuen Mun 38 (TM-A1)

Acceptance Criteria : Correlation coefficient (r) of the calibration curve greater than 0.990 after a 5-point calibration

The high volume sampler complies* / ~~does not comply*~~ with the specified requirements and is deemed acceptable* / unacceptable* for use.

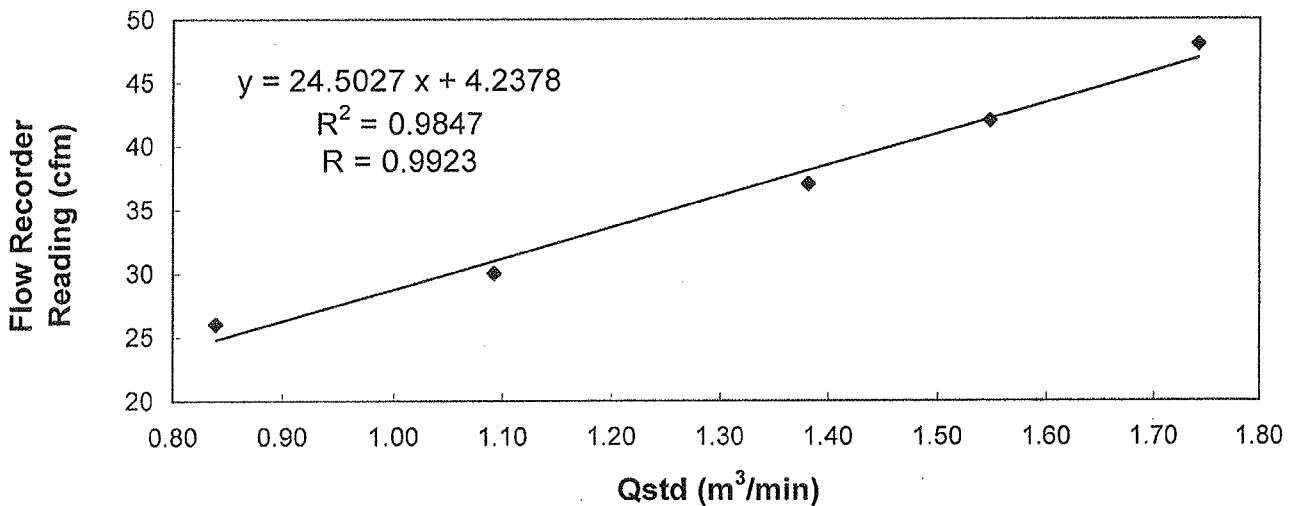
Sampler 9864 Calibration Curve
Site: Tuen Mun (TM-RA2)

Acceptance Criteria : Correlation coefficient (r) of the calibration curve greater than 0.990 after a 5-point calibration

The high volume sampler complies* / ~~does not comply*~~ with the specified requirements and is deemed acceptable* / unacceptable* for use.

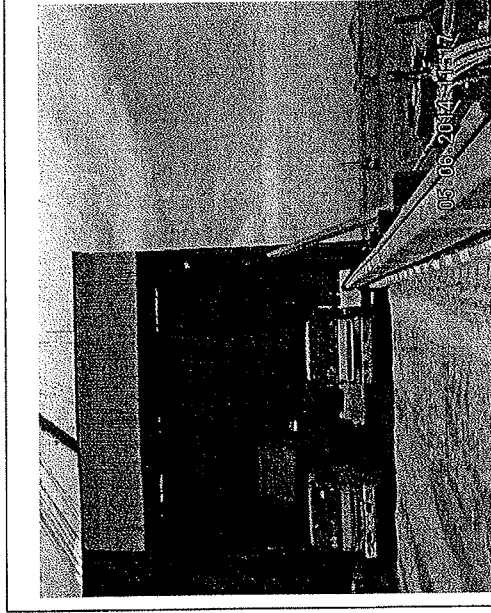
Photo 140605_001 (Tipping hall No.2)
(Improved)

| <i>Date</i> | <i>Key Findings</i> | <i>Action(s) Taken recommended by ET</i> | <i>Action(s) Taken by the Contractor during the site audit</i> | <i>Rectification Status by ET</i> |
|---|---|--|---|---|
| 05 June 2014 | The enclosure of tipping hall No.2 was damaged. (Previous item) | To repair the damaged part of tipping hall properly. | The enclosure of tipping hall No.2 was repaired. | Closed |

| Item | Details of defective works or observations | Proposed Follow Up Action | Photo Ref. | Further Action Required (Yes/No) | Target Completion Date |
|---|---|---|---|---|---|
| 1 | Follow up action to item 1 on 22/05/14 and item 1 on 29/05/14, the enclosure of tipping hall No.2 was repaired. | — | 140605_001 | No | --- |

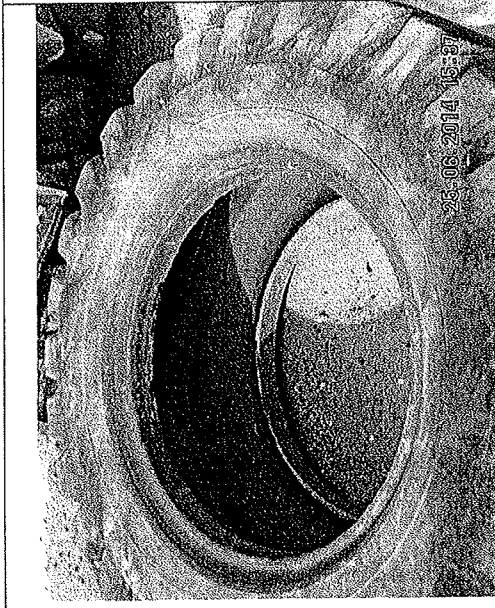
Photo 140625_002 (Workshop)

| Date | Key Findings | Action(s) Taken recommended by ET | Action(s) Taken by the Contractor during the site audit | Rectification Status by ET |
|---|---|---|---|---|
| | Stagnant water was found inside the idle tyre near Workshop. (New item) | To drain the stagnant water out and store the idle tyre properly to avoid accumulation of rain water. | --- | Follow-up |
