**Contract No.: CV/2013/06  
Handling of Surplus Public Fill  
(2014-2016)**

**TUEN MUN AREA 38 FILL BANK  
MONTHLY EM&A REPORT NO.27  
(MARCH 2016)**

Report No.: ENA61280

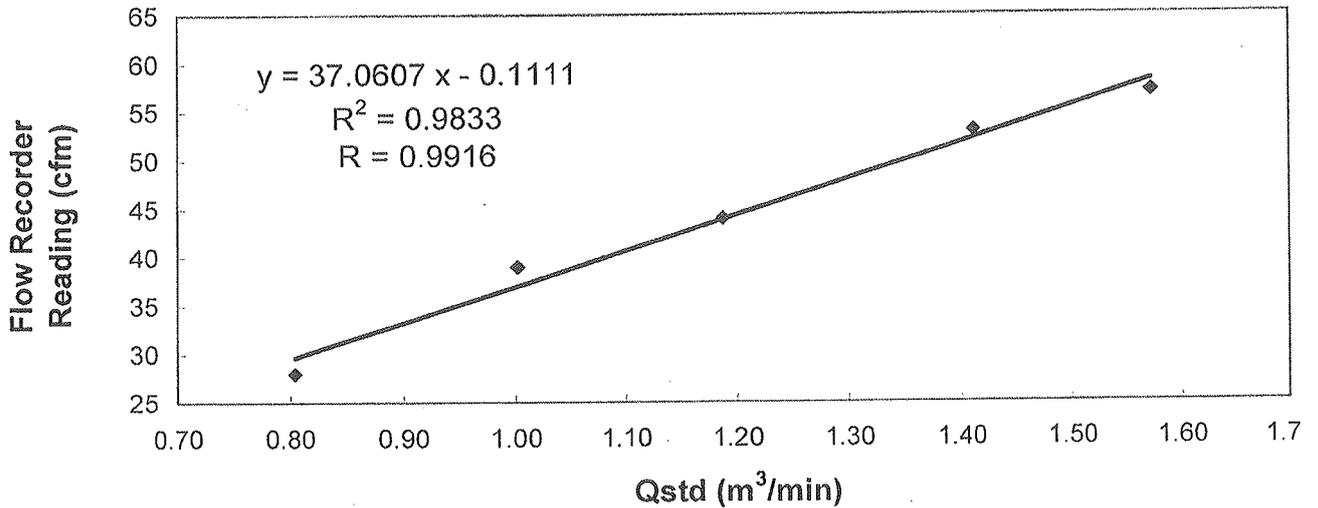
**Sampler 10347 Calibration Curve**  
**Site: Tuen Mun 38 (TM-A1)**

Results	Flow recorder reading (cfm)	57	53	44	39	28
	Qstd (Actual flow rate, m <sup>3</sup> /min)	1.57	1.41	1.19	1.00	0.80
	Pressure : 763.56 mm Hg	Temp. : 295 K

Acceptance Criteria : Correlation coefficient (r) of the calibration curve greater than 0.990 after a 5-point calibration

The high volume sampler complies\* / ~~does not comply\*~~ with the specified requirements and is deemed acceptable\* / unacceptable\* for use.

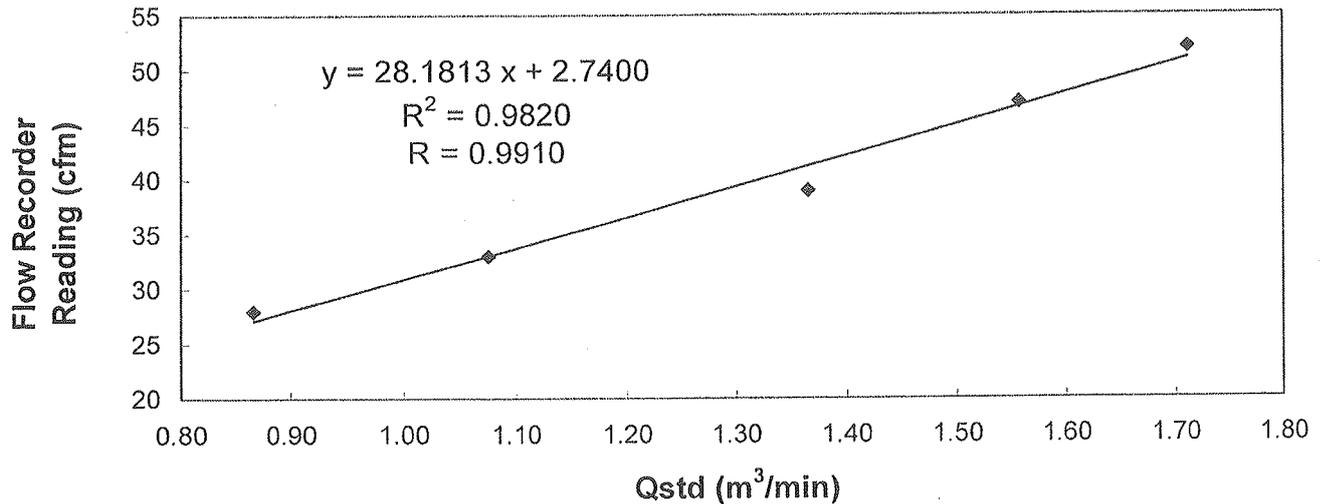
**Sampler 9864 Calibration Curve**  
Site: Tuen Mun (TM-RA2)

Results	Flow recorder reading (cfm)	52	47	39	33	28
	Qstd (Actual flow rate, m <sup>3</sup> /min)	1.71	1.56	1.37	1.08	0.87
	Pressure :	763.56 mm Hg		Temp. :	295 K

Acceptance Criteria : Correlation coefficient (r) of the calibration curve greater than 0.990 after a 5-point calibration

The high volume sampler complies\* / ~~does not comply\*~~ with the specified requirements and is deemed acceptable\* / unacceptable\* for use.

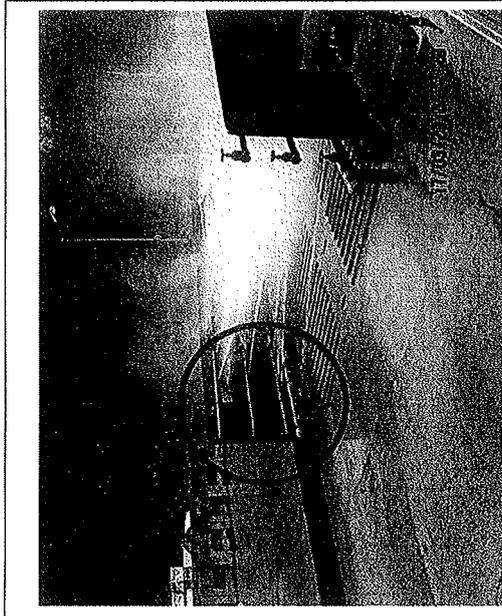
Photo 160317\_001 (Wheel washing bay near site entrance)

17 March 2016	Part of high-pressure water jet of wheel washing bay near site entrance was blocked. (New item)	To repair the blocked high-pressure jet and maintain the wheel washing bay properly.	---	Follow-up

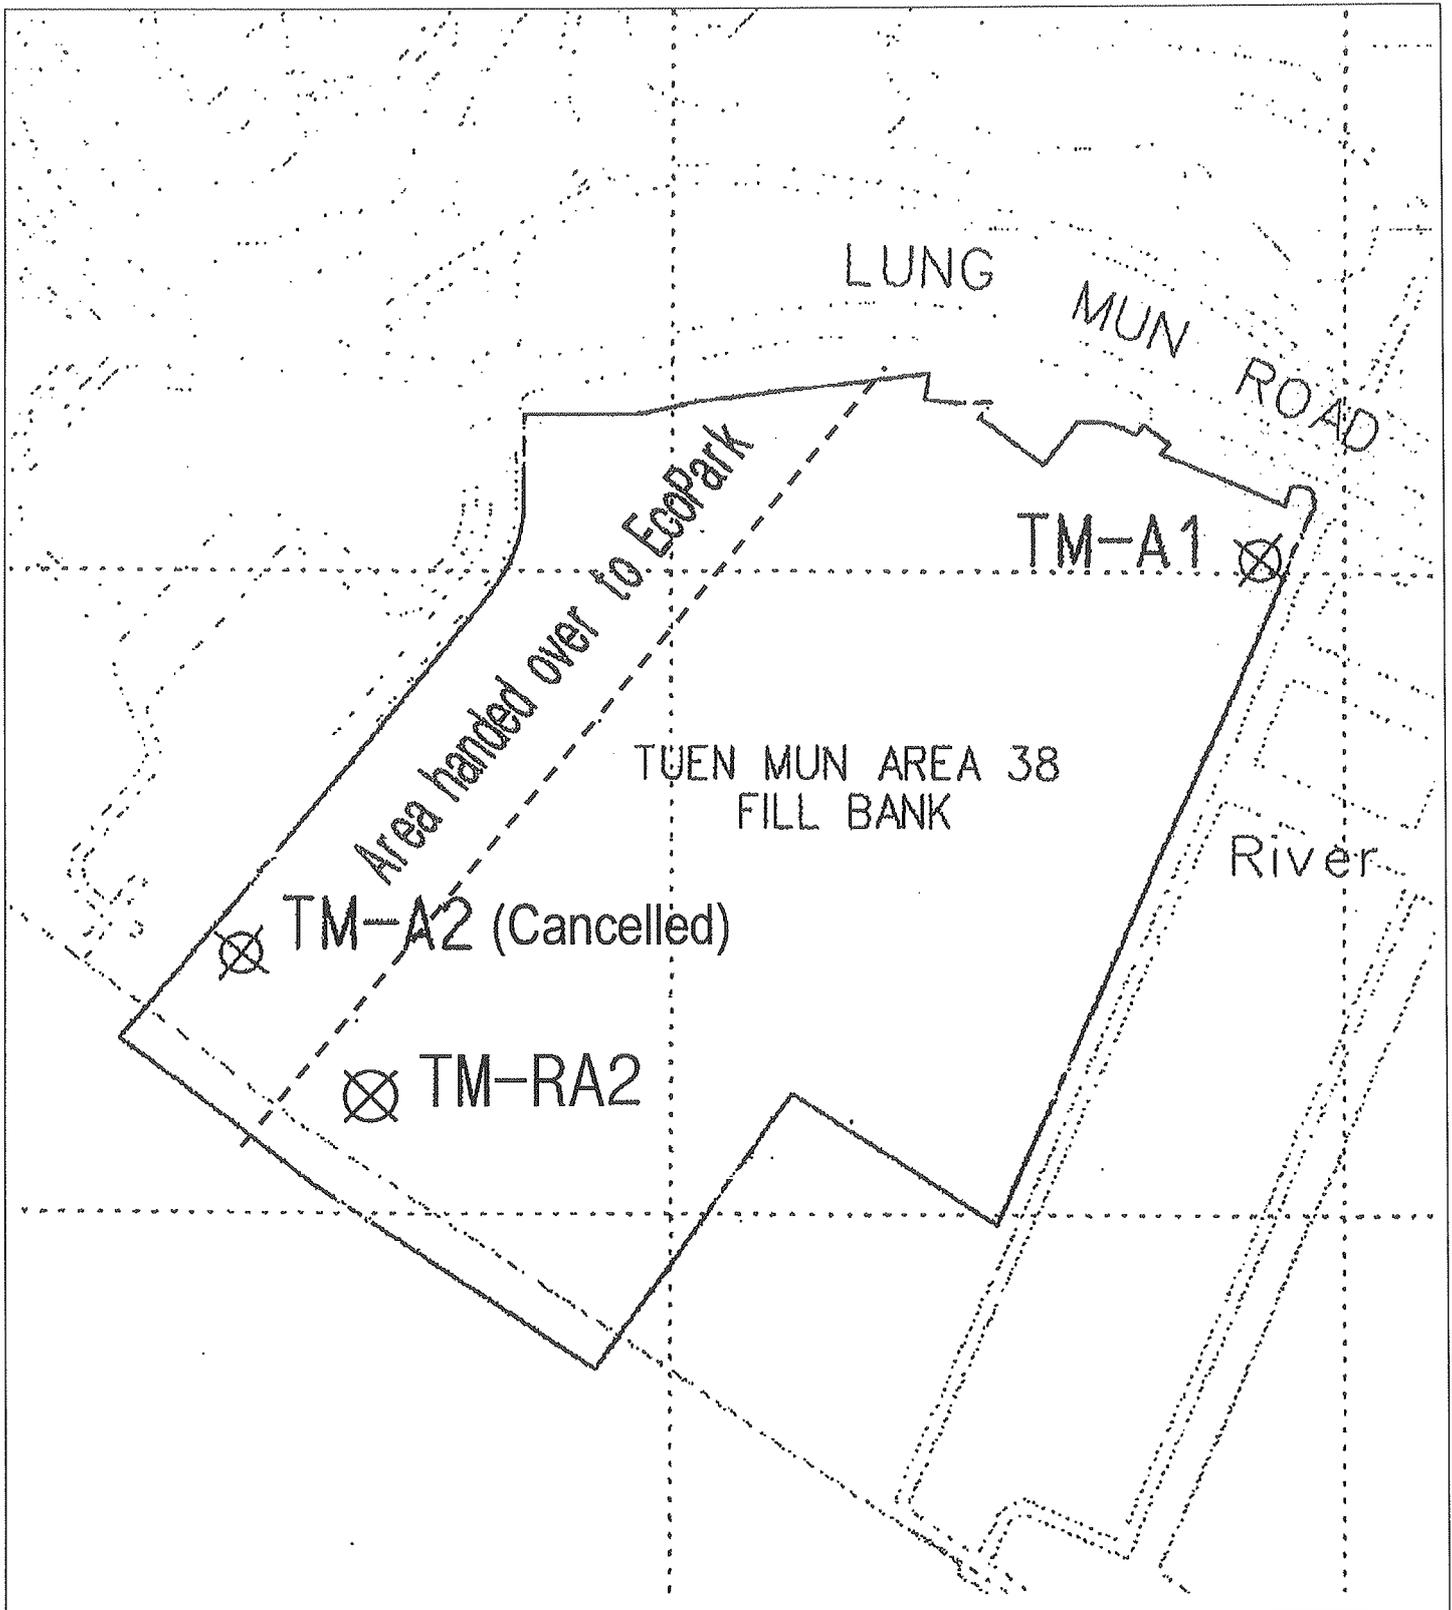
Figure 1  
 Locations of Air Quality Monitoring Stations –  
 Tuen Mun Area 38 Fill Bank

Remark (\*): Since the area for existing air monitoring station TM-A2 near Tipping Hall No.1 was handed over to EcoPark, air monitoring station TM-A2 was cancelled and the air monitoring was carried out at an alternative air monitoring station TM-RA2 from 28 October 2008. Since dust monitoring stations TM-A2 and TM-RA2 are located close to the major dust emission sources and no significant difference between them on the prevailing meteorological conditions, the baseline data from TM-A2 can also be valid in the case of TM-RA2.

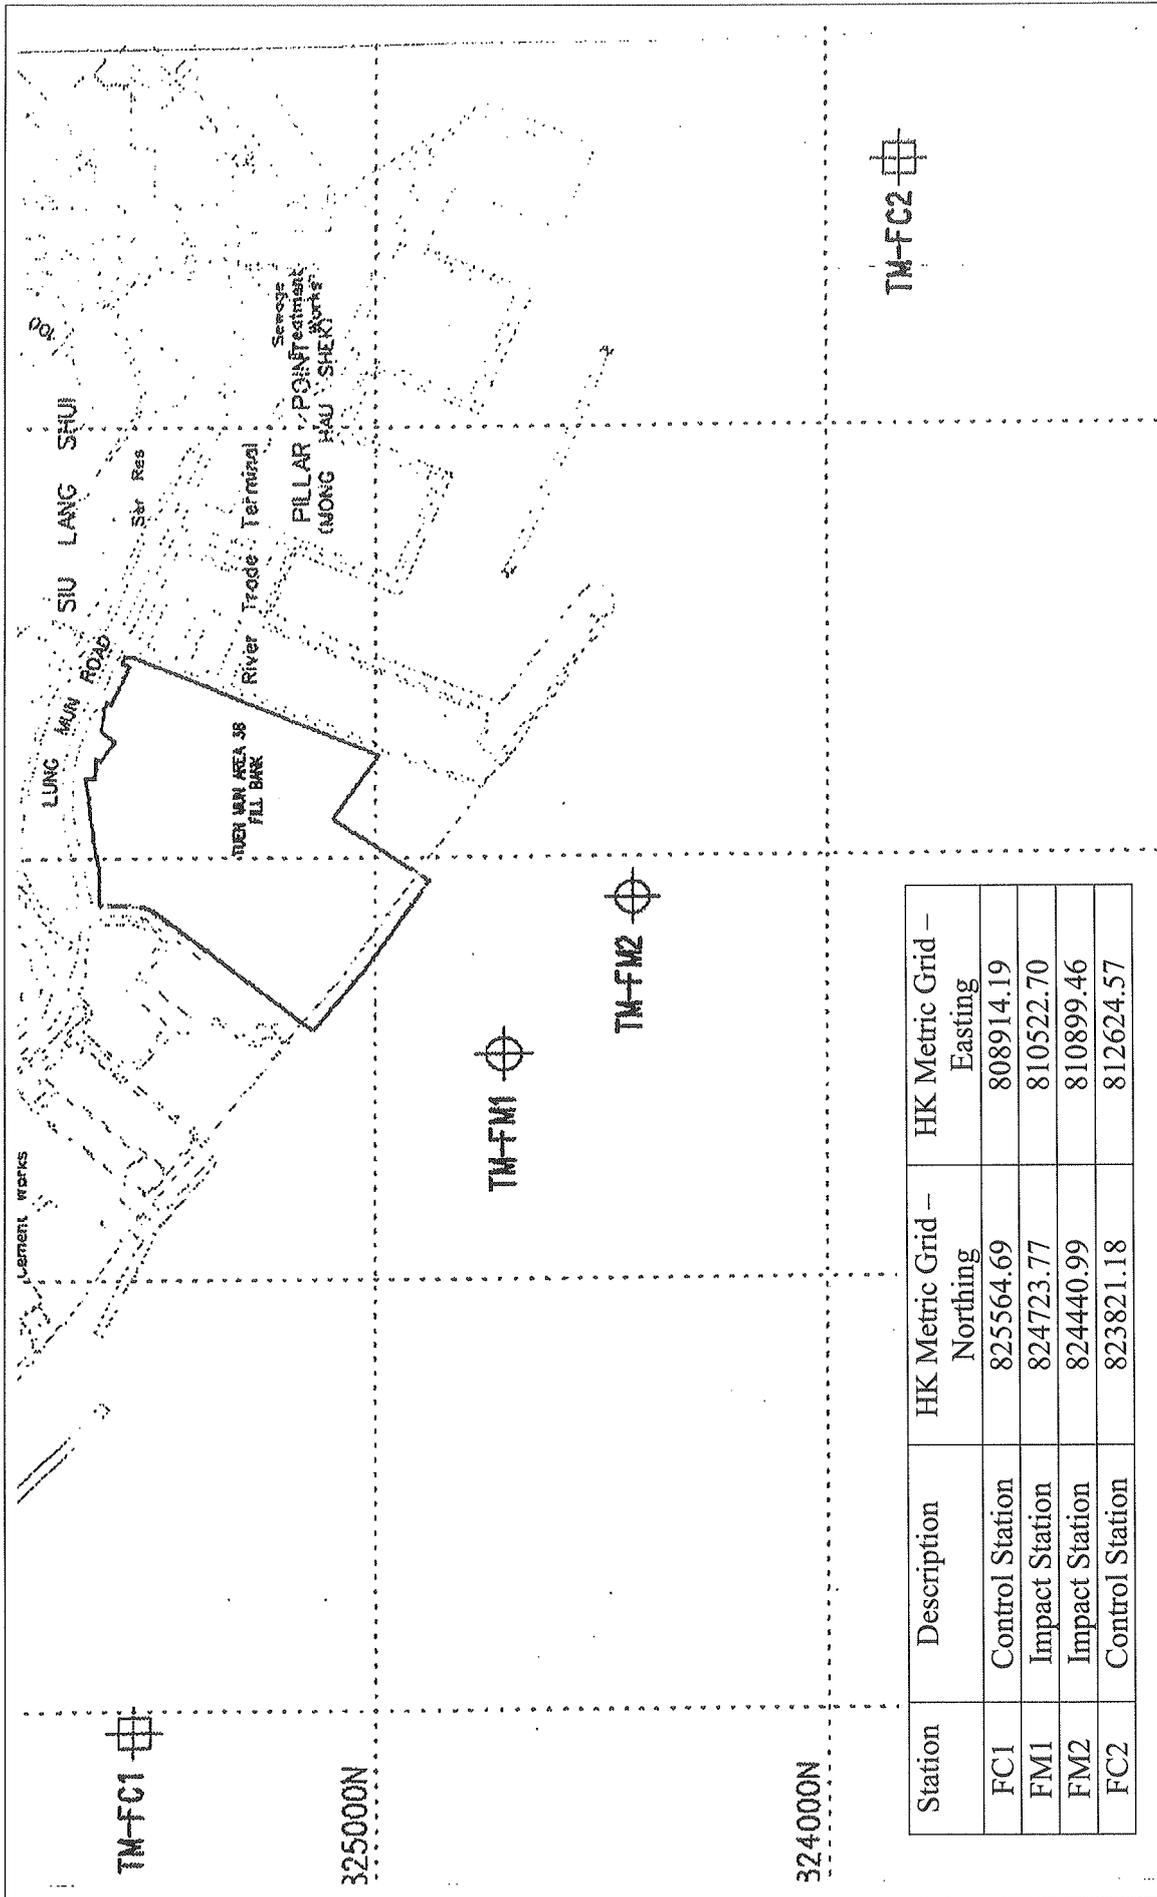
Station	Description	HK Metric Grid – Northing	HK Metric Grid – Easting
FC1	Control Station	825564.69	808914.19
FM1	Impact Station	824723.77	810522.70
FM2	Impact Station	824440.99	810899.46
FC2	Control Station	823821.18	812624.57

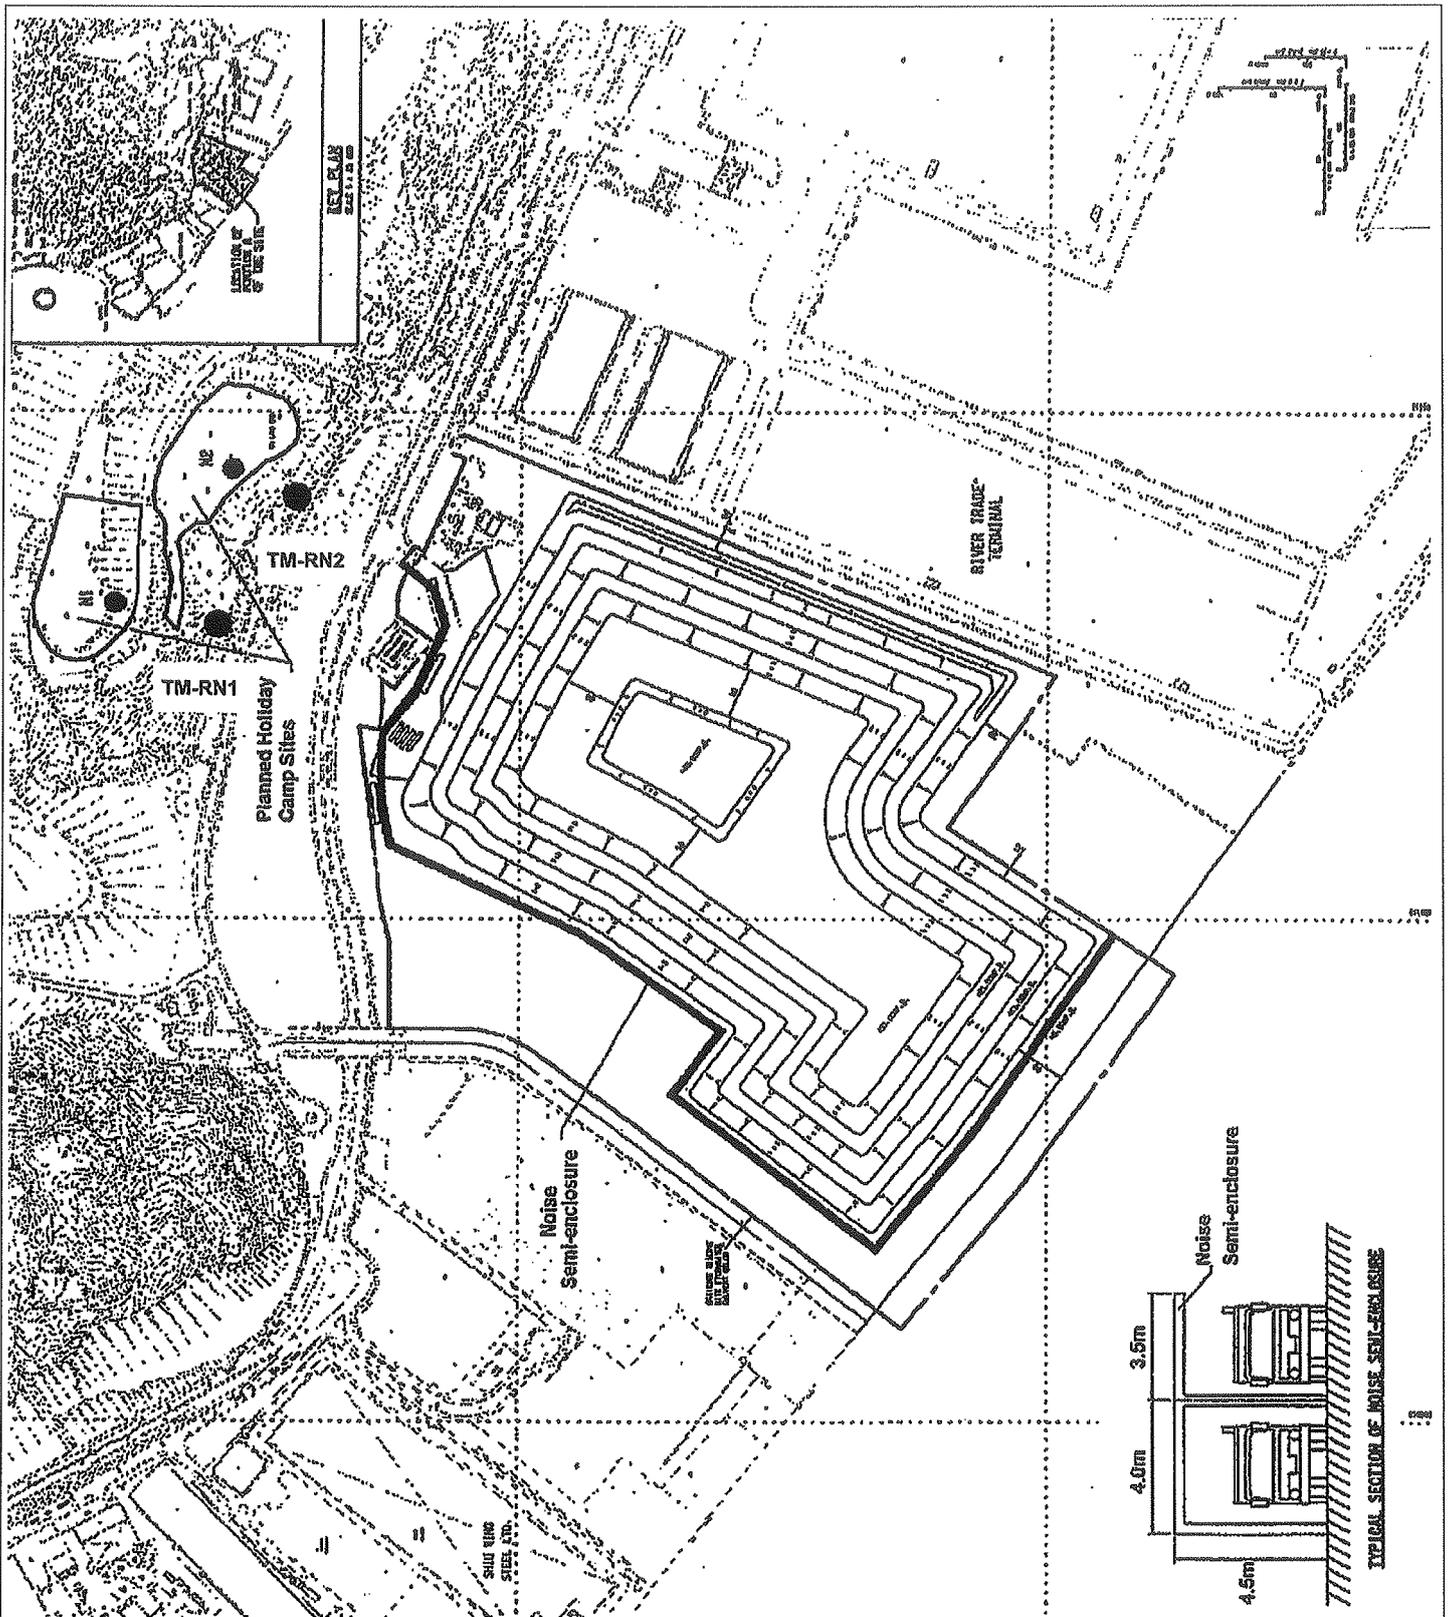
Figure 3  
 Locations of Noise Quality Monitoring Stations –  
 Tuen Mun Area 38 Fill Bank

Since Lands Dept did not approve to carry out noise monitoring at their own area where the noise monitoring stations TM-N1 and TM-N2 located due to the security, noise monitoring carried out at two noise monitoring stations TM-RN1 and TM-RN2 (refer to the figure 3 attached) from 18 December 2007.

The noise monitoring locations, TM-RN1 and TM-RN2 are shown in Figure 3. The noise measurement at TM-RN1 and TM-RN2 are façade measurement.

Remark: Since Lands Department did not approve us to enter their own area where the noise monitoring stations TM-N1 located due to the security, noise monitoring was carried out at noise monitoring stations TM-RN1 (refer to the figure 3 attached) in this reporting month.

Remark: Since Lands Department did not approve us to enter their own area where the noise monitoring stations TM-N2 located due to the security, noise monitoring was carried out at two noise monitoring stations TM-RN2 (refer to the figure 3 attached) in this reporting month.
