**Contract No.: CV/2013/06  
Handling of Surplus Public Fill  
(2014-2016)**

**TUEN MUN AREA 38 FILL BANK**

**MONTHLY EM&A REPORT NO.33**

**(SEPTEMBER 2016)**

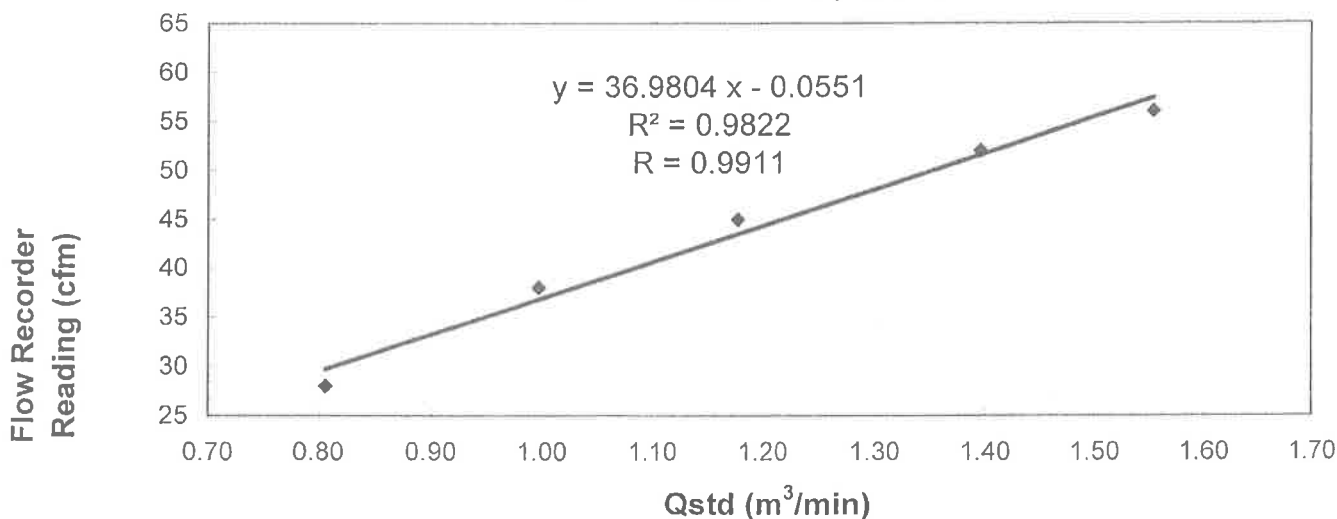
**Sampler 10347 Calibration Curve**  
**Site: Tuen Mun 38 (TM-A1)**

Flow recorder reading (cfm)	56	52	45	38	28
Qstd (Actual flow rate, m <sup>3</sup> /min)	1.55	1.40	1.18	1.00	0.81
Pressure :	747.06 mm Hg		Temp. :	299 K

Acceptance Criteria : Correlation coefficient (r) of the calibration curve greater than 0.990 after a 5-point calibration

The high volume sampler complies\* / ~~does not comply\*~~ with the specified requirements and is deemed acceptable\* / unacceptable\* for use.

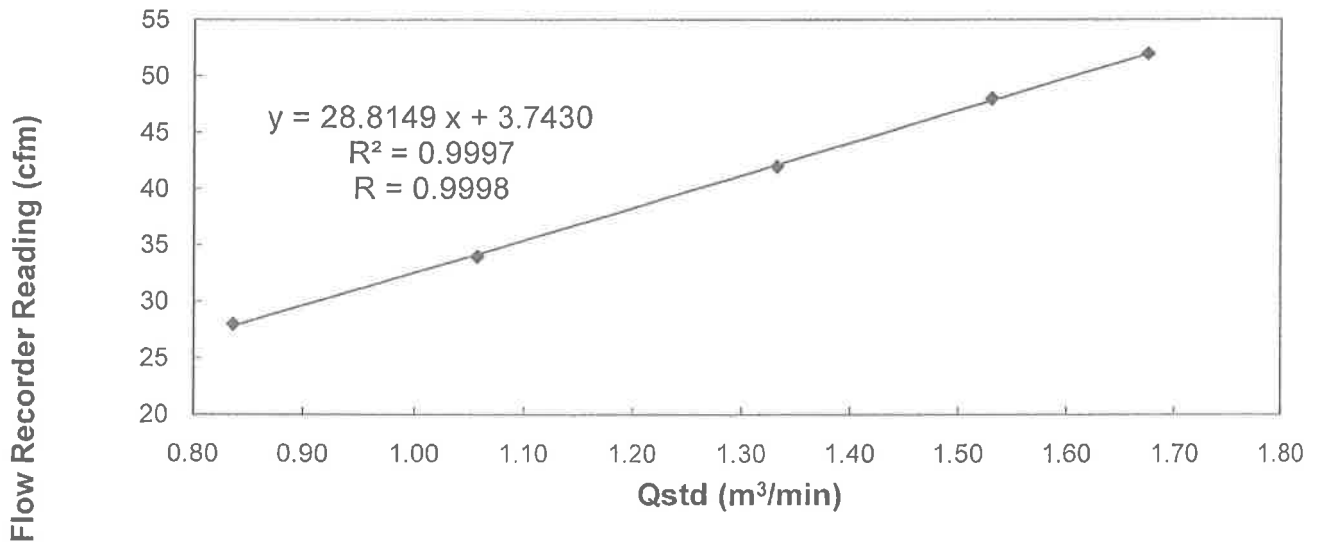
**Sampler 9864 Calibration Curve**  
**Site: Tuen Mun (TM-RA2)**

<b>Results</b>	Flow recorder reading (cfm)	52	48	42	34	28
	Qstd (Actual flow rate, m <sup>3</sup> /min)	1.67	1.53	1.33	1.06	0.84
	Pressure :                      747.06 mm Hg	Temp. :                      299 K

Acceptance Criteria : Correlation coefficient (r) of the calibration curve greater than 0.990 after a 5-point calibration

The high volume sampler complies\* / ~~does not comply\*~~ with the specified requirements and is deemed acceptable\*/ unacceptable\* for use.

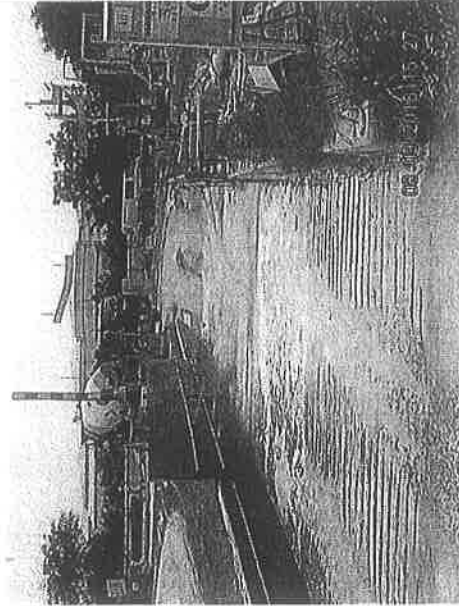
Photo 160908\_001 (Wheel washing bay before weighbridge B3)

Date	Key Findings	Action(s) Taken recommended by ET	Action(s) Taken by the Contractor during the site audit	Rectification Status by ET
01 September 2016	Several holes of high-pressure water jets of wheel washing bay before weighbridge B3 were found out of order. (New item)	To check and repair properly.	---	Follow-up
08 September 2016	Several holes of high-pressure water jets of wheel washing bay before weighbridge B3 were found out of order. (Previous item)	To check and repair properly.	---	Follow-up
	Stagnant water was found inside the new wheel washing bay before weighbridge B3. (New item)	To apply pesticide to avoid mosquito breeding.	---	Follow-up
	Stagnant water was found inside the bucket of excavator at plant maintenance area. (New item)	To clear the stagnant water or apply pesticide to avoid mosquito breeding.	---	Follow-up
15 September 2016	Several holes of high-pressure water jets of wheel washing bay before weighbridge B3 were found out of order. (Previous item)	To check and repair properly.	The defect holes of high-pressure water jets of wheel washing bay before weighbridge B3 were repaired.	Closed

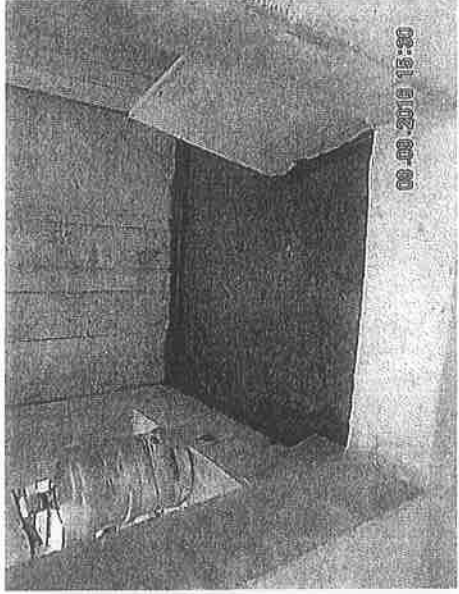
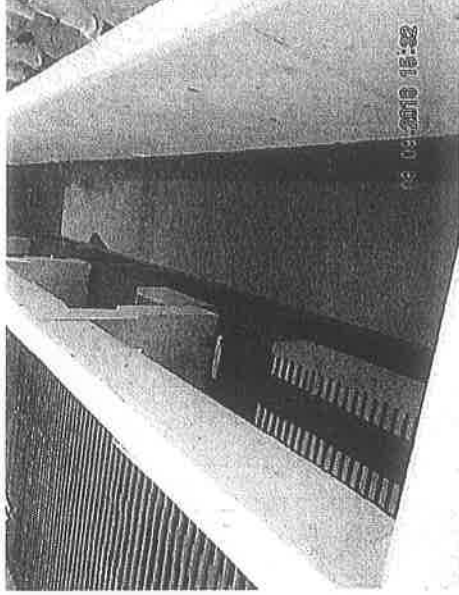
Photo 160908\_002 (New wheel washing bay before weighbridge B3)

Stagnant water was found inside the new wheel washing bay before weighbridge B3. (Previous item)	To apply pesticide to avoid mosquito breeding.	No stagnant water was observed since related section of the new wheel washing bay had been removed. However, pesticide was applied to stagnant water inside the existing new wheel washing bay.	Closed
	Stagnant water was found inside the bucket of excavator at plant maintenance area. (Previous item)	To clear the stagnant water or apply pesticide to avoid mosquito breeding.	No stagnant water was found inside the bucket of excavator at plant maintenance area.	Closed
	Rubbish, such as plastic bottle and sheets, were discarded on the ground beside the haul road near site entrance. (New item)	To collect and dispose of the rubbish properly.	---	Follow-up
22 September 2016	Rubbish, such as plastic bottle and sheets, were discarded on the ground beside the haul road near site entrance. (Previous item)	To collect and dispose of the rubbish properly.	Rubbish, such as plastic bottle and sheets, discarded on the ground beside the haul road near site entrance were collected.	Closed

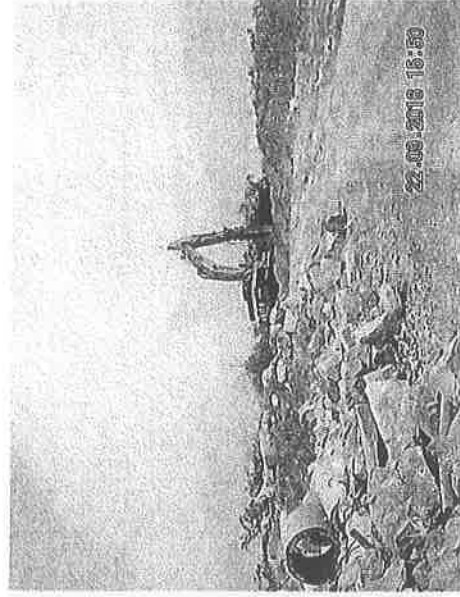
Photo 160922\_002 (Asphalt area)

Black smoke was observed emit from an excavator at asphalt area. (New item)	To stop to use the defect excavator until repaired properly.	---	Follow-up
29 September 2016	Black smoke was observed emit from an excavator at asphalt area. (Previous item)	To stop to use the defect excavator until repaired properly.	No black smoke was observed emit from an excavator at asphalt area.	Closed
	Dry mud zone was noted dusty. (New item)	To water the dry mud zone properly to avoid dust generation.	---	Follow-up
